Arboricultural Report (ver 6)

Elmsall House

Ellerker

July 2021

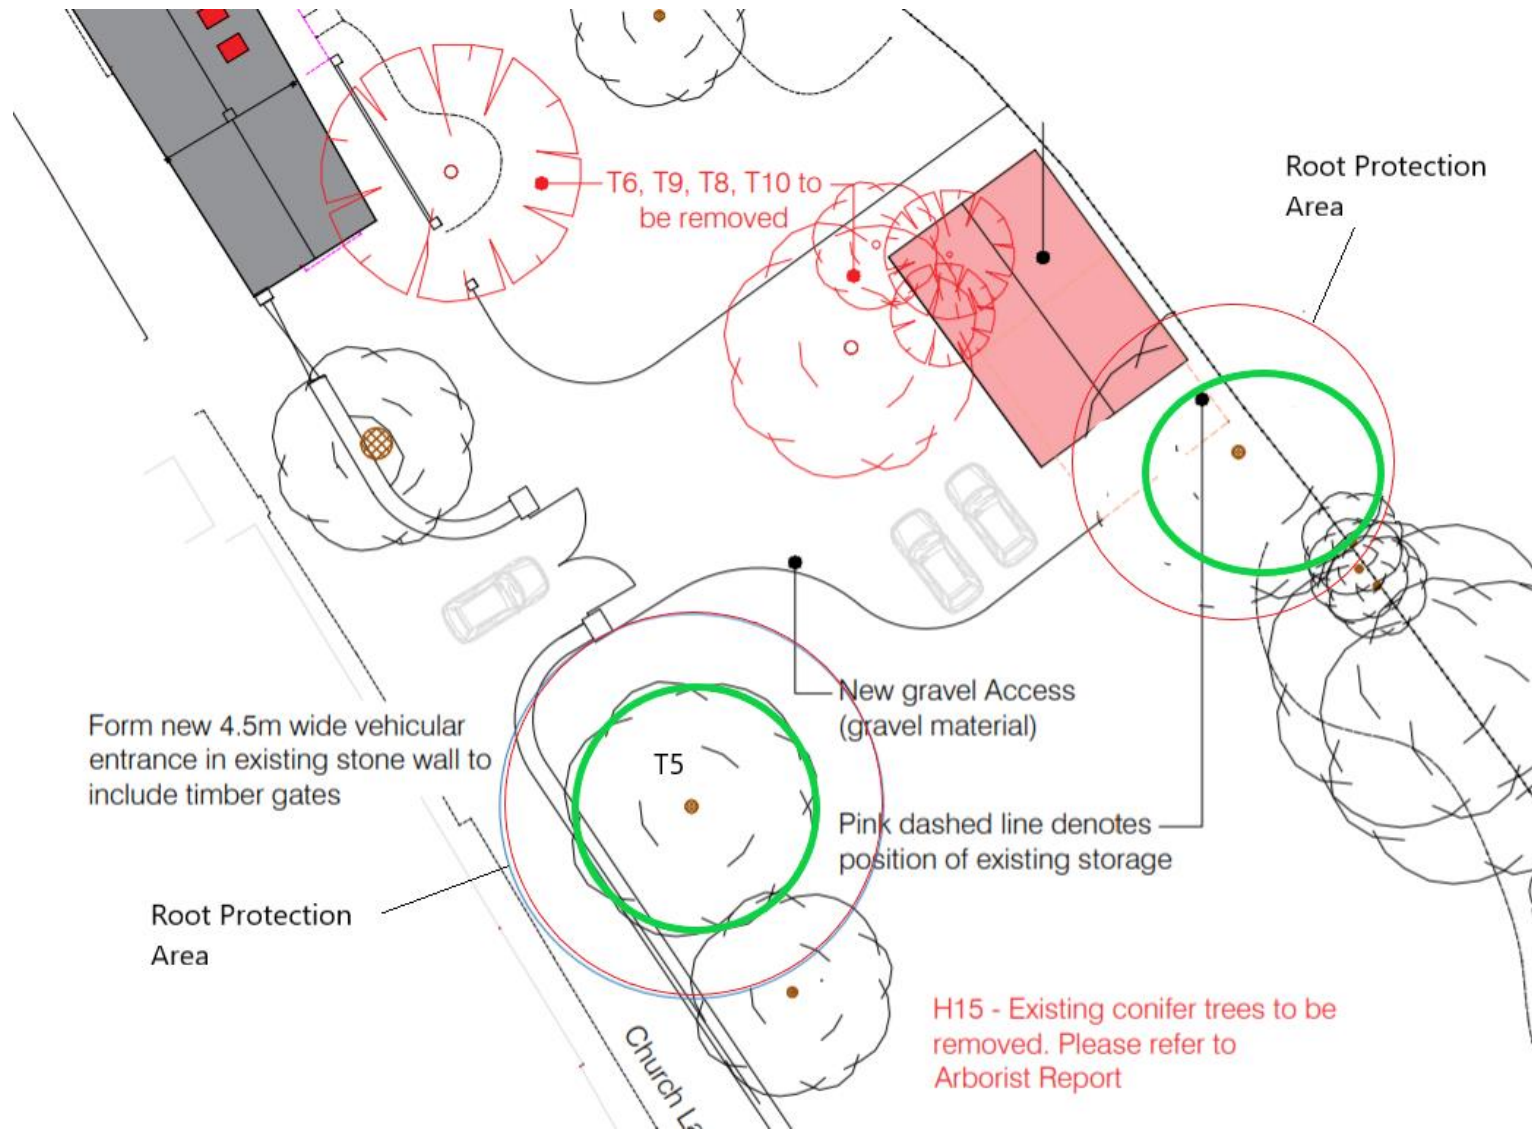
4.0 ARBORICULTURAL IMPLICATIONS ASSESSMENT - Proposed Layout – Plan 2A

The proposed garage / workshop would extend just within the root protection area for the sycamore tree (T11). However, given the age, species and the very small percentage of encroachment this would not have any significant impact on the tree. The building is also going to be further away from the tree than the existing garage.

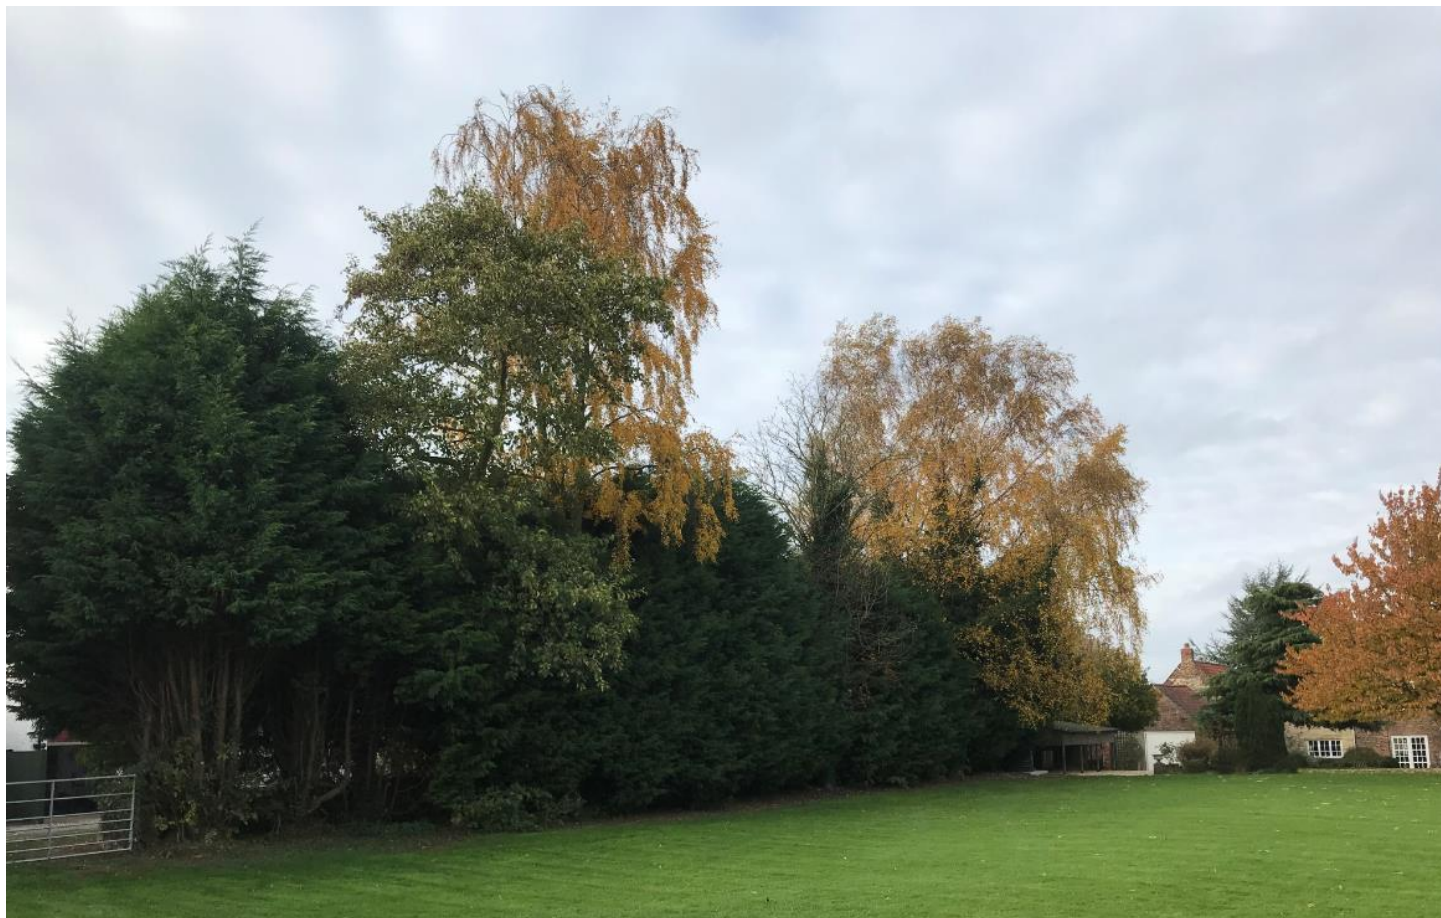
The proposal seeks to remove the overgrown Leyland cypress hedge (H15) illustrated in the photograph below. All the trees along the frontage of the plot will be retained.

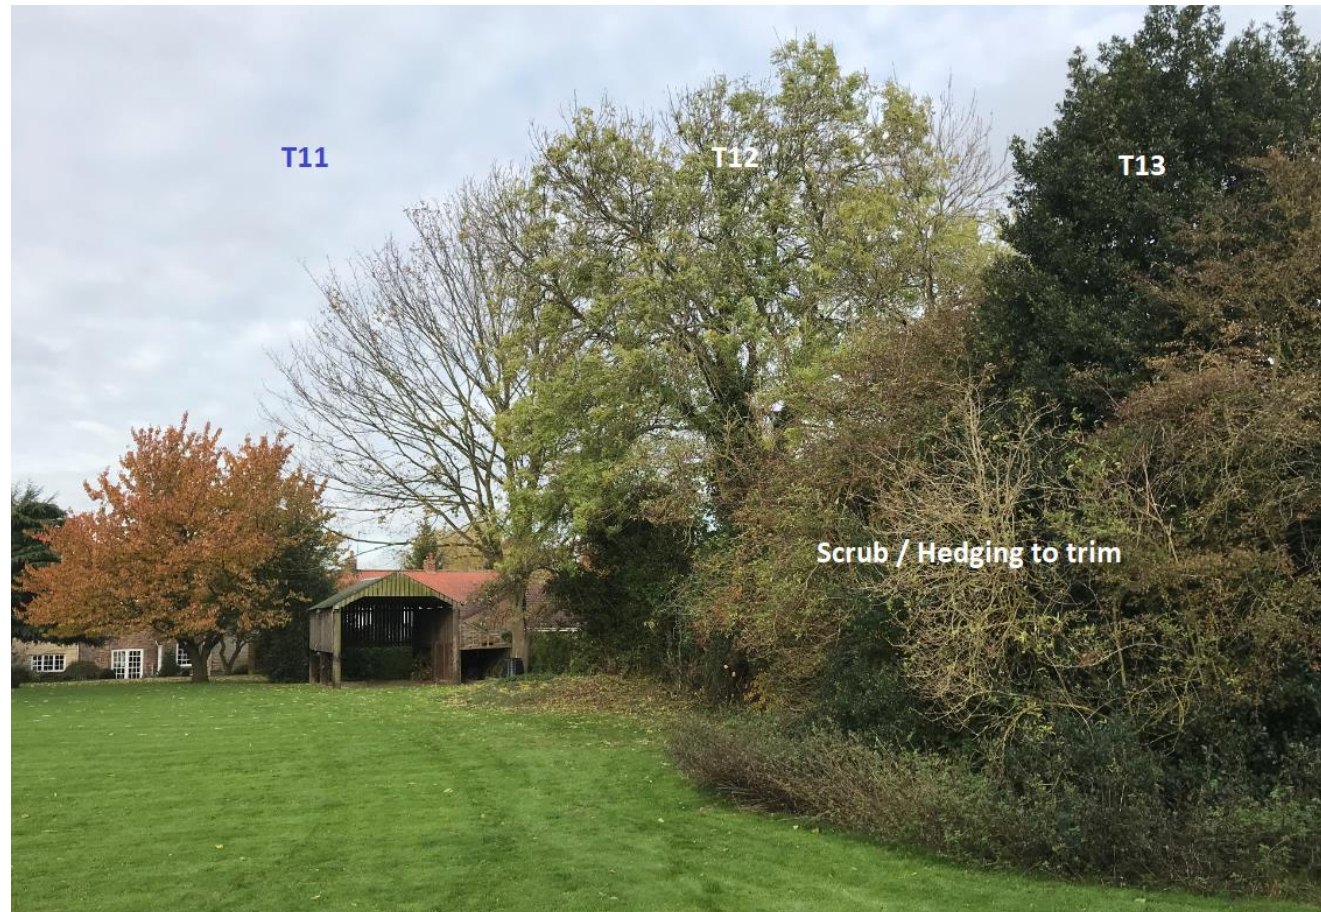
The proposal seeks to retain all the trees along the eastern boundary. The cedar tree (T6) is proposed to be removed to improve the main views down the garden from the rear of the property. Trees T8, T9 and T10 to be removed for the proposed workshop and garage.
