Client **THE SEZINCOTE ESTATE**
 Project **THE PIGGERIES HOME FARM SEZINCOTE ESTATE MORETON-IN-MARSH**
 Drawing **BARN 2 ROOF STRUCTURE PLAN SECTIONS & DETAILS**

Status **CONSTRUCTION**
 Scale **1:50 UNO** Leaf **A1**
 Drawn **J.T.** Date
 Checked Date
 Project No. **19055**
 Drawing No. **41** Revision **D**

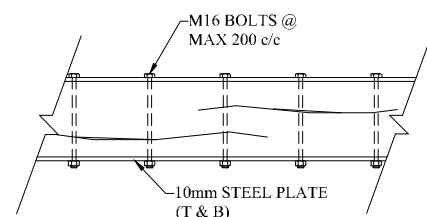
DETAIL 1 - TYPICAL BOLT AND PLATE REPAIR TO TRUSS (1:10)

EXISTING TRUSS TO RECEIVE BOLTS AND PLATES FOR SHAKES (SEE DETAIL 1) SHOWN THUS: *

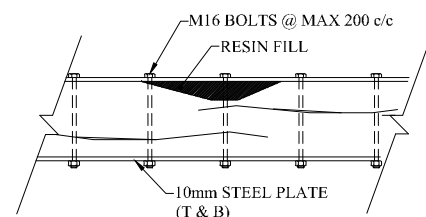
DETAIL 2 - TYPICAL BOLT AND PLATE REPAIR WITH RESIN INFILL (1:10)

EXISTING TRUSS TO RECEIVE BOLTS AND PLATE FOR SHAKES WITH RESIN INFILL (SEE DETAIL 2) SHOWN THUS: #

- Repair purlins suffering from shakes through grouting shakes with sikadur 32 hi-mod epoxy adhesive (or similar) and bolting as required.
- Realign trusses & purlins.

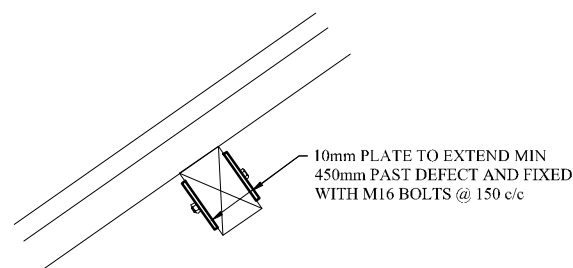
DETAIL 3 - TYPICAL BOLT AND PLATE REPAIR WITH RESIN INFILL (1:10)

EXISTING PURLIN TO RECEIVE BOLTS & PLATES TO DAMAGED AREA (SEE DETAIL 3) SHOWN THUS: \$

- Stiffen existing purlins suffering from excessive deflection with bolted steel plates top and bottom, see detail.
- Repair existing truss where severe wet rot has occurred in principal rafter by splicing in a new section of timber, with timber to match existing and sikadur 32 hi-mod epoxy adhesive (or similar).
