ENGINEER'S INSPECTION REPORT

BARN NORTH OF CZAR TREES

SCHOOL ROAD

TERRINGTON ST JOHN

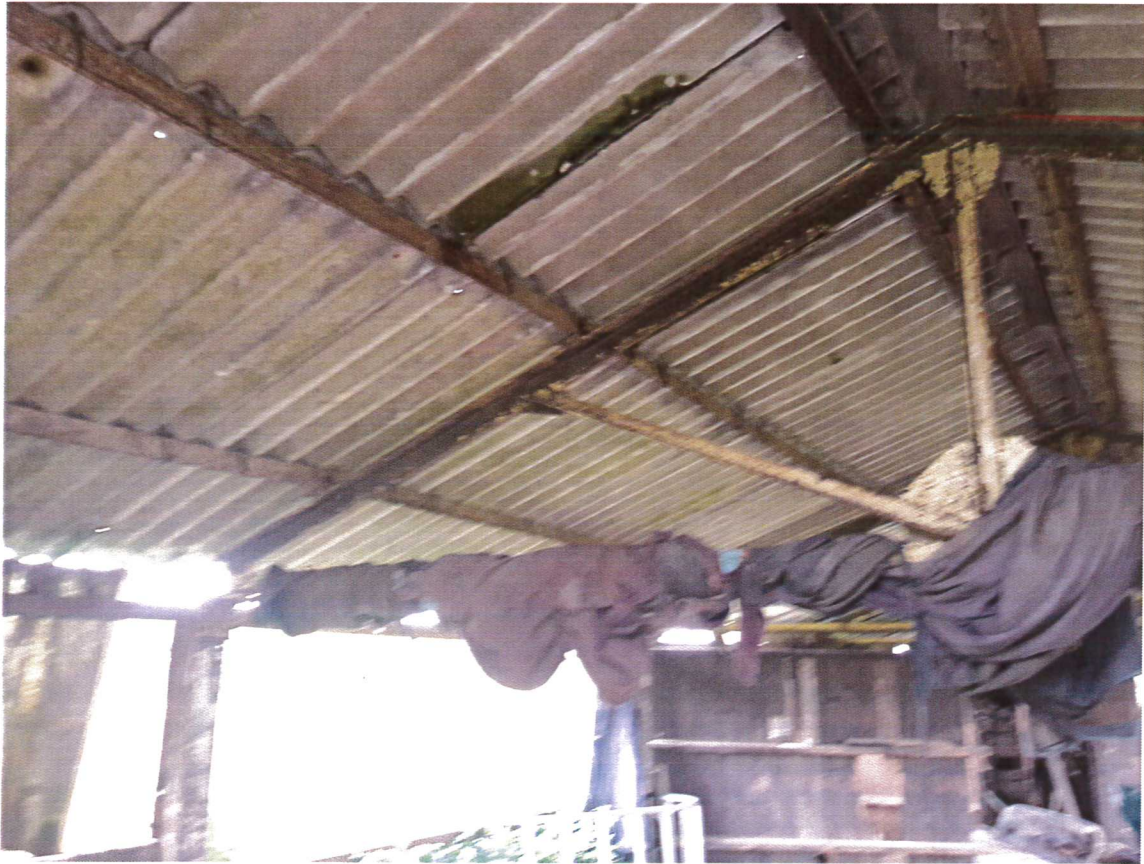
H7715-5

The structure comprised five steel frames. These were all similar with a steel angle truss supporting steel purlins with asbestos cement sheeting over. The stanchions were a 203 x 152 RSJ with two further steel angle cladding rails at eaves and halfway in the elevation.

There was some corrosion but this was largely at the surface.

The roof trusses would need to be cut out to facilitate headroom and thus some internal adjustment would be required to the roofing forming a new crank beam in lieu of the trusses.

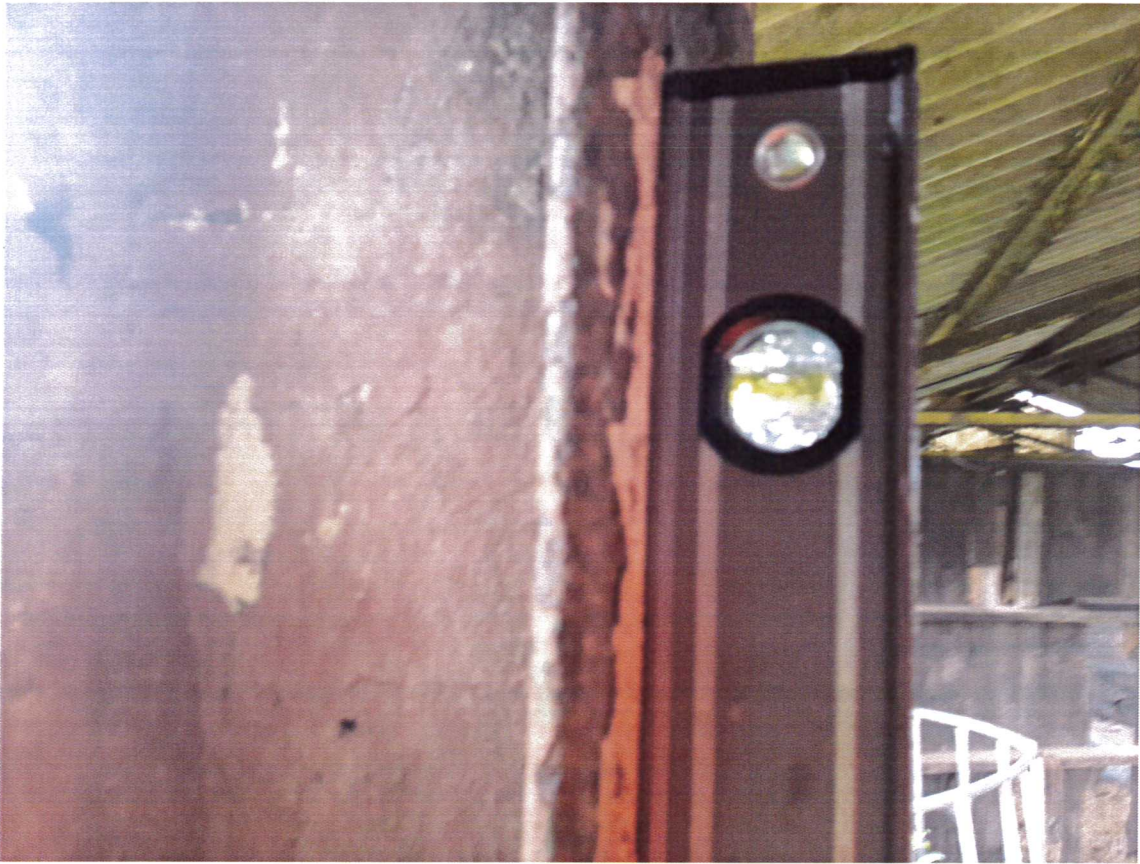
H7715-7

Spirit levels were placed on the framework which was reasonably aligned.

Although on first appearances the building had a dilapidated appearance, the actual steel framed structure was reasonably aligned.

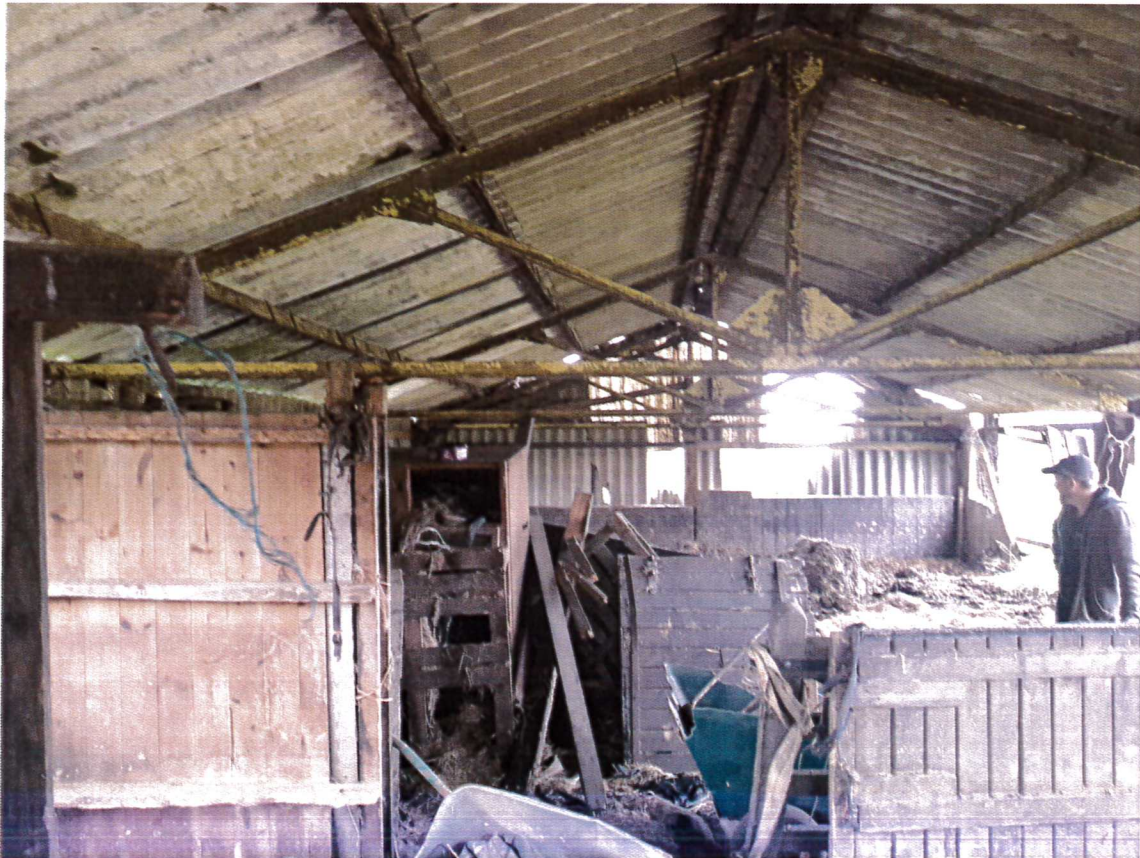
H7715-8

To the rear gable there was a central stanchion and there were two similar stanchions either side of a front entrance. These were reasonably aligned and were measured as 152 x 76 RSC.
