Proposed Window Replacement at 56 Devonshire Road, Aberdeen

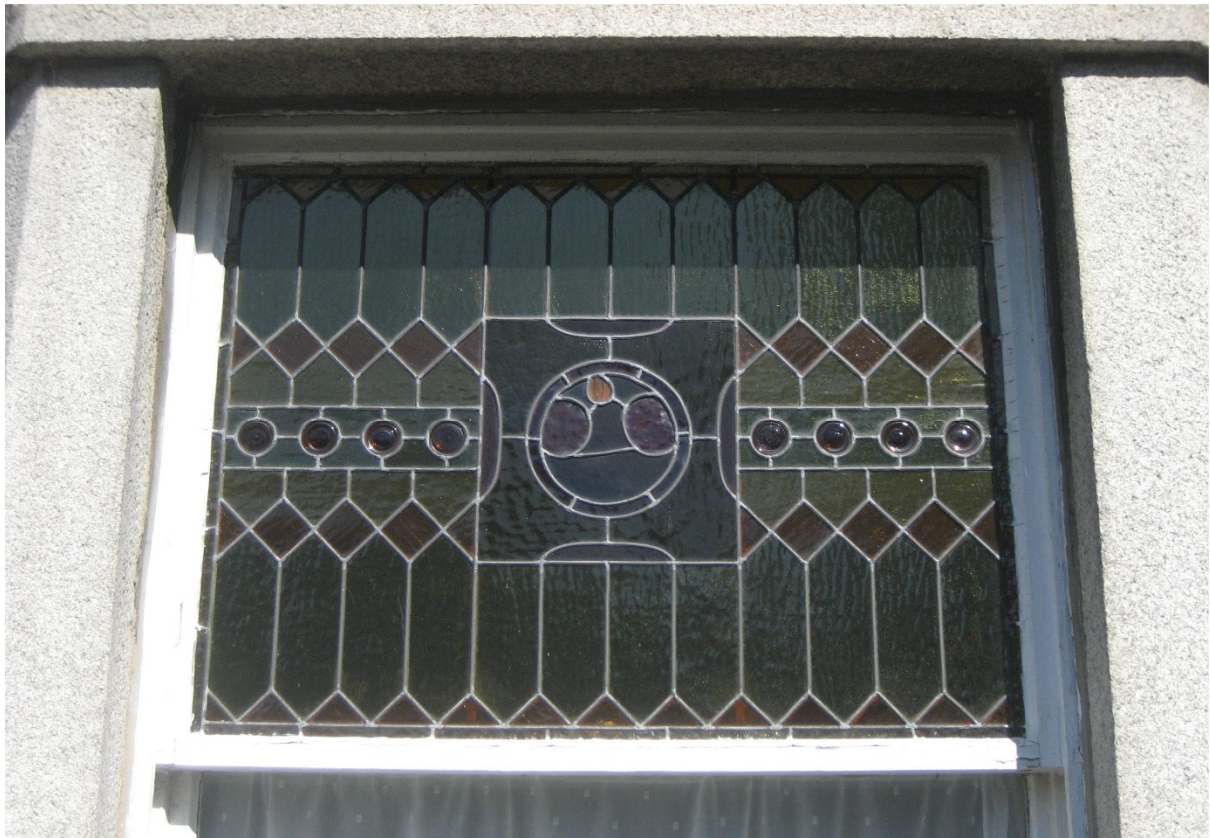
Existing Lounge (W2) Bay Window showing the existing Lead detailing. The lead detailing is going to be carefully removed from the existing sash and placed within additional new frame (not within the new sash) that will sit inside the new windows. The existing windows are beyond repair as the frames are all warped and let in a huge amount of draught, the windows currently have timber wedges placed between the sashes and the frame to try and prevent air ingress (see photo below)

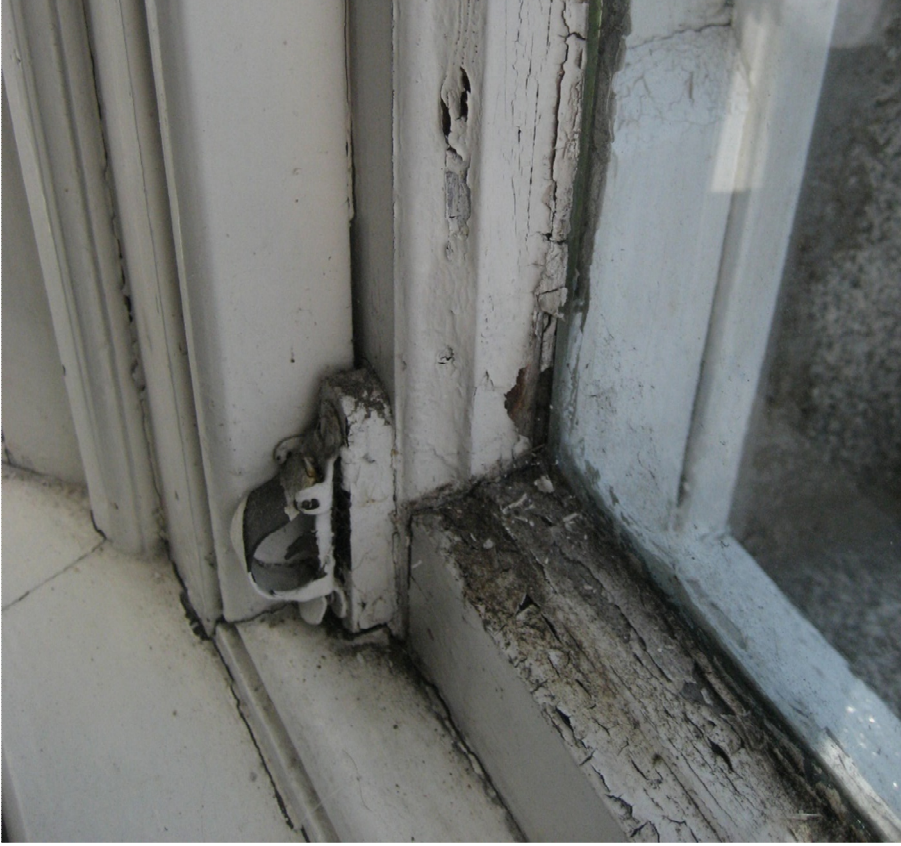
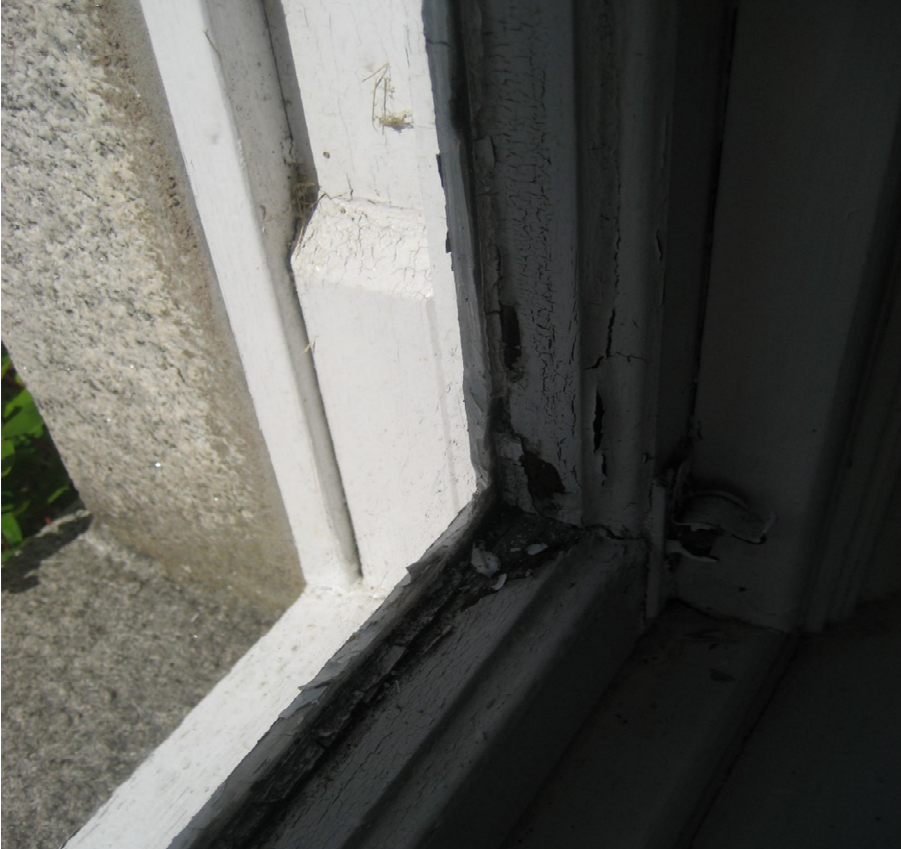
The existing frames are rotten through and are beyond repair.

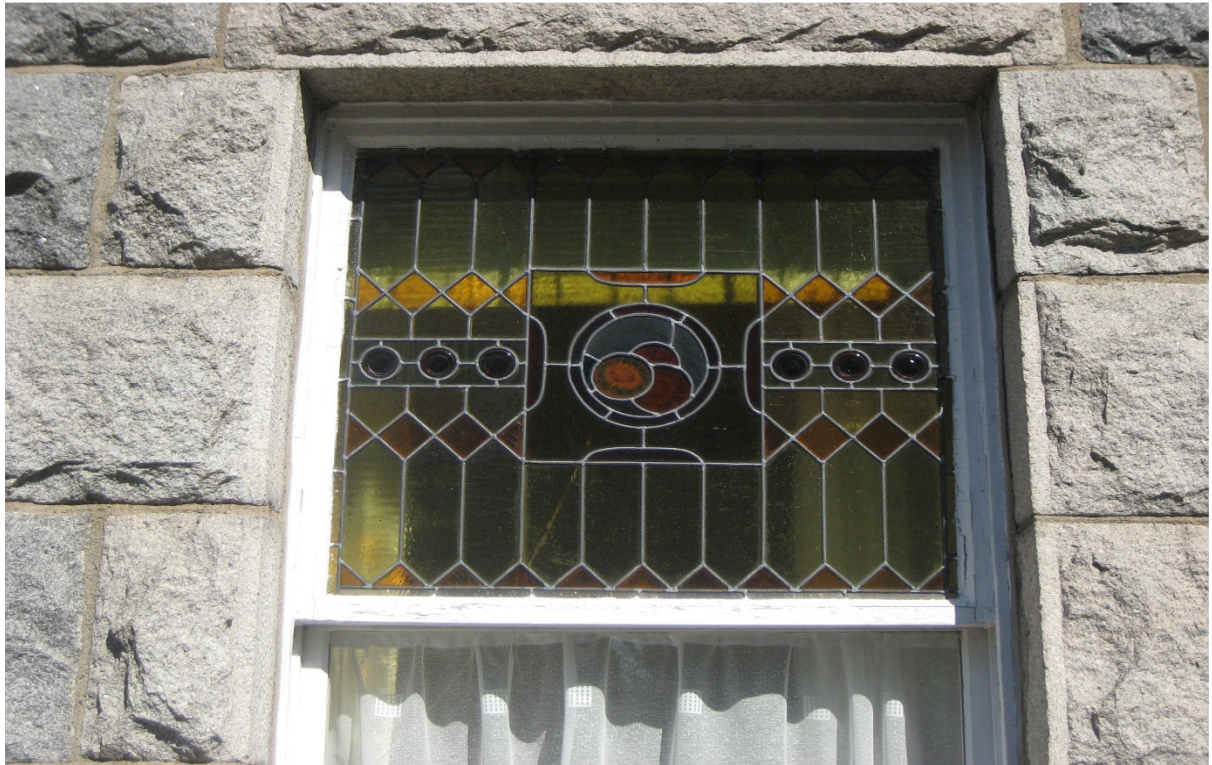
Existing Bedroom (W4) Window showing the existing Lead detailing. The lead detailing is going to be carefully removed from the existing sash and placed within additional new frame (not within the new sash) that will sit inside the new windows

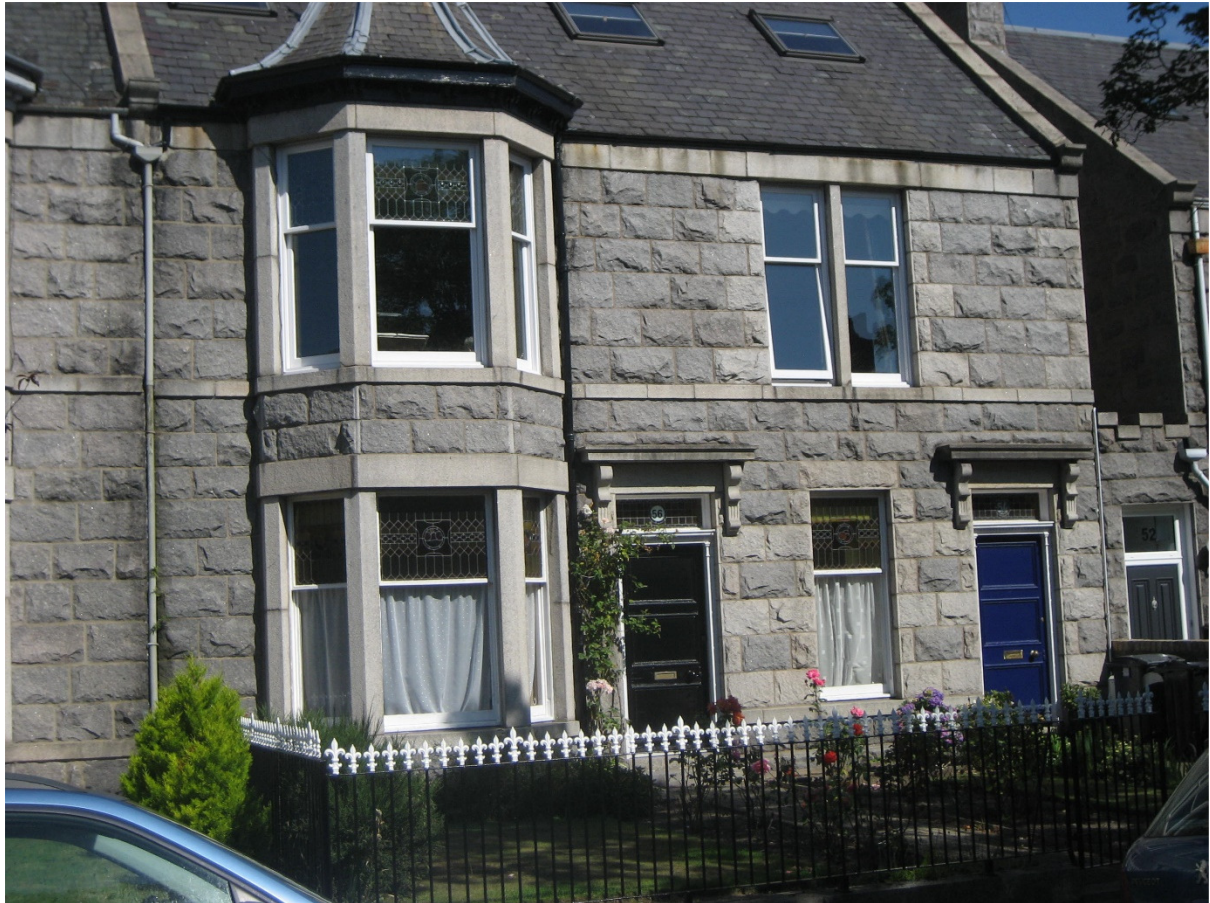
The existing frontage for 54 & 56 Devonshire Road.

The flat above (No.54) has had the same process done to the Lead detailing as the client is proposing for his new windows – in fact, No. 54 will be carrying out the Lead detailing work.
