EXISTING STEPS NO.02 - URN AND PIER

HABERDASHER'S SCHOOL Job No: 9756-1 9756-1 P(0)1001 May 2021 1:50 & 1:20 @A3 Checked: GQ NCB 7 BISHOP'S TERRACE LONDON SE11 4UE GILES QUARME ARCHITECTS
(Chartered Architects)

PLAN WITH REPAIRS/REBUILDING - 1:50@A3

**EXISTING TERRACE STEPS NO.02:**

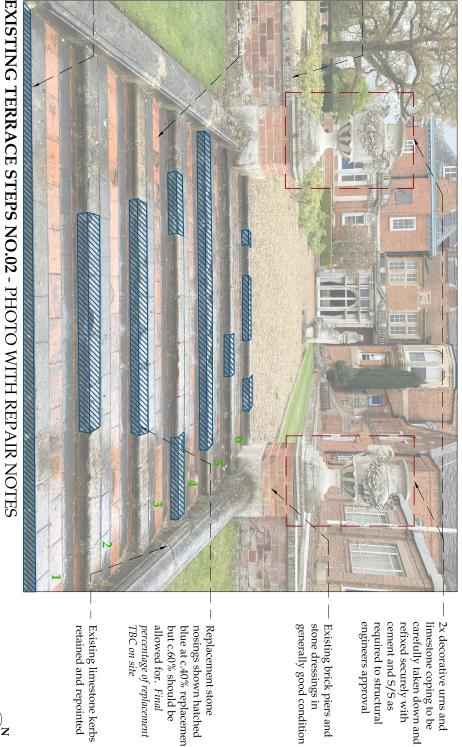
generally in good condition and are to

Existing engineering brick treads are

not included in works. To be

Existing low walls

step 01 missing. Stone nosing to bottom

blue engineering and red brick. Mostly in good condition with

alternating courses of

some bricks requiring replacement with

missing to tread no.1. Limestone nosing 840

replaced with new

section to match

repointed at a later repaired and and stone copings

> repointed be retained and

profiles to upper New to match nosing
