Mrs S Lewis
Stable Cottage
Westend
Wickwar
GL12 8JZ

23 August 2021

TREE CONDITION INSPECTION REPORT. Single Mature Horse Chestnut (to the right of the back gate)

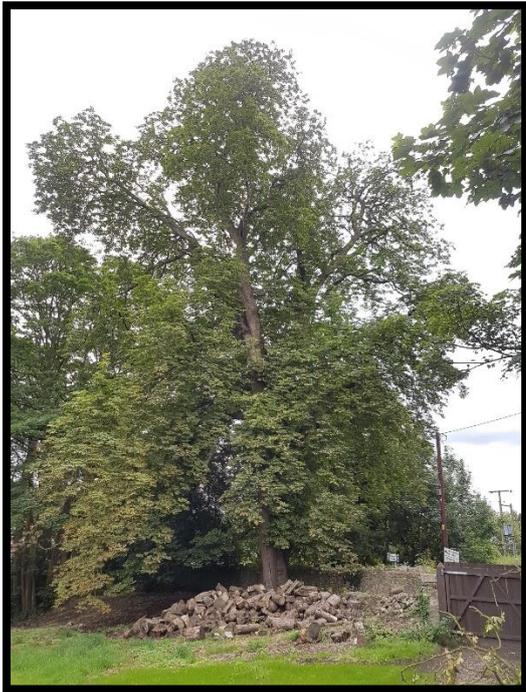
5.1 Tree 1

5.1.1 Mature Horse Chestnut (*Aesculus hippocastanum*) standing approximately 27.0m tall. This tree is twin stemmed from approximately 1.25m with these 2 stems being co dominant.

The crown is very flat and exposed on the west side following the removal of the adjacent, equally large Horse Chestnut. This has left the crown to suffer several significant branch losses, which may well be attributed to the increase of exposure (and being subject to winds from a previously protected direction).

There are some minor bark wounds at the base, these are relatively minor and of low significance. There are also some strips of dead bark extending up both stems, these are associated with historic bleeding canker damage and again, are of low significance.

The recent branch loss is from high in the crown of the roadside stem, it is one half of a forked secondary branch that has failed at a healthy branch fork union, possibly due to damage sustained in the recent high winds.

There are multiple stubs and pockets of minor decay from historic branch loss throughout the crown.

Further branch loss, like that experienced in the recent past, cannot be ruled out. While these are not predictable (we cannot say this or that branch is going to fail) the increased exposure the tree has, and the sail area of the crown make further branch loss inevitable.

The tree appears to be in good health both physically and structurally, it is suffering from an extensive infestation of Horse Chestnut Leaf Minor and no doubt later in the summer / autumn will suffer the fungal disease Horse Chestnut Leaf Blotch, neither of these are significant to the tree's health or its safety.

The tree overhangs a busy road with stationery traffic waiting for the traffic lights at peak time. Given the above to do nothing may be a little unwise.

- Reduce the overall height of the tree, to leave it no less than 20m tall.
- Reduce the overall lateral spread, to leave it no less than 7.0m and shape.
- Remove significant deadwood throughout the crown.
- Crown raise over the highway to approximately 5.5m.

I would describe these works as routine and recommend that this work is undertaken within 12 months.
