CHARE HEAD FARMHOUSE PHOTOGRAPH SCHEDULE

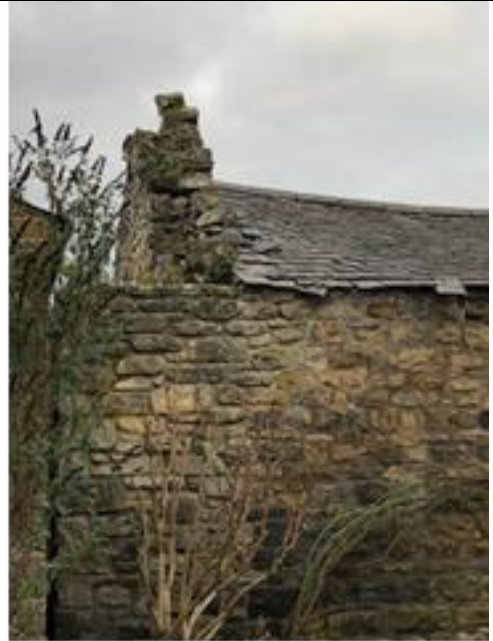
4. *Loose stonework to the top section of the gable wall*

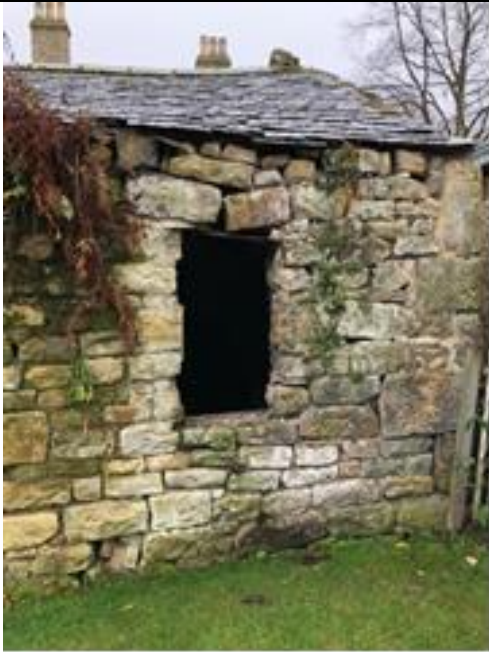
5. *Defective stone lintel above the window opening on the rear elevation*

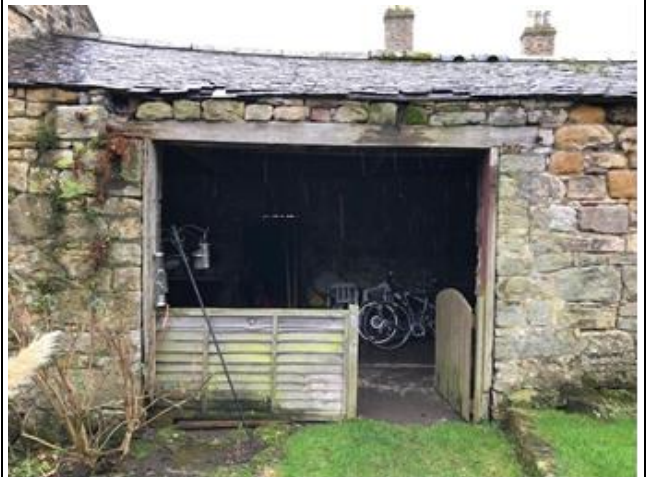
8. *Defective timber beam above the large opening on the rear elevation*
