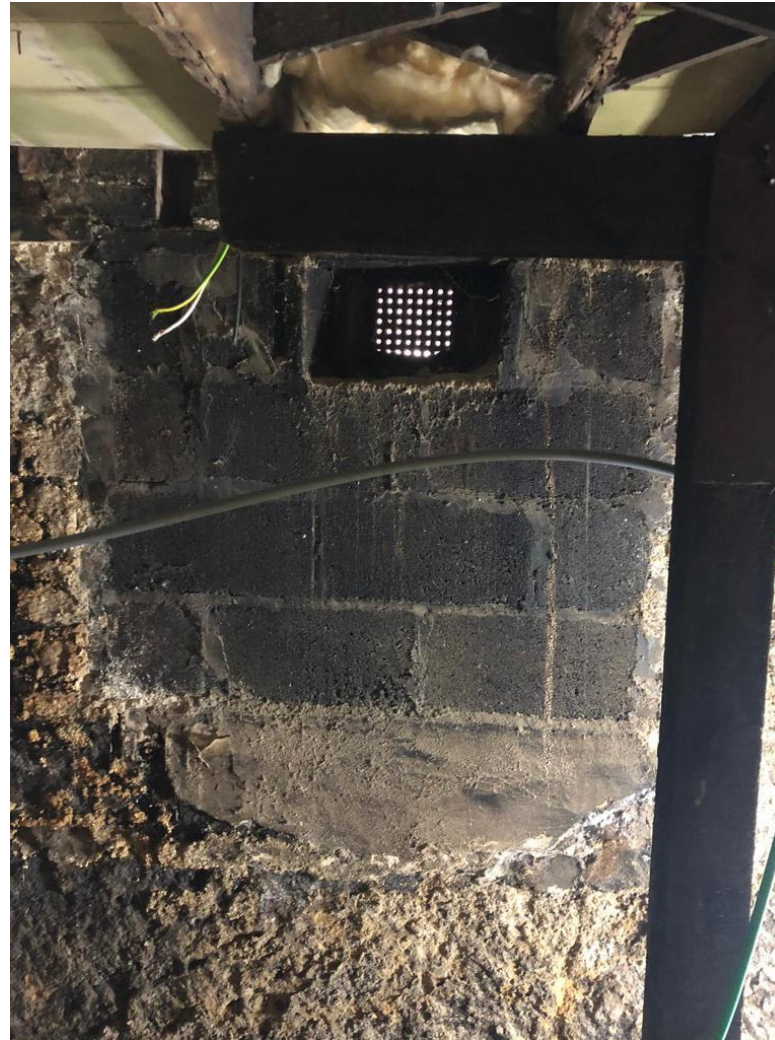
Basement windows prior to commencement of works showing blocking up of original windows using non-original materials (breeze blocks vs original bungaroosh construction). Both window openings were found to be of identical construction

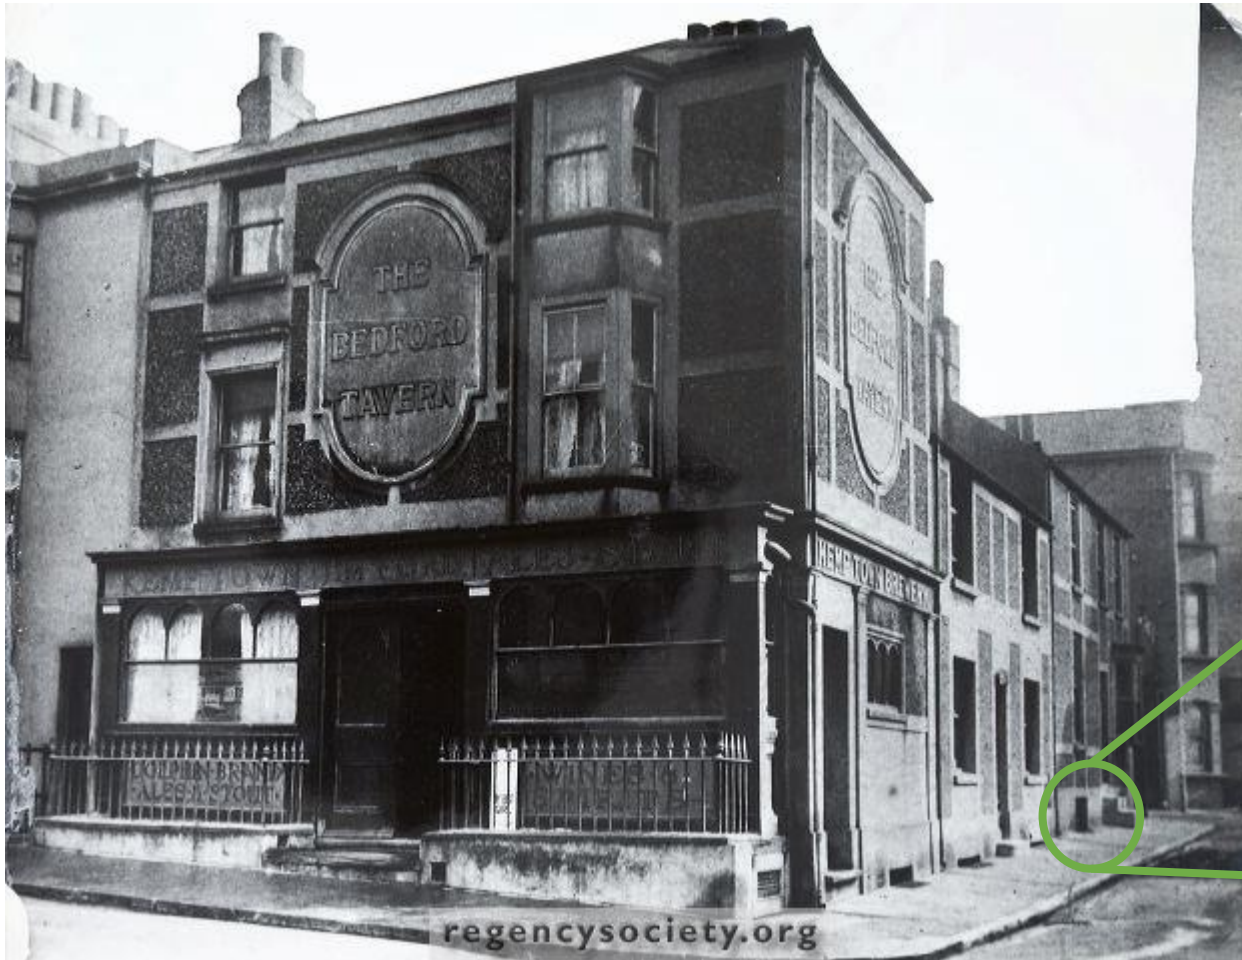
Regency Society photograph of property showing original windows and pavement details as found at:

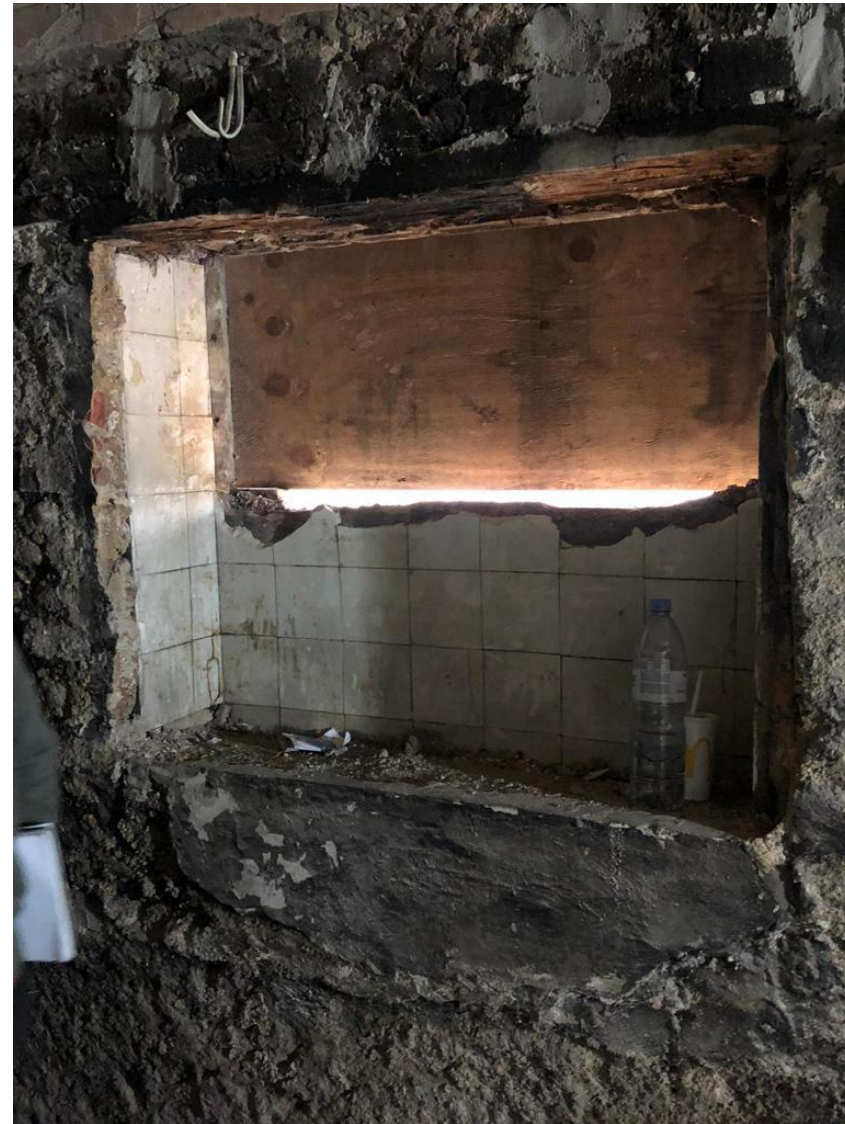
Original window opening following removal of breeze blocks. Tiles were found to be modern industrial tiles.
