Letter Addendum to Desk Study Referenced 1696,DS/DB,JD/28-06-16/V2.

This Addendum Letter Report has been prepared by Geosphere Environmental Limited for M Scott Properties and relates to the proposed residential development of the site at Landermere Road, Thorpe Le Soken, CO16 0LW.

Selected Photographs Relating To Site Walkover Survey

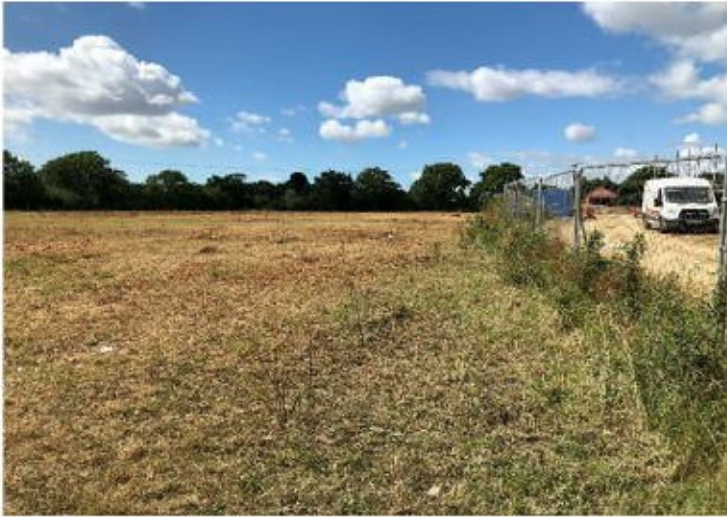
Photograph 1

Photo looking south along western boundary

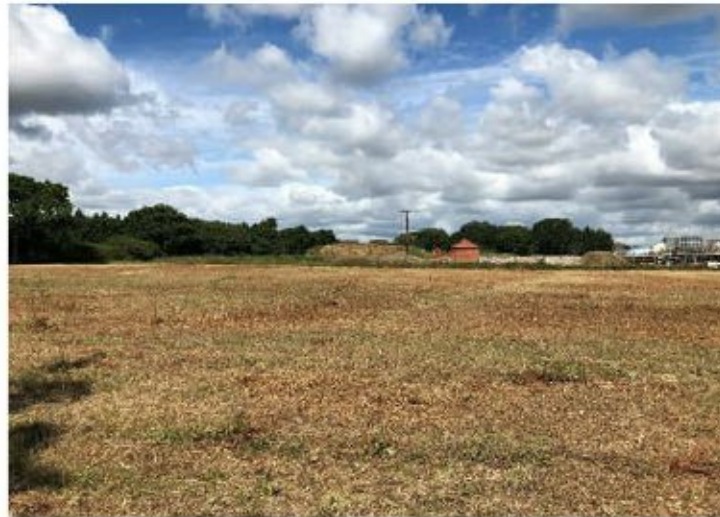
Photograph 2

View from east to west

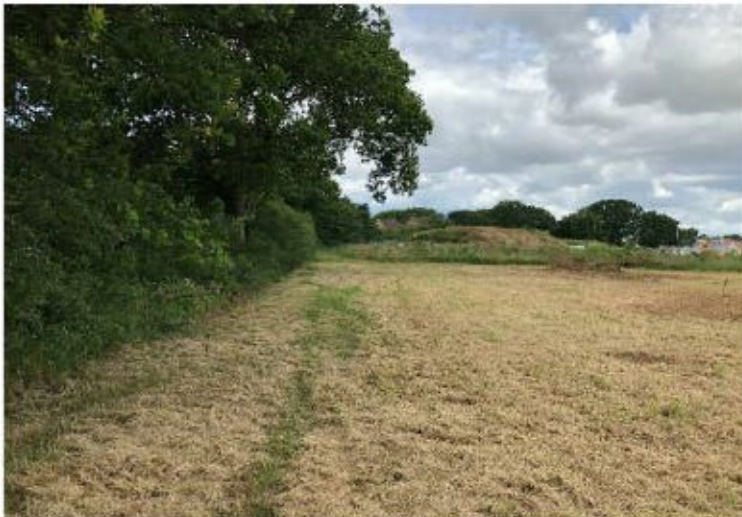
Photograph 3

View of southern boundary looking west

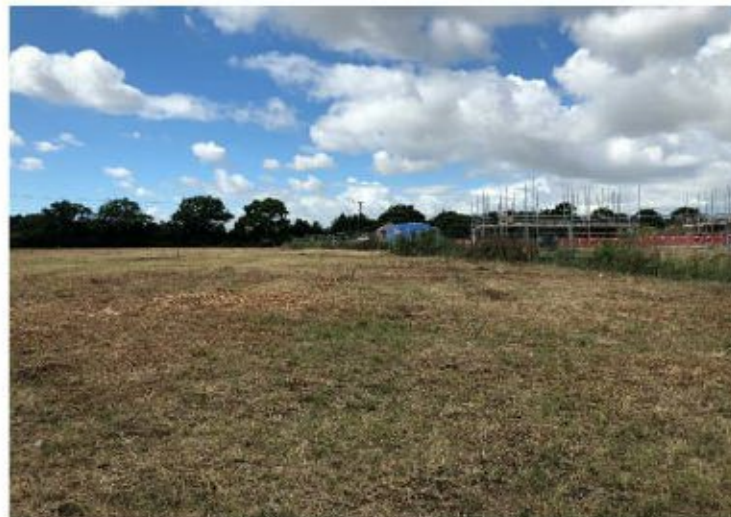
Photograph 4

- Recent construction activities immediately west of the site. The associated impact is considered to be negligible due to the contained nature of the development (i.e. site secure fencing) and the impermeable nature of the underlying geology;

View of western boundary and neighbouring Bellways development
