Proposed Repair Works
209 Gilesgate
Durham City DH1 1QN
for Dr M. Judson

As Existing & As Proposed

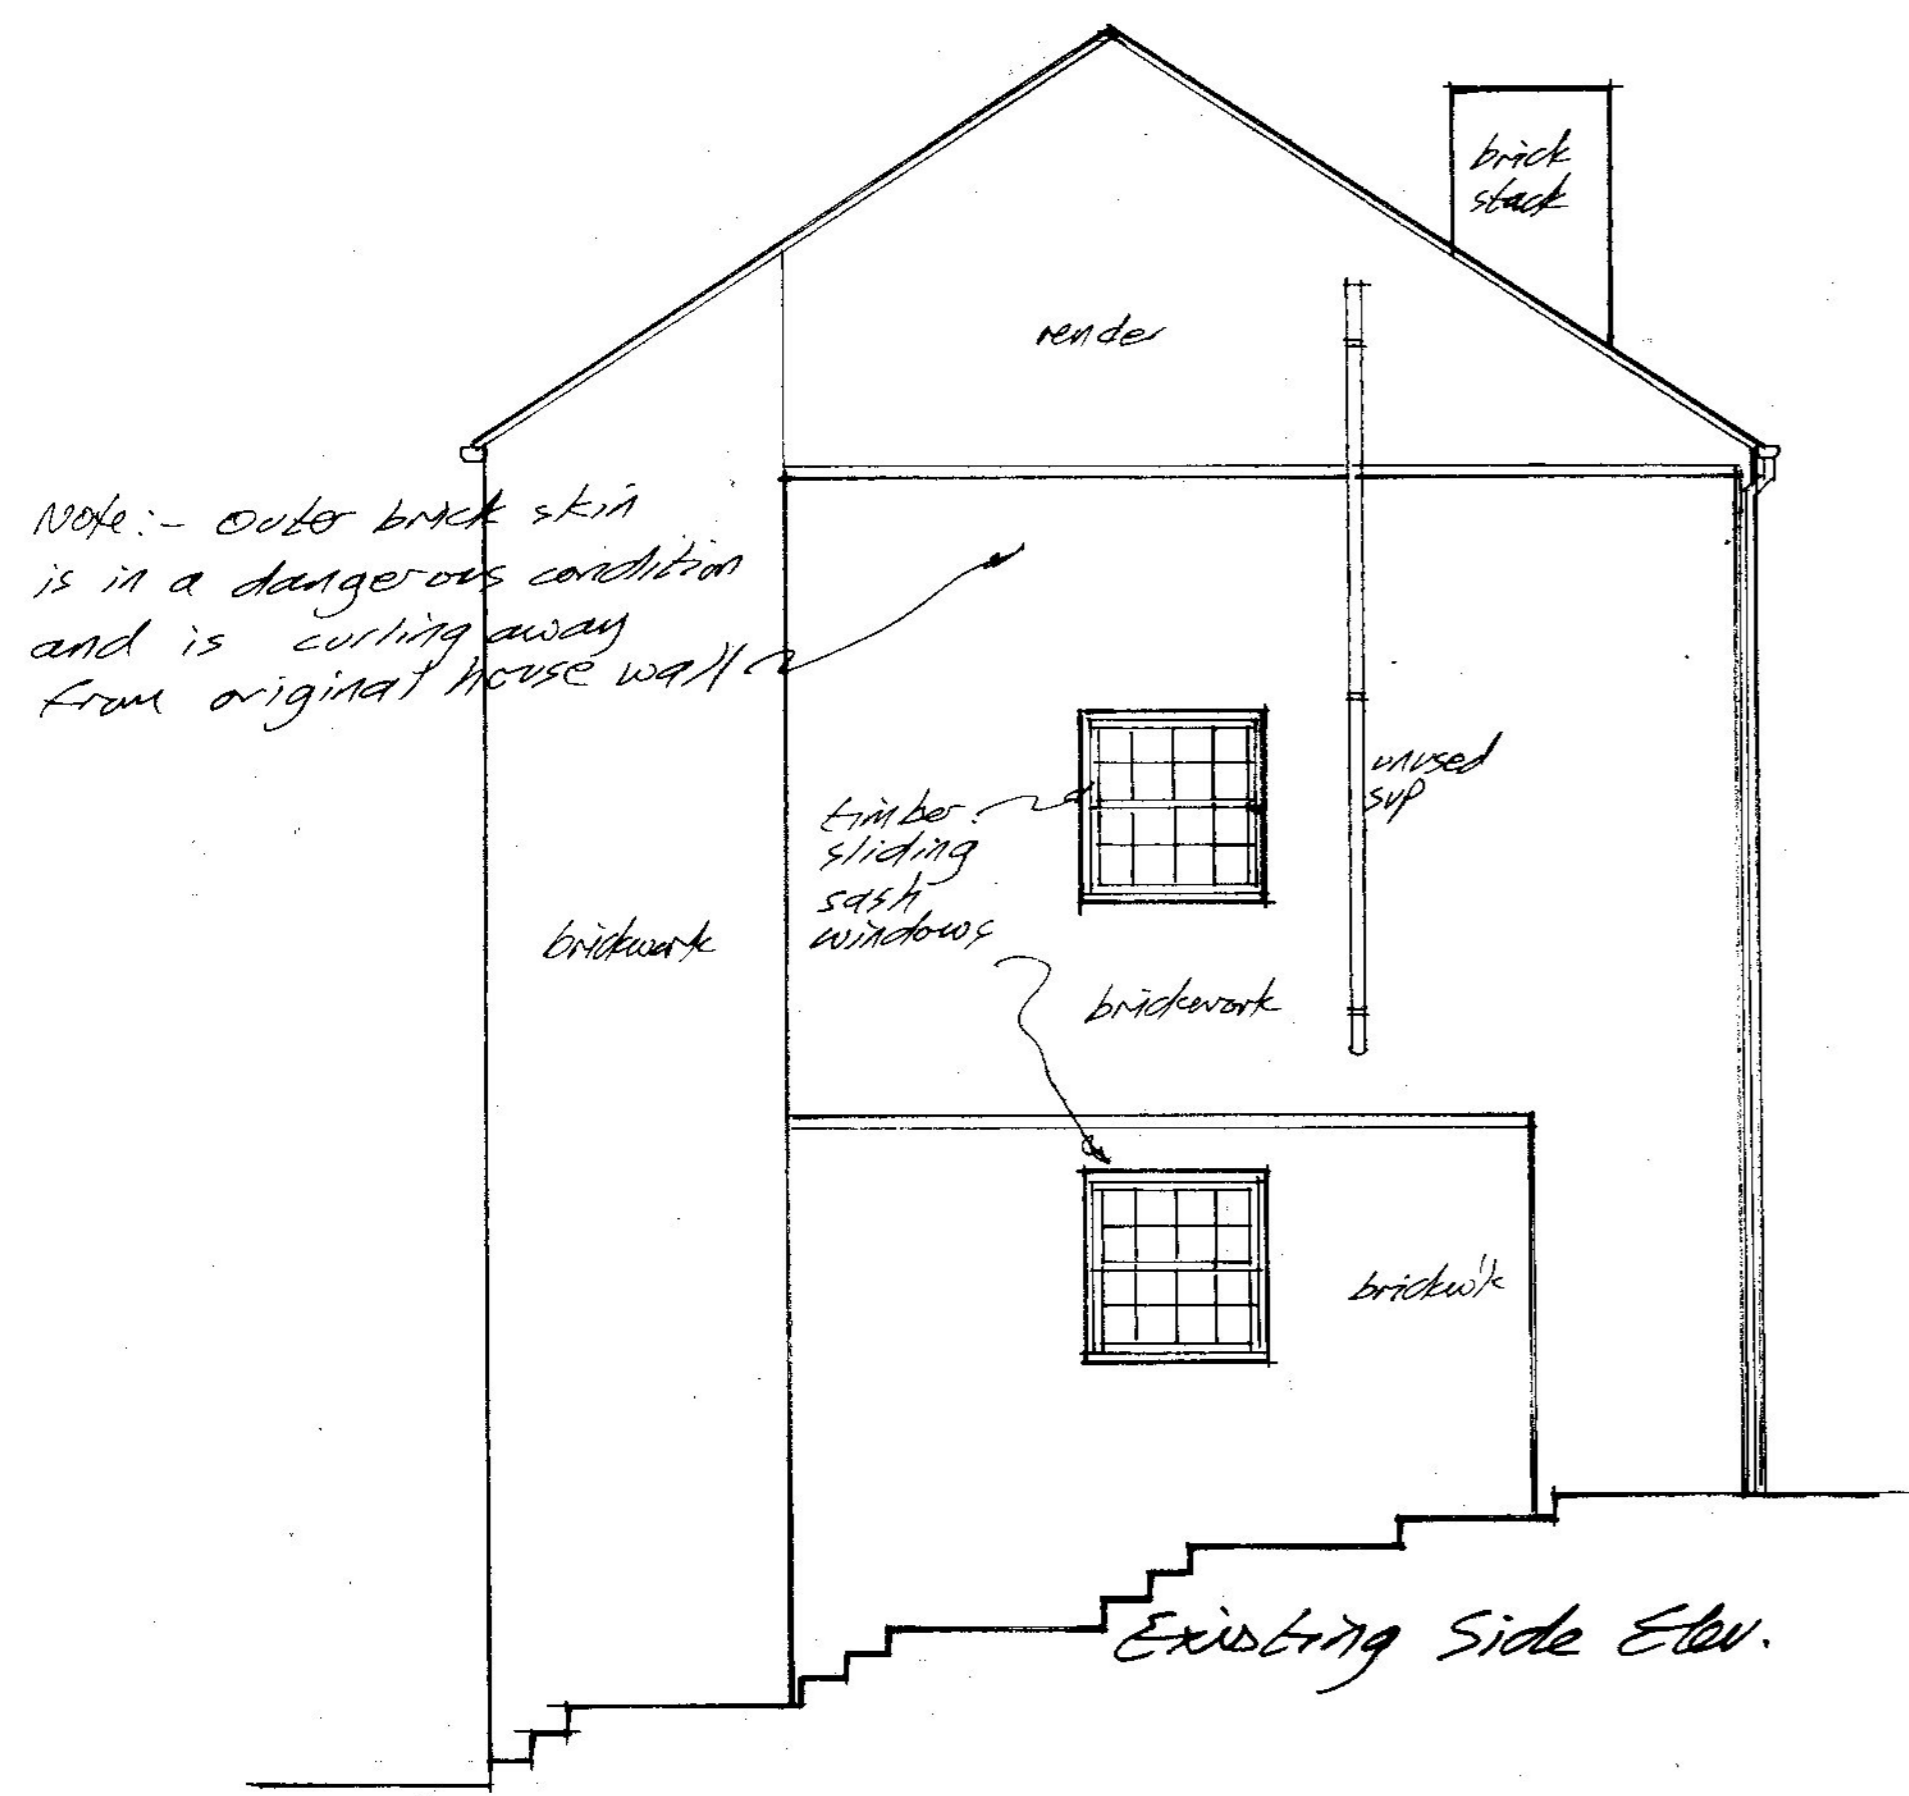
Note: - Outer brick skin is in a dangerous condition and is curling away from original house wall

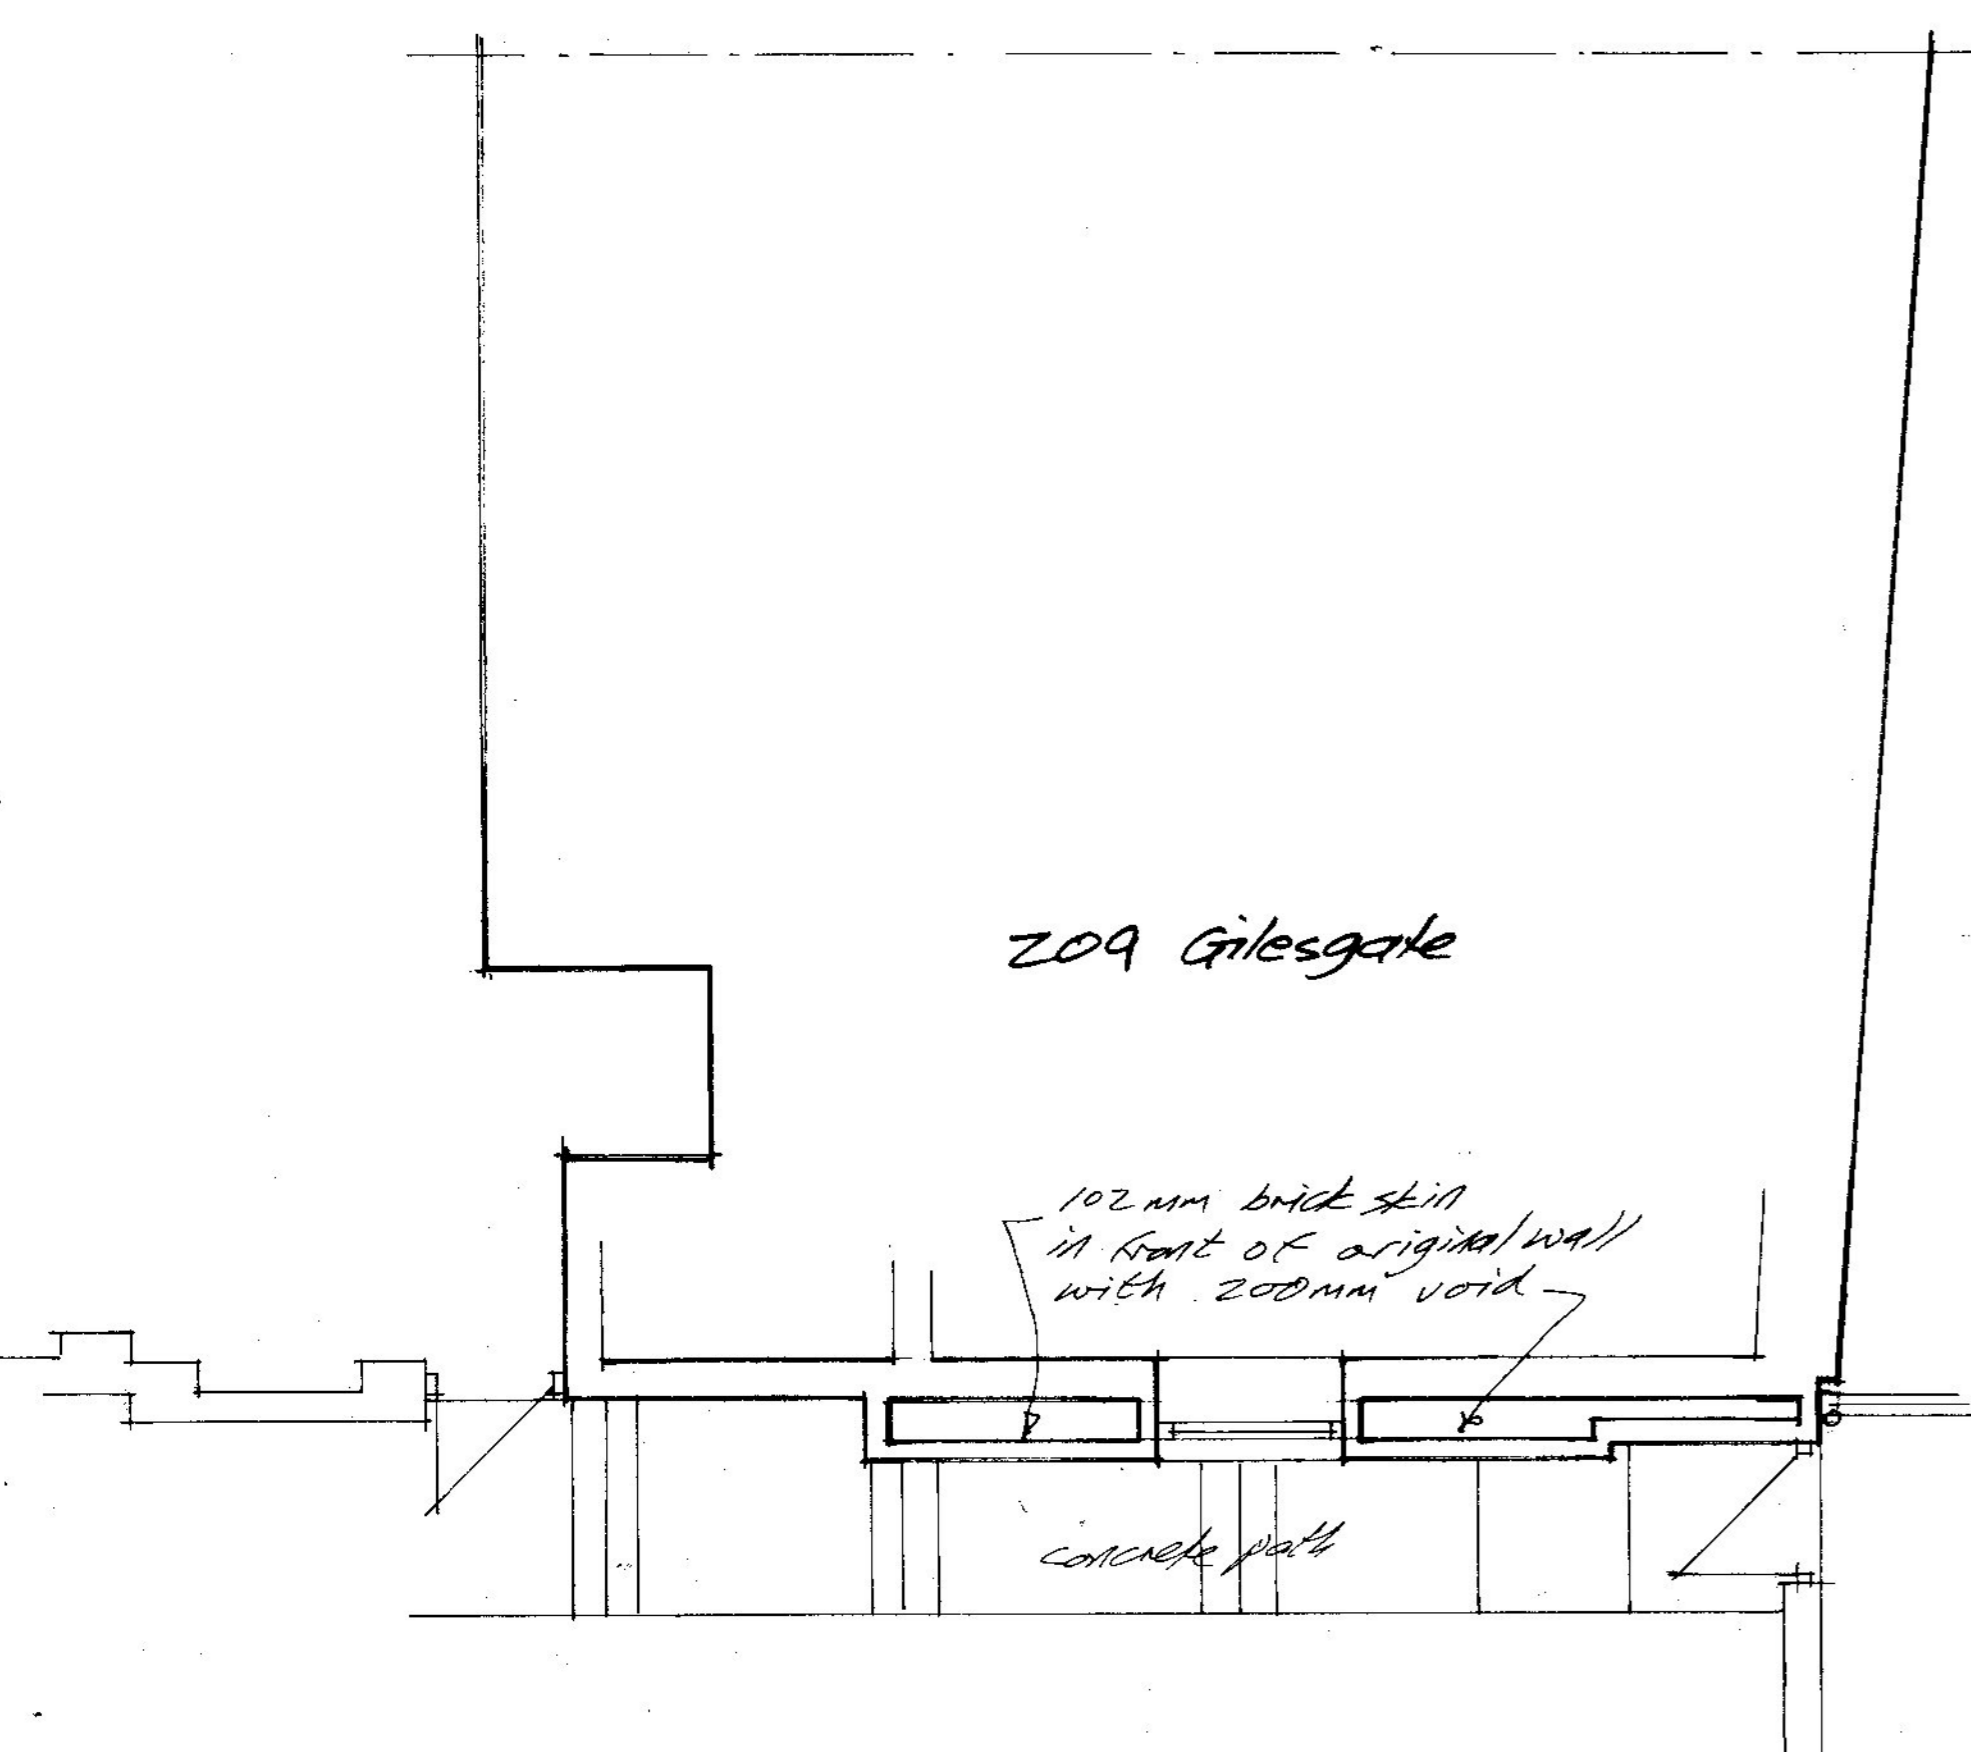
209 Gilesgate

102mm brick skin in front of original wall with 200mm void
