**Pictures of the original barn**

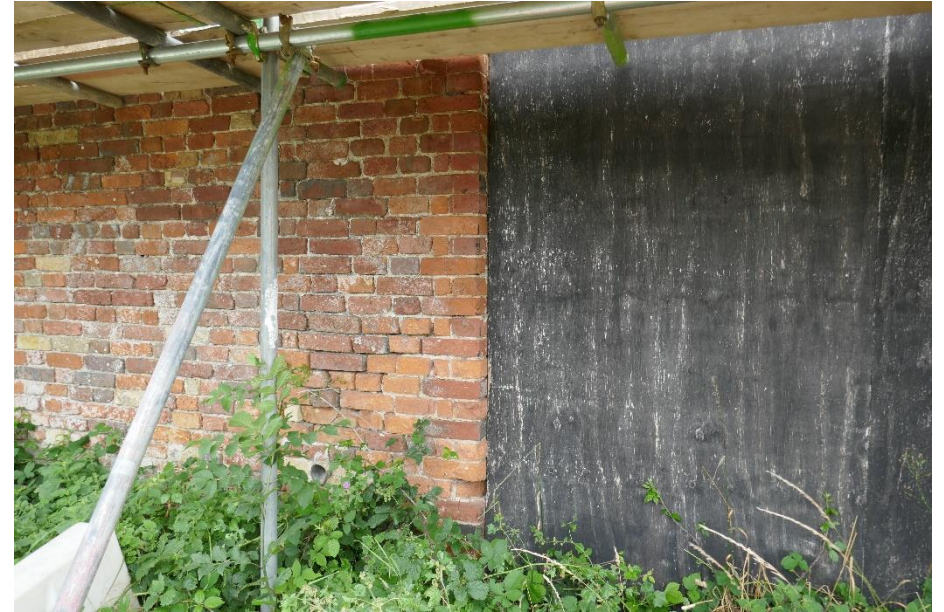
**Example of localised area requiring repointing on west elevation**

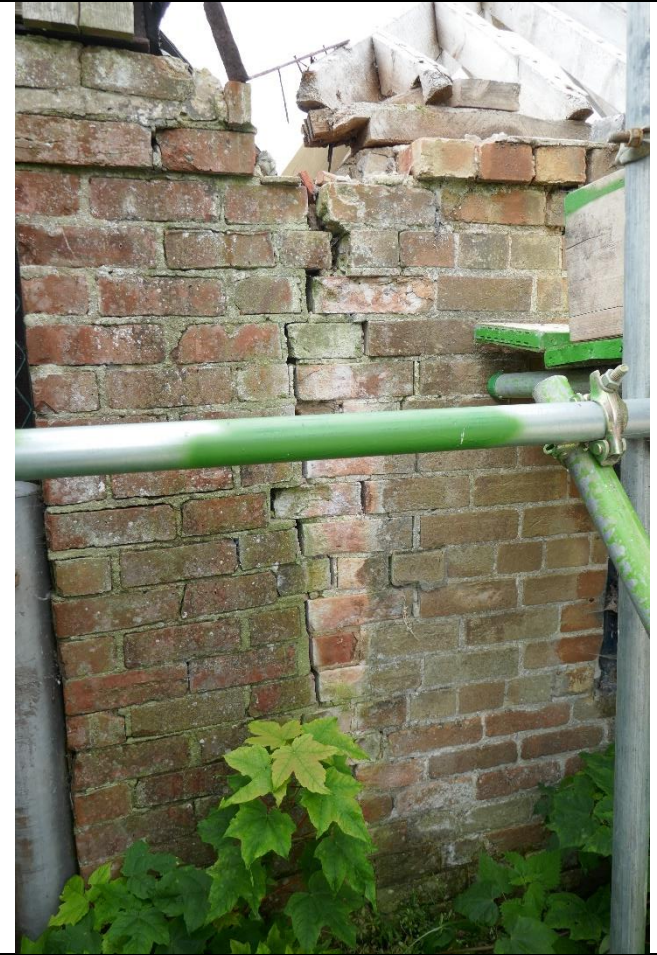
**Example of cracking to the north elevation**

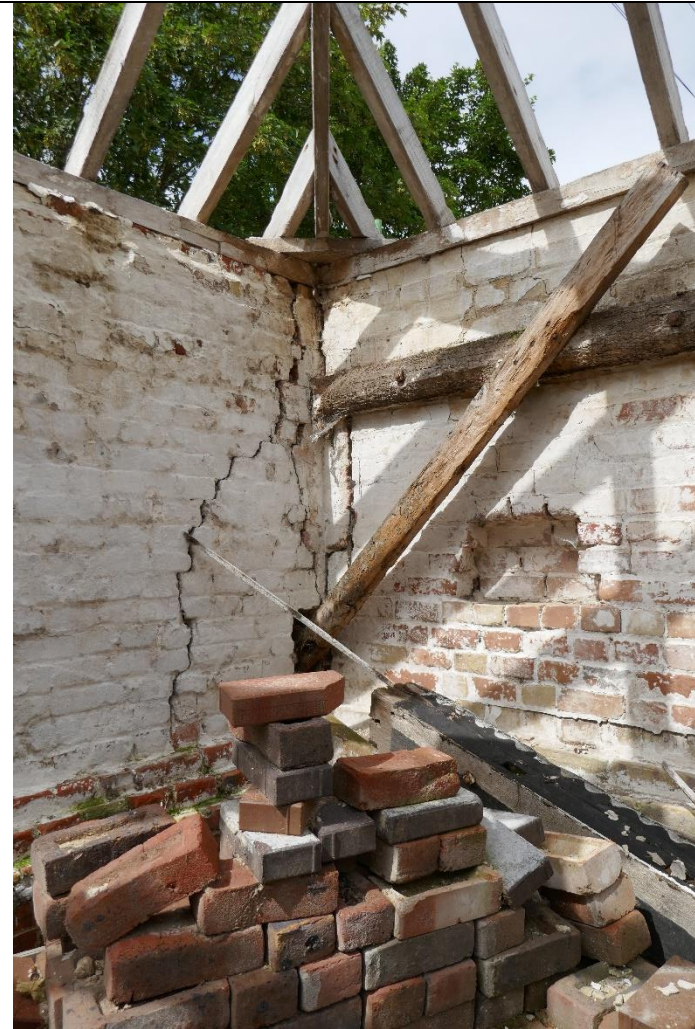
**Example of crack to west elevation**

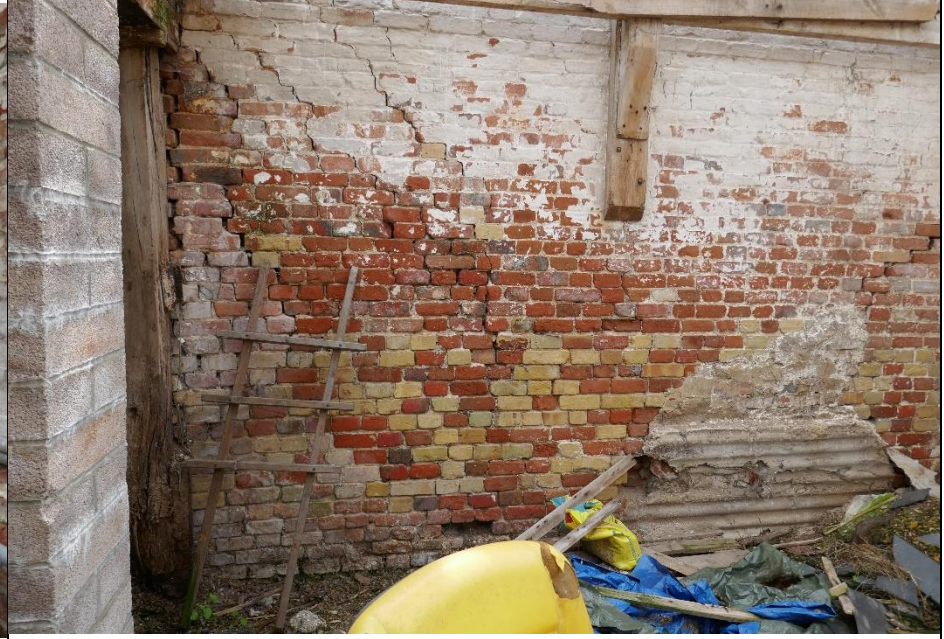
**Example of cracking to partition wall**

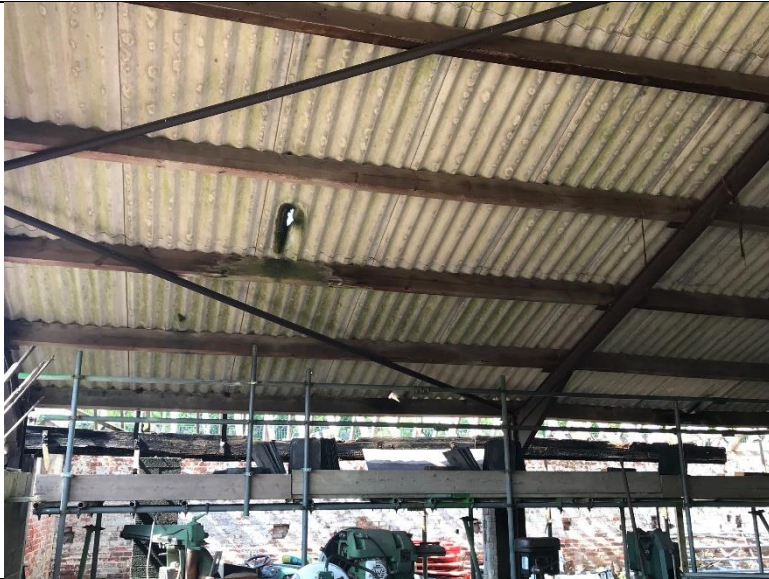
**Example of damaged roof sheets**

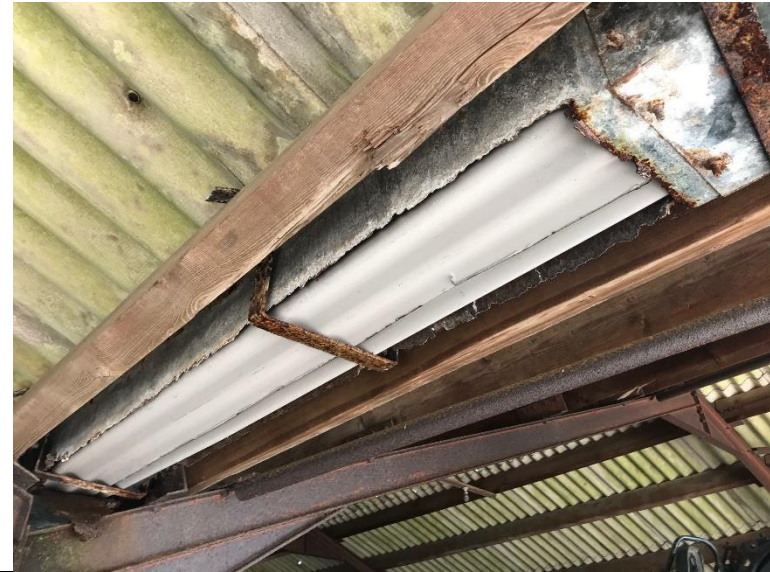
**Example of corroded gutters**
