**EMBLETON TOWER  
EMBLETON  
ALNWICK**

**PLAN OF NORTH WEST BEDROOM  
AND ADJACENT BATHROOMS  
AS EXISTING**

M631 / 02

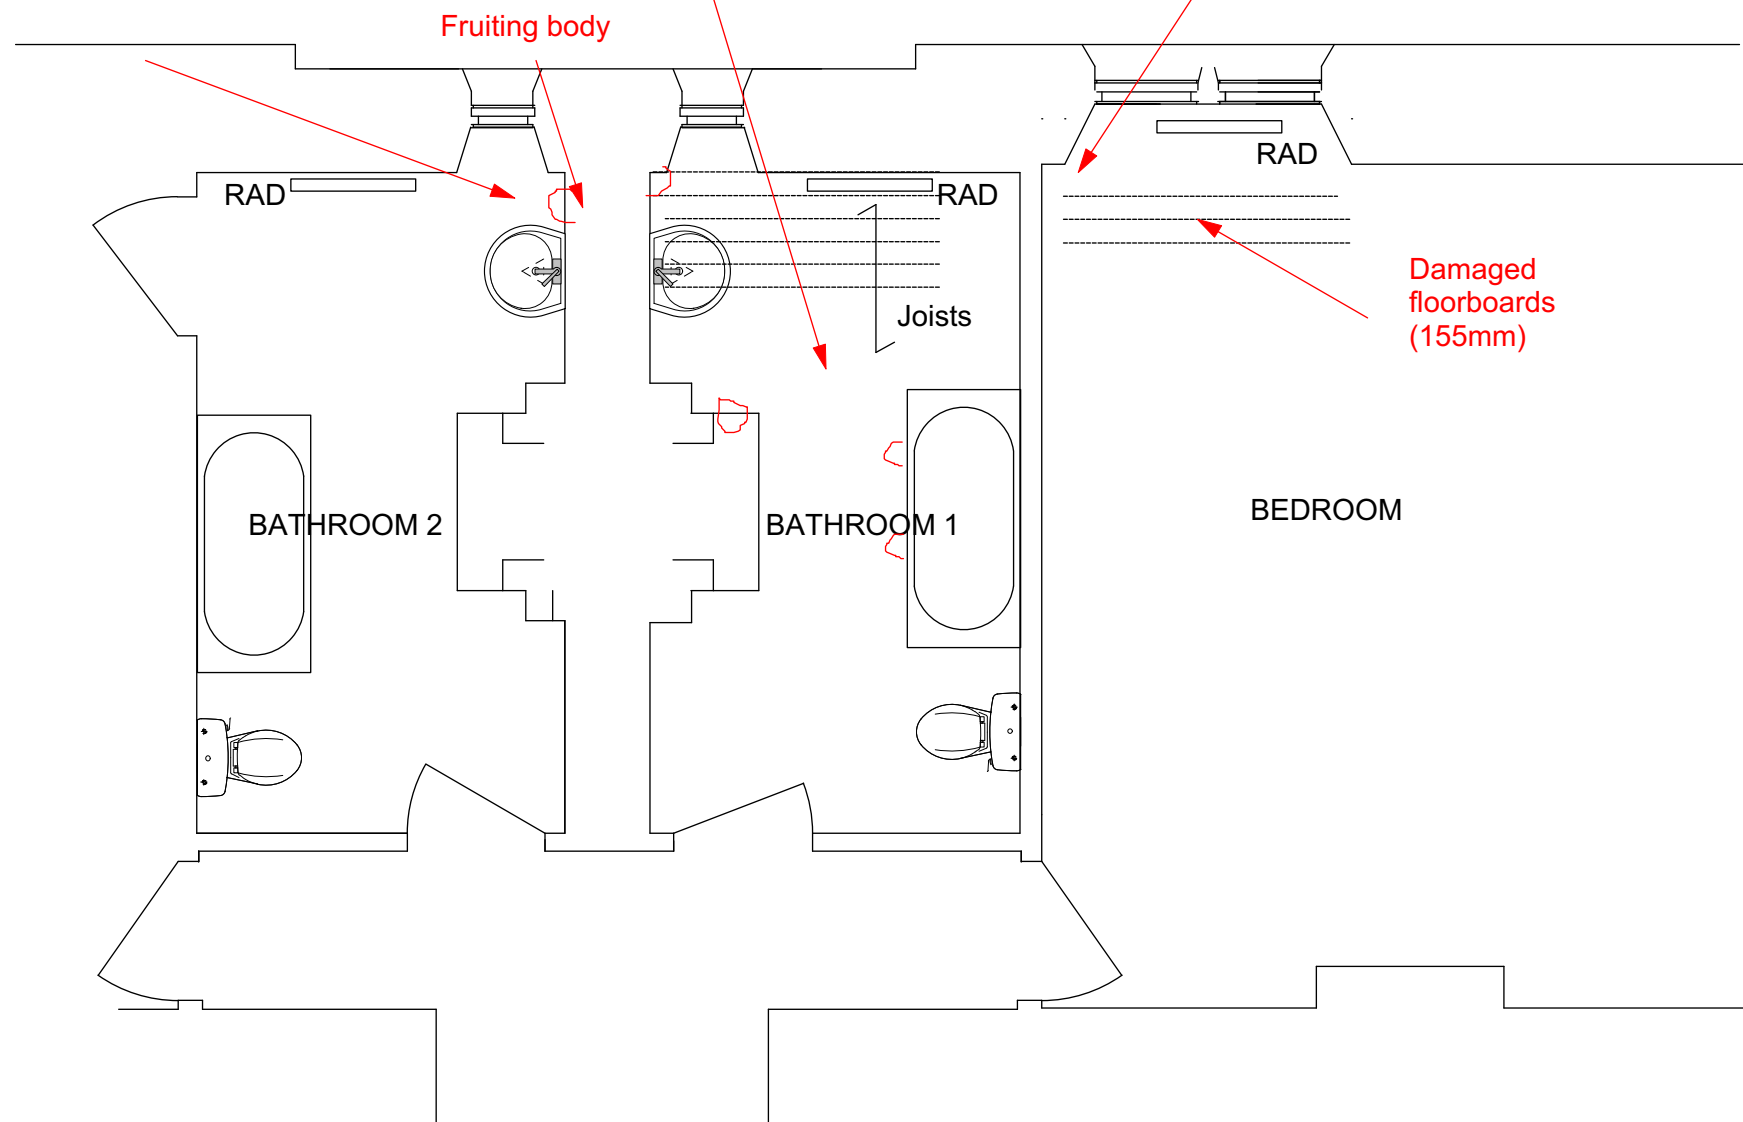
Significant damage - all paneling and skirting against external wall damaged (part of the frame to sash window possibly also damaged) with some damage to skirtings on the South and North wall at the Western end of the room. Fruiting bodies visible throughout Western part of the room including alongside the bath paneling (approx 2/3rds of the room is affected). Significant damage to floorboards at the Western end of the room and since drying out to central areas too. Potential damage to joist ends adjacent to the West wall and to lower sections of plasterwork in the worst affected areas Access to this room is unsafe at present

Damage to a small area of floorboards

Damp/mould on wall behind shutters. Damage to skirting and panelling
