**EMBLETON TOWER  
EMBLETON  
ALNWICK**

**PLAN OF DINING ROOM  
AS EXISTING**

M631 / 01

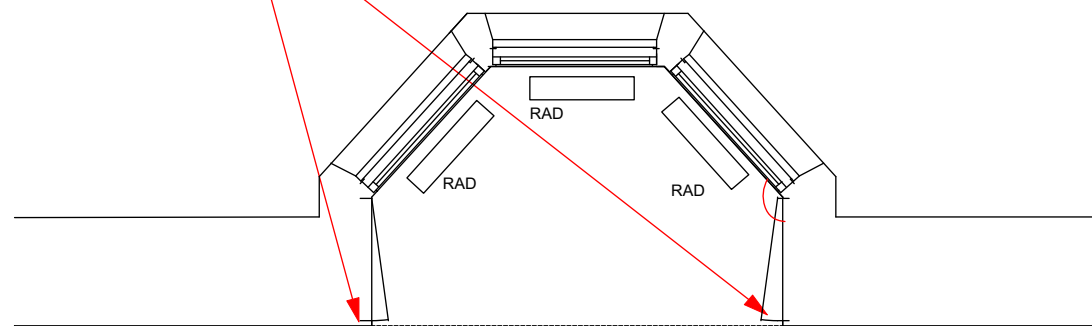
Damage to shutters (leaf adjacent to the wall), panelling, architrave, dado and skirting both within and to either side of the bay window
