SURVEY REPORT

PROPERTY: Embleton Tower
Embleton

REF: 9170929/RM/JB

DATE SURVEY: 20th September 2017 & 26th April 2018

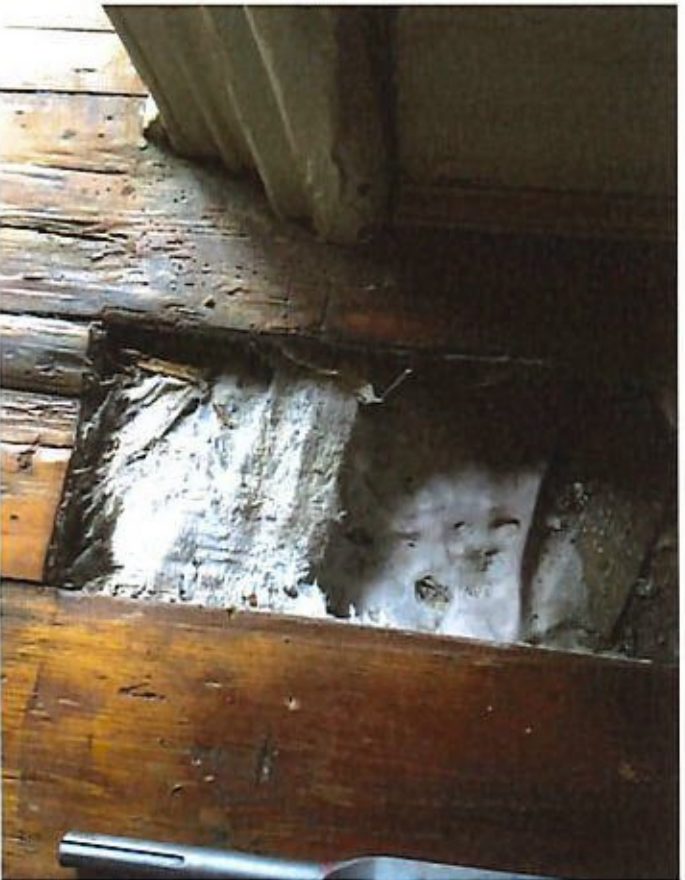
Floorboards, joists, architraves, decorative paneling, skirting boards, box windows and window shutters and were noted to be distorted and corrugated due to the attack of Dry Rot (Serpula Lacrymans) and severe breakdown is occurring in places.

Floorboards and joists

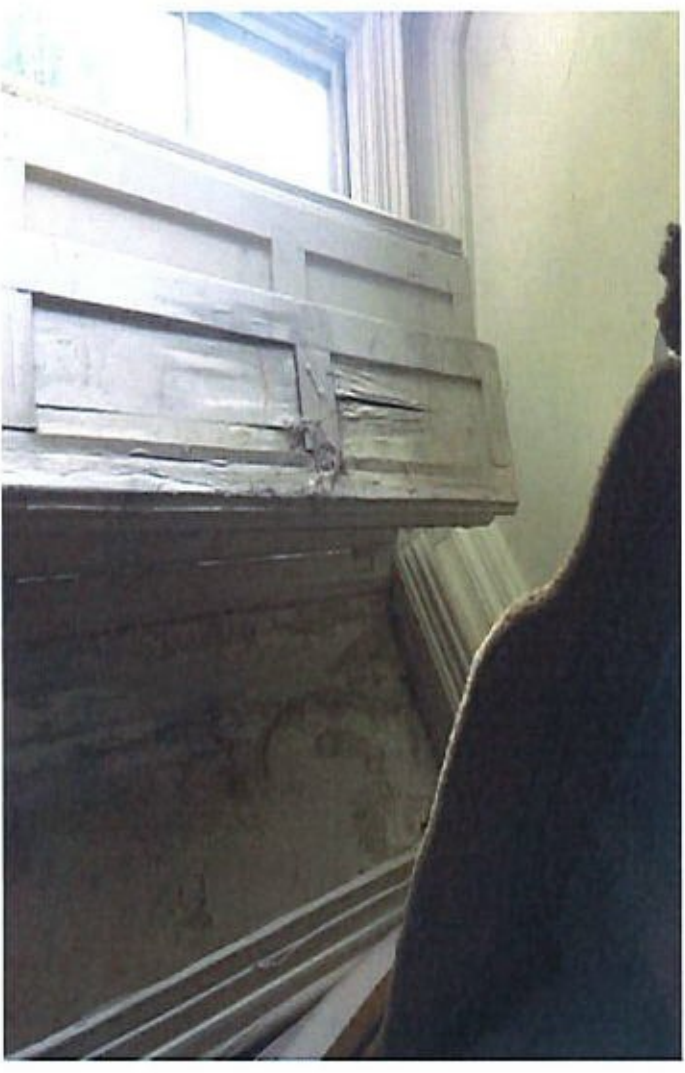
Box window shutters

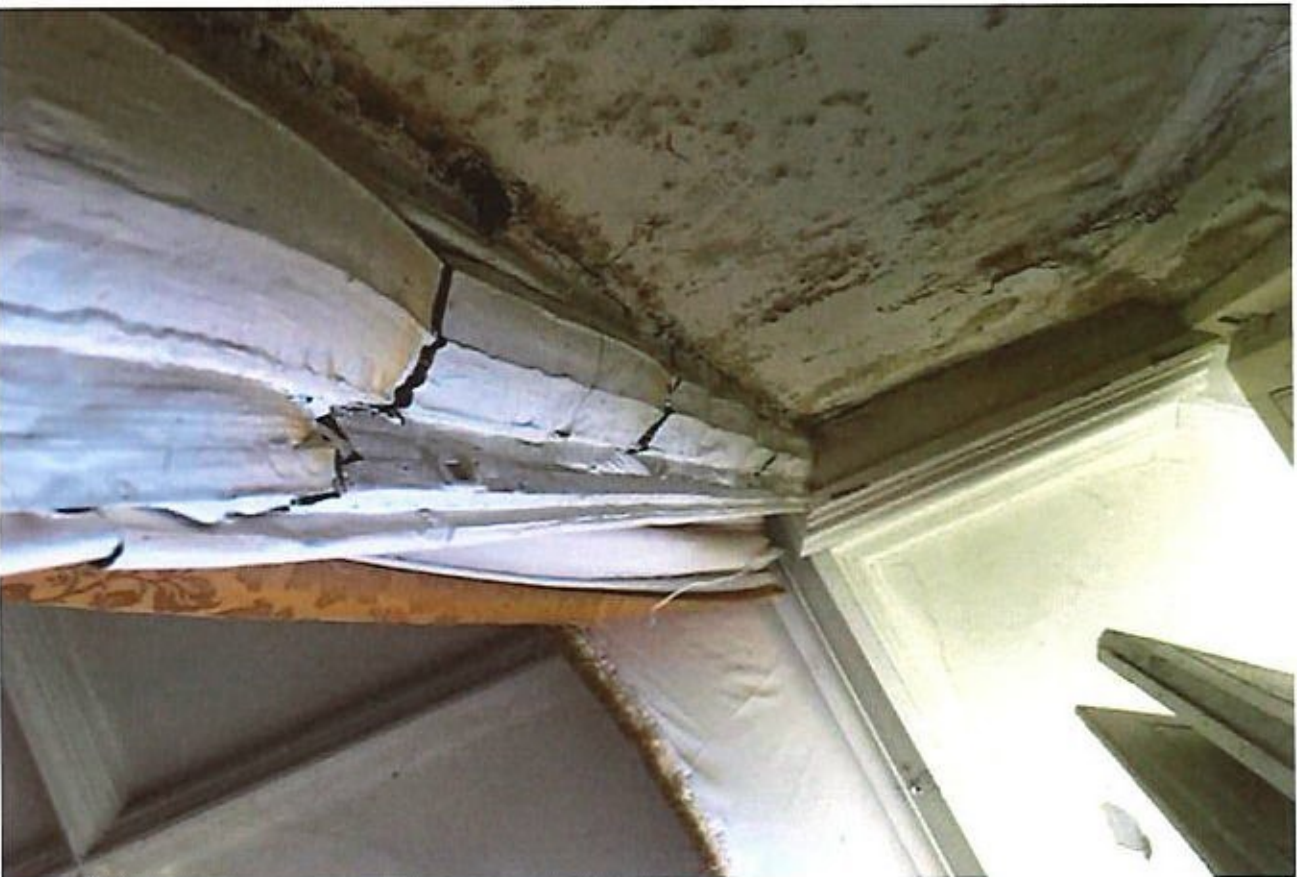
Architrave

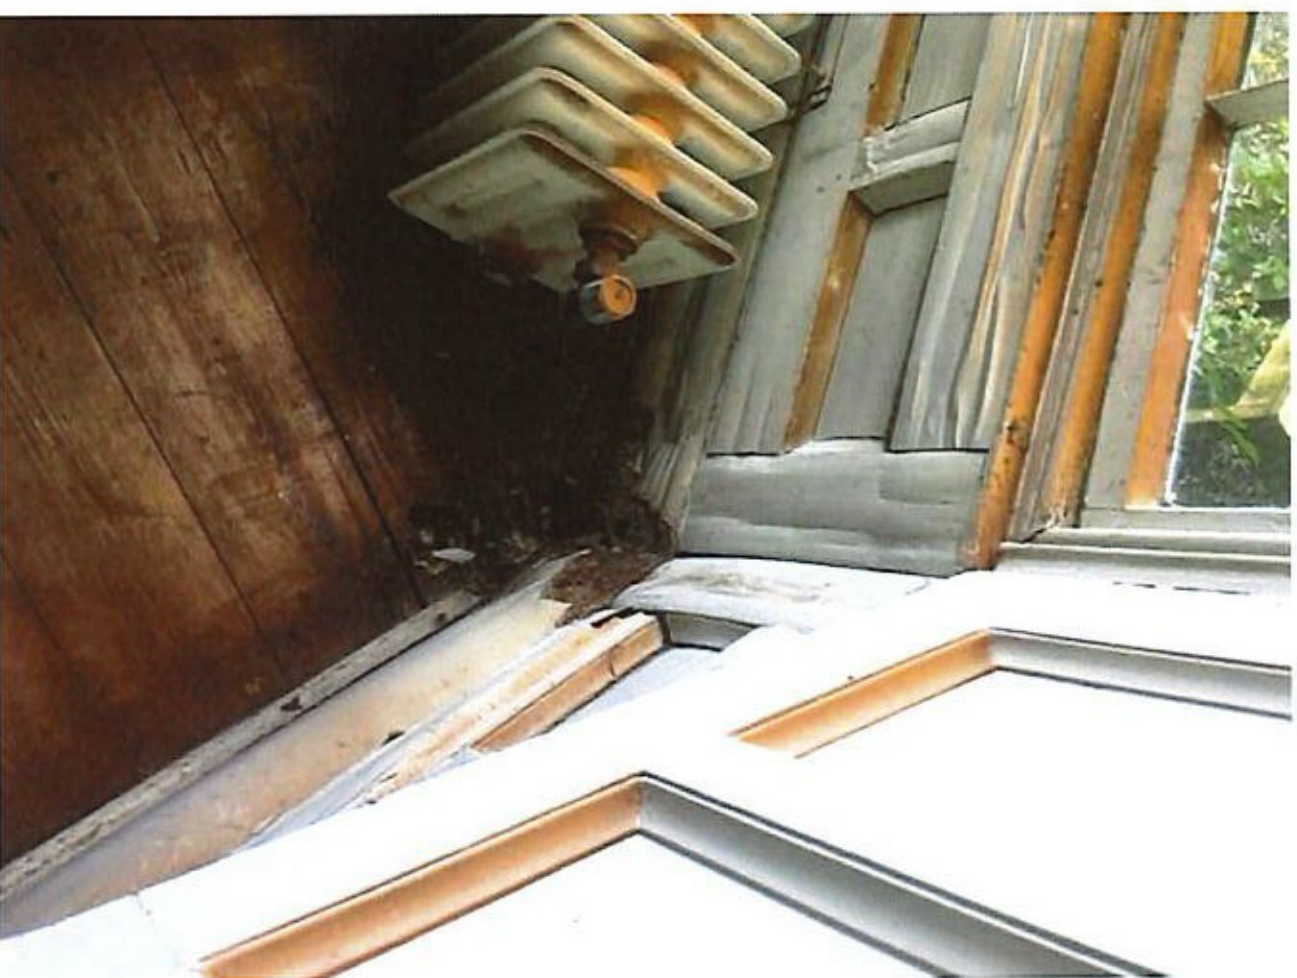
Decorative panels

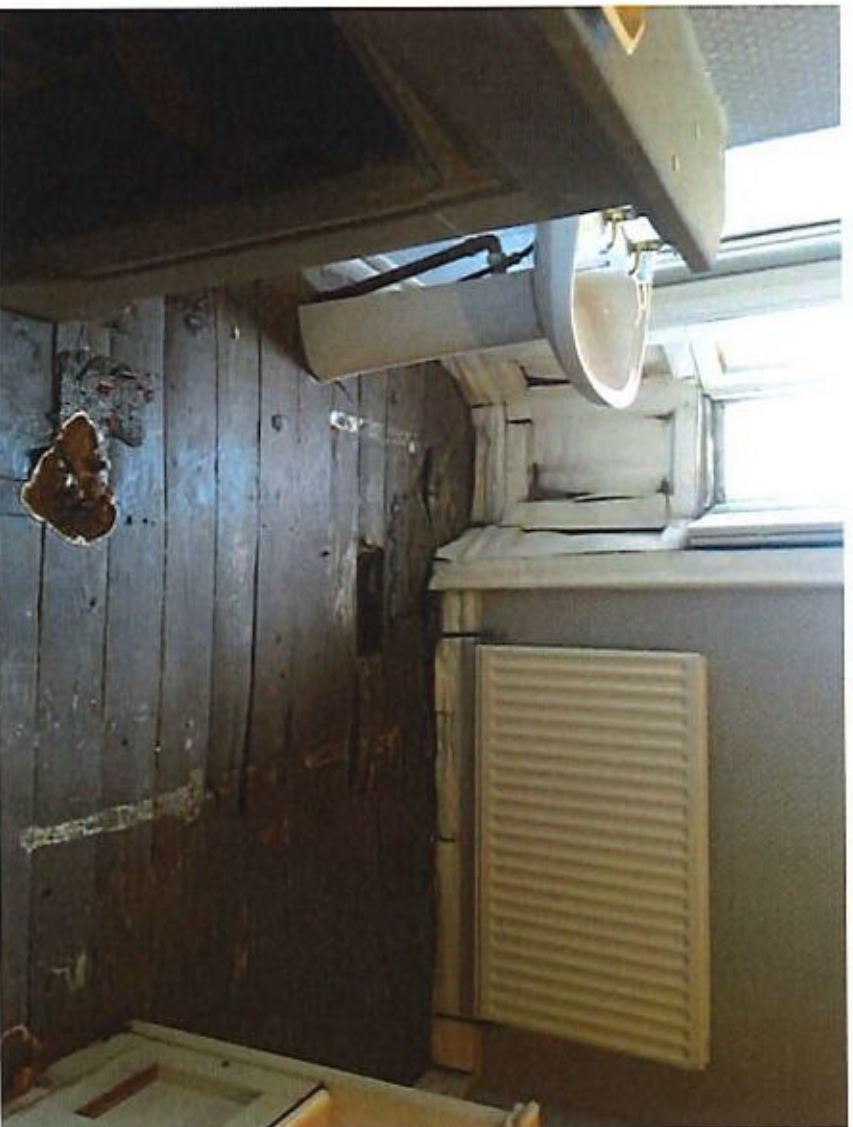
Bathroom

Dry rot spore dust was noted to the whole floor area in the bathroom, and white sanitary items has a fine layer of dust over

Please note that decay has resulted in joists breaking down severely, and we suspect joists are decayed up to 3.2m back into the room, which may have to be renewed in their entirety back to the solid spine wall

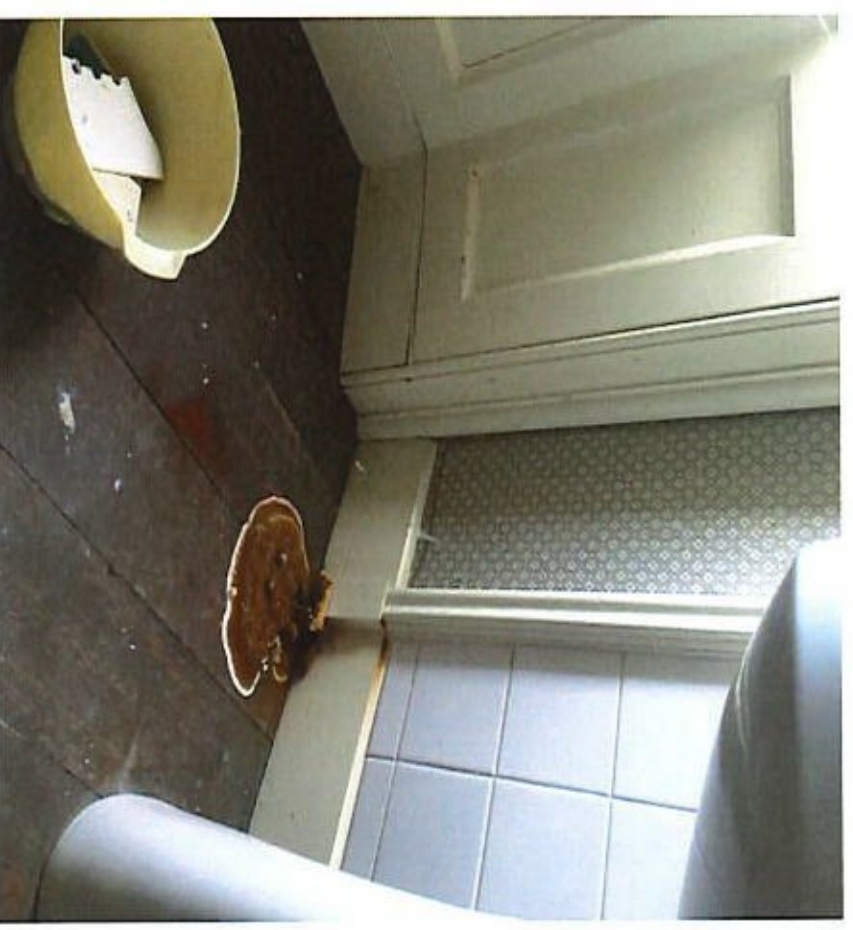
En Suite

Please note that we strongly suspect Dry Rot is affecting floor joists to the en suite area, however, at this stage we have made no allowance to renew any floor timber in this area, due to the cornice being so decorative to the floor below.

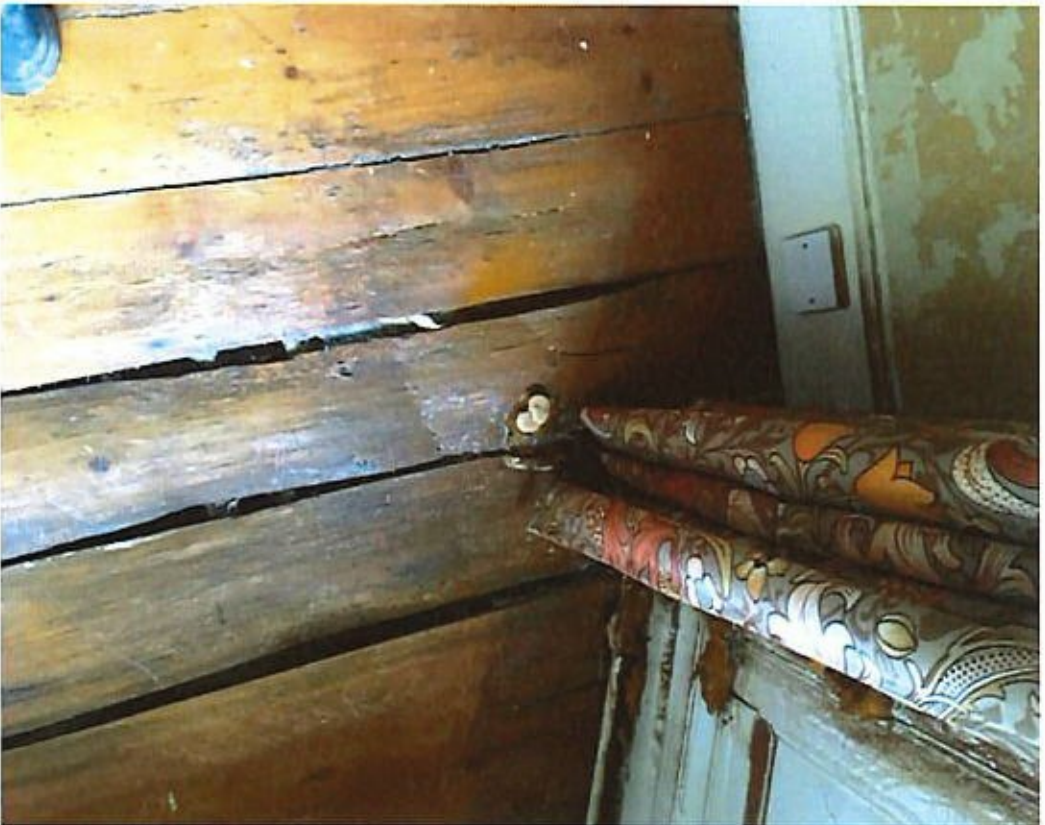
Floorboards decayed

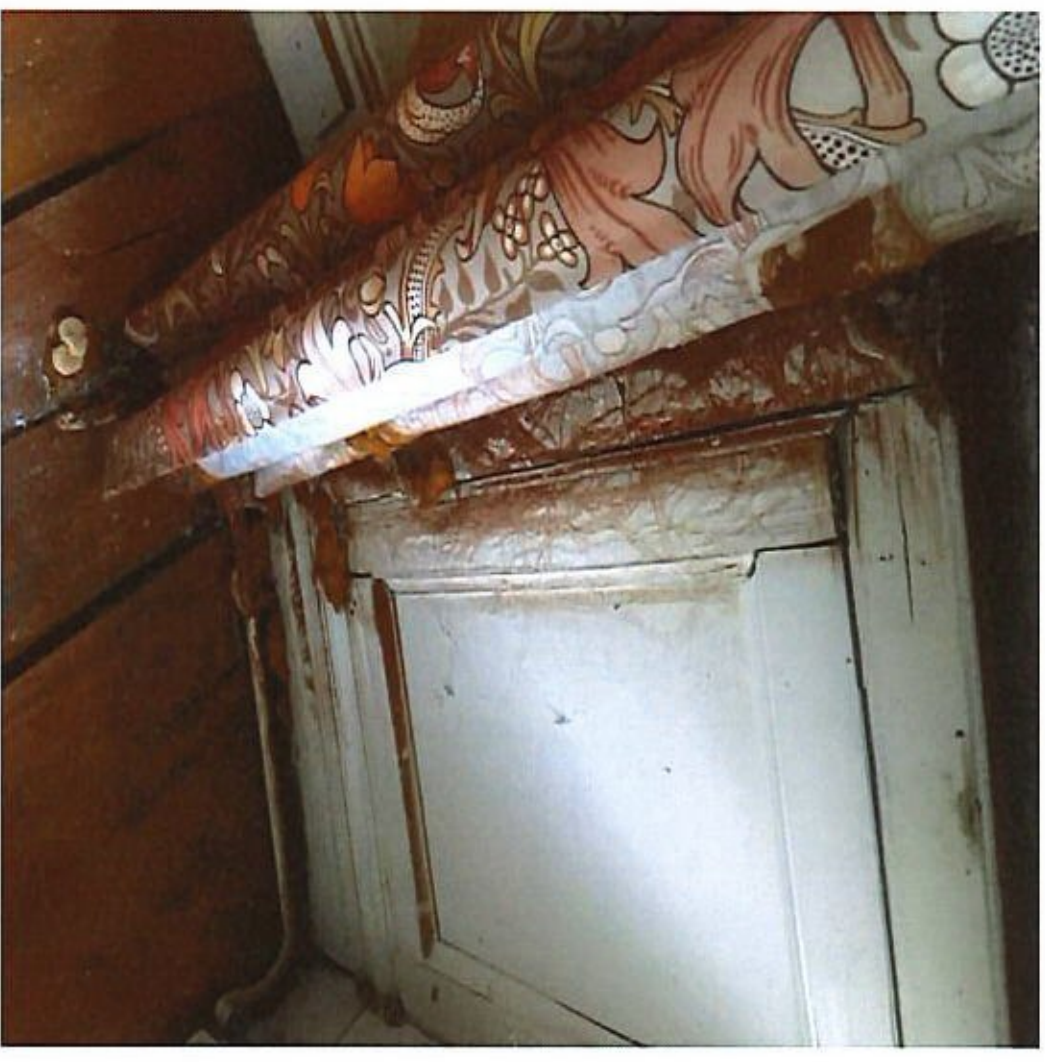
Dry Rot Sporophores were noted to various areas, more noticeably to the box window panels

Decorative panelling

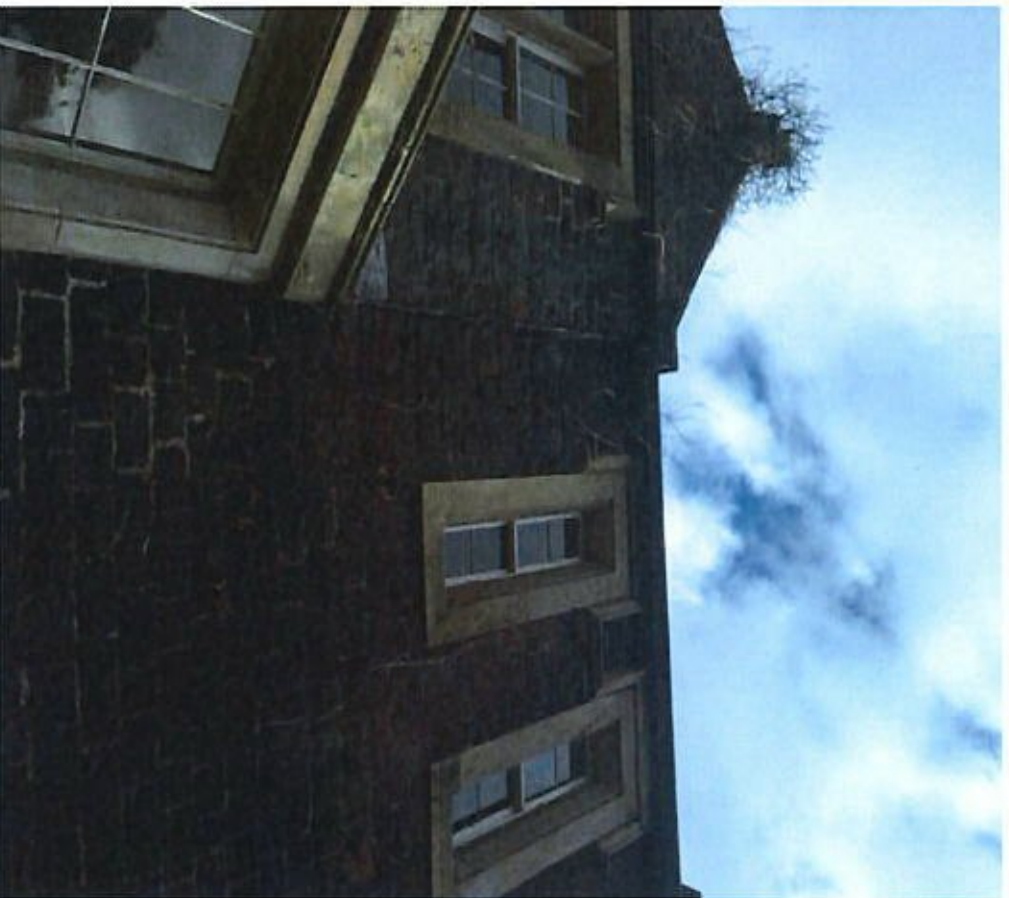
Vegetation was noted at high level around the chimney stack, which we suggest is addressed by our Client.

Vegetation to chimney Stack

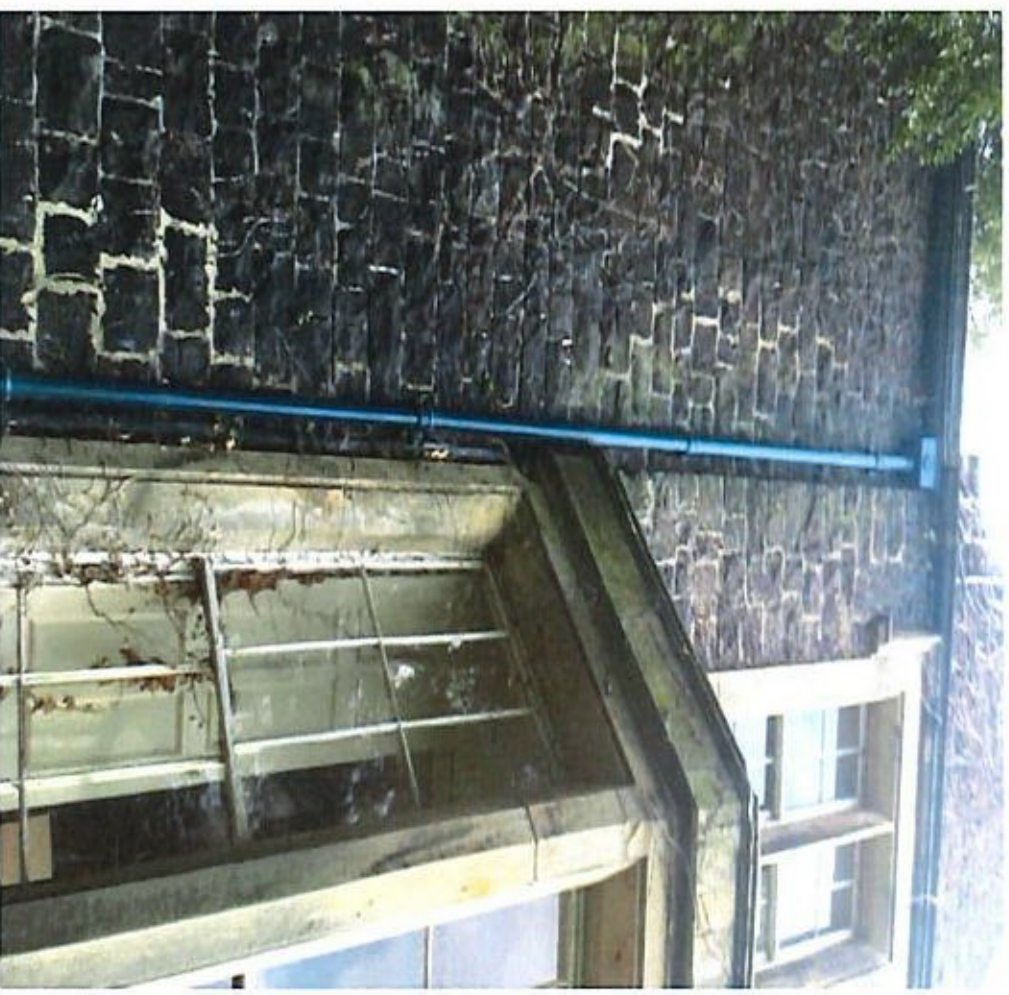
Vegetation was note to have been removed from the bay window area, however, vegetation was clearly visible through the top sash of the ground floor bay window, which again has resulted in rainwater ingress.

We noted that a cast rainwater pipe has been renewed recently, which we suspect was due to faults with the previous section.

Vegetation growing through sashes and renewed rainwater pipe
