**EMBLETON TOWER  
EMBLETON  
ALNWICK**

**PLAN OF NORTH WEST BEDROOM  
AND ADJACENT BATHROOMS  
SHOWING WORKS REQUIRED TO  
REPAIR DAMAGE DUE TO DRY ROT**

M631 / 09

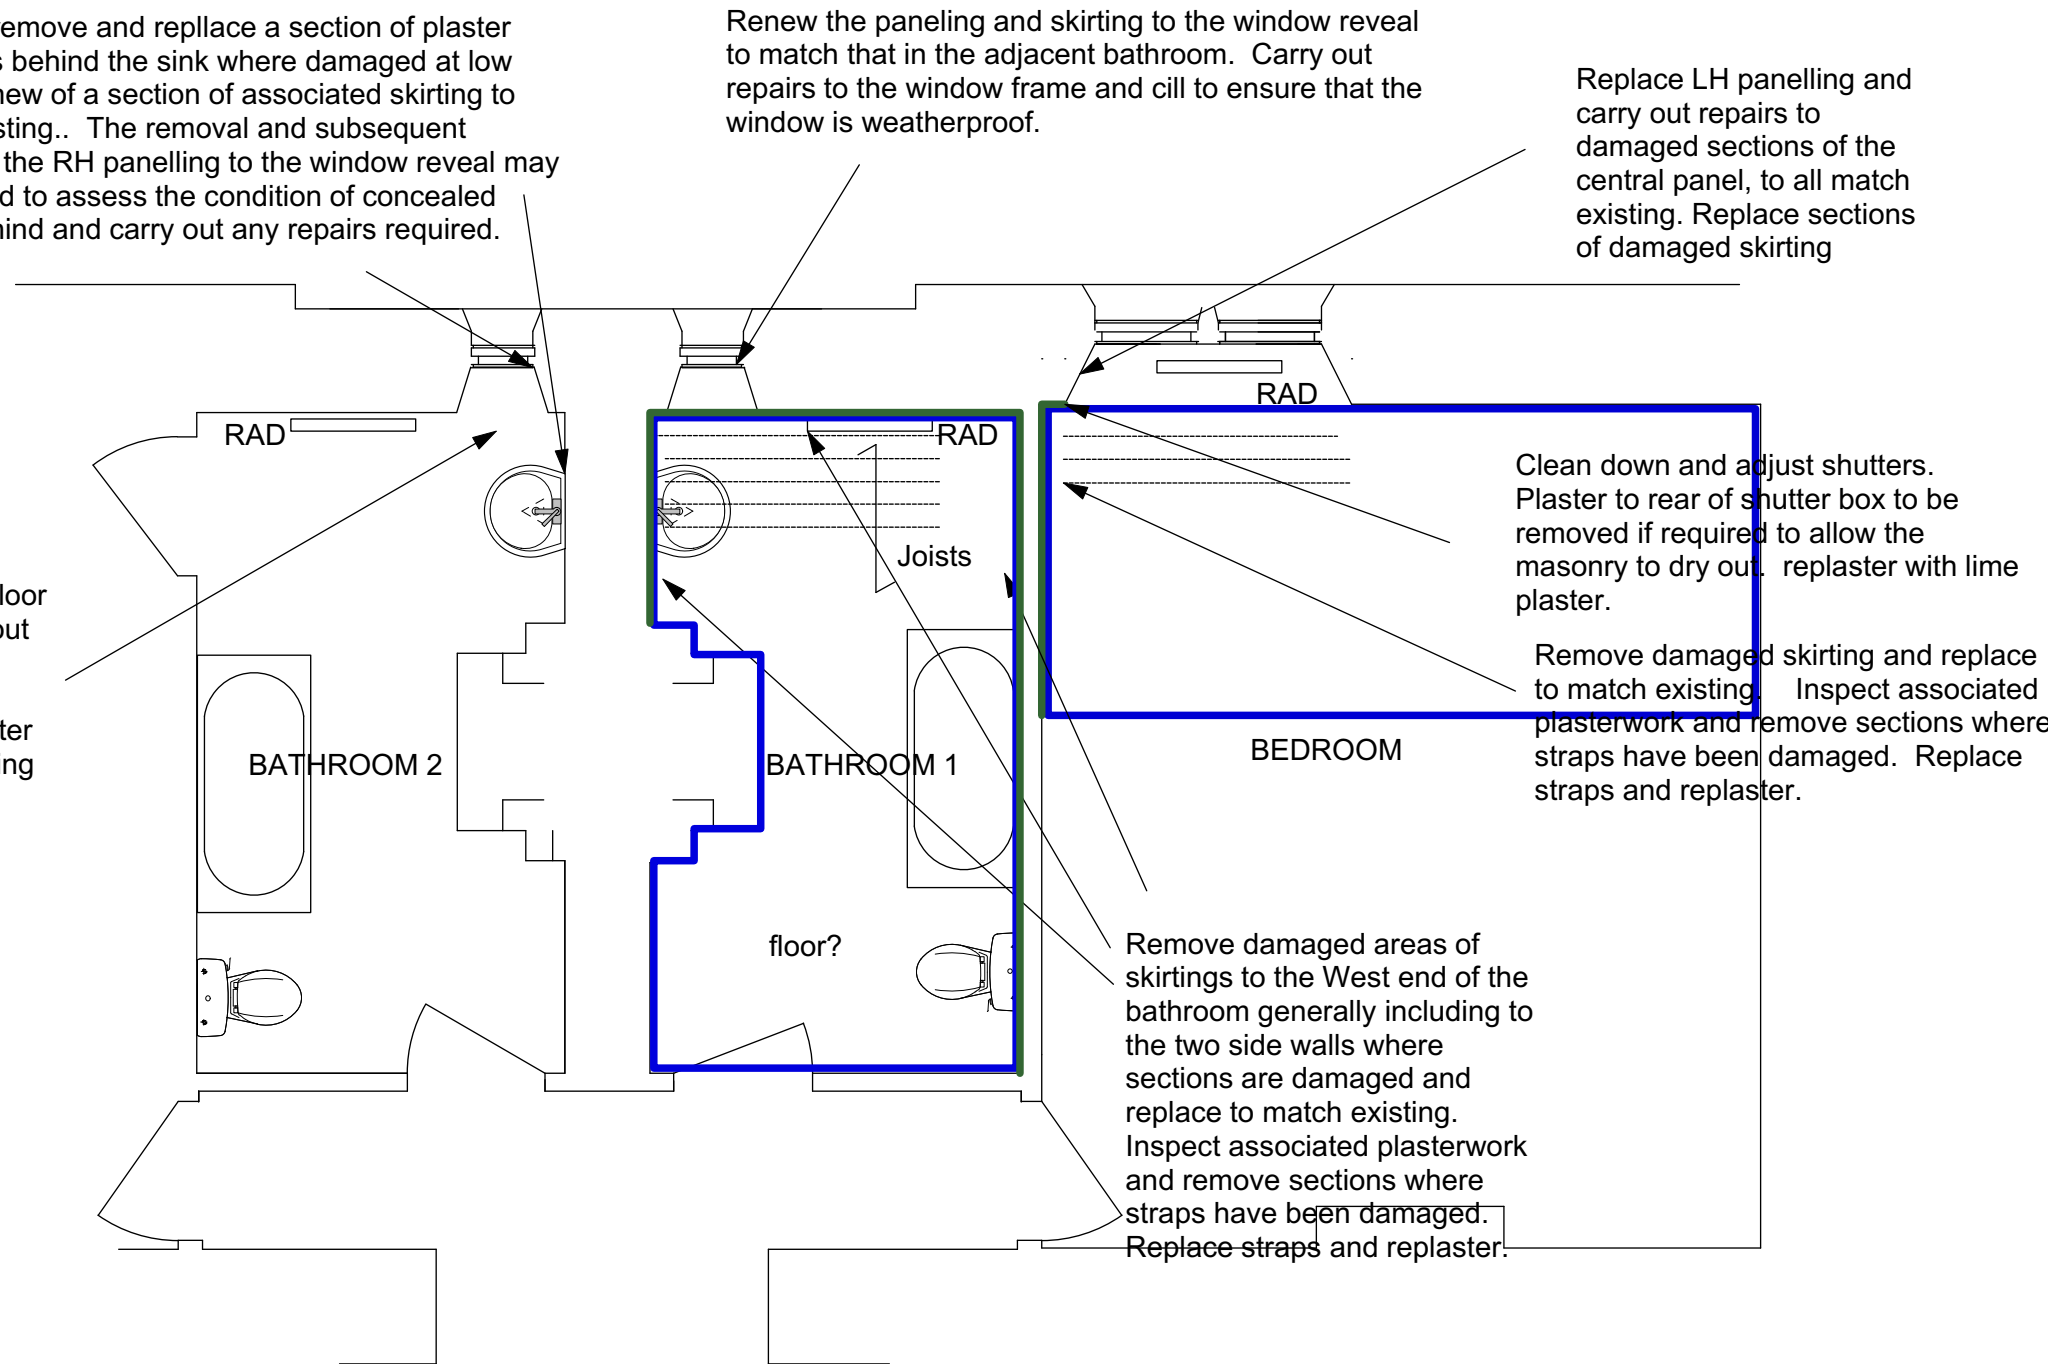
Plaster, laths and battens removed to approx 1 - 1.5m high in areas affected by dry rot to remove damaged material. Walls made good using lime plaster.

Area where floor joist renewal is expected to be required to replace timber damaged by dry rot. Floor boards to be replaced to match existing where boards are damaged beyond repair.

Carefully remove and replace a section of plaster and straps behind the sink where damaged at low level. Renew of a section of associated skirting to match existing.. The removal and subsequent refitting of the RH panelling to the window reveal may be required to assess the condition of concealed timber behind and carry out any repairs required.

Renew the paneling and skirting to the window reveal to match that in the adjacent bathroom. Carry out repairs to the window frame and cill to ensure that the window is weatherproof.

Replace LH panelling and carry out repairs to damaged sections of the central panel, to all match existing. Replace sections of damaged skirting

Renew damaged floor boards and carry out minimal repairs to joists to avoid disturbing the plaster ceiling in the drawing room.

Clean down and adjust shutters. Plaster to rear of shutter box to be removed if required to allow the masonry to dry out. replaster with lime plaster.

Remove damaged skirting and replace to match existing. Inspect associated plasterwork and remove sections where straps have been damaged. Replace straps and replaster.

Remove damaged areas of skirtings to the West end of the bathroom generally including to the two side walls where sections are damaged and replace to match existing. Inspect associated plasterwork and remove sections where straps have been damaged. Replace straps and replaster.
