## **Embleton Tower - repair works following dry rot outbreak Design, Access and Heritage Statement**

### History

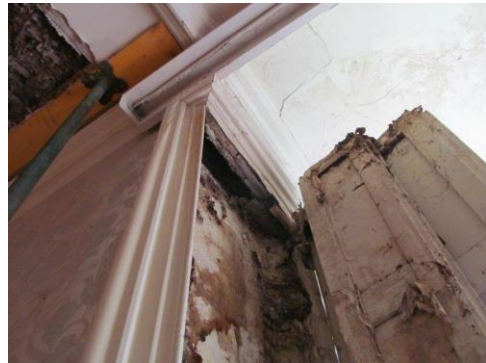
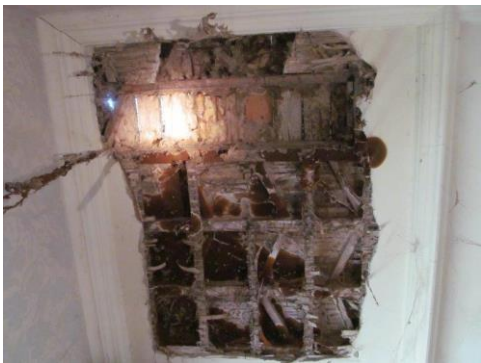
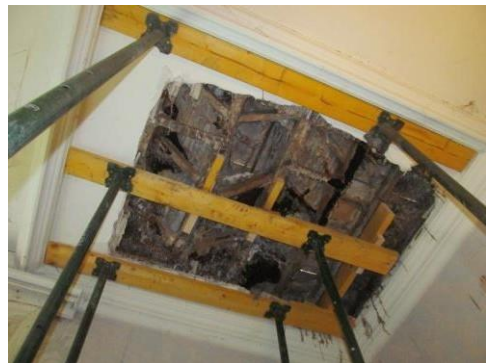
Collapsed ceiling and dry rot in the Dining Room before and after propping

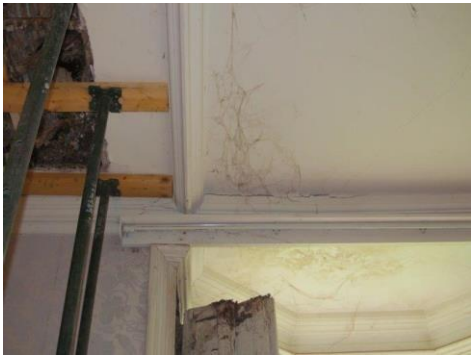
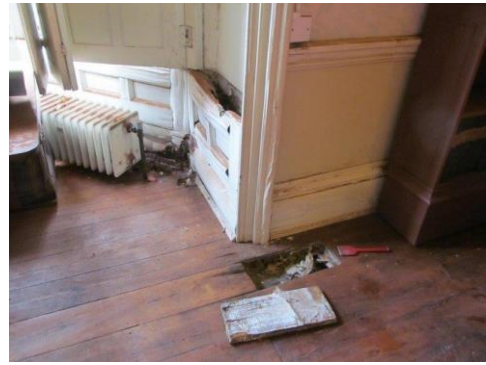
Bay window at high and low level in the Dining Room

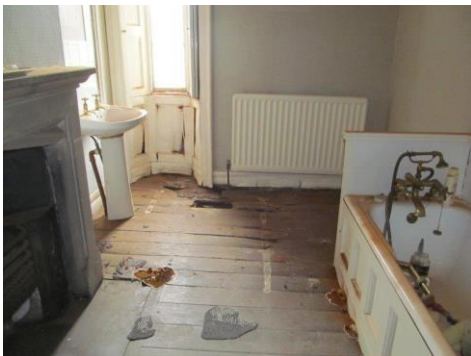
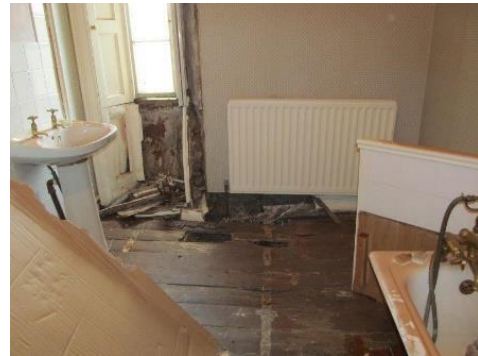
Main bathroom showing damage to panelling and floorboards – shown before and during drying out

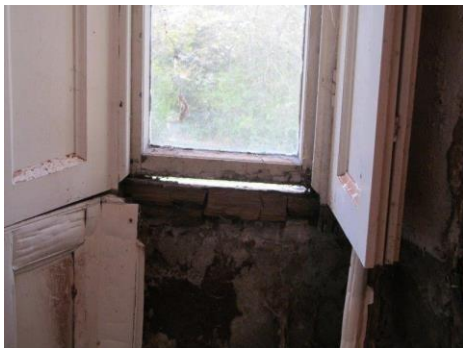
Damage to cill of main bathroom window

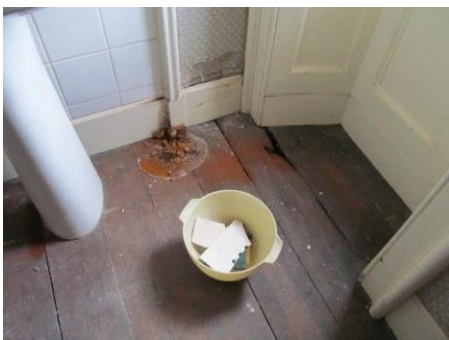
Damage to floorboards in ensuite

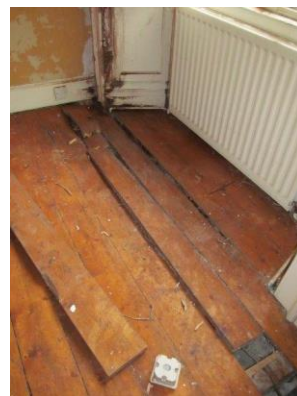
Damage to floorboards and panelling in North West bedroom

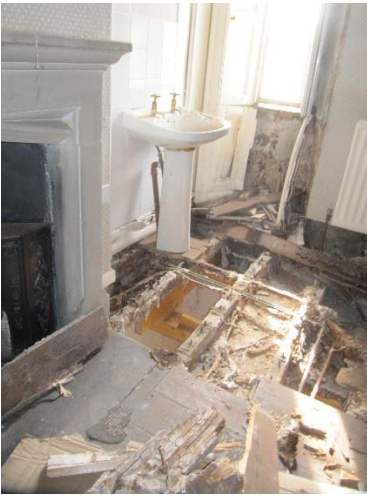
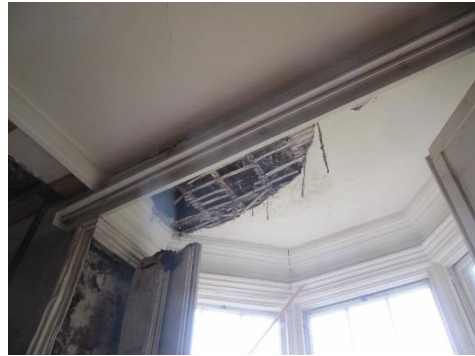
Updated photographs from 2021 showing areas of damaged floorboard removed in the first floor bathroom and some additional loss of plaster in the bay window in the dining room following drying out
