Our ref:	DS0721–SE57JZ/JB	Author:	Andrew Dallen
Name	Mr. Khawaja	Client	Mr. Khawaja
Address	8 Addington Square London SE5 7JZ	Contact	Christopher Read
		Initial visit	4 th August 2021
		Return visit	10 th August 2021

Scope

Following instruction from Mr. Khawaja, attend the above property to report on moisture conditions and were possible identify sources of loss moisture affecting the structure.

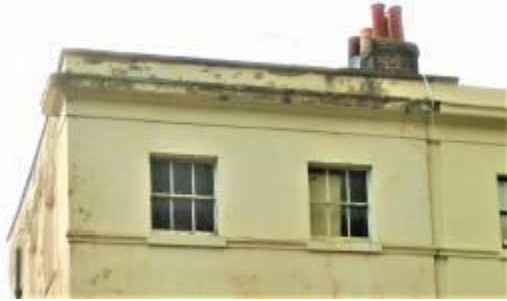
3.2.1 Top floor front room high level water ingress:

Readings through survey locations 6,7,8 & 9 strongly suggest periodic water ingress through the parapet and associated upper wall structures and, corresponding ceiling readings tend to suggest the ingress is limited to the wall structure and not the roof. A similar detail was noted at survey location 11 to the flank wall and in this area, significant cracking was noted to the exterior render to the upper wall. Loss water able to migrate behind

external render systems will, over time, migrate to the interior due the fact the external render and associated decoration greatly reduces, if not prevents the wall venting moisture back to the exterior.

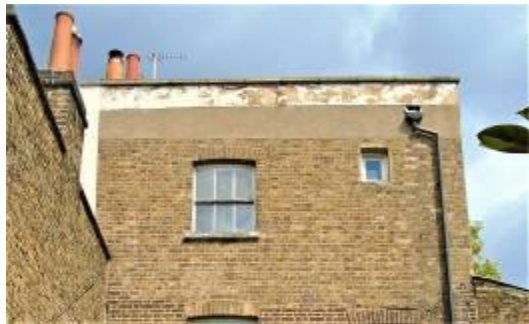
3.2.2 Rear elevation rainwater ingress:

Significant water ingress is occurring in the area of the shoe passing through the parapet wall to the external hopper from the valley gutter behind the parapet. Water ingress in this area may well be a mix of issues affecting the copings, gutter, and shoe detail etc. This area of ingress is significant affecting all the floors down through the structure, saturating the brick elements and driving fungal decay in associated timbers including the stairs etc.

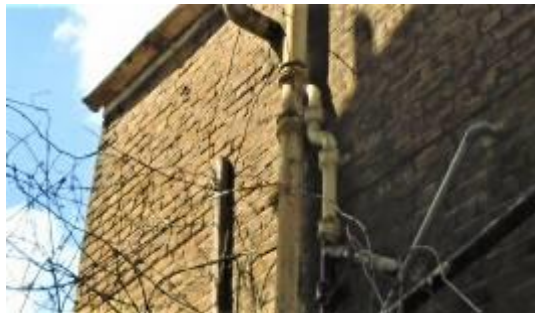
3.2.4 First floor flank wall to bathroom:

The moisture survey indicated significantly high moisture in regard to the mortar to the exterior with moderately dry readings to the bricks. A review of the exterior highlighted a significant issue with the pointing to this area of exterior wall which is also influenced by the prevailing weather. Significant rainwater penetration of the exterior wall is indicated and a sample of the affected mortar has been sent for gravimetric analysis.

This will allow a clear understanding of free capillary moisture and/or hygroscopic moisture affecting the mortar with results to follow. Significant rainwater ingress through issues with the window units was also affecting this area.

Gravimetric Analysis – 21st August 2021:

Total moisture content	Hygroscopic moisture	Free capillary moisture
1.9 %	2.4 %	Nil

The gravimetric analysis would tend to suggest the mortar was dry at the time of the survey with Hygroscopic salts in the said mortar driving the elevated readings. However, it is the opinion of the author it would be prudent to remediate the exterior wall structure.

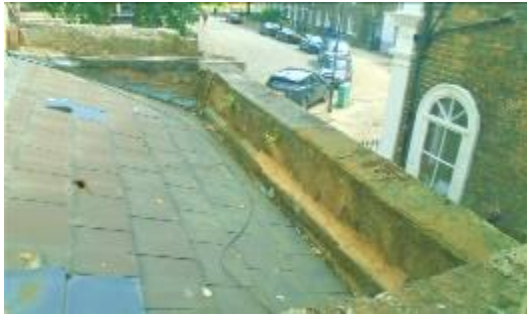
3.2.5 Ground floor flank wall entrance:

The exterior wall is saturated generally floor to ceiling and is certainly the case towards the front of the property at survey location 45. Issues with the weather-proofing of the parapet, integrity of the valley gutter etc. may well be allowing the water ingress. This area of the structure has been subject to movement and is also likely to be a contributory factor.

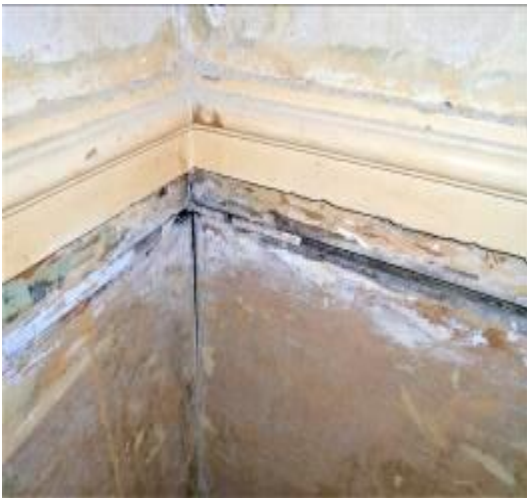
3.2.6 Previous damp remediation works:

Regarding many of the original wall structures through the ground floor, it was noted the lower wall finishes have been removed and replaced with modern boarding up to the dado rail. As mentioned, the property possibly dates from or before 1820, prior to DPC's being a requirement. The noted boarding is most likely part of remediation carried out in regard to ground moisture affecting the structure and, in a number of areas where boarding was not noted, significant moisture levels to the lower wall was recorded for example survey locations 62 & 64. In the case of the adjoining area survey location 67, elevated resistance readings were recorded in relation to the remediation boarding noted to the lower wall.

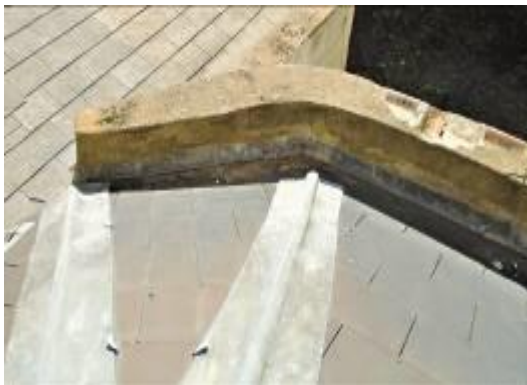
3.2.7 Curved exterior walls to rear:

As indicated in the moisture survey, elevated readings were noted at high and low level either side of the patio doors etc. The nature of the wall structure and associated waterproofing to the parapet, is likely to be allowing rainwater penetration to be an issue in regard to the wall structure. In addition, observations noted the roof timber in the area of survey location 93 was saturated as is the floor structure below with significant timber decay noted. This would suggest rainwater ingress through the roof is also an issue in this area.

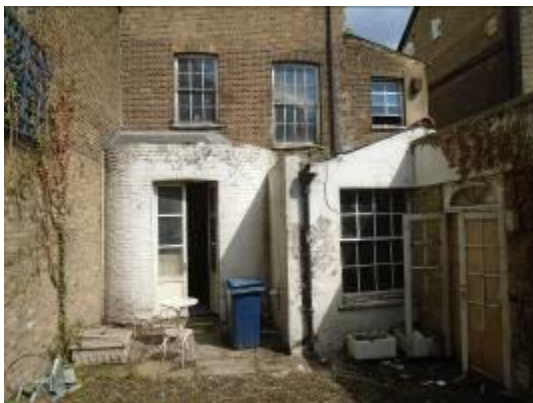
3.2.8 Older single structures to the rear:

In regard to the single storey slate pitched room areas, significant cracking and deterioration was noted to the render and associated decoration. This, and possible issue with the integrity of the roof structure is allowing rainwater ingress to affect the structure.

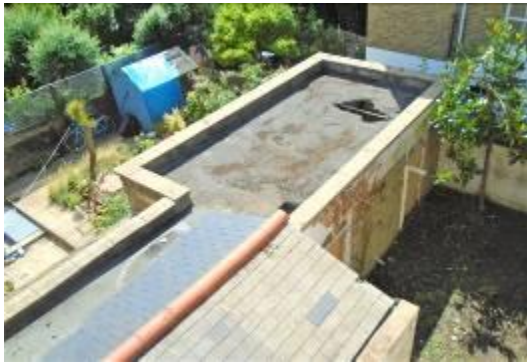
3.2.8 Modern flat roof room to the rear:

In a number of areas, the flat roof has failed allowing long term rain ingress to affect the structure. In general wall and floor structure through these areas were saturated.

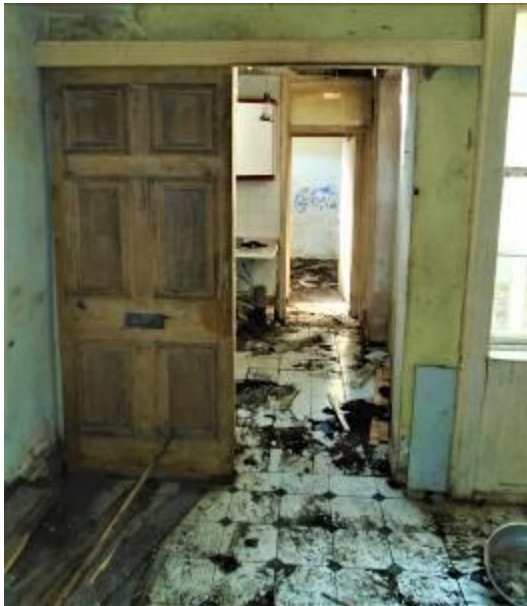
3.2.9 Ground supported concrete slabs:

In a number of areas concrete floor slabs were noted and, due to ongoing rainwater ingress, in general these were saturated. With regard to possible restorative drying, their period and nature of construction would have to be understood to allow drying requirements to be determined.

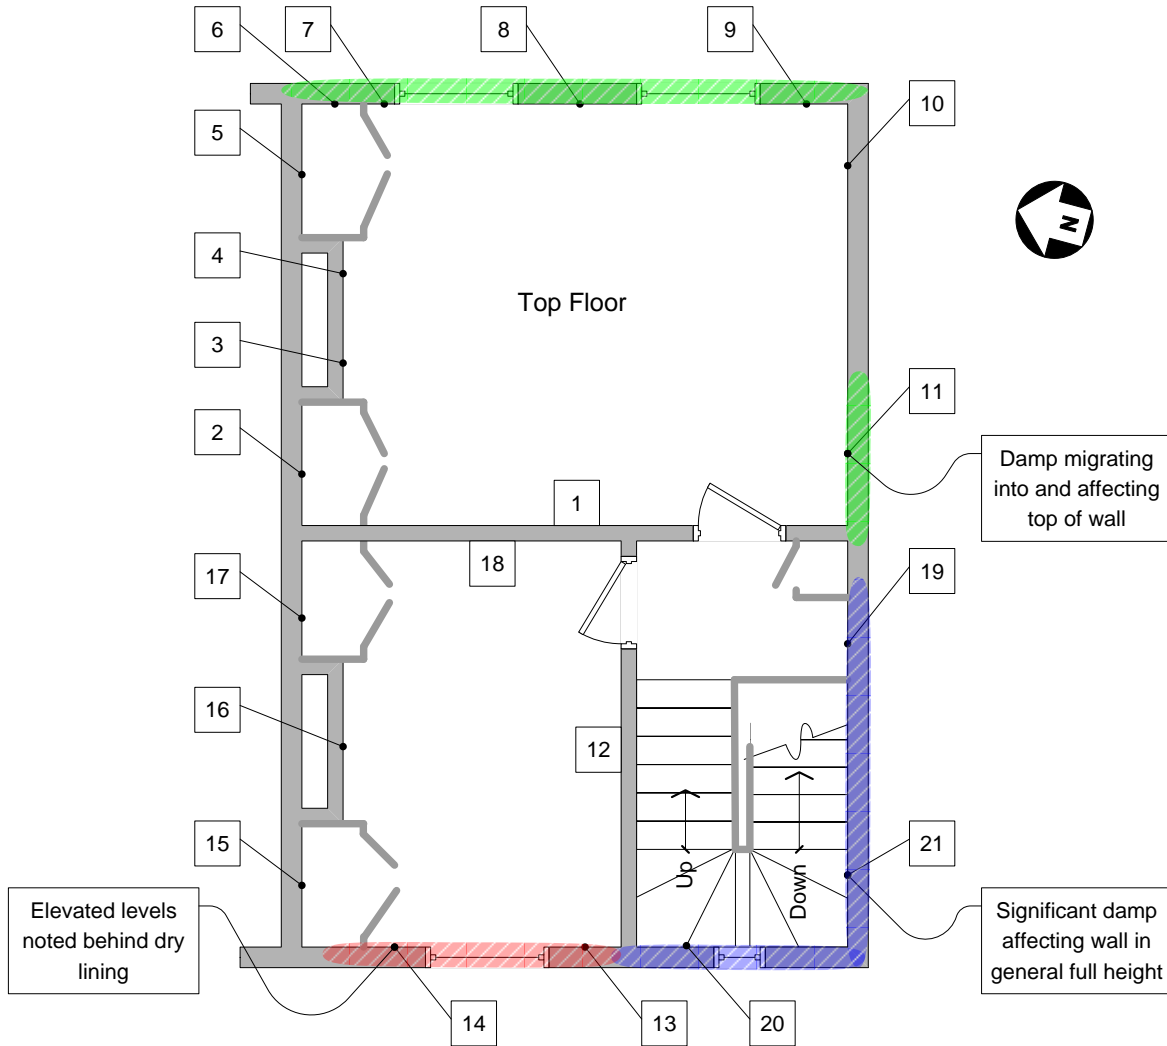
4.0 Moisture survey – Top floor:

4.0.1 Structural wall and ceiling readings – Top floor:

Loc	Skirt. %mc	Base of wall		Height REL =250	REL(PS) up wall and ceiling			Comments
		% WME	REL(PS)		Middle	Top	Ceiling	
1	13.9 %	13.8 %	86		81	101	114	
2		10.3 %	107		114		104	
3	8.2 %	8.7 %	136		131	142	116	
4	9.0 %	11.2 %	129		127	145	116	
5		12.2 %	114		112		156	
6		10.8 %	116		116	480	107	350mm Down
7	10.2 %	< 6.0 %	120		118	566	116	640mm Down
8	13.2 %	8.4 %	133		136	999	116	670mm Down
9	9.8 %	9.6 %	136		121	999	250	740 mm Down
10	14.8 %	12.3 %	136		155	143	153	
11	11.5 %	12.3 %	156		135	999	112	830mm Down
12	12.2 %	< 6.0 %	101		110	104	121

Loc	Skirt. %mc	Base of wall		Height REL = 250	REL(PS) up wall and ceiling			Comments
		%WME	REL(PS)		Middle	Top	Ceiling	
13		17.5 %	145		155	140	117	Drilled Base 30.9 %
14	8.9 %	14.1 %	112		132	118	127	Drilled Mid. 31.8 %
15		10.2 %	138		139		122	
16	9.7 %	9.9 %	136		139	149	110	
17			144		132		129	
18			130		126	116		
19	< 6.0 %	22.7 %	999		499	141	112	Drilled Base 19.9 %
20		25.5 %	999		999	999		Drilled Base 28.5 %
21		42.1 %	999		999	999

4.0.2 Structural readings floors joists – Top floor:

Loc	%mc	Comments
8	17.7 %	Dry readings in general noted in exposed floor joists
19	19.2 %

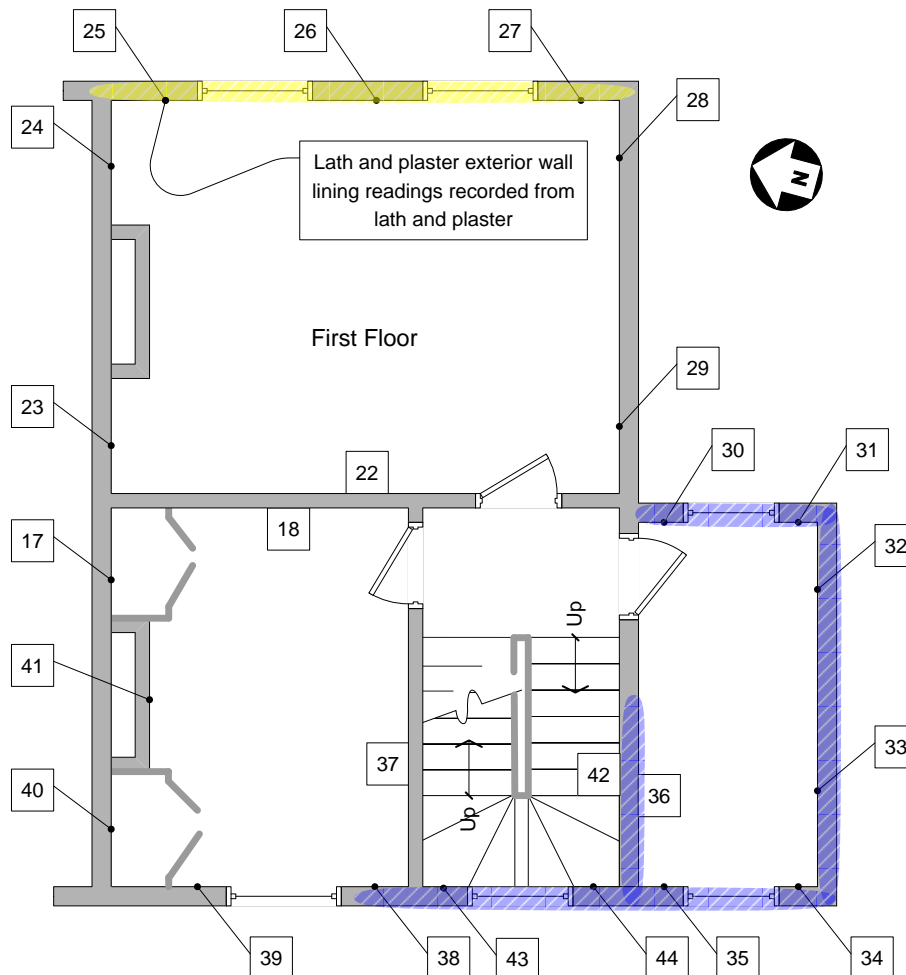
4.1 Moisture survey – First floor:

4.1.1 Structural wall and ceiling readings – First floor:

Loc	Skirt. %mc	Base of wall		Height REL =250	REL(PS) up wall and ceiling			Comments
		% WME	REL(PS)		Middle	Top	Ceiling	
22	< 6.0 %	< 6.0 %	132		142			
23	< 6.0 %	14.7 %	146		138			
24	10.1 %	11.0 %	146		138	136	131	
25	8.0 %	7.9 %	131		129	131	134	
26	< 6.0 %	13.9 %	131		129	124	124	
27	< 6.0 %	8.9 %	129		134	134	129	
28	< 6.0 %	11.7 %	135		136	139		
29	8.6 %	11.9 %	141		138	127	121	Drilled Mid. 8.7 %
30		30.2 %	143		132	121	122	Middle 25.4 %WME
31		76.7 %	430		166	166	131	Middle 24.9 %WME
32		74.8 %	166		220	177		Sporadic readings Mortar 42.9 %
33		26.2 %	129		210	135		
34		93.0 %	177		999	135	127	
35		24.3 %	127		555	230	122	
36		44.3 %	147		999	999		
37	< 6.0 %	< 6.0 %	131		127	136	112	
38	< 6.0 %	14.6 %	133		212	168	121	Drilled Mid. 41.3 %
39	8.7 %	9.9 %	131		132	136	122	
40	< 6.0 %	11.6 %	141		145			
41	9.6 %	10.5 %	141		138			
42		65.4 %	999		999	999		
43			999		999	567		Wall timber 27.2 %
44			999		999	999

4.1.2 Structural readings floors joists:

Loc	%mc	Comments
29	16.9 %	
33	25.2 %	Joist nearest to rear wall to property Rest of joists 17 – 19 %
38	19.9 %

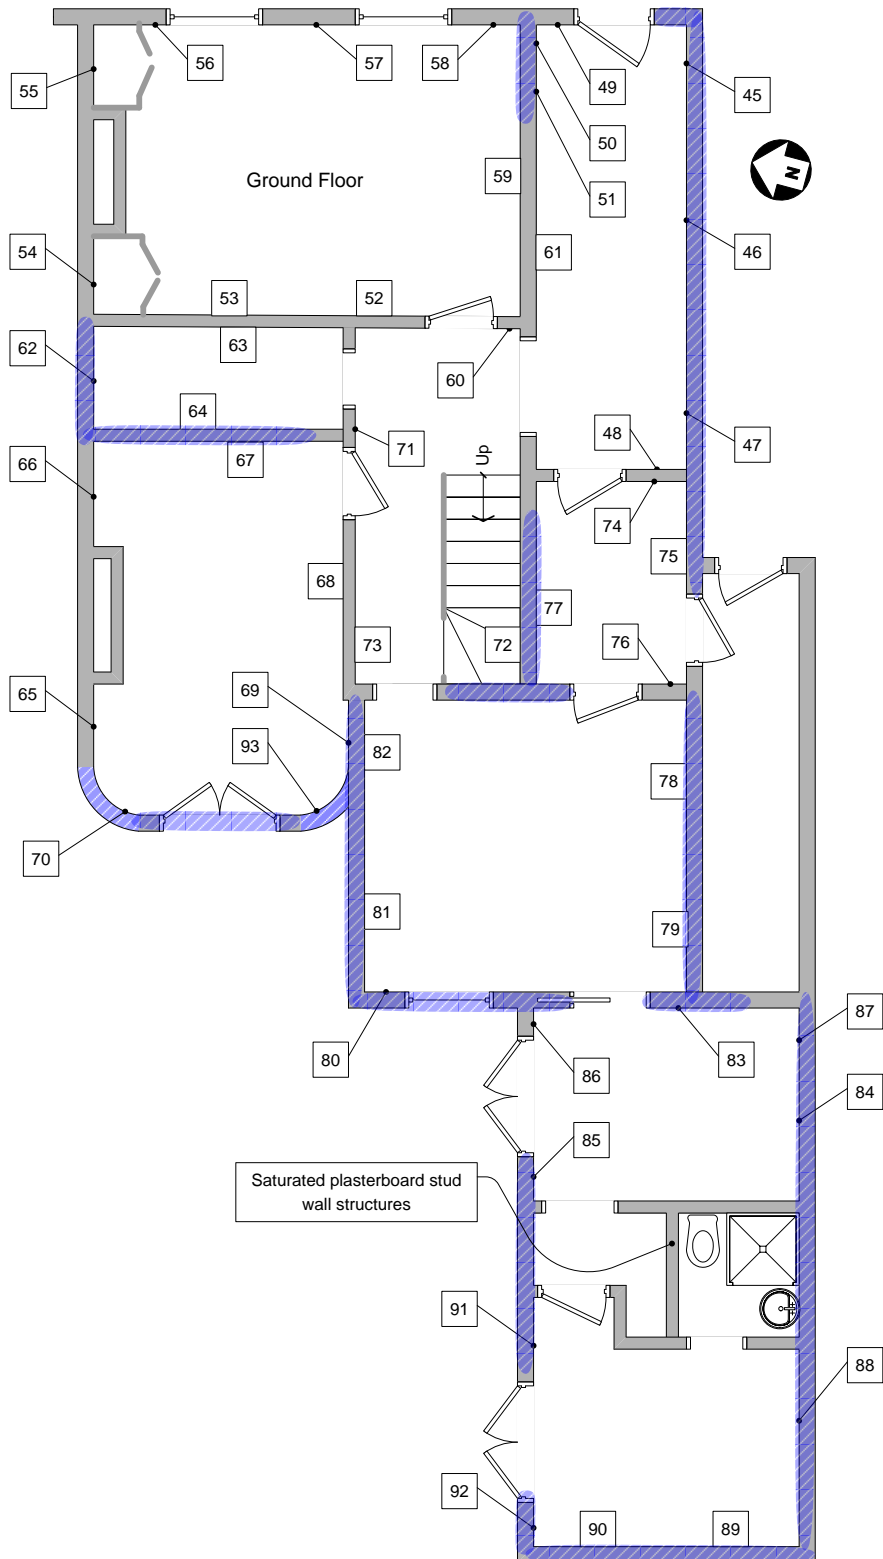
4.2 Moisture survey – Ground floor:

4.2.1 Structural wall and ceiling readings – Ground floor:

Loc	Skirt. %mc	Base of wall		Height REL =250	REL(PS) up wall and ceiling			Comments
		% WME	REL(PS)		Middle	Top	Ceiling	
45		99.9 %	999		999	999		Wall timber 47.2 %
46			999		999	999		
47		41.6 %	999	1500mm	166	172		
48		14.0 %	167		131	138		
49	8.7 %	11.5 %	187		158	166		
50	17.2 %	61.2 %	999		136	134		
51	15.1 %	43.2 %	999		132	136		
52	14.3 %	18.7 %	182		151	145		Middle 10.6 %WME
53	8.1 %	23.4 %	172		141	142		
54	8.1 %	15.4 %	145		131	136		
55	15.2 %	15.5 %	149		138	145		
56	12.5 %	16.4 %	136		146	129		
57	14.4 %	12.8 %	134		149	132		
58	8.1 %	14.1 %	136		158	138		
59	10.7 %	14.0 %	129		143	136		
60	12.6 %	15.8 %	139		129	137		
61	18.7 %	18.1 %	126		141	139		
62		95.6 %	999	1700mm	390	132		
63		15.2 %	155		128	101		
64		88.8 %	999	860mm	210	229		Wall timber 15.2 %
65	14.6 %	15.8 %	135		145	148		Middle 12.6 %WME
66		14.4 %	127		142	143		
67		22.3 %	164		141	143		Boarding to base
68	18.2 %	16.1 %	144		143	133		Middle 9.9 %WME

69			151		999	999		Middle 99.9 %WME
70	30.7 %	29.9 %	287		134	999		Middle 55.6 %WME
71	25.6 %	13.5 %	136		154	142		
72			999		999	999		Middle 55.3 %WME
73	11.2 %	13.4 %	143		146	152		
74		14.2 %	167		151	153		
75		32.7 %	999	500mm	165	229		
76	18.6 %	14.0 %	197		169	999		Top 71.2 %WME
77		99.9 %	999	2200mm	999	197		
78	41.7 %	99.9 %	999		360	258		
79	42.0 %	99.9 %	999		999	999		
80			999		999	124		Middle 85.2 %WME
81		99.9 %	999		999	325		Middle 99.9 %WME
82	18.0 %	18.7 %	250		202	466		Top 53.9 %WME
83		96.5 %	999		999	999		Middle 86.5 %WME
84			Kitchen base units		258	999		
85		42.6 %	999		287	584		
86			999		999	999		Middle 62.1 %WME
87			999	1000mm	229	221

Loc	Skirt. %mc	Base of wall		Height REL = 250	REL(PS) up wall and ceiling			Comments
		%WME	REL(PS)		Middle	Top	Ceiling	
88	41.8 %	55.4 %	999	1500mm	208			
89	35.6 %	23.0 %	999		431	999	999	
90	39.6 %	22.6 %	999		287	999		
91			999		338	999		
92	52.8 %	92.9 %	999		431	999		
93			999			485

4.2.2 Structural readings floors joists:

Loc	%mc	Comments
45	82.1 %	
53	26.2 %	
57	21.4 %	
58	24.8 %	
62	25.7 %	
70	27.1 %	
93	99.9 %	Saturated timber joists significant decay
