## A.T. COOMBES ASSOCIATES Ltd.

28<sup>th</sup> September 2015

### Tree Report at The Old Rectory, The Street, Fritton, NR15 2QT

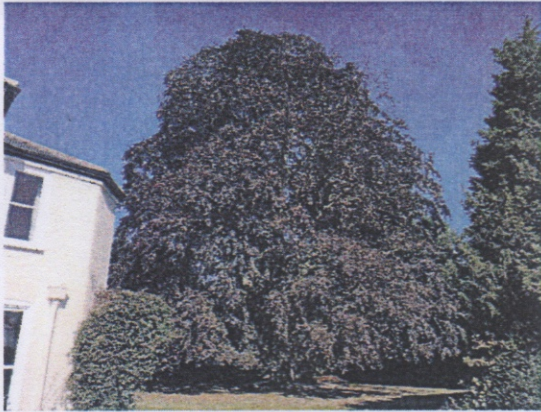
Fig 1: Picture taken from southern aspect of tree with dwelling left of photo

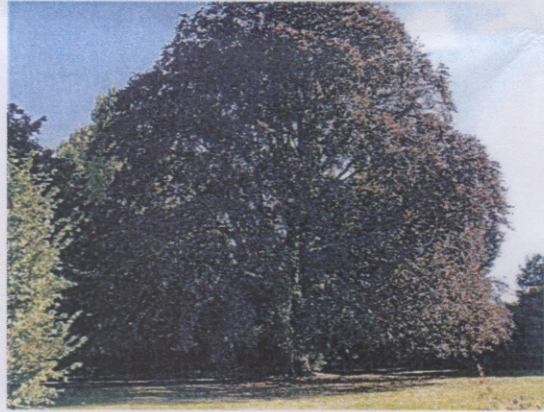
Fig 2: Full extent of canopy spread and lawn area, picture taken from south west

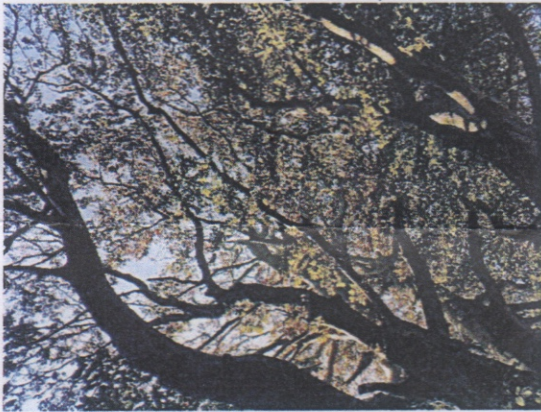
Fig 3: Comparison between thin / sparse crown (north) and healthy (south)

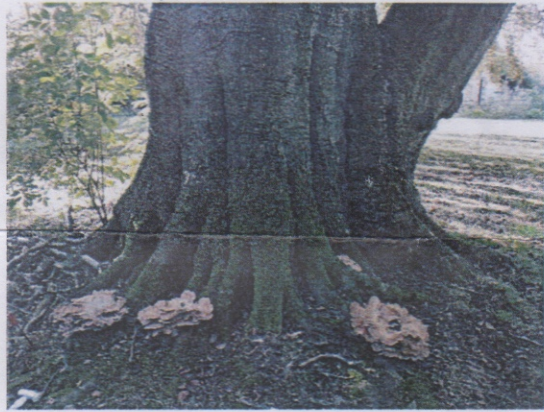
Copper beech ( <i>Fagus sylvatica</i> 'Purpurea')	No. T1
Comments on Condition Cont.	<p>present, in this instance however the onset of decay is considered significant with advanced levels of decay into the surface roots and buttressing where indicate with the sounding hammer.</p> <p>The sounding hammer indicated the presence of decay within the buttresses and adjoining roots spreading radially from the tree to the north, in relation to the existing fruiting bodies, and around to base the east where the presence of fruiting bodies had previously been report.</p> <p>Interesting the presence fructifications and decay on one side of the tree is mirrored with the thin and sparse crown on the north eastern side of the tree which is likely to indicate the advance stages of decay.</p>
Protection Factors	In the event of uprooting protection factors considered during the inspection were the lower branches of the overall crown and the adjacent trees between the copper beech and the road that could arrest a tree failure.

The risk rating associated with the tree has been identified as high. This has been given in relation to the entire tree uprooting and falling into the adjacent dwelling. Low risk levels have been associated with the tree falling into the house injuring residents inside the property and large bits of deadwood or limbs failing from the tree into the garden and hitting occupants.

Fig 4: Four *Meripulus giganteus* at base of tree to the north

Due to the significance of this type fungus and the level of decay present further investigation work to uncover the root system is not advised due to the amount of evidence currently present.

**Option 1;** reduce the overall height of the tree to 20-22m retaining lower canopy branches, this height is around 1m less than the distance to the wall of the adjacent dwelling. Cleanout loose and dangerous deadwood.

**Option 2;** completely remove the tree and plant with a replacement specimen to including stump grinding of the existing buttress and large surface roots eliminating the risk associated with this tree and ongoing management.

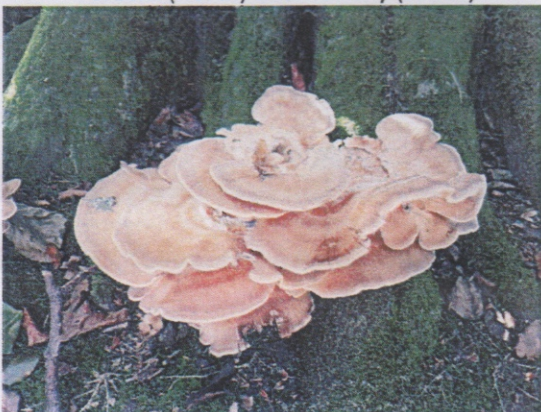
Fig 5: Fruit body of *Meripulus giganteus* at base

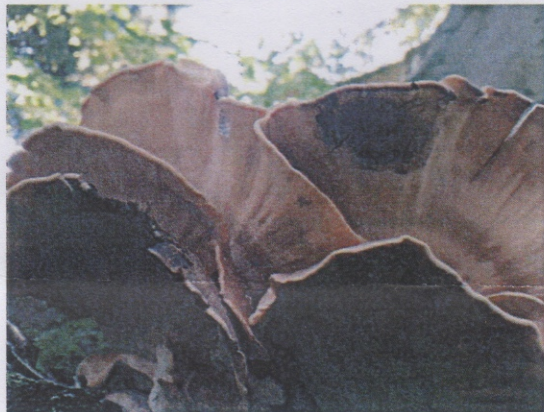
Fig 6: Bruising of flesh indicating positive identification of *Meripulus giganteus*
