Our Ref: 3676/ACW

19 August 2021

Structural inspection of outbuildings at The Old Rectory, Somerton

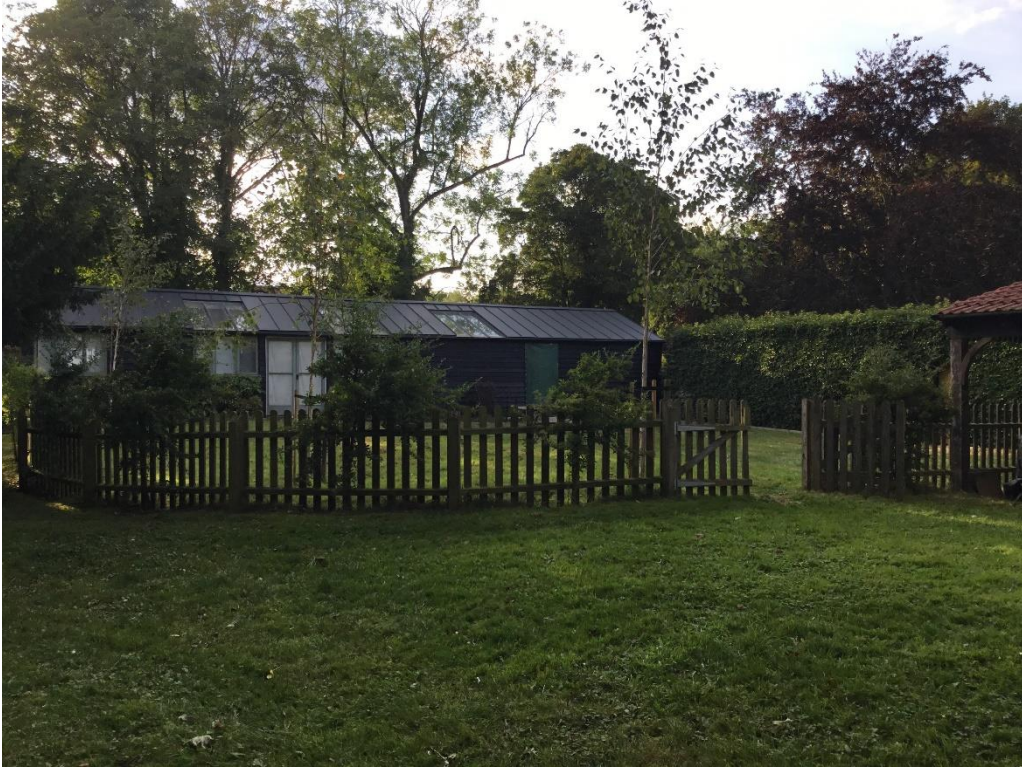
Building 1 – front elevation

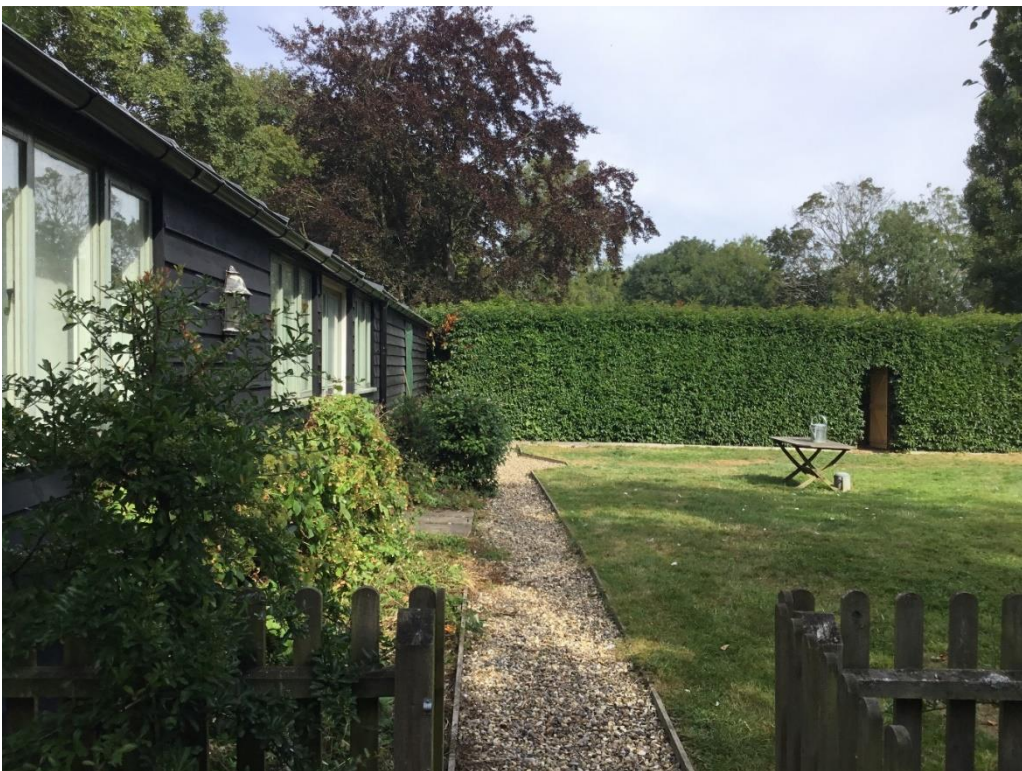
Building 1 – front elevation from left hand end

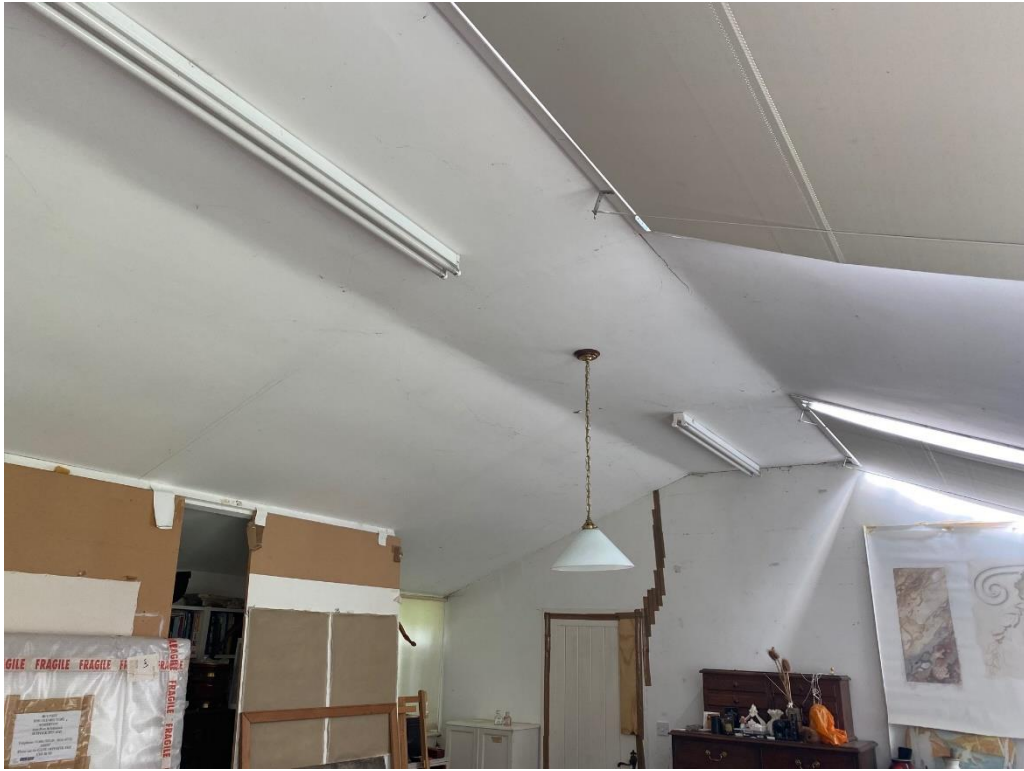
No evidence of distress or significant deterioration was noted in any of the concrete sections inspected, neither any evidence to suggest significant sway or foundation related movement. The infill walling also appears generally robustly formed and remains free from significant damage. One area of cracking was noted, however, to an internal partition wall towards the right-hand end of the building at the rear. We suspect this wall was built off the floor slab to form a sub-division of the internal space and has cracked as a consequence of slight localised

settlement of the floor slab. Further partition walls towards the left-hand end of the building were free from significant damage.

Building 1 – internal view showing location of cracking to partition wall

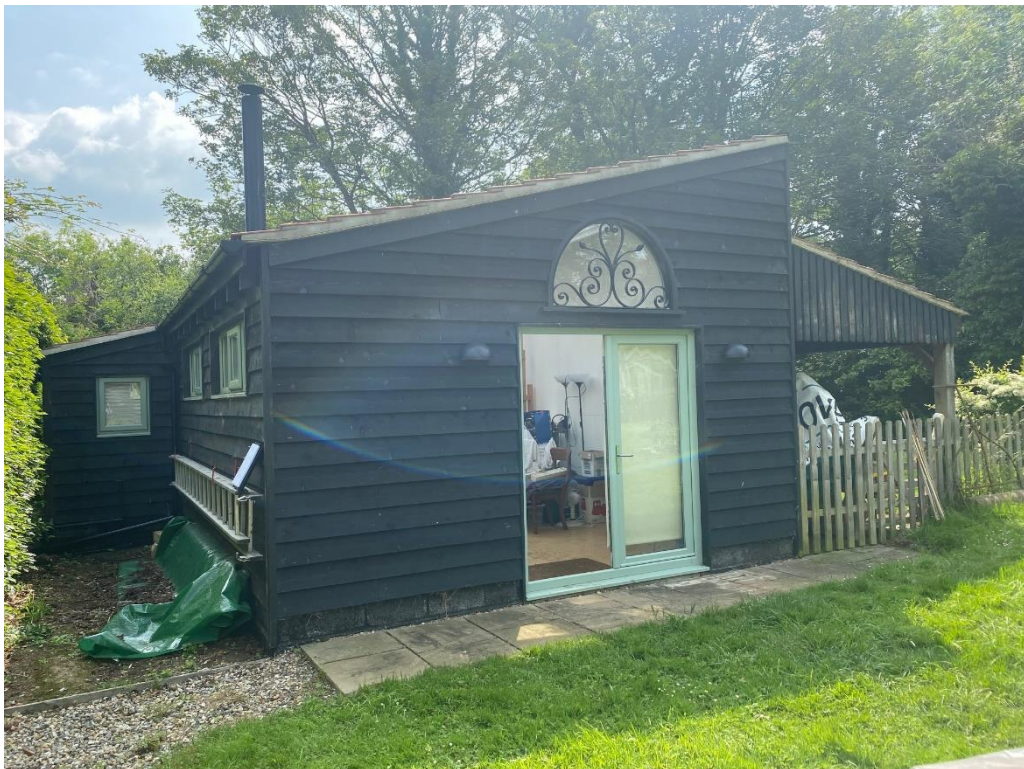
Building 2 – front elevation

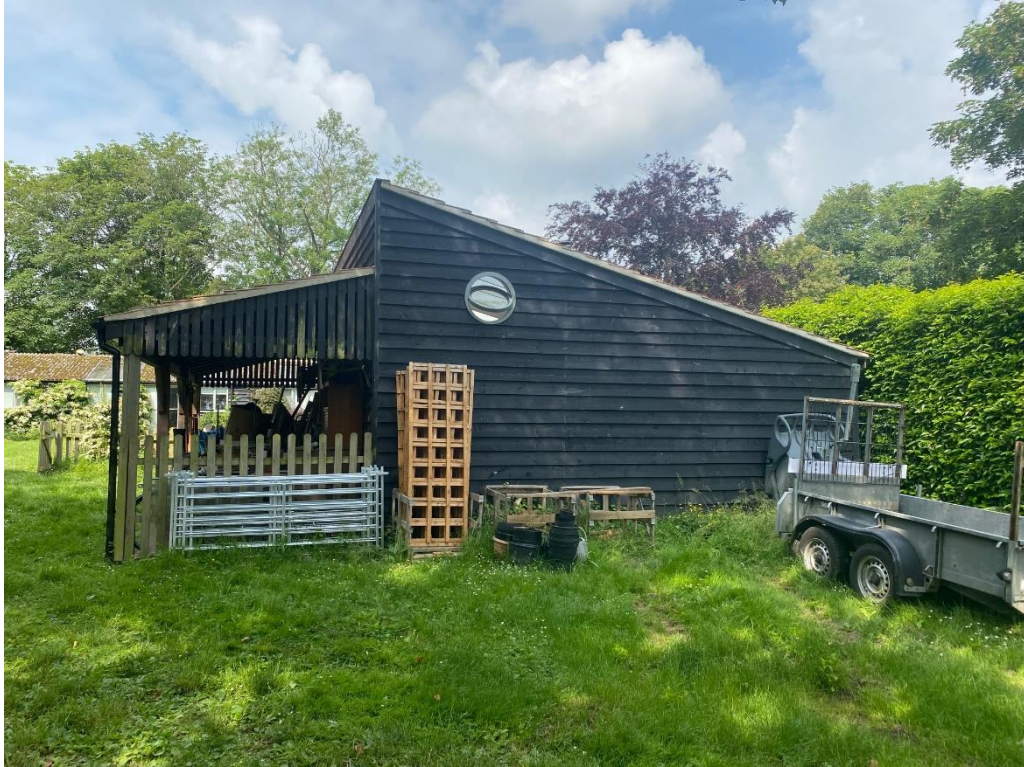
Building 2 – rear elevation

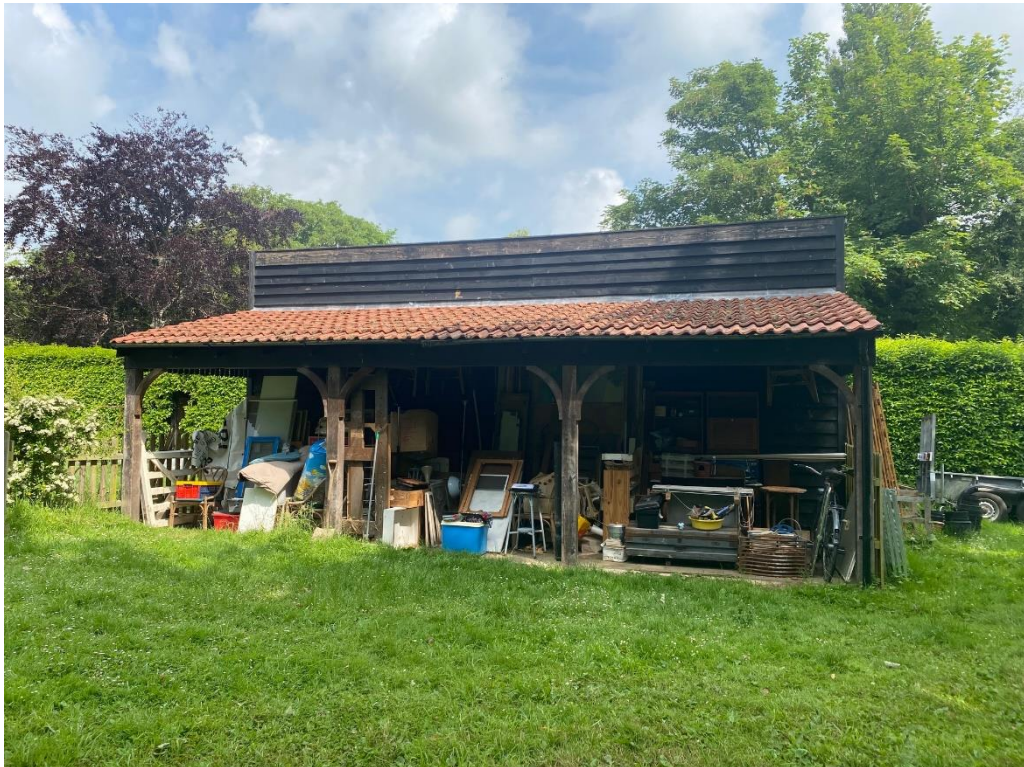
Building 2 – right side showing lean-to addition

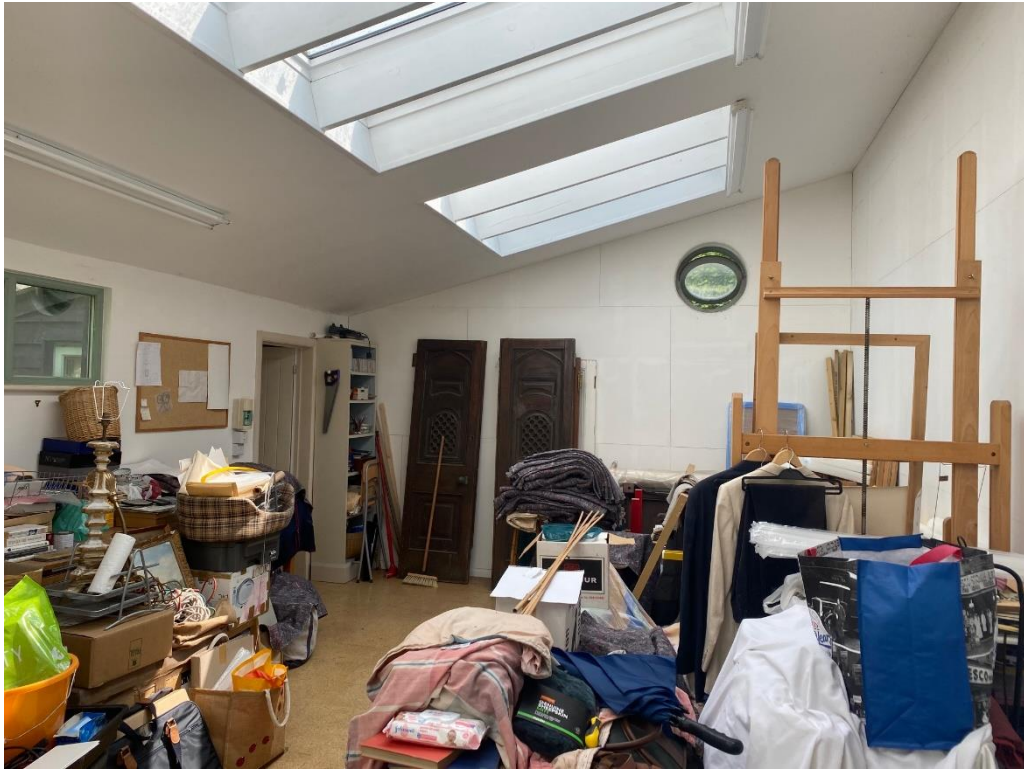
Building 2 – internal view
