STRUCTURAL APPRAISAL REPORT

**Barn Farm,
Cranebrook Lane,
Hilton,
Lichfield,
Staffordshire.
WS14 0EZ**

14th October 2020

Project Title	Barn Farm, Cranebrook Lane, Hilton, Lichfield, Staffordshire.	Project Ref.:	15430
Report prepared by

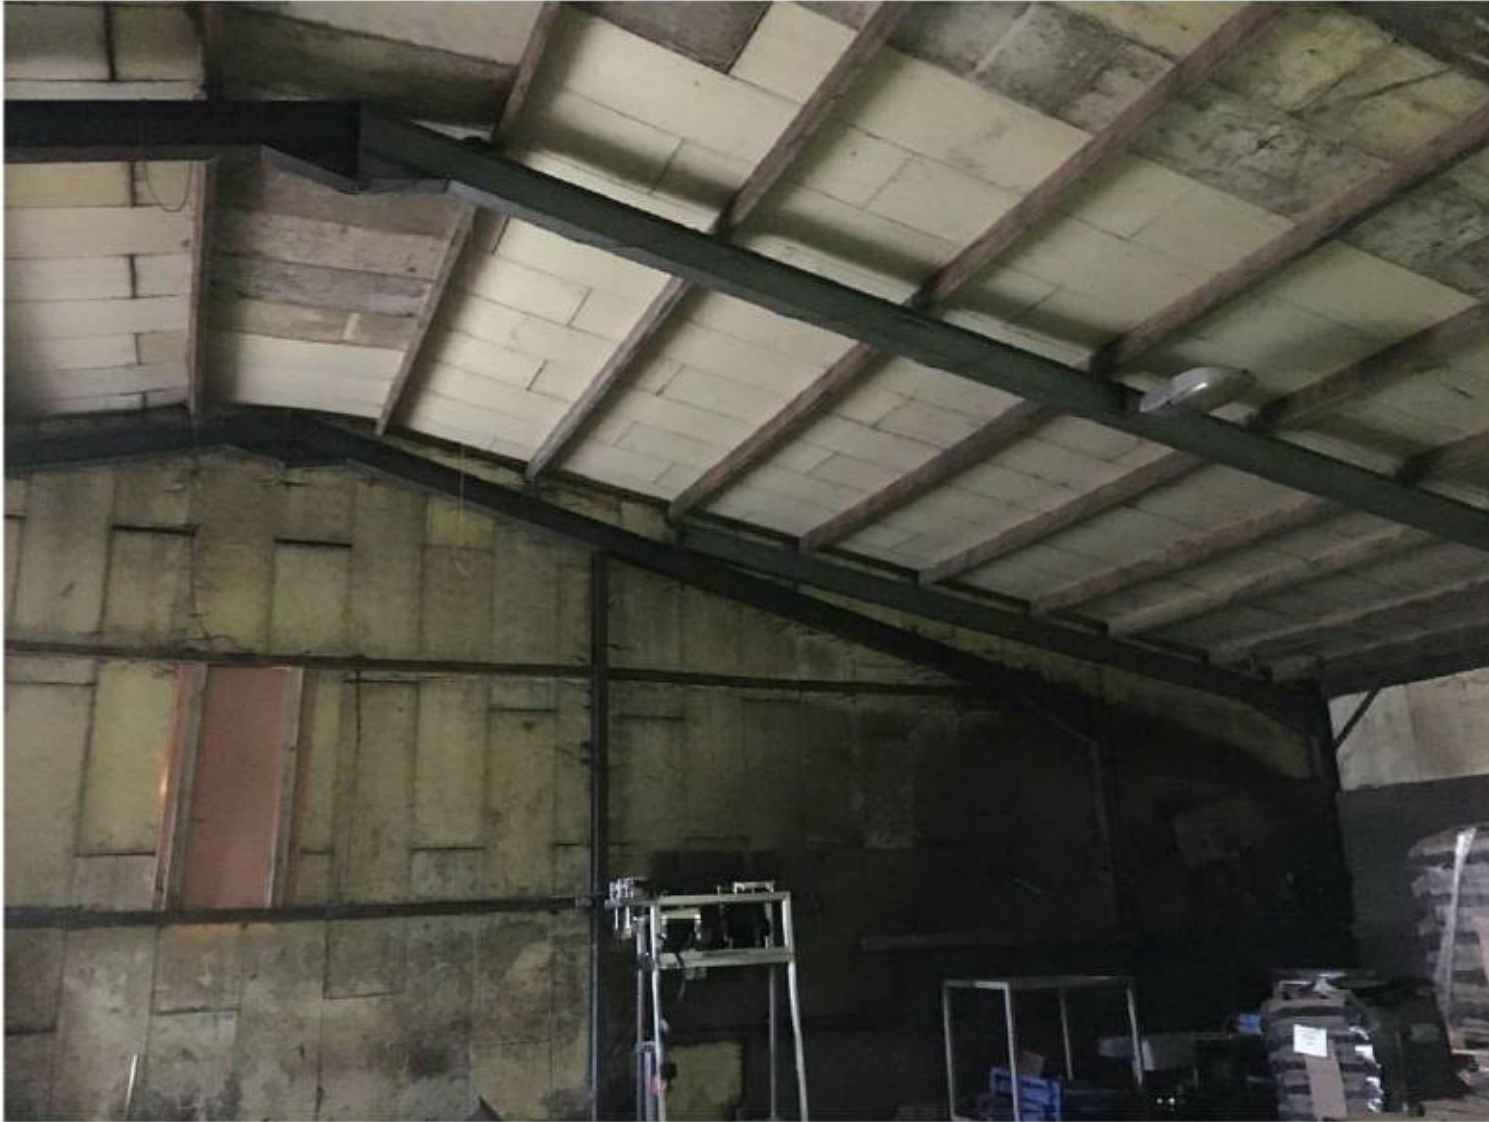
- 4.1.1 The existing barn appears to have been extended or built using reused steelwork evidenced by the differing paint specifications (Figure 1). The main internal frame rafters are longer to the Northern end of the building, making an asymmetric duo-pitch roof.
- 4.1.2 The gable portal frames are constructed using a symmetric portal; however, they have been supplemented with a lean-to extension to match the internal portal frames (Figure 2). The extension to the gables appear to be formed using a bolted connection between the bottom flange of the steel lean-to and the top of the main portal frame.

Figure 1: Differing paint specification noted to both sides of the portal frame.

- 5.1.1 Barn 1 appears to have been constructed using reused steelwork or retrofitted during its working life to extend the plan width of the building. This has resulted in an unusual arrangement for the gable ends with a 'lean-to' section of frame supported off the gable portal frames. In principle this arrangement is acceptable if the intersecting beam is adequately fixed to the top of the main gable portal. At the time of the inspection, this could not be determined, and it is recommended that this detail is investigated further.

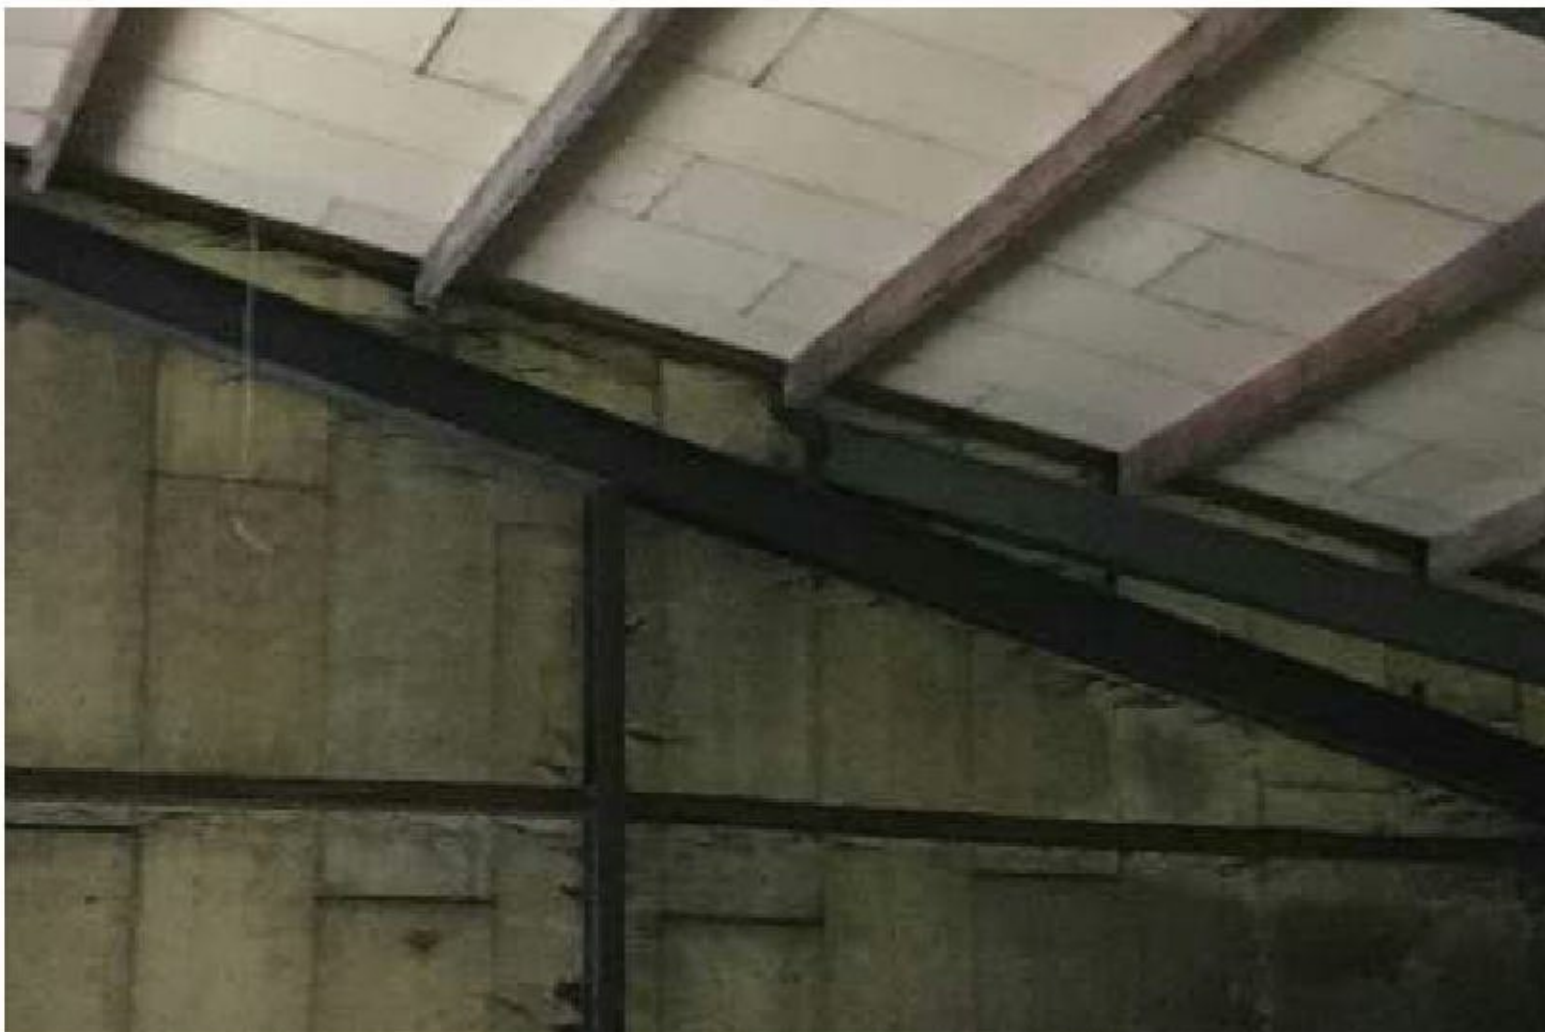
Figure 2: Steel connection to gable portal frame.

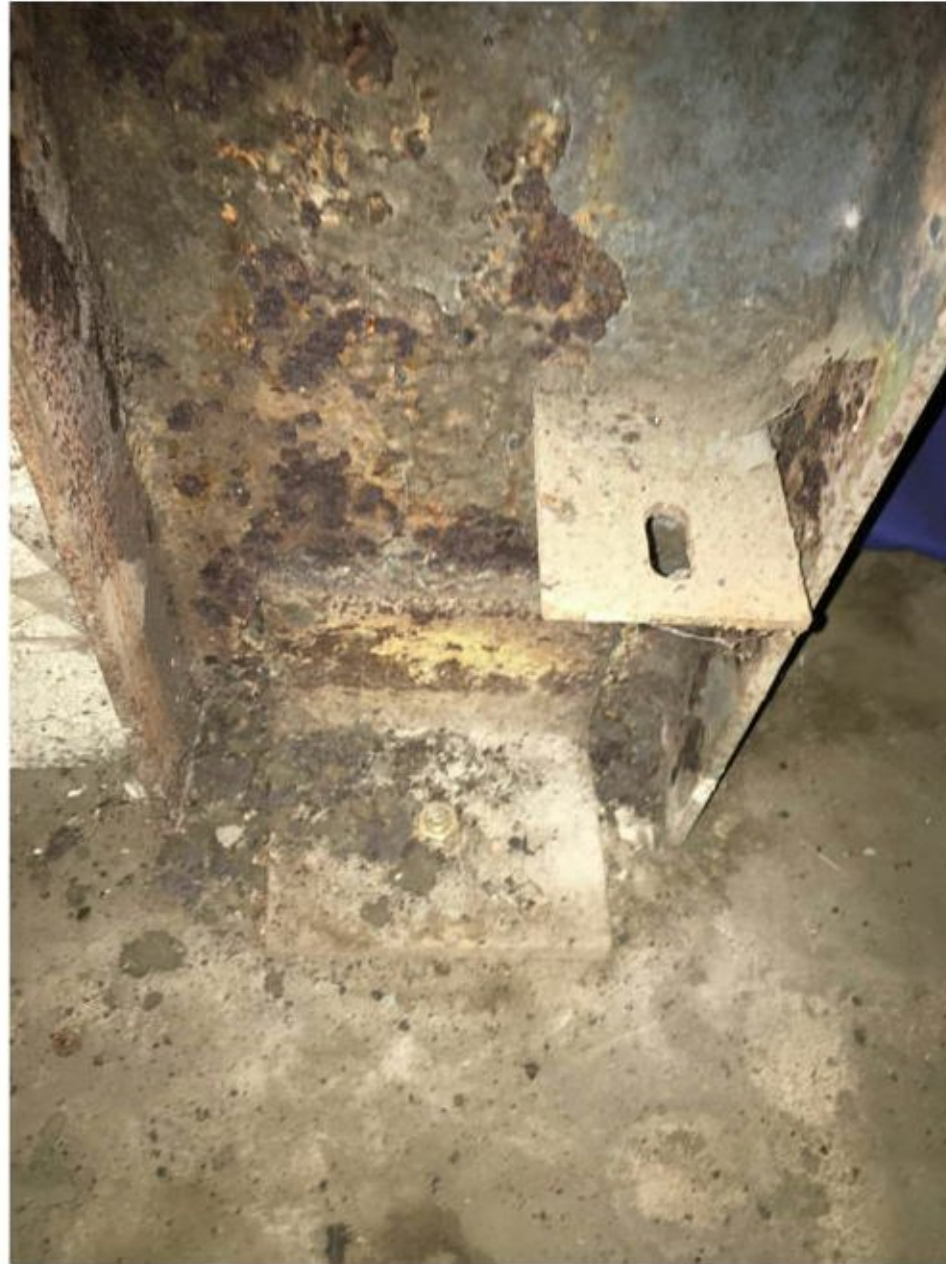
- 4.1.4 The intermediate stanchions are bolted into the top of the ground bearing slab (Figure 3). One of the stanchions does not have all bolts required into the partial base plate. The base plates do not cover the entire plan area of the columns, and instead the column flanges project beyond the plates.

Figure 3: Internal column baseplate.

ground bearing slab from the columns mentioned were found to be missing. It is advised that these bolts are introduced.

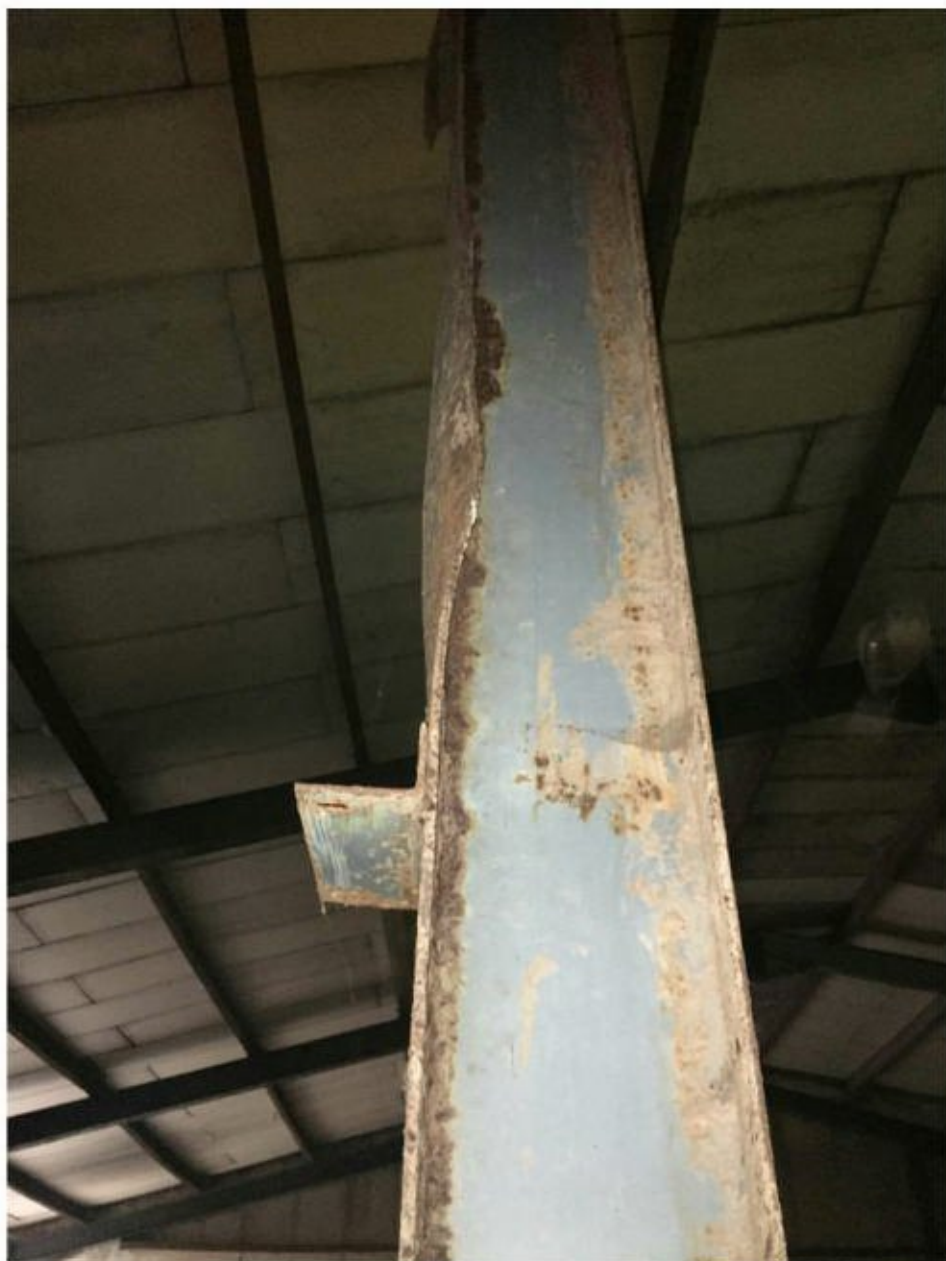
- 4.1.5 Significant distortion was noted to one of the three intermediate stanchions (Figure 4).
- 4.1.6 Unused hot-rolled cleats were noted to the intermediate stanchions.

- 5.1.3 One of the internal columns shows signs of significant distortion. Should it be concluded that the column should be retained, it is strongly advised that this column is replaced. Bolts to the

Figure 4: Flange distortion to internal column.

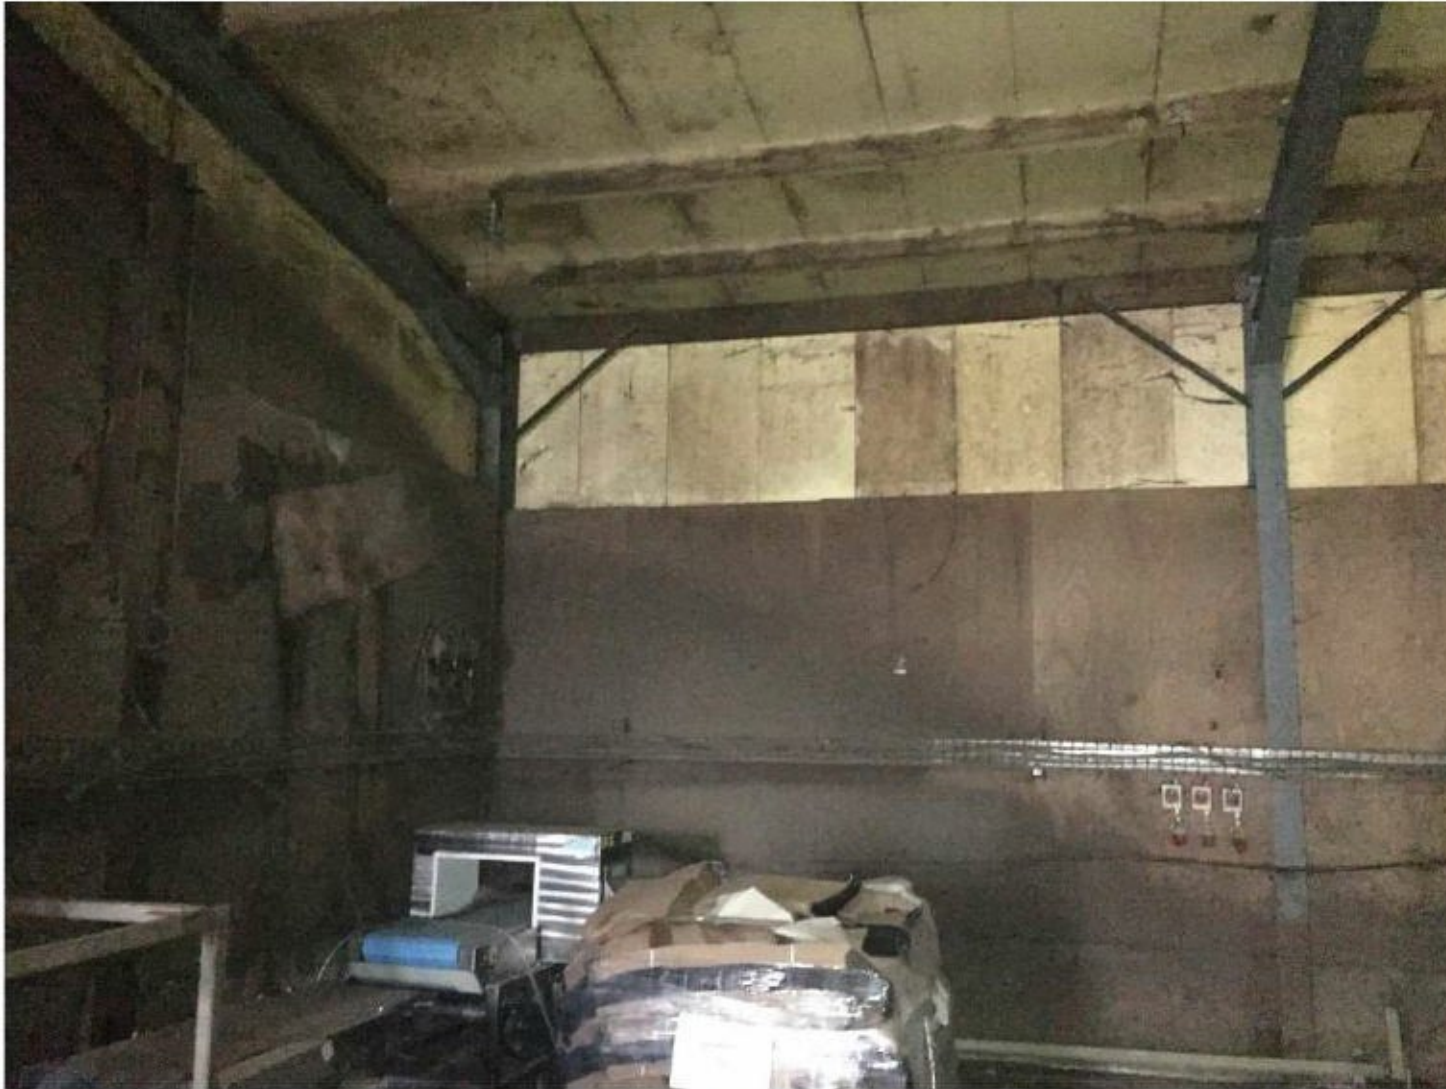
- 4.1.7 Superficial rusting was generally noted to all the steelwork internally.
- 4.1.8 Knee bracing was noted to the eaves to the Northern elevation of the building; however, no bracing was observed to the Southern end incorporating the main barn doors (Figure 5).

Figure 5: Knee bracing to Northern elevation.

- 5.1.4 Knee bracing was noted to the Northern elevation, however similar bracing was not noted to the Southern elevation. It is recommended that bracing is introduced to the Southern Elevation.

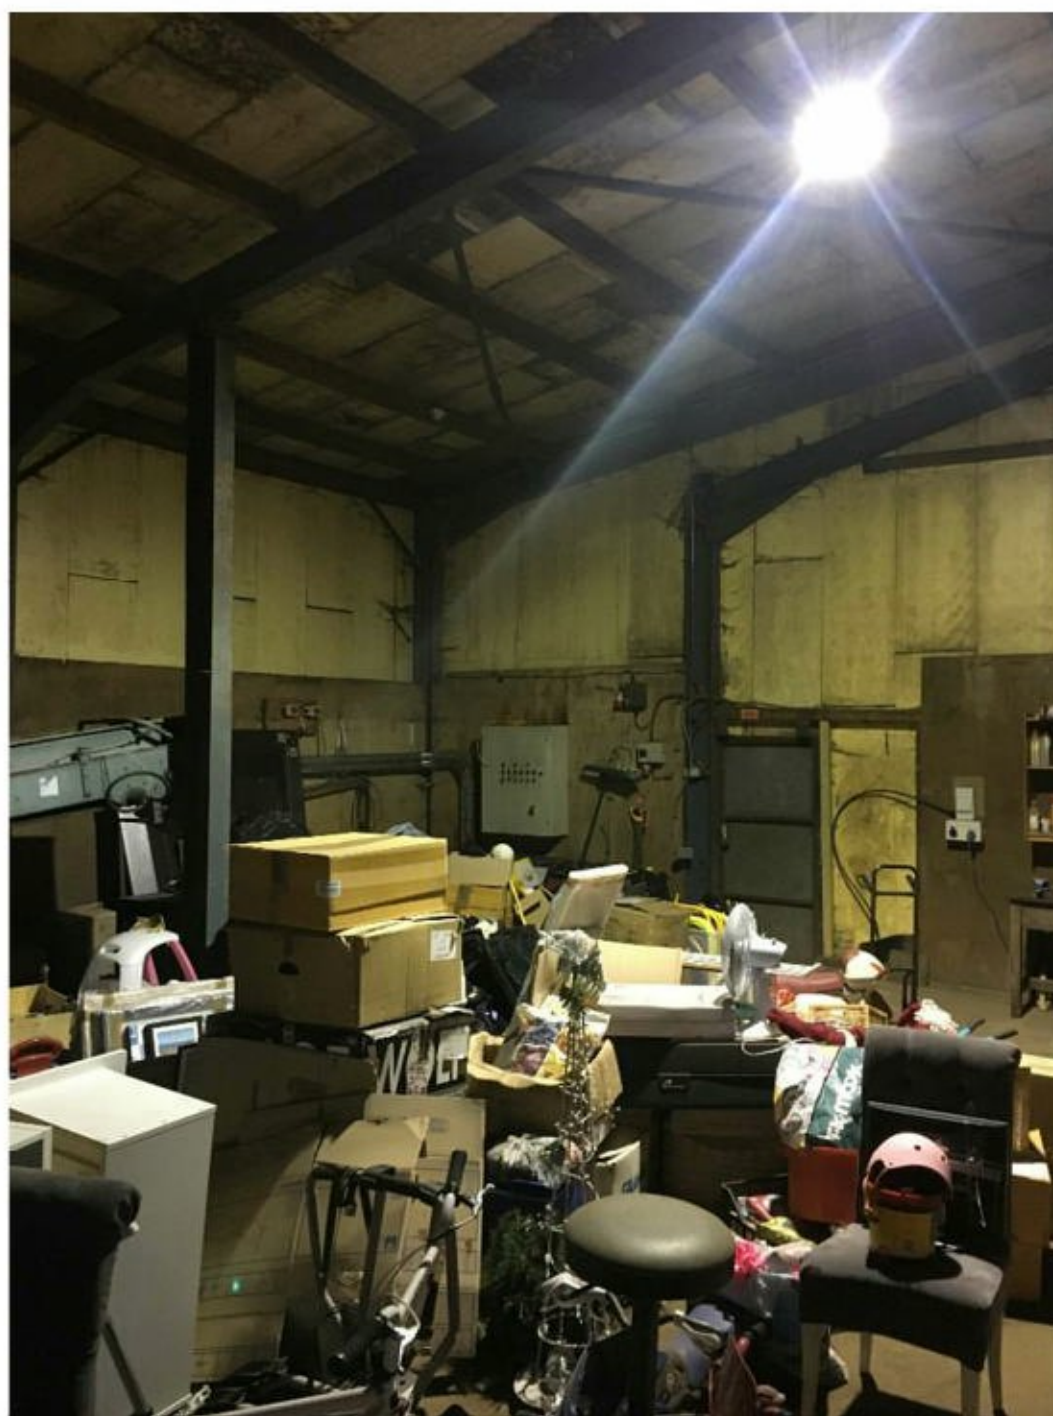
- 4.1.9 The timber cladding rails to the perimeter were all noted to be exhibiting excessive sagging.
- 4.1.10 Roof bracing to the Eastern end of the barn was observed to not be complete, with large gaps between bracing nodes and end column nodes. A large gap was also noted at the apex. (Figure 6).

Figure 6: Incomplete roof bracing.

- 5.1.5 Roof bracing was observed to be incomplete. It is recommended that further CHS bracing is installed to ensure the stability of the frame is not compromised.

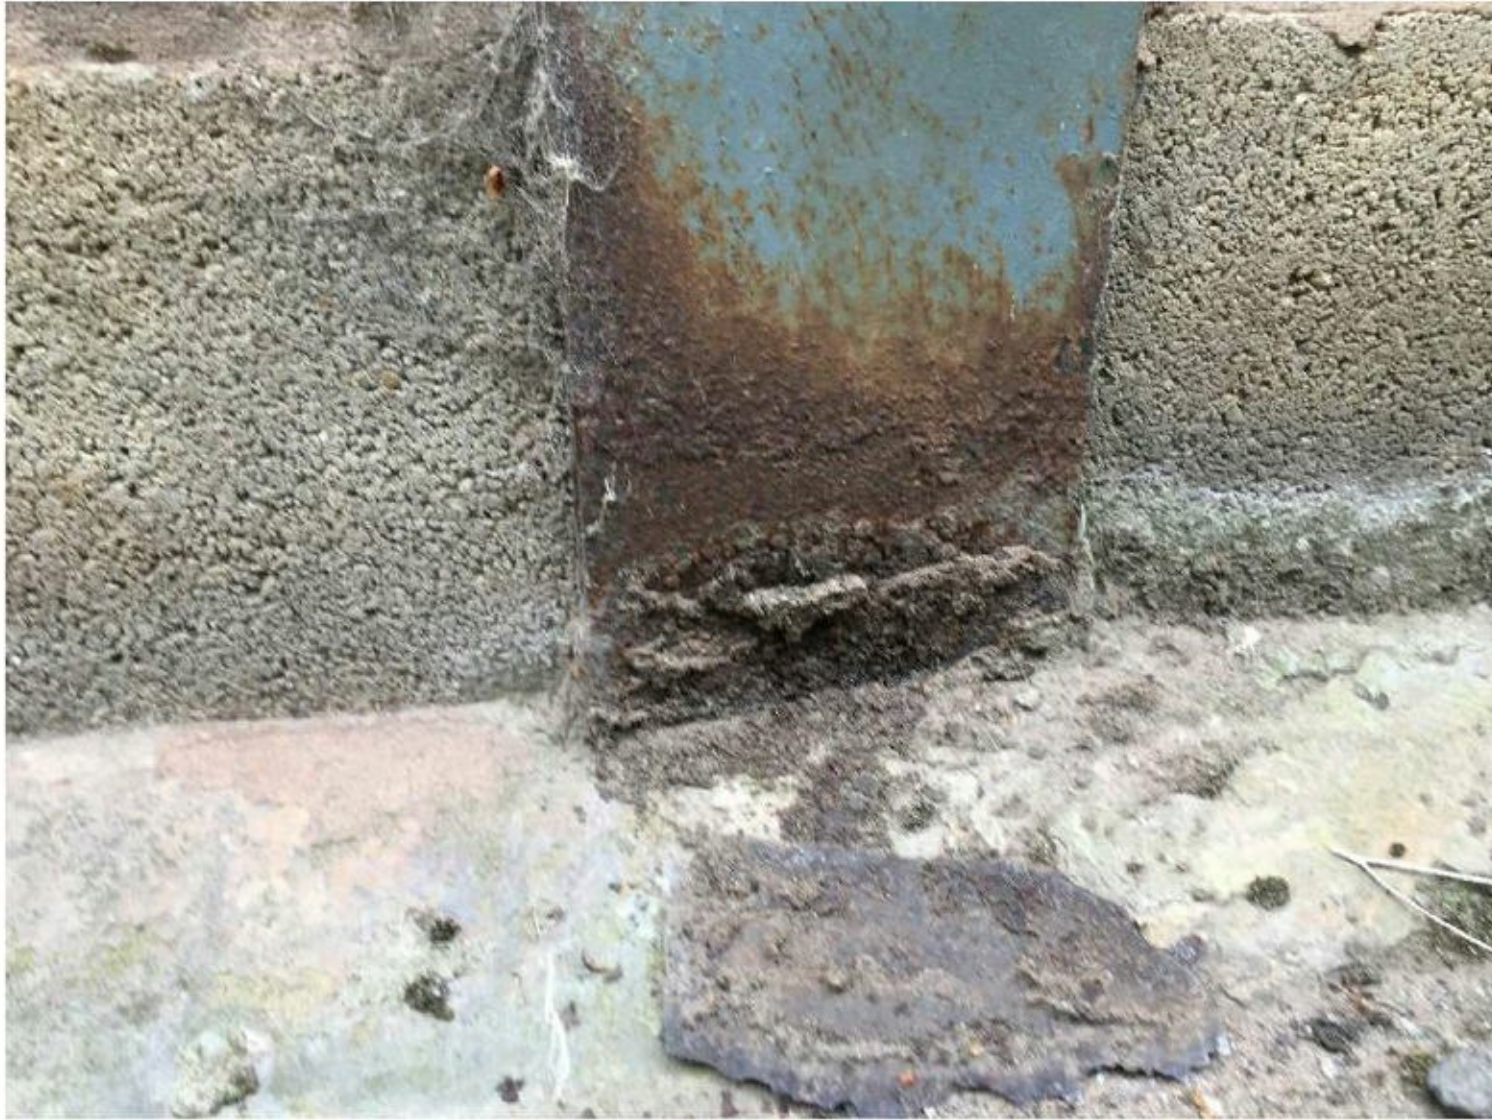
- 4.1.11 The concrete ground bearing slab appears to be in sound condition with movement joints noted at regular centres.
- 4.1.12 Surface rusting was noted to the base of columns that are not protected externally (Figure 7). No external protection measures were noted (e.g. bituminous paint, column surround etc.).

Figure 7: External column corrosion.

- 5.1.6 Columns to the perimeter were observed to be showing early signs of corrosion. It is advised that the base of all columns to the perimeter have a protection system installed to avoid further decay.

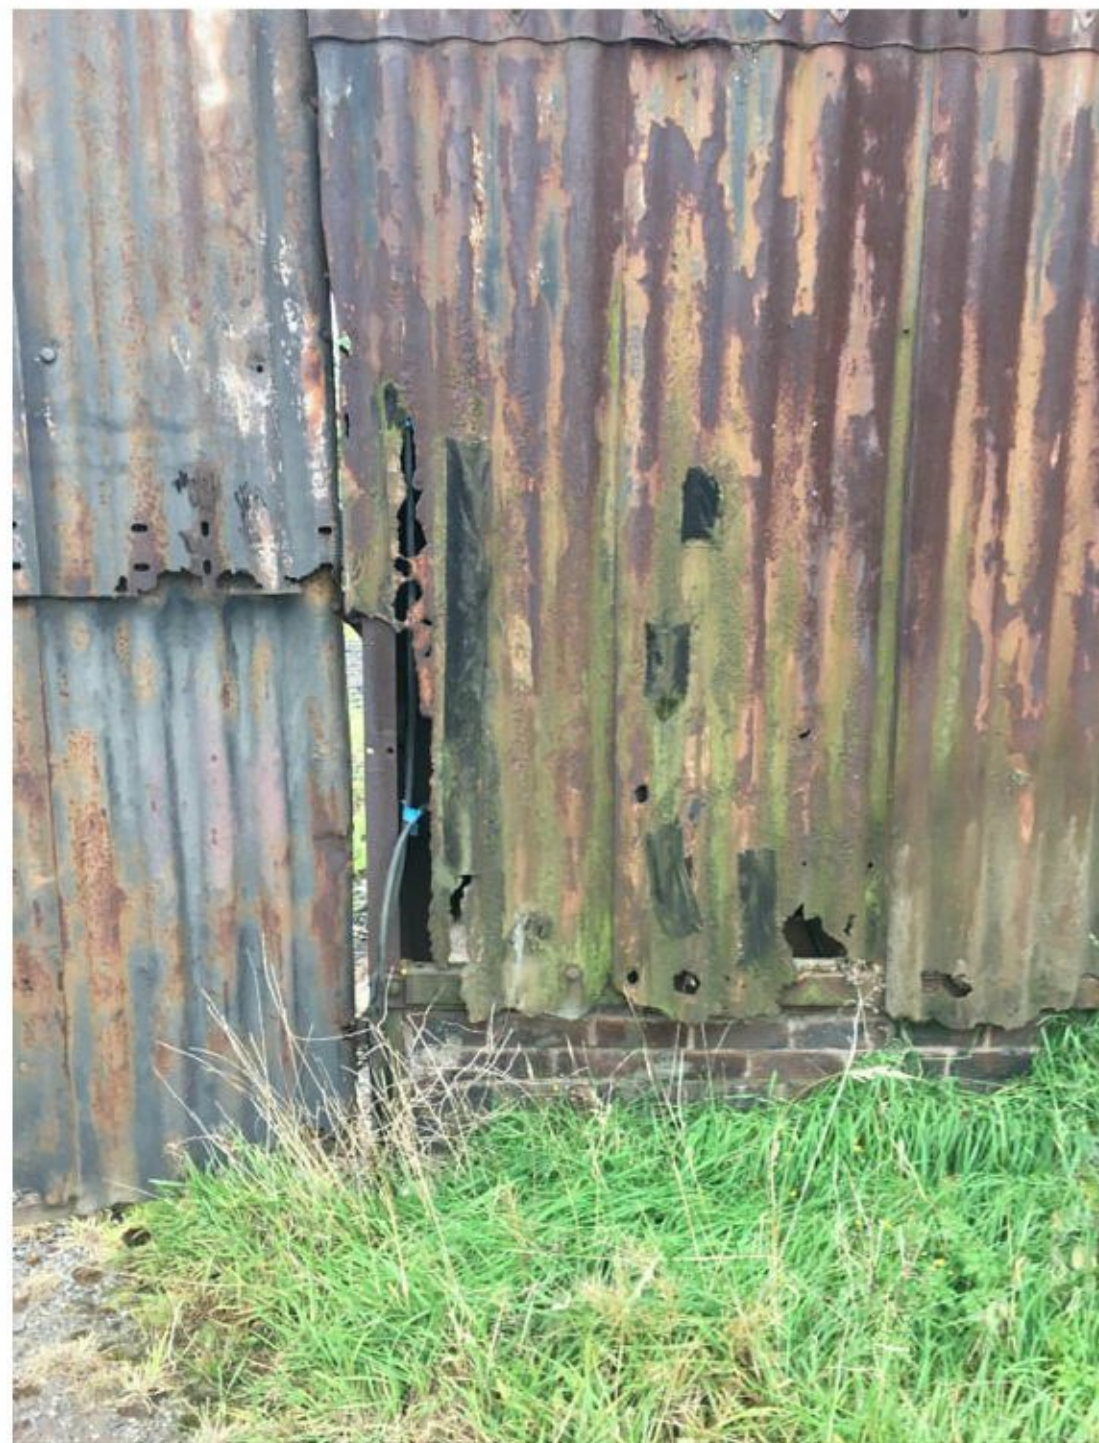
- 4.2.1 Metal cladding to the main barn was observed to be in poor condition (Figure 8).
- 4.2.2 The single skin brick sleeper wall to the barn perimeter was observed to be in poor condition with loss of jointing evident.
- 4.2.3 The condition of the ground bearing slab could not be determined due to existing items obscuring the view.
- 4.2.4 Evidence of paint loss, corrosion and pitting to the structural steelwork was noted throughout the main barn. No significant loss of section was noted at the lower level. High level steelwork could not be adequately inspected for corrosion.
- 4.2.5 No horizontal or vertical bracing was observed.

Figure 8: Metal cladding corrosion.

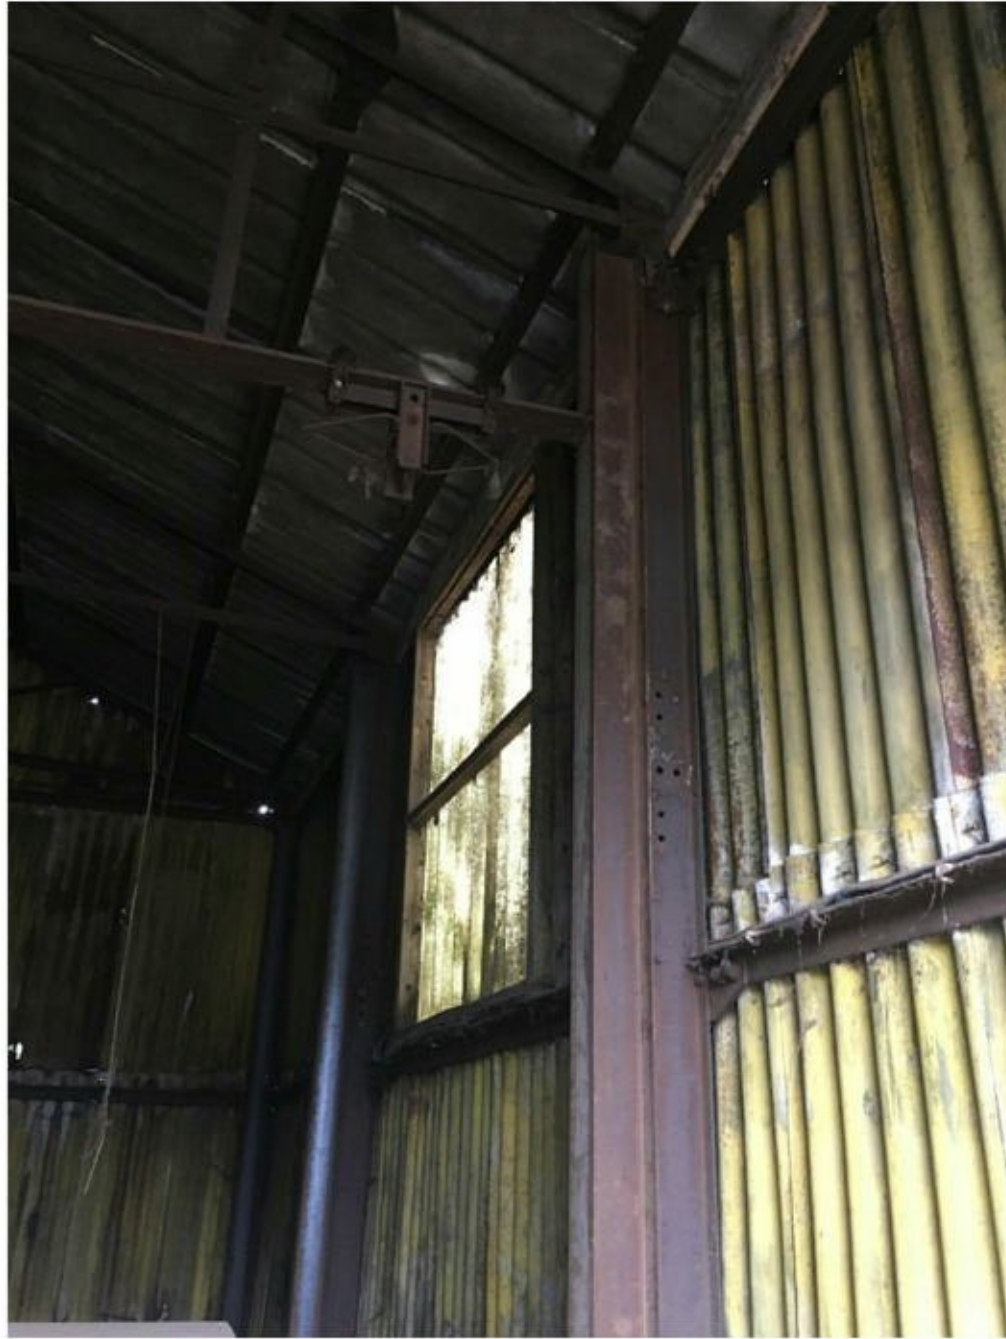
- 4.2.6 Internal columns are rolled steel joist sections with retrofitted 152UBs welded to the internal flange (Figure 9).
- 4.2.7 Internal columns were generally observed to be leaning towards the barn doors at 25mm per metre. Columns supporting the associated lean to were observed to lean outwards 10mm per metre.

Figure 9: Rolled steel joist columns with retrofitted 152UBs.

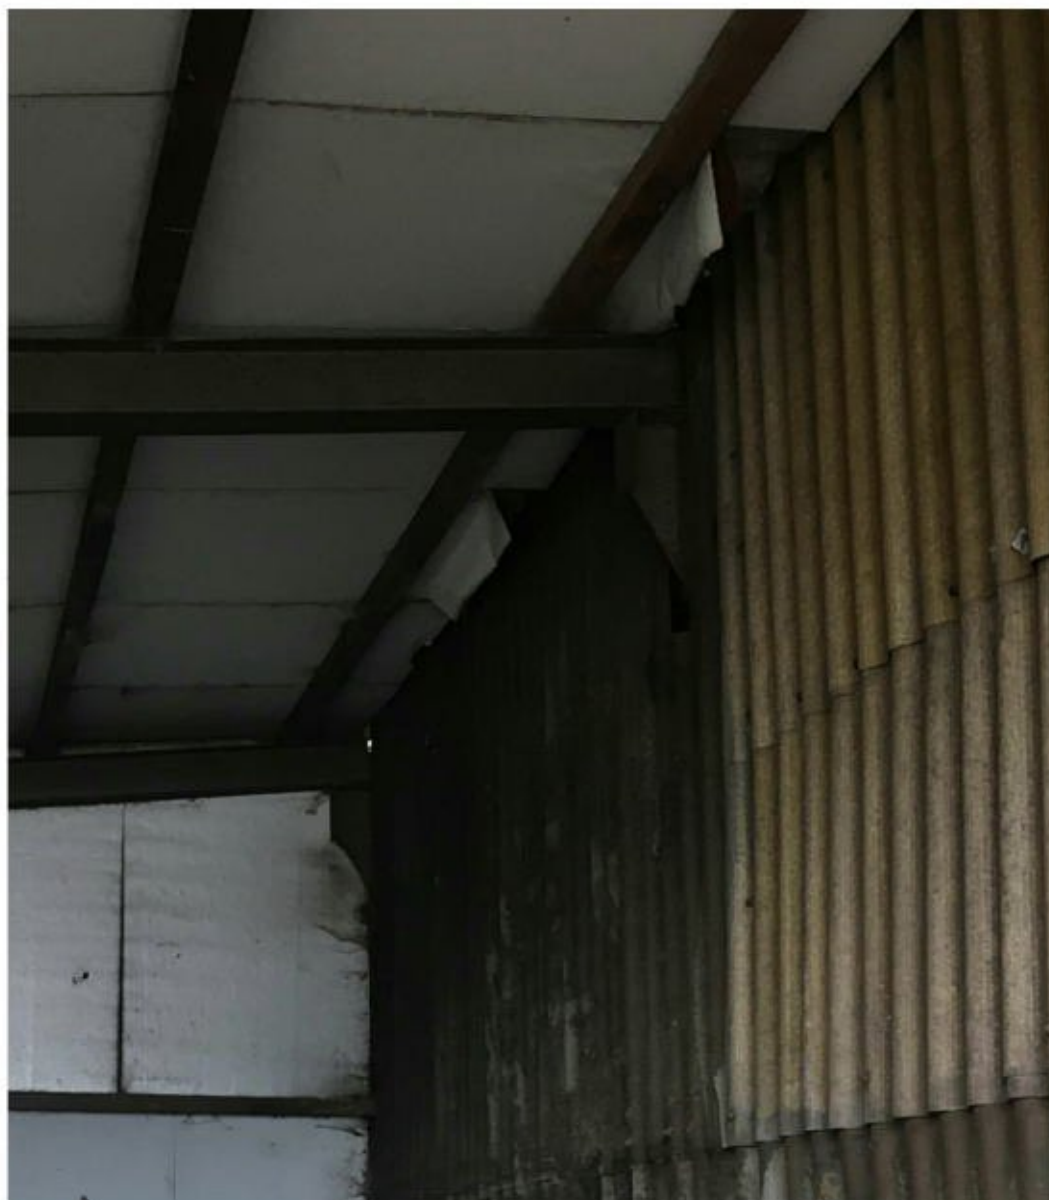
- 4.2.10 Steel beams to the roof of the lean to are supported by the rolled steel joist columns of the main barn via a gusset plate shelf angle (Figure 10).

Figure 10: Lean-to support angle.

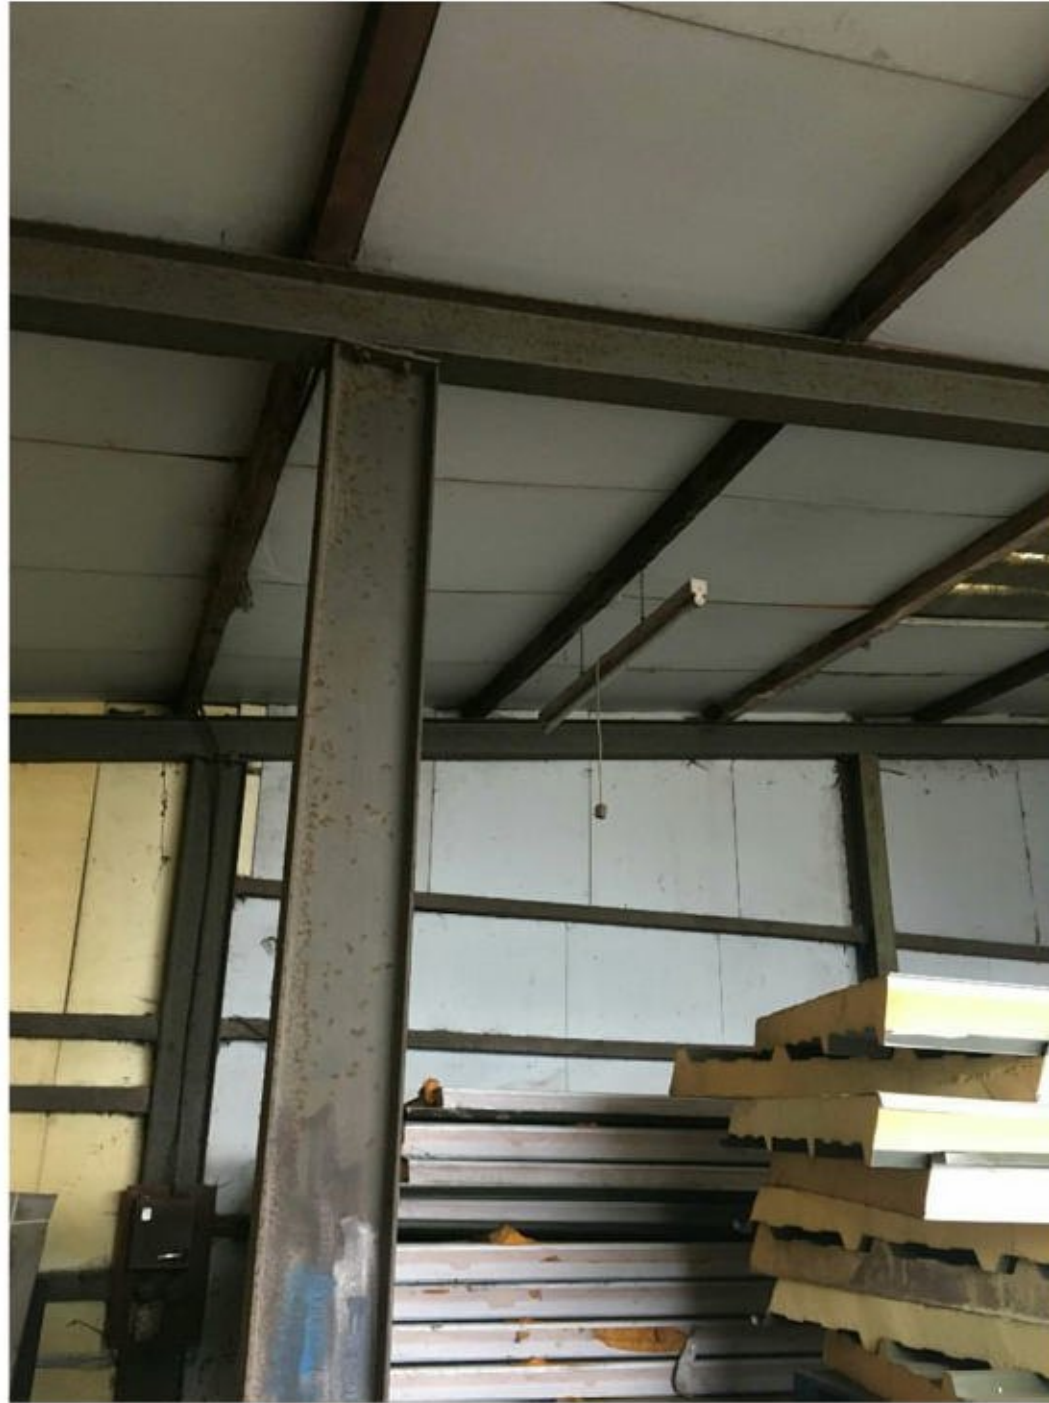
- 4.2.12 Capping plates to the top of columns are not angled to match the roof pitch leaving a visible gap between plate and bottom flange of columns (Figure 11).

Figure 11: Column capping plate detail.
