# **Preliminary Roost Assessment Survey**

Dower House, Dunthrop Road, Heythrop, Chipping Norton, Oxfordshire OX7 5TL

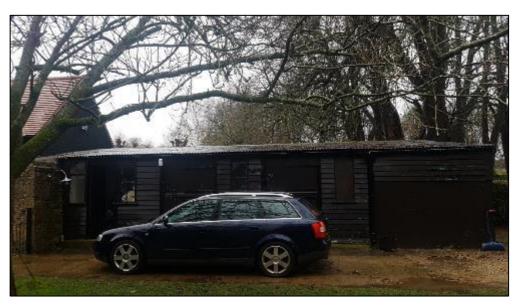
B1 – south east elevation (pictured opposite).

B1 is a detached timber, stone and breezeblock constructed barn building with a shed style roof. Much of the south east elevation is covered by timber cladding, although gaps beneath the cladding are generally insufficient to allow access for crevice dwelling bats. The building has timber framed windows, one of which is boarded, with no large gaps around any of the frames, although one window has a broken pane. Three timber doors are present, with minor gaps occurring below the top of the frame while the doors are closed. The outer roof is corrugated plastic, with small gaps beneath the corrugations that may provide roosting space for crevice dwelling bats.

The photo opposite shows a close-up of corrugations on the plastic roof, which are unsealed and could provide roosting space for crevice dwelling bats, although temperature conditions beneath the plastic roof may not be ideal for bats. Some of the corrugations are cobwebbed, indicating disuse, although others, such as the examples shown, are open.

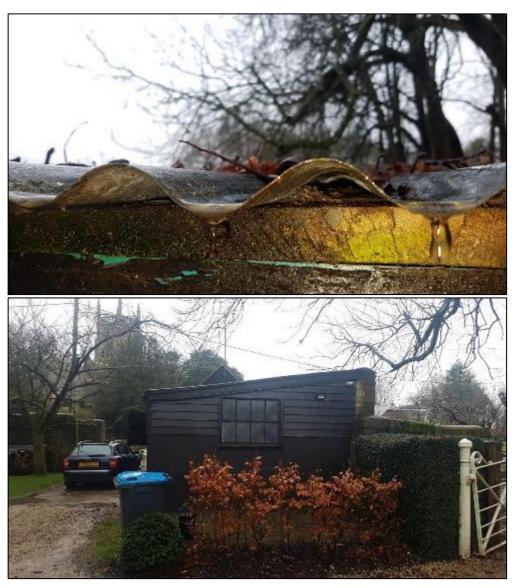
B1 – north east elevation (pictured opposite).

The north east elevation is also covered by timber cladding, although again, gaps in the cladding were generally too narrow to allow for bat access, and many were cobwebbed. The lower part of this wall is of painted breezeblock construction and in good condition, with no gaps. A timber fascia board is also present, although space under the fascia is not deep enough to be utilised by crevice dwelling bats. A gap occurs where the timber wall adjoins the stone wall of the north west elevation, which could allow bat access to the interior.

The photo opposite shows a close-up of a gap between the timber and stone walls, which could allow void dwelling bats access to the interior of B1.

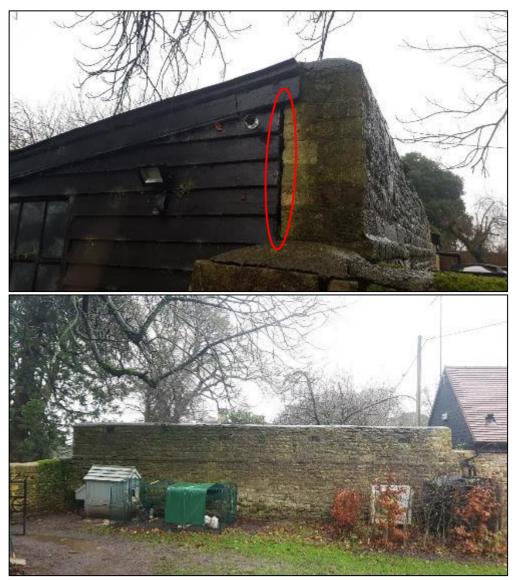
B1 – north west elevation (pictured opposite).

The rear elevation of the building is constructed from stone and is in poor condition, with numerous gaps created by missing mortar that could be utilised by crevice dwelling bats.

The photo opposite shows a close-up of some of the gaps towards the south west end of the rear wall which crevice dwelling bats could utilise.

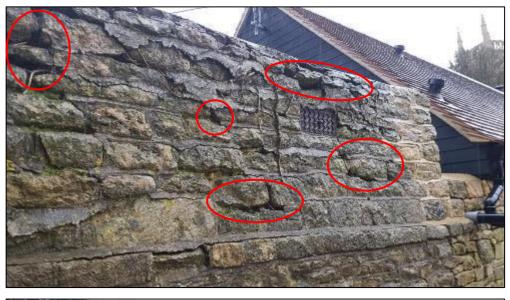
B1 – north west elevation (pictured opposite).

The photo opposite shows additional examples of gaps further north east along the wall, which again could be utilised by crevice dwelling bats. Similar gaps were also present lower down on the wall, although some of these may be situated too low down to be utilised by bats.

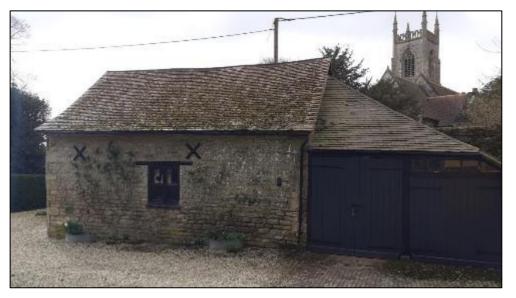
#### B2 – north east elevation (pictured opposite).

B2 is a stone-built barn with an attached stone and timber-built garage on its north west side. The barn has an open gable roof, while the garage has separate hip roof, with both roofs clad in clay tiles and raised tiles occurring on all roof pitches. Mortar gaps also occur between the wall tops and the roof structure beneath the eaves of the main barn. The barn has timber doors on its upper and lower floors. The upper door has a gap leading into the building interior, while the lower door has gaps occurring between the door frame and the surrounding wall. A set of double doors provide access to the attached garage, with gaps between the door and the frame providing interior access. Timber framed windows occur on the two long elevations, with no gaps around the frames, although a dislodged windowpane occurs on the side of the attached garage.

The photo opposite shows a close up of the north eastern roof pitch of the main barn, which is heavily moss covered. Raised tiles occur along the roof edge, as well as further up on the roof, all of which may provide roosting space for crevice dwelling bats.

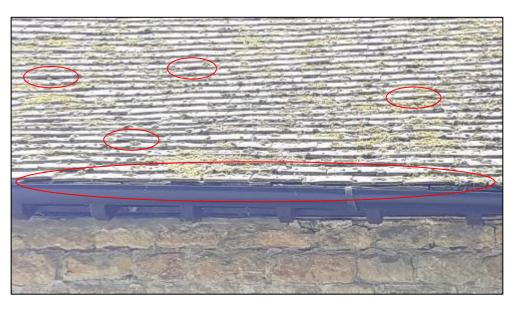
B2 – north east elevation (pictured opposite).

The photo opposite shows an example of a gap occurring beneath the eaves of the building which may provide additional roosting space for crevice dwelling bats.

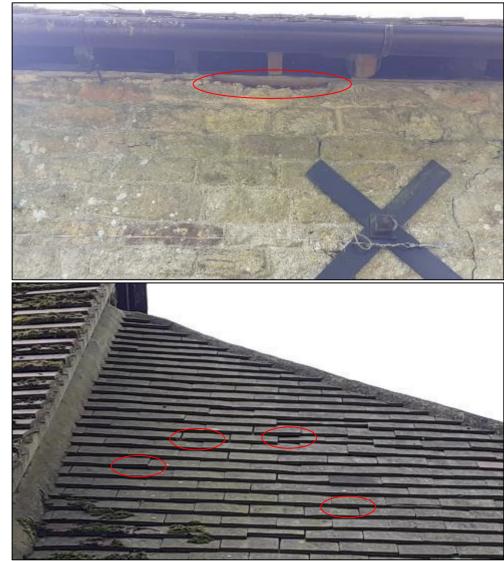
# B2 – north east elevation (pictured opposite).

The photo opposite shows a close-up of the north eastern roof pitch of the attached garage, with several raised tiles highlighted which may provide additional roost space for crevice dwelling bats within this roof structure.

The photo opposite shows a close up of doors and windows on the attached garage, with a gap above the door and dislodged window pane highlighted, both of which might provide access to the garage interior for void dwelling bats.

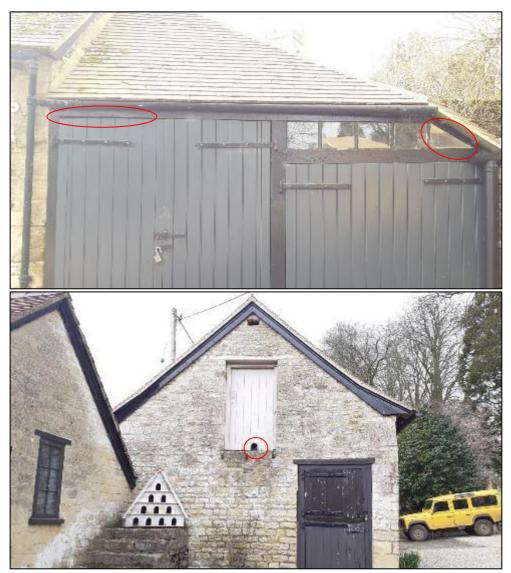
B2 – south east elevation (pictured opposite).

Several mortar gaps occur beneath the fascia board on the south east gable end which might be utilised by crevice dwelling bats. A ventilation gap occurs towards the roof apex, and a hole also occurs at the base of a timber door leading to the upper floor. Interior inspection found the former to be sealed, although mesh blocking the latter has become dislodged and may provide interior access for void dwelling bats and nesting birds. Finally, gaps occur around the edges of the timber frame of the ground floor door, which may provide additional roosting space for crevice dwelling bats.

The photo opposite shows a close up of a gap occuring beneath the fascia board on the south west side of the gable end.

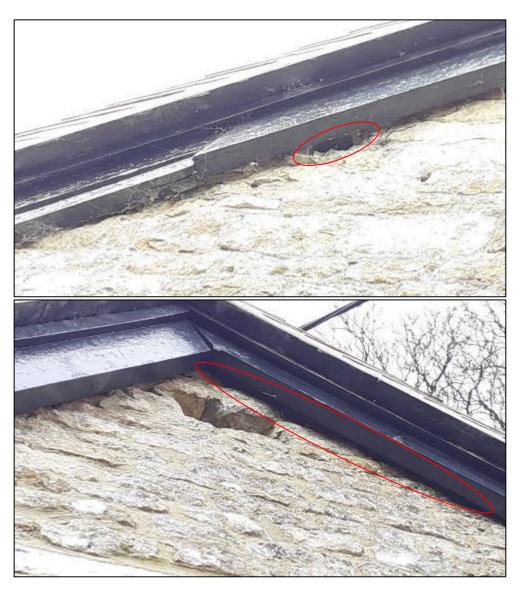
# B2 – south east elevation (pictured opposite).

The photo opposite shows a close-up of a larger apparent gap beneath the fascia board on the north east side of the gable end.

The photo opposite shows a close-up example of gaps around the door frame on the ground floor barn door. Close inspection of these gaps showed many of them to be cobwebbed and infilled with debris, possibly indicating disuse.

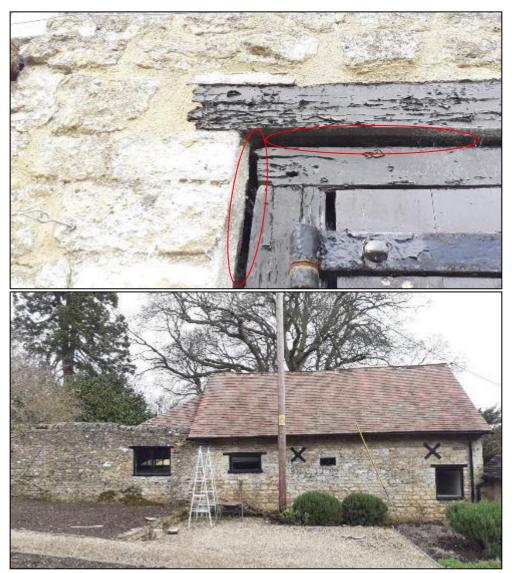
B2 – south west elevation (pictured opposite).

The barn wall on the south west elevation adjoins a stone wall which forms the south west wall of the garage and continues east as a boundary wall. Gaps are present in the stonework of this wall, one of which occurs on the side of the garage, and a gap also occurs in the stone wall of the barn on this elevation. Raised and warped tiles also occur on the south western roof pitches of both the barn and garage roof, and one additional gap is present beneath the eaves of the barn roof. All of these features might provide roost space for crevice dwelling bats.

The photo opposite shows a close-up of the south western roof pitch of the barn, with several raised tiles highlighted. This roof pitch is free from moss, resulting in these features being more clearly visible.

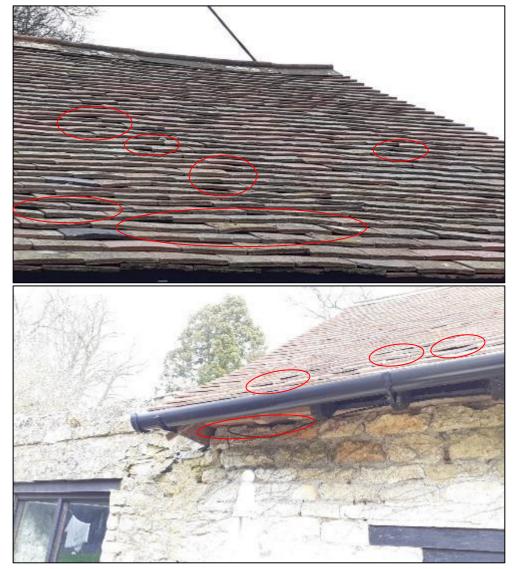
B2 – south west elevation (pictured opposite).

The photo opposite shows additional raised tiles as well as a gap occurring beneath the eaves of the barn roof.

The photo opposite shows a close-up of a gap in the stonework of the main barn wall.

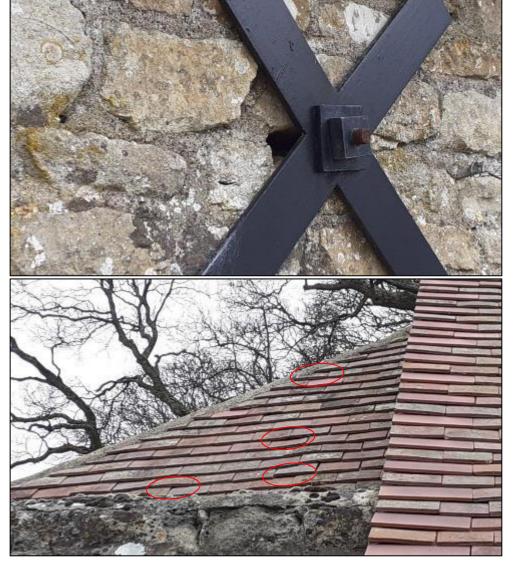
B2 – south west elevation (pictured opposite).

The photo opposite shows several slightly warped and raised tiles occurring on the south western roof pitch of the adjoining garage.

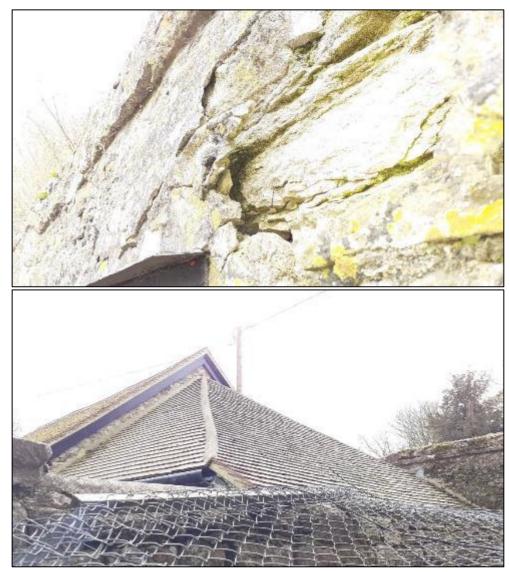
B2 – north west elevation (pictured opposite).

The north west elevation of the building adjoins a chicken run. No mortar gaps or gaps beneath the fascia board were noted on the roof of the main barn, although the north western roof pitch of the garage roof has several minor raised tiles present which may provide space for crevice dwelling bats. Gaps also occur on both sides of the wall between the garage and the adjoining chicken run, although these are situated fairly low down and on the north west side the wall occurs under a wire mesh covering, making it less likely that these features would be utilised by bats.

The photo opposite shows examples of several slightly raised tiles on the north western roof pitch of the garage.

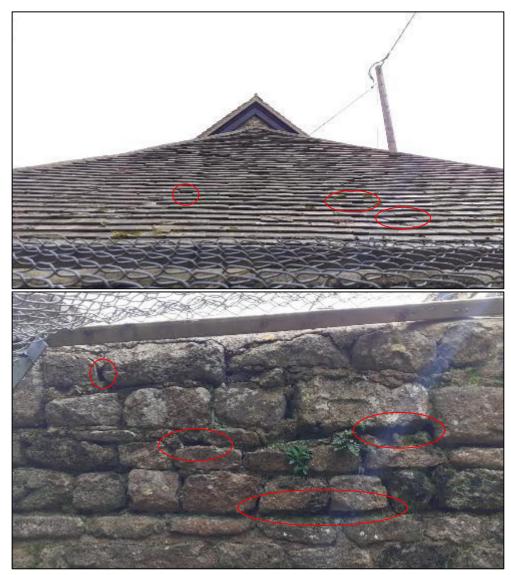
The photo opposite shows examples of mortar gaps in the stone wall between the garage and chicken run. Similar gaps also occur on the opposite side of the wall.

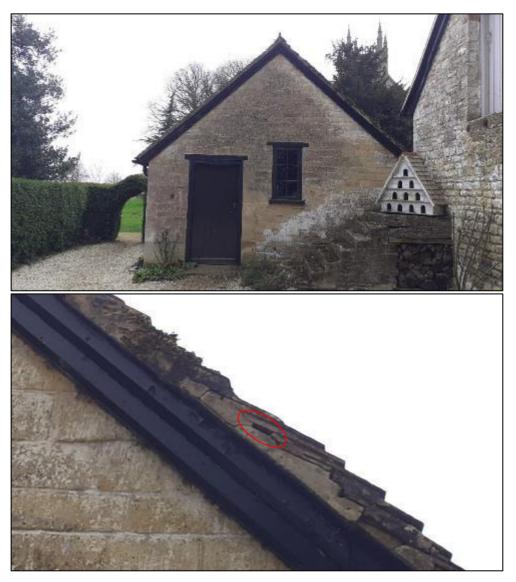
# B3 -south east elevation (pictured opposite).

The photo opposite shows a close up of the minor mortar gap occurring at the edge of the north western roof pitch, which could provide a small amount of space for crevice dwelling bats.

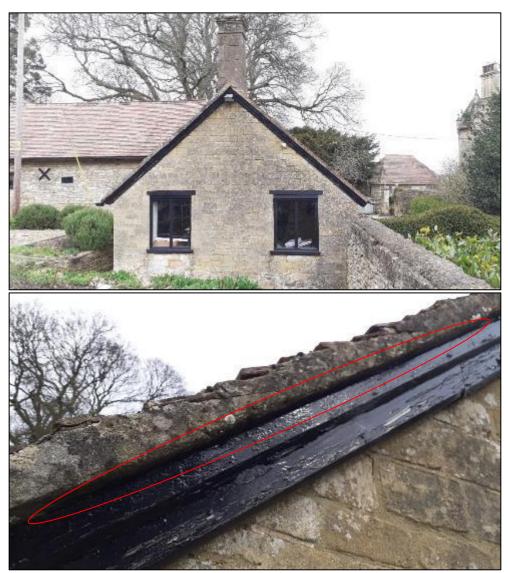
# B3 – north west elevation (pictured opposite).

Multiple warped and raised tiles occur on the south east elevation, creating space which crevice dwelling bats could utilise. Damage has also occurred to ridge tiles near the chimney, although it was unclear from the ground whether this damage creates any additional roosting space. Stonework on this elevation is in good condition, and no gaps occur beneath the eaves of the building.

The photo opposite shows a close-up of the gaps beneath the fascia board and overlying roof.

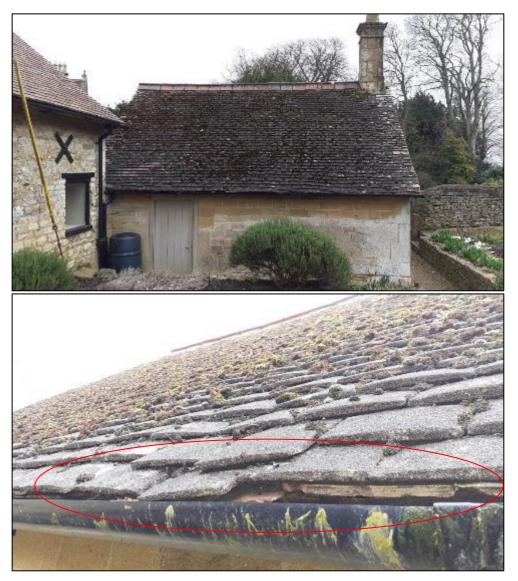
B3 – north west elevation (pictured opposite).

The photo opposite shows raised tiles occuring at the roof edge, with gaps occurring between the tiles and underlying mortar.

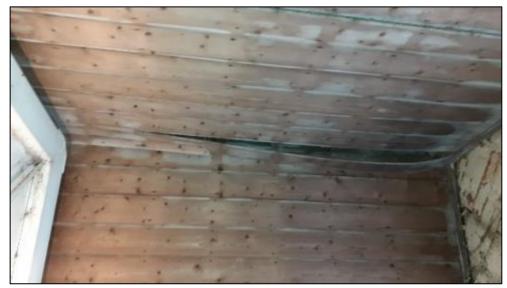
## B3 – south west interior roof (pictured opposite).

Damaged ridge tiles on the exterior have led to damage and warping of a timber board below the roof apex, with exposed roof tiles visible above, providing a possible route of access to the interior for void dwelling bats. However, a thorough search of all walls and exposed surfaces in both rooms found no evidence of bats being present.

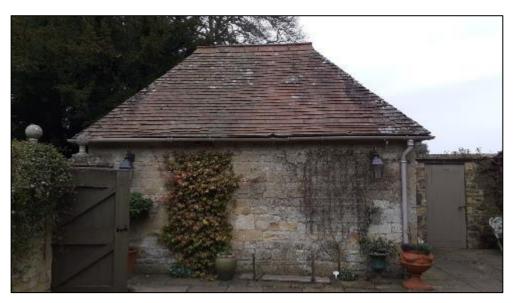
# B4 – south elevation (pictured opposite).

B4 is a detached stone-built oil store with a hip roof clad in clay tiles. Warped and raised tiles occur on all roof pitches, although only one roof pitch has interior lining present. Gaps also occur beneath the eaves of the building on all elevations. The building has no windows and a single door on the east elevation, which is timber framed with no gaps occurring around the doorframe.

The photo opposite shows an area of damaged roof tiles on the southern roof pitch. This may create a small amount of space for crevice dwelling bats where tiles overlap, although the lack of interior lining limits the available space. This feature may also provide access to the interior for void dwelling bats. Less pronounced examples of raised tiles occur elsewhere on this roof pitch.

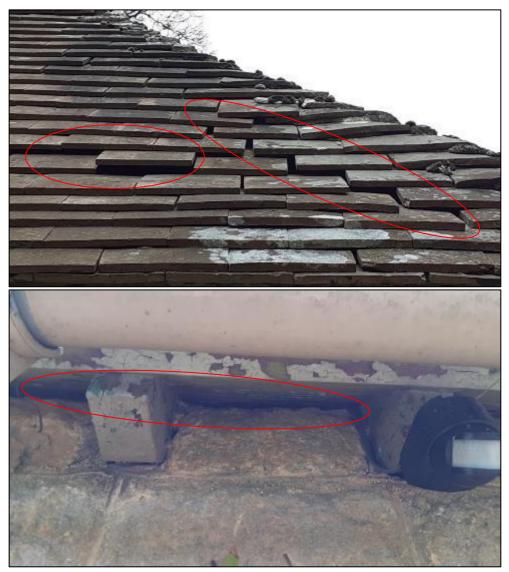
B4 – east elevation (pictured opposite).

The photos opposite show gaps occurring beneath the eaves of the building on the south elevation, which may provide space for crevice dwelling bats.

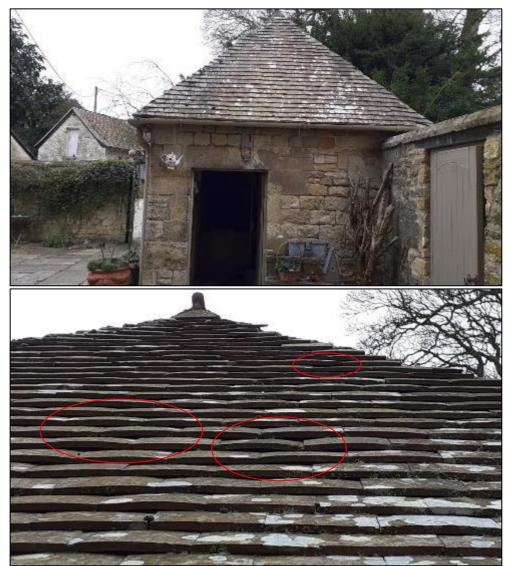
# B4 – east elevation (pictured opposite).

The photo opposite shows examples of minor warped and raised tiles on the eastern roof pitch.

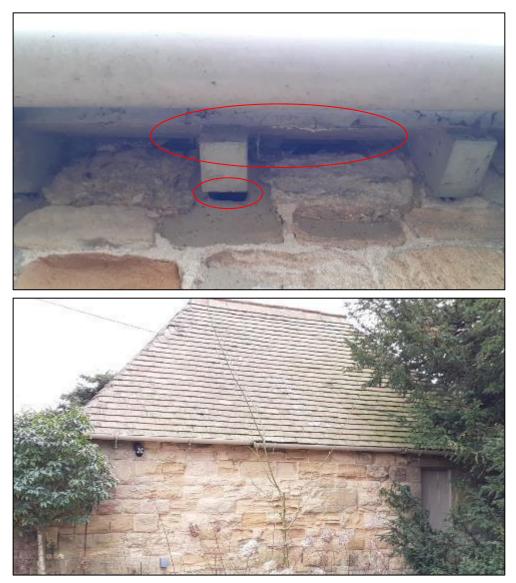
# B4 – north elevation (pictured opposite).

Several raised tiles are present on the northern roof pitch of the building. Unlike the other pitches, the interior of this roof is lined, increasing the available space for crevice dwelling bats. However, the lining present appears to be a breathable roofing membrane, and research has shown that such membranes can lead to entanglement and a reduced suitability of microclimate conditions for crevice dwelling bats (Bat Conservation Trust, 2020). Gaps present beneath the eaves on this elevation are narrow and cobwebbed and appear to be unsuitable for roosting bats.

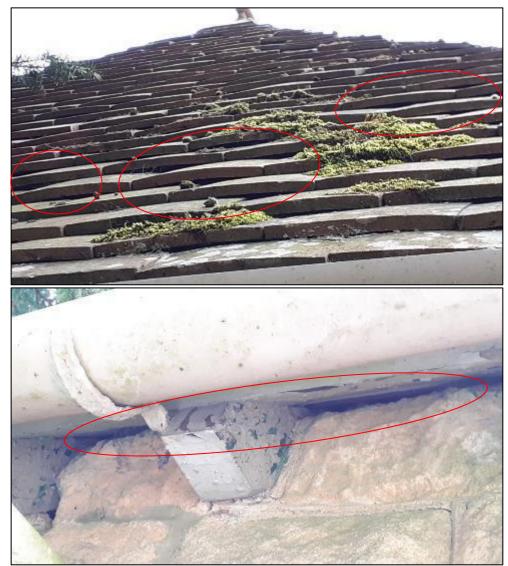
The photo opposite shows an example of gaps occuring beneath the eaves on the west elevation.
