WRDELW73274A\210603 sgh GSI (1/7)
3 June 2021

GENERAL STUCTURAL INSPECTION

The Barn, Parsons Farm
West End Green
Stratfield Saye
READING
RG7 2DP

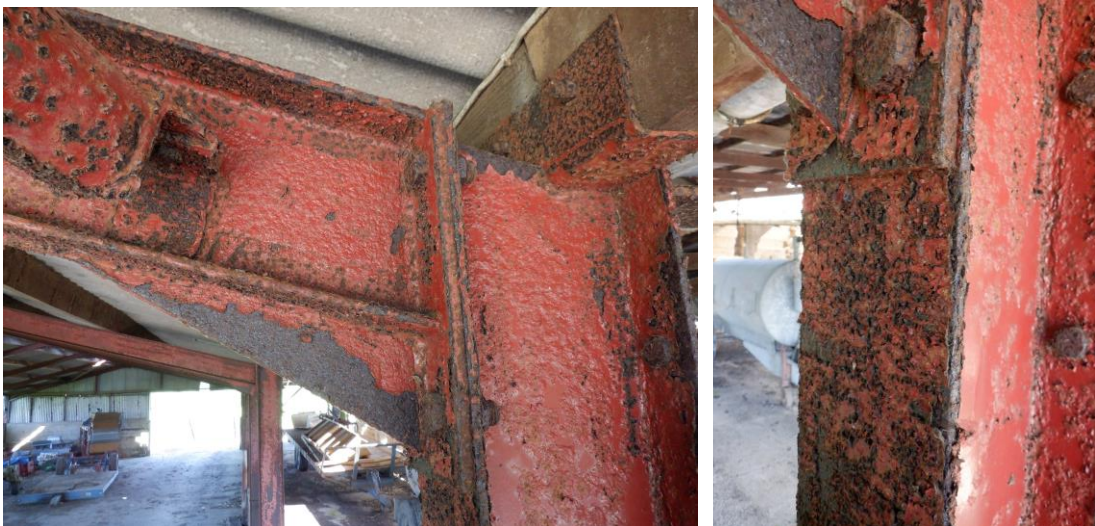
- 2.4 To the front and rear bays there is diagonal roof bracing to the rafter slopes formed with 80 CHS sections.
- 2.5 The columns are true and plumb, the rafters are straight and undistorted, and there are no signs of structural movement or structural distress.
- 2.6 The steelwork is painted with a red lead type protective coating but there is extensive failure of the paintwork exposing the bare steel. Surface corrosion of the steel is present throughout but no deep corrosion that would affect the structural integrity is present.

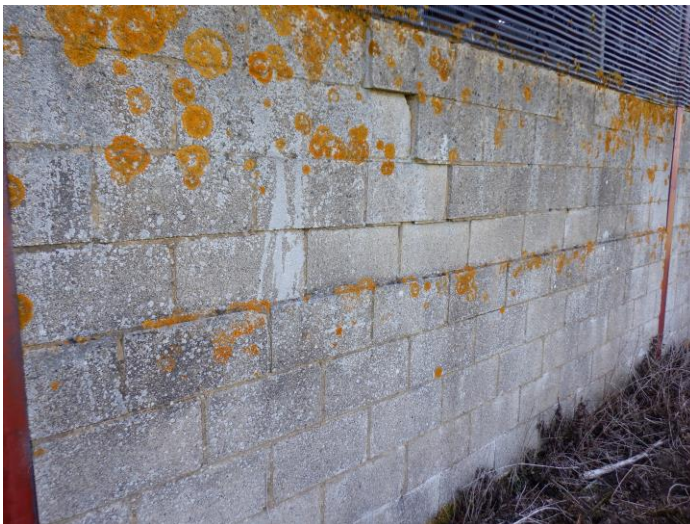
- 2.9** The external walls to the front, left side and rear comprise 215mm thick, hollow, concrete blocks to a height of about 1m with 4 course (900mm) of 130mm thick, hollow, concrete blocks above.
- 2.10** The blockwork generally appears to be in a good structural condition. It is clearly built off a foundation (rather than off the floor slab) and there are no signs of any significant settlement, subsidence or other foundation movement to it.
- 2.11** Some local damage has occurred to the blockwork along the left side. The blockwork to the 3rd bay appears to have suffered impact damage from the inside, pushing the wall out, with slippage on the bed joints of around 30mm and a slight outward bulge. This section needs to be rebuilt.

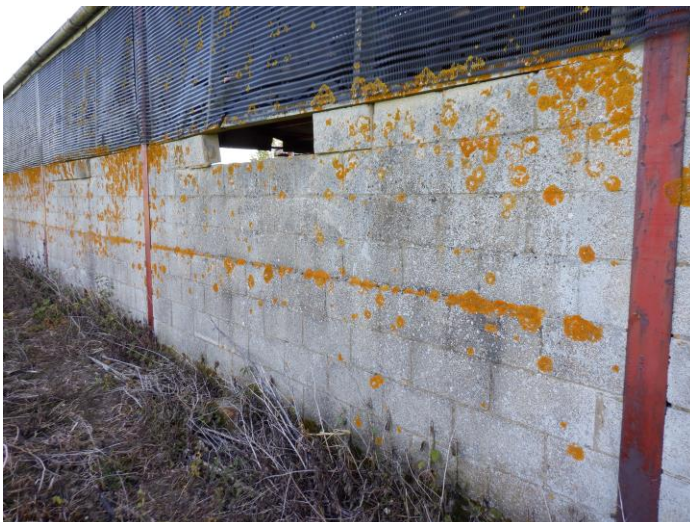
- 2.12** To the 5th and 6th bays along the left side part of the top course blockwork has been displaced and some blocks are missing. Again this appears to be due to impact damage from the inside and merely requires to be rebuilt as necessary.

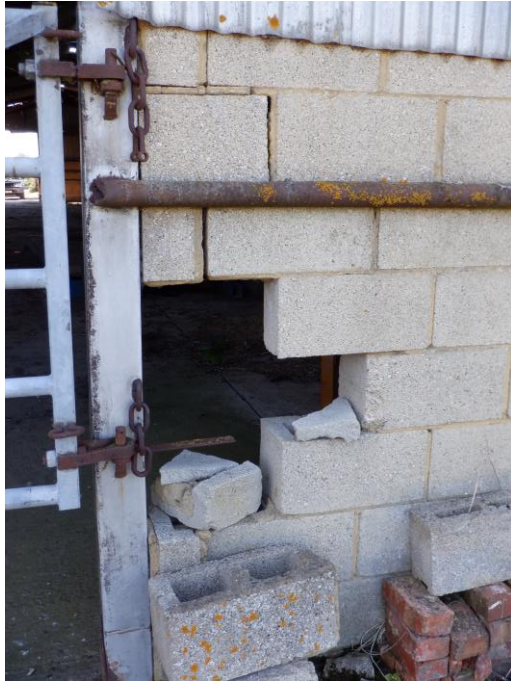
- 2.13** To the rear a few blocks adjacent to the entry gate post are missing, again as a result of internal impact damage.
