**Bovill's Hall, St Osyth Road, Little Clacton, Essex CO16 9NN.**  
Description and analysis of NW of Bovill's Hall. Surveyed 30 06 2014.

This report details and analyses the fabric and form of The Barn and its attached buildings to preserve by record its current state, before it is altered, to English Heritage Level 3 as defined in 'Understanding Historic Buildings A guide to good recording practice by English Heritage 2006' (Page 14).

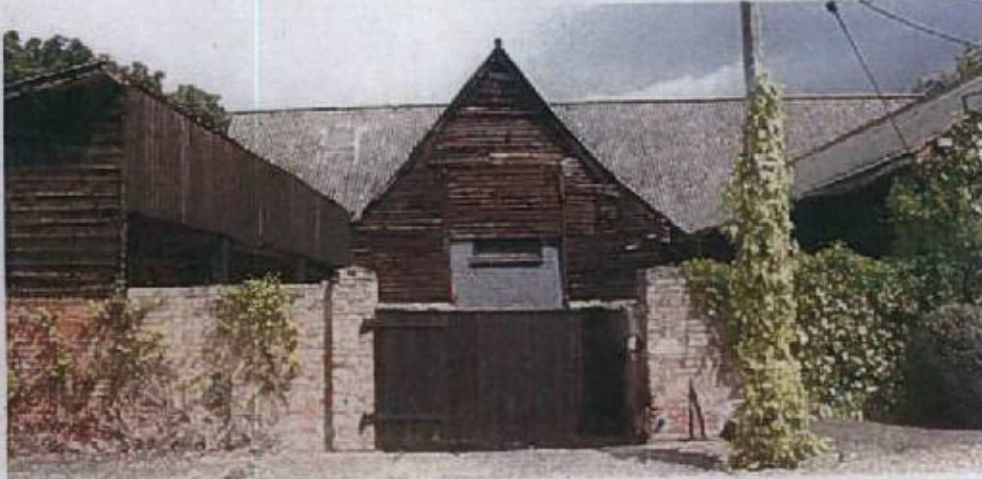
C20th brick infill to close the yard.

Between the shelters are C20th brick walls with LC20th timber gates. The spalling Fletton brickwork is bonded with grey cement and is likely to date to the 1970's or 80's.

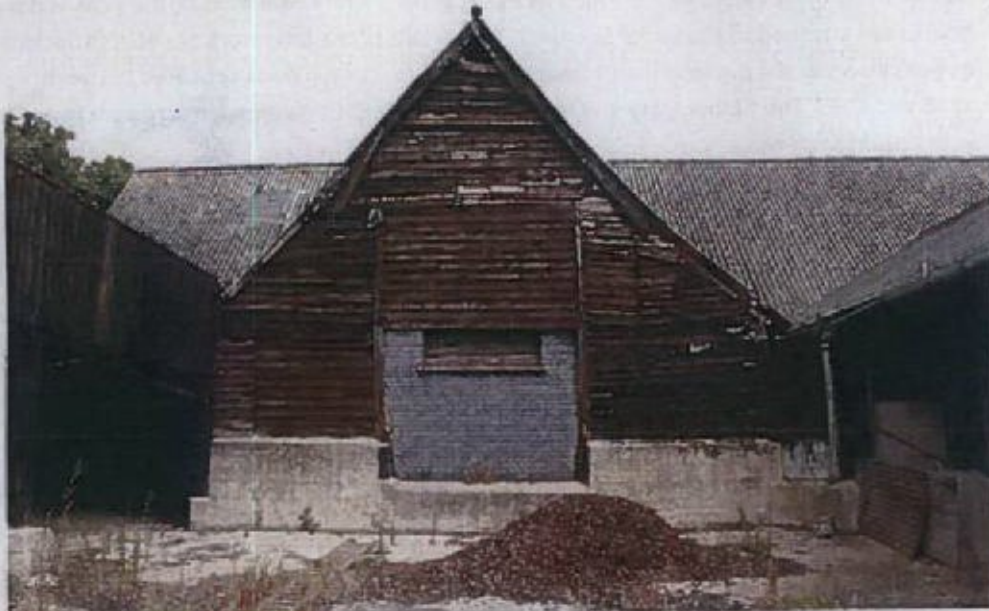
Looking N into the Western Farmyard. The midstrey porch of the Barn.

The midstrey porch of the Barn is contained in the Western Farmyard. The weather-boarded gable of the porch is in poor condition and has many patches. The boards are C20th. The full height doorway has been part boarded over and the lower section infilled with C20th Fletton bricks painted grey. There is a centrally placed window opening with a tiled cill of MC20th design and a smaller opening in the eastern side of the gable. Both have been boarded over. The plinth has been replaced with shuttered concrete.

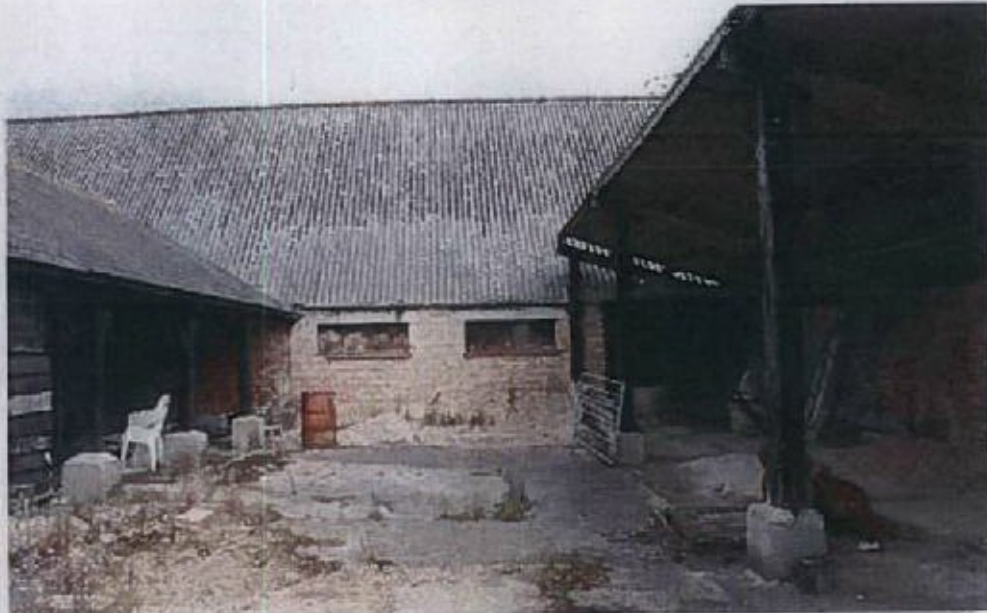
The southern flank of the Barn visible in the Eastern Farmyard.

The southern wall of the Barn has been replaced with C20th Fletton bricks and there are two MC20th style window openings with concrete lintels and tile cills. Inside Shelter 2/3 the Barn wall has been replaced with the red brickwork of the shelters.

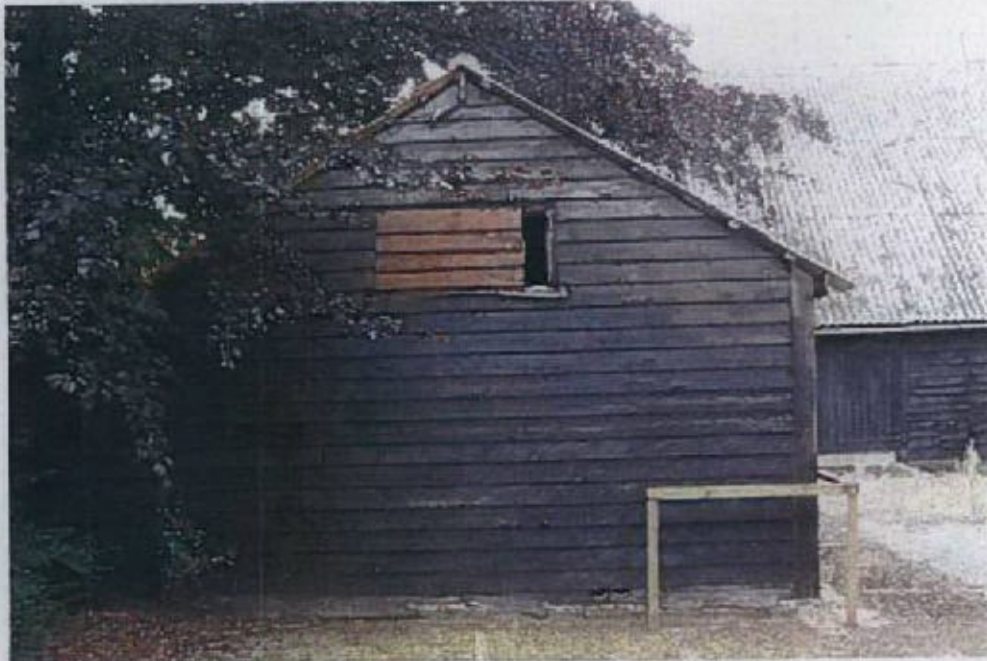
Northern elevation of the Shed.

The Shed is clad with LC20th weather-boards fastened with French nails. The western side of the roof is clad with corrugated asbestos sheets to match the other buildings. A small window has been partly boarded over with recent weather-boards.

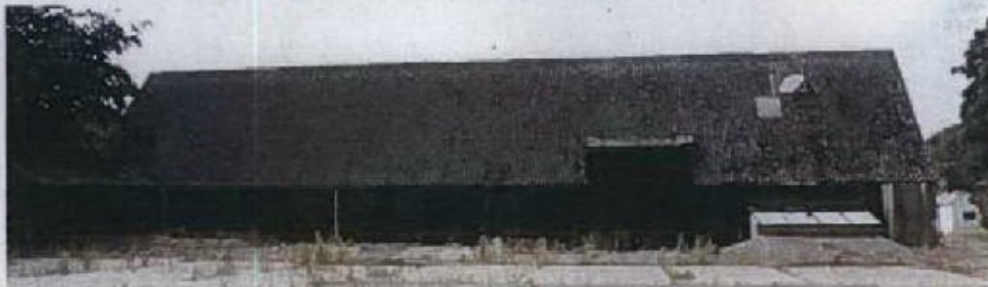
The northern elevation of the Barn.

The northern elevation of the Barn indicates it has been converted for grain dressing in the M-LC20th. At the western end is a large concrete hopper to feed the pre-dresser. There are a number of C20th inserted windows to provide light for operating the machinery inside. The full height double doors are LC20th replacements skinned with marine ply and hung on MC20th reversible hinges.

The weather-boarding is a patchwork of original C19th boards and many later repairs, each one representing a different technological development that was later removed.

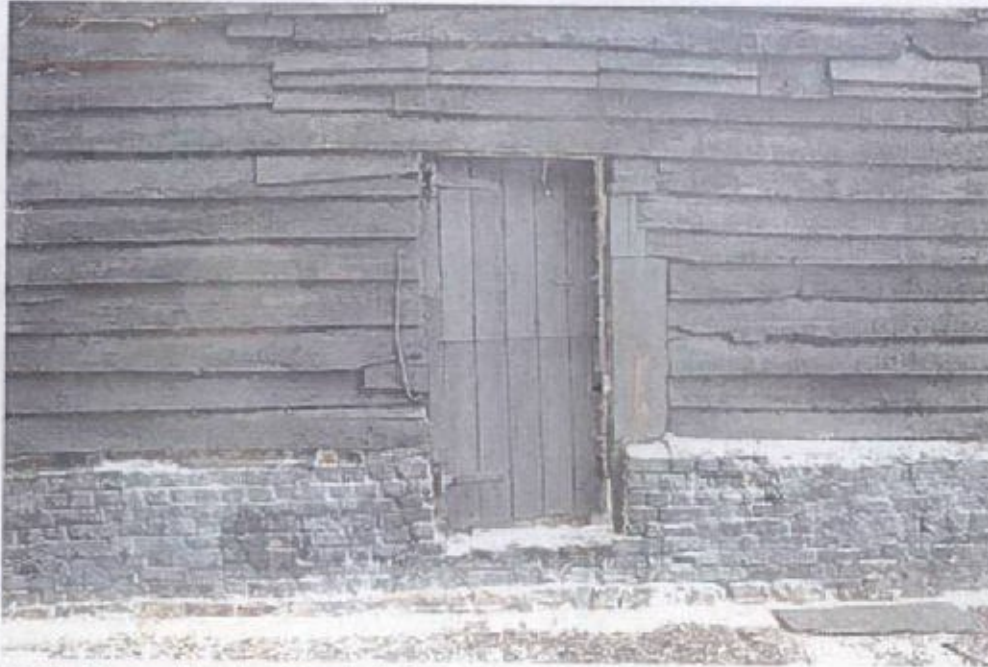
Detail of the weather-boards and plinth on the western elevation.

The western elevation of the Barn retains a larger number of original boards than elsewhere which have been coated with hot tar. The timber-frame stands on a tarred plinth of 65x110x225mm red/orange bricks. There is a MC20th timber door on reversible hinges.

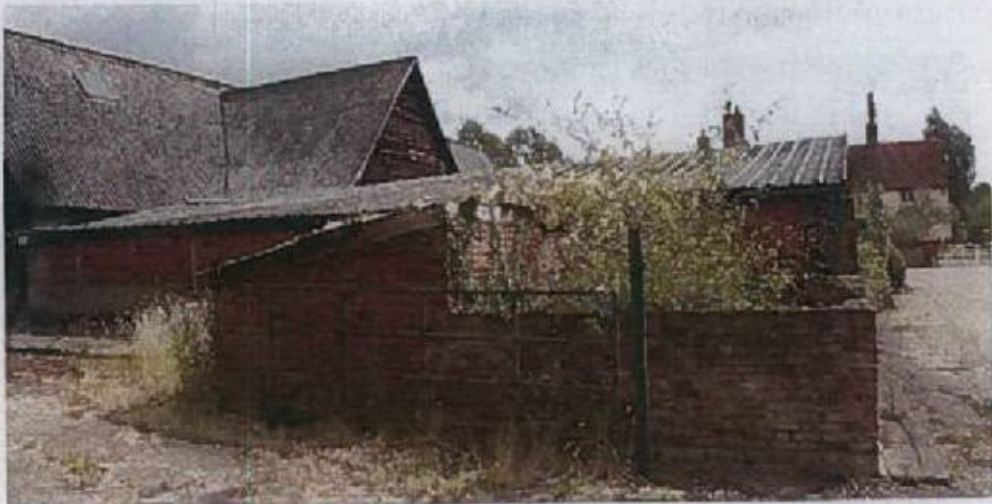
The western elevation of the Pig Pens.

The western elevation of Shelter 1 has been part-rendered in concrete and a concrete raft floor and brick scars indicate there was a larger animal pen set against the building in the LC20th. These were pigpens. (Manager - pers comm).

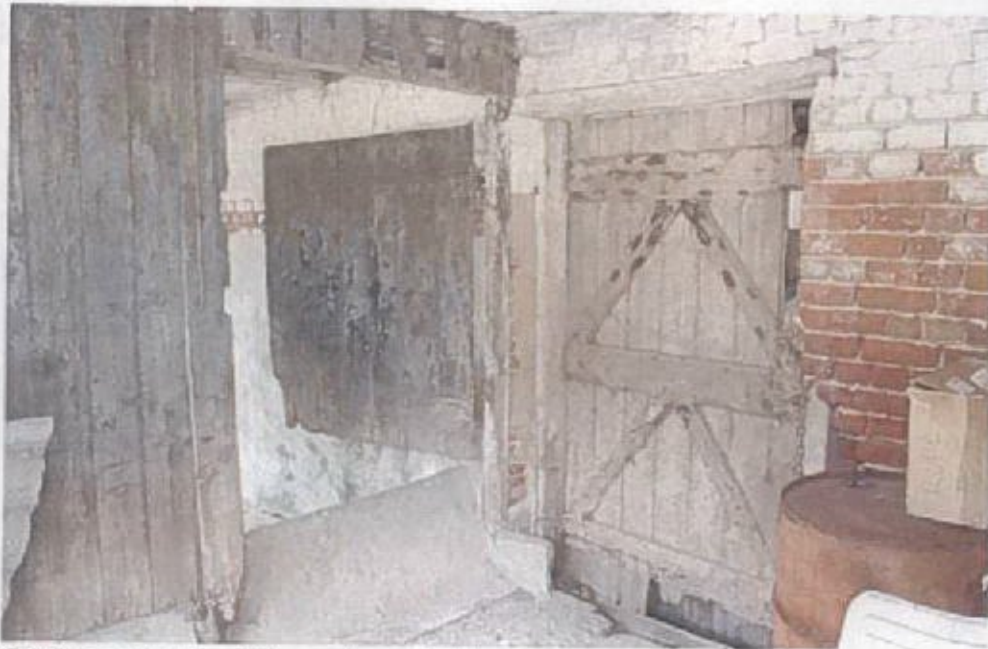
C19th doors into the milking parlour and Shelter 2.

There is an LC19th gate and ledger timber door in parlous condition connecting Shelter 2 to Shelter 3. The opening for it appears inserted as there are no closer bricks. Adjacent is the top leaf of an LC19th stable door that has been reused in the end wall of the milking parlour. The lower part is closed with a deep concrete cill.

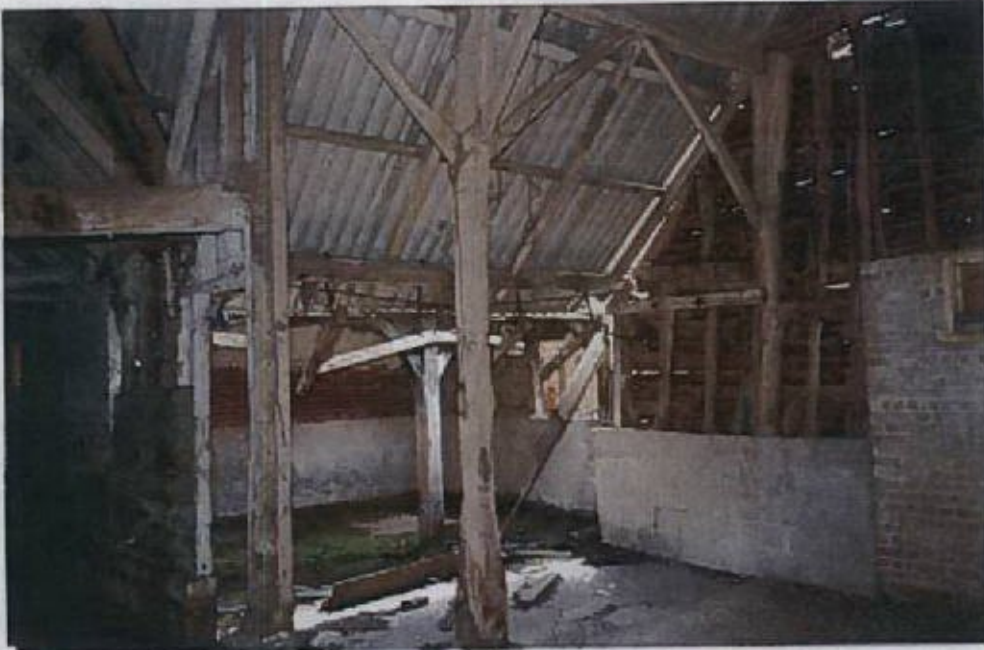
Looking SE into Shelter 2 from inside the porch.

The eastern side of the porch has been removed to conjoin with Shelter 2 where a separate store has been created. The guttering, of welded sheet iron has pulled itself off its fixings and water now pours into Shelter 2. Pigs were also kept here in the LC20th but the railings have been removed.

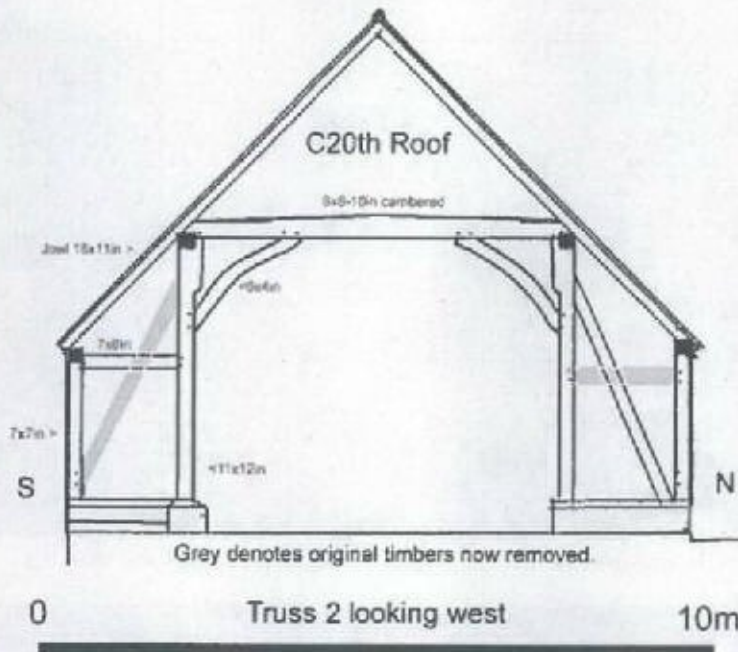
Section through the Barn at Truss 2 looking W.

Trusses 1 to 5 are of the same form and come from a C16th style aisled barn that has been dismantled and re-erected making some changes to the bracing. On the north side, the horizontal aisle ties and passing braces have been removed for diagonal shores and on the south side the passing braces from the arcade posts to the wall post have been removed leaving the trenches and mortices to show where they were.

Each truss has been raised on timber sleepers on top of brick plinths that have been rendered in cement. The arcade posts have wide, deep jowls and are braced to the cambered tie-beams with curved spandrels, some of which are replacements. The frame has been reinforced with LC20th steel tie rods that pass parallel to the tie-beams.

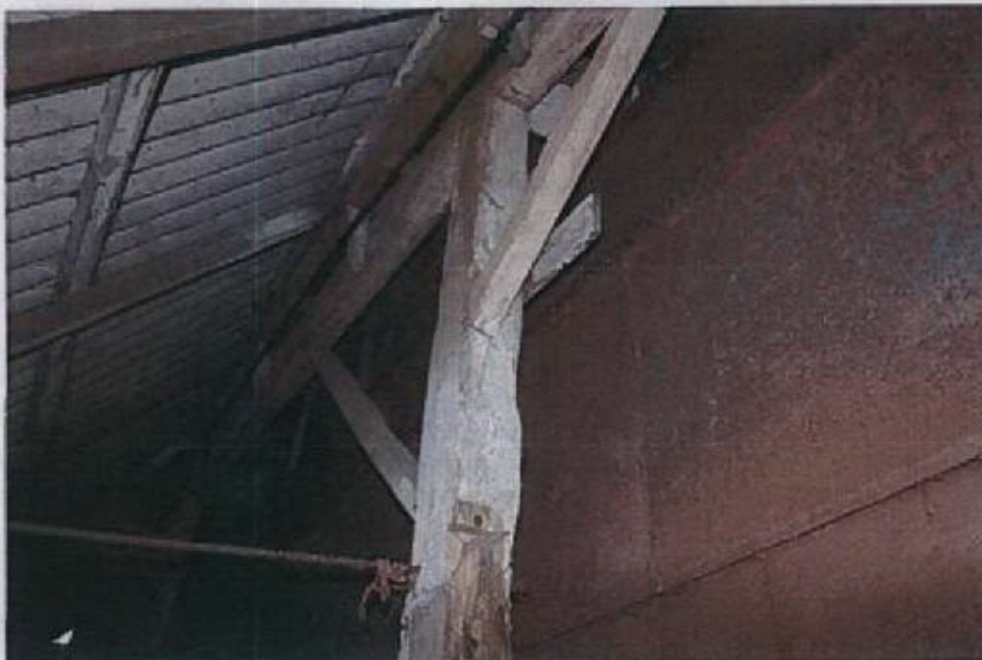
Detail of Truss 6. Note lack of jowl. Narrow braces and abandoned mortices.

Trusses 6 to 8 are cut from reused timbers and have no jowls and thin irregular braces. The arcade plate is scarfed with a face halved and bladed scarf, a very long lived joint. Beside them are several drill holes for mortices that were not completed. The tie-beam braces have been removed to allow a very large 12 cell steel grain store to be inserted.
