Aston Hall Barns, Shropshire

Schedule of Structural Repairs

Project Number: 10854

Date: September 2021

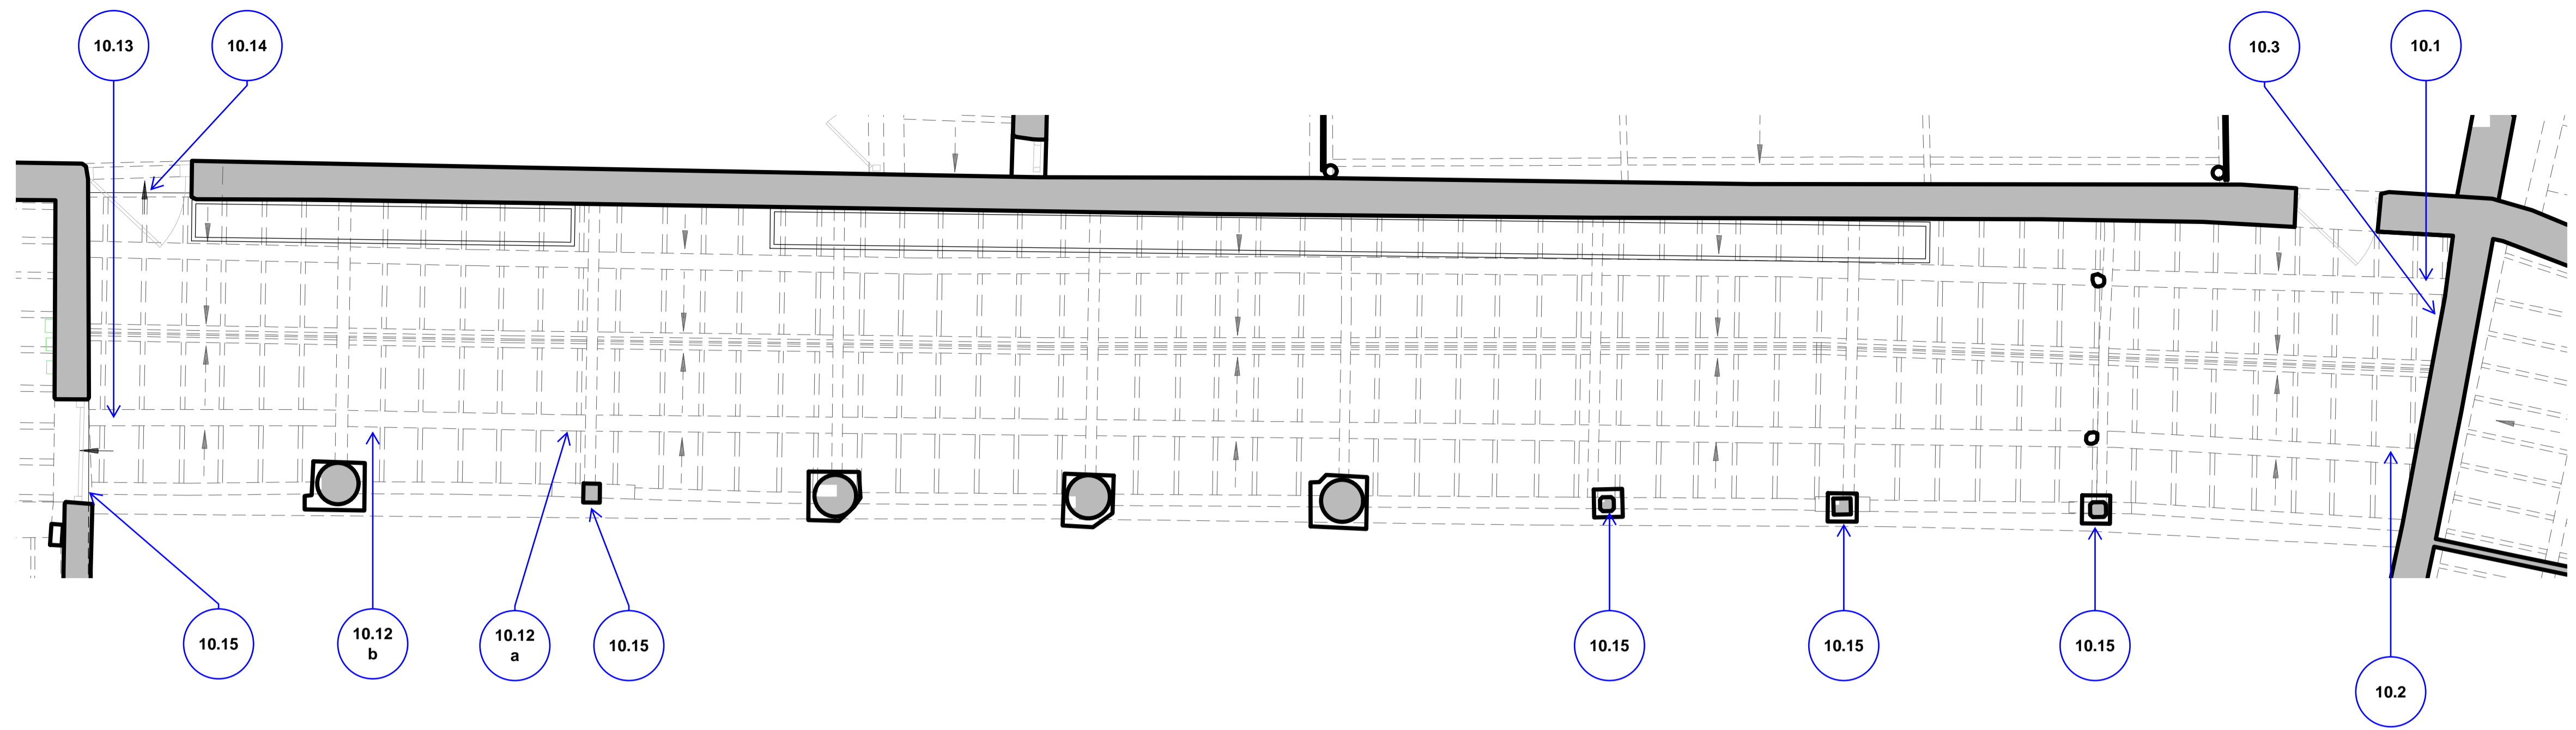
Reference	Defect Description	Photo	Repair Description	Indicative Sketch	Notes
10.1	Decayed embedded purlin bearing end		Splice on new end using seasoned oak (preferably reclaimed) of matching section size. Tabled scarf joint with s/s coach screws.		New bearing to be fully isolated from masonry using continuous DPM sock.

10.2	Decayed embedded purlin bearing end		Splice on new end using seasoned (preferably reclaimed) oak, of matching section size. Tabled scarf joint with s/s coach screws.		New bearing to be fully isolated from masonry using continuous DPM sock.

10.3	Decayed rafter		Remove and replace using seasoned oak (preferably reclaimed) of matching section size.		<ul style="list-style-type: none"> Assuming corrugated metal roof is retained, only severely decayed rafters require renewal. If roof finishes are changed to tiles, more moderately decayed rafters will also require strengthening, by partnering – say up to 20no.

10.12a	Purlin connection compromised by local splits &/or superficial decay		Reinforce splits using s/s woodscrews		
10.12b	Purlin connection compromised by local splits &/or superficial decay		Reinforce splits using s/s woodscrews

10.13	Decayed embedded purlin bearing end		Splice on new end using seasoned oak (preferably reclaimed) of matching section size, using tabled scarf joint with s/s coach screws.

Reference	Defect Description	Photo	Repair Description	Indicative Sketch	Notes
10.14	Excessive historic notch weakening wall plate where it spans over doorway		Relieve load on plate by packing rafter feet off extg outer/lower lintel, using oak blocks

10.15	Brickwork in poor condition over doorway and at south jamb, including corbelled head of pier on inside face.		<ul style="list-style-type: none"> Carefully take down defective masonry and rebuild using reclaimed brick/stone with lime mortar. Over doorway allow for area 1.0m wide x 5 courses tall. For corbel allow for 0.5m thk (full thickness of jamb) x 0.6m h x 0.3m wide. 		<ul style="list-style-type: none"> Temp propping required to 2no. adjacent doorways / openings. Rebuild to include s/s joint bed reinforcement (detailed spec to be developed).

10.16	Decayed timber posts		Replace with circular brick piers based on original detail.		<ul style="list-style-type: none"> 4no. replacement piers required. Allow for oak bearing plates under purlins as original detail. 4no. surviving piers require isolated brick repairs.

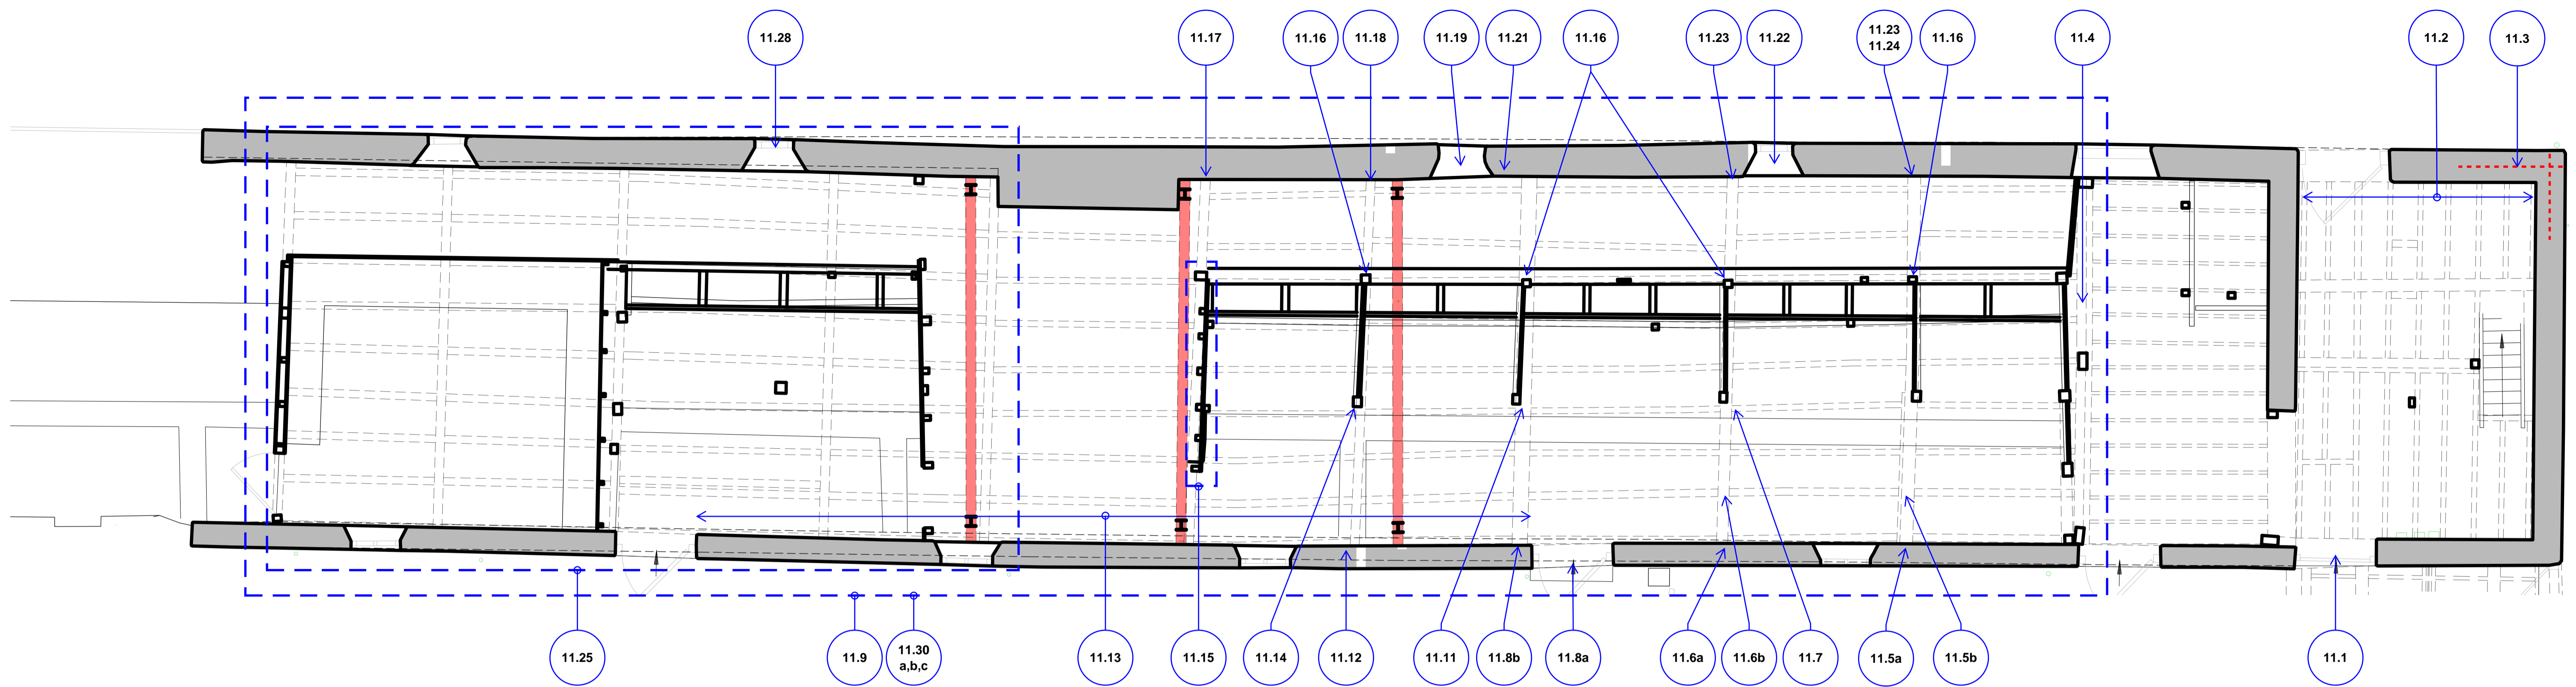
Reference	Defect Description	Photo	Repair Description	Indicative Sketch	Notes
11.1	Sagging lintels – inner section excessively notched, outer section notched & decayed		Replace both inner and outer lintels using reclaimed heartwood oak of similar cross sections (approx. 225x100 & 175x100 respectively, TBC)	-

11.2	Floor joists ends decayed where embedded in external west wall.		Splice replacement ends onto extg joists, using same bearing holes in masonry. Replacement to be seasoned oak, section sizes to match extg (approx. 100x75).		<ul style="list-style-type: none"> Current joists in this area probably late C19th. Bolted splice connections using s/s. New bearings to be fully isolated from masonry using continuous DPM sock. Allow for 9no. joists.

11.3	Masonry fractures at corner due to lack of effective bonding and tying to rubble walls.	-	Cintec anchors installed from outside face in pairs to cross-bond corner.	-	<ul style="list-style-type: none"> Number and spec of anchors tbc. Anchor heads recessed. Alternative approach could be to use RC elbow ties. Result is less subtle, but allows work to be done from inside face.

11.5a	Brickwork fractured & damaged, caused by local area around beam bearing and lintel being restrained while surrounding masonry has leaned outwards.		<ul style="list-style-type: none"> Improved tie through wall to beam end, with large external pattress. Void in wall locally opened up and lime grouted. Remedial walls ties (inc. @ adjacent window reveal) and helibar crack stitching installed locally. 		<ul style="list-style-type: none"> Expressed pattress detail to be developed, probably cruciform arrangement similar to extg ones. Steelwork galv'd and painted.

11.6a	Brickwork fractured & damaged, caused by local area around beam bearing and lintel being restrained while surrounding masonry has leaned outwards.		<ul style="list-style-type: none"> Improved tie through wall to beam end, with large external pattress. Local re-set area of brickwork on inside face (approx. 0.3m x 0.3m). 	As 11.5a	<ul style="list-style-type: none"> Similar to 11.5a but damage less severe. Expressed pattress detail to be developed, probably cruciform arrangement similar to extg ones. Steelwork galv'd and painted.

11.6b	Concerning split or shake in main beam, approx. 2.5m long.		Strengthen beam using vertical screws or through-bolts at regular centres along length of split, to prevent further development of split.		<ul style="list-style-type: none"> Detailed spec for fixings TBC. Eastern stalls post is loose (i.e. not load-bearing) in this bay.

Reference	Defect Description	Photo	Repair Description	Indicative Sketch	Notes
11.7	Floor joist tenon split at interface with beam		Re-support using coach-screwed oak bearer face-fixed to beam.		S/S fixings

11.8a	Outer timber lintel split beyond repair and partially decayed		Replace with matching lintel using reclaimed oak, approx. 100x200 section size.	-	Also allow for rebuilding upper parts of brickwork reveals to enable installation of new timber.

11.8b	Brickwork damaged by relative movement around beam bearing (similar to 11.6a).		<ul style="list-style-type: none"> Improved tie through wall to beam end, with large external pattress. Fractured bricks at adjacent door reveal replaced. 	-	Pattress as 11.5a & 11.6a-

11.9	Many floor joists are undersized in this area	-	Allow for supplementing 50% of joists using additional 150dp x 70wd seasoned grade TH1 oak joists, placed between existing ones and supported using concealed proprietary joist hangers e.g. Simpson Strongtie ETB90-B or equiv. approved.	-	<ul style="list-style-type: none"> Specific positions to be confirmed. Spans vary 2.3m – 3.1m clear. Extg sizes vary considerably: Around 25% are circa 80x80, which is too small. Around 50% are circa 120x70, which is adequate only up to 2.5m span. Around 25% are circa 150x70, which is adequate. Recommendations assume that 1st floor loading requirements will be no greater than / equiv. to domestic type loading (i.e. not heavy storage or equipment). Perimeter of joists hangers potentially require protection with intumescent mastic – TBC.

11.11	Major fracture of floor beam, with former iron bar repairs plus supporting timber post	-	Appears long-standing / non-progressive. No further action required at this time assuming post is retained.	-	Observations recorded for info only

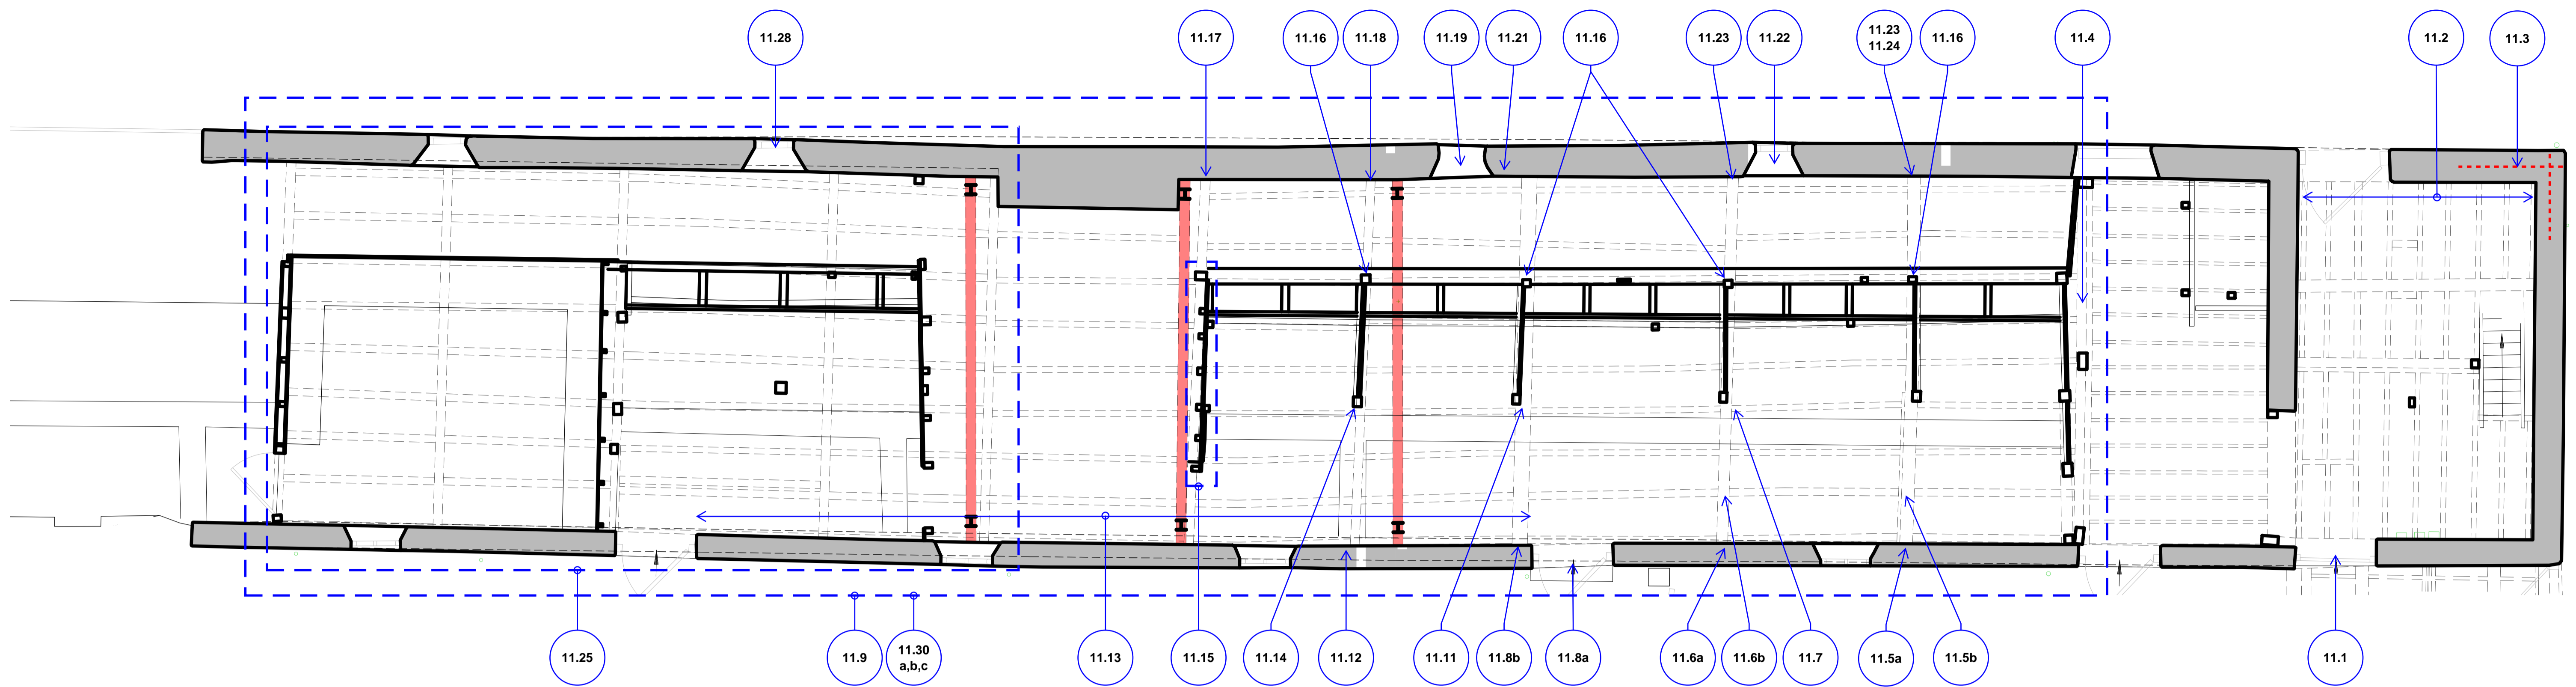
DRAWN	CHKD	SIZE	SCALE	DATE
HP	-	A1	1:50	AUG '21
STATUS				
PRELIMINARY				
PROJECT	DRAWING	REV		
10854	SK11-2	P1

Reference	Defect Description	Photo	Repair Description	Indicative Sketch	Notes
11.12	Historic mortice in embedded timber pad directly beneath beam end		Piece in timber accurately cut to fit slot, using very dry oak. Screw in place.		Requires skilled conservation carpenter.

11.13	Bottom 3-5 brick courses of wall on inside face are in poor condition in this area.		Localised rebuilding or repointing as appropriate, all in lime mortar & by conservation mason.		<ul style="list-style-type: none"> Applies to 13m run of wall. Assume 50% requires rebuild of inside face (3 - 5 courses high x 1/2 - 1 brick deep) and remainder requires deep-pack repointing (3 - 5 courses high). Where rebuilding assume 50% of bricks salvageable, 50% to be matching new. Rebuild to be undertaken in short sequential sections to avoid undermining.

11.17	Substantial diagonal fracture in masonry beneath beam bearing approx. 0.7m from edge of formerly rebuilt area.		TBC. Provisionally a combination of localised rebuilding to the ground floor portion (effectively extending the "buttress" by approx. 1m) and helibar stitching at first floor.		Requires further site review.

Reference	Defect Description	Photo	Repair Description	Indicative Sketch	Notes
11.18	Historic mortice in embedded timber pad directly beneath beam end		Piece in timber accurately cut to fit slot, using very dry oak. Screw in place.		Requires skilled conservation carpenter.

11.19	Timber lintels decayed beyond repair		<ul style="list-style-type: none"> Replace using 100mm dp precast concrete lintels to core of wall, with 100sq reclaimed oak facing lintel on inside face. Rubble stone reveals to be made good. Also remove decayed timber cill and make good. 		<ul style="list-style-type: none"> Outside face of wall has brick arch facing (1/2 brick thick) - to be carefully preserved / repaired as necessary. Lintel bearings to match extg. All work to use lime mortar. Temporary propping/needling required.

11.21	Embedded timber beam pad partially decayed.		Cut out / remove decayed portion (south end up to & including mortice). Infill scar using matching rubble stone masonry.		For costing assuming 250mm deep.

11.22	<ul style="list-style-type: none"> Timber lintels excessively decayed. Opening reveals fractured on both sides near mid-line due to poor bonding & wall movements; possibly indicative of more widespread delamination of wall faces due to weak core. 		<ul style="list-style-type: none"> Replace using 100mm dp precast concrete lintels to core of wall, with 100sq reclaimed oak facing lintel on inside face. Reveals to be stitched using helibar at each course & fractures repointed good. More widespread use of consolidation ties may be considered. 		<ul style="list-style-type: none"> Outside face of wall assumed to have brick arch facing (1/2 brick thick) - to be carefully preserved / repaired as necessary. Lintel bearings to match extg. All work to use lime mortar. Temporary propping/needling required. Helibar detailed spec tbc.

11.23	Floor beams very deeply notched and partially decayed at west bearings.		Although beam capacities are compromised, while support from stall posts is retained no action is required.		Observations recorded for info only. Applies x 2no. beams.

11.24	Structurally significant crack in main beam end, with former bolted repair		While support from stall post is retained no action is required.		Observation recorded for info only.

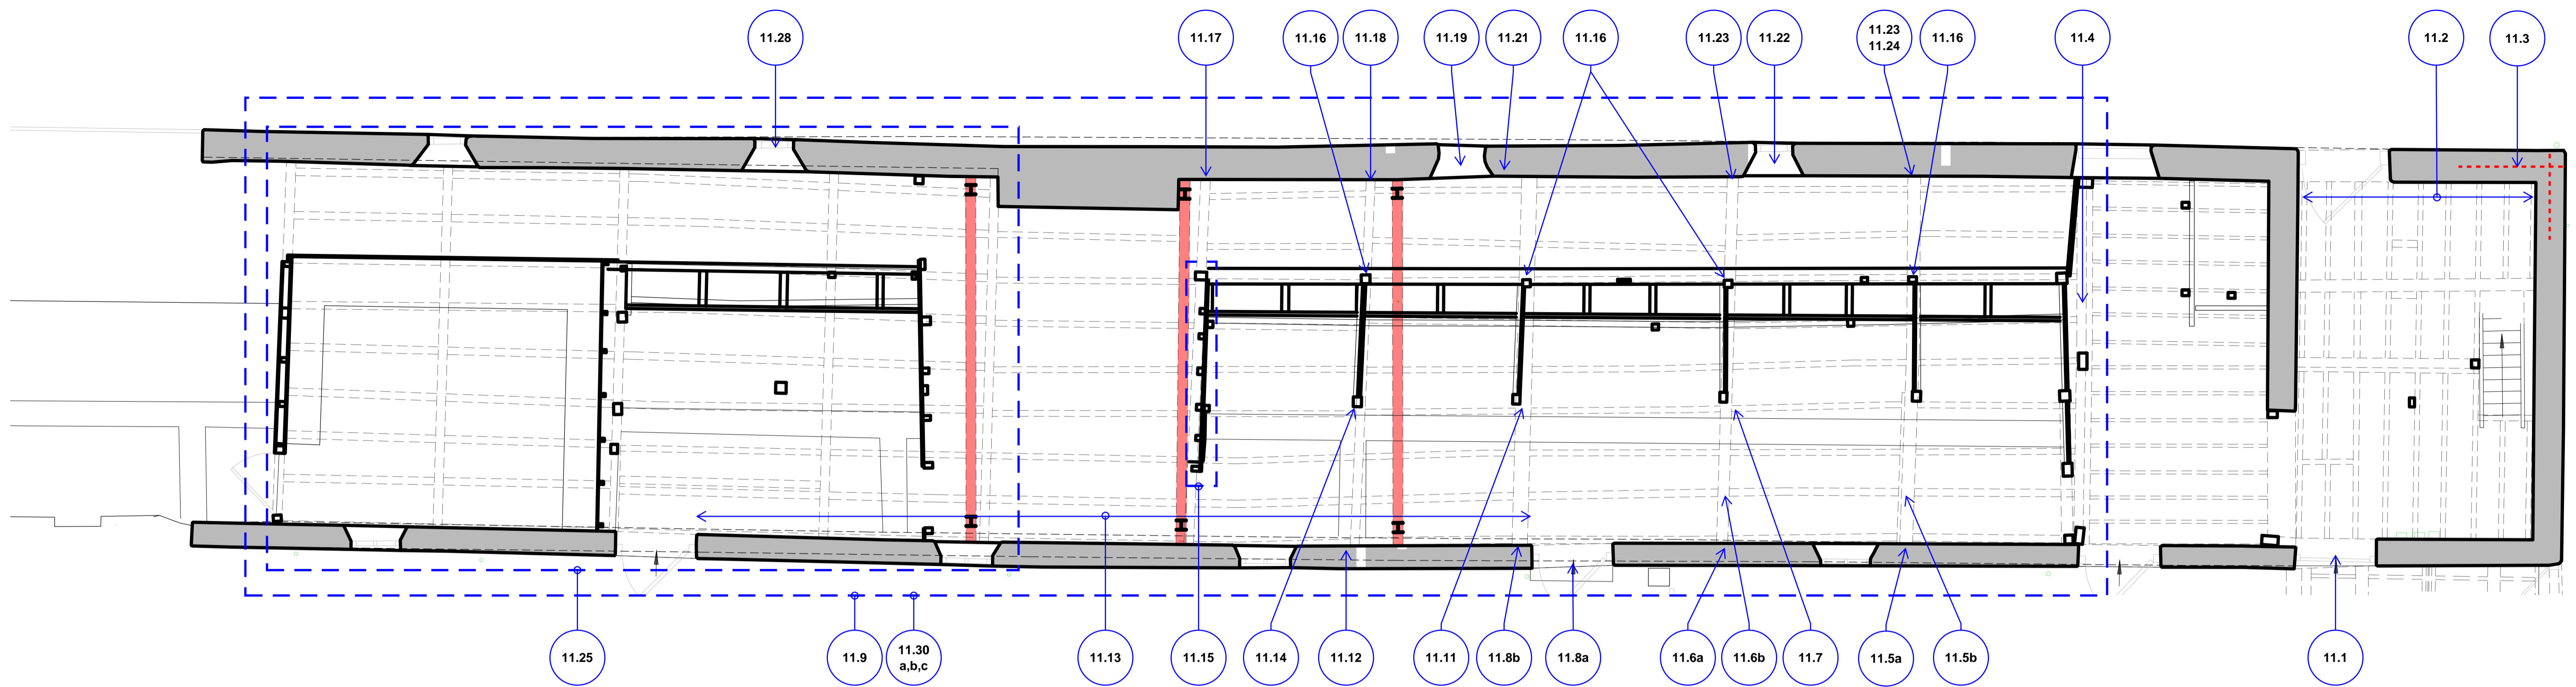
Reference	Defect Description	Photo	Repair Description	Indicative Sketch	Notes
11.25	Main floor beams typically reliant on existing posts / studs for support, due to inherent under-sizing, plus various splits and localised instances of decay.		<ul style="list-style-type: none"> Beams to be strengthened using supplementary steelwork, where extg props are to be removed. Typically allow for bolting fabricated profiled angle sections either side, 150x150x20. End beam could have a single 200x20 profile flat plate coach screwed to outside face. Bespoke details to be confirmed for each beam. Alternative internal "fitch plate" detail may be considered. Advantage is end result is hidden. Disadvantage is that the timber beam is irreversibly damaged in the process, and installation is difficult for relatively narrow beams (130mm wide typ.) esp. where they are heavily notched / morticed or split. 		<ul style="list-style-type: none"> Further detailed surveying required in this area following removal of modern insertions. Assume 5-6no. beams strengthened similarly to create open-plan zone at southern end of barn. Provisional sizing assumes that 1st floor loading requirements will be no greater than / equiv. to domestic type loading (i.e. not heavy storage or equipment). Steelwork to have intumescent paint or other fire protection. All steels fabricated suit deflected profile of timber beams, using templates. Steelwork may stop at wall face, or be built in the strengthen bearing, depending on detailed inspection of each extg timber bearing condition. Where steelwork is built in to masonry locally bitumen paint and concrete encase for corrosion protection.

11.27	Historic mortice in embedded timber pad directly beneath beam end		Piece in timber accurately cut to fit slot, using very dry oak. Screw in place.		Requires skilled conservation carpenter.

11.28	<ul style="list-style-type: none"> Outer timber lintel excessively decayed. Opening reveals fractured on both sides. 		<ul style="list-style-type: none"> Replace using matching oak heartwood section (approx. 100mm sq TBC). Reveals to be stitched using helibar at each course & fractures repointed good. Also remove decayed timber cill and make good. 		<ul style="list-style-type: none"> Temporary local opening up of reveals necessary to facilitate installation. Outside face of wall assumed to have brick arch facing (1/2 brick thick) - to be carefully preserved / repaired as necessary. Lintel bearings to match extg. All work to use lime mortar. Temporary propping/heeling required.

Reference	Defect Description	Photo	Repair Description	Indicative Sketch	Notes
11.30a	<p>Walls leaning very substantially to the east, by up to 470mm (-H/10).</p> <p>Underlying cause is thought to be an inherent lack of cross-walls & excessive slenderness of unbraced external walls, combined with a tendency for the footings to rotate in the direction of dip of the underlying rockhead bedding planes.</p>		<p>The existing steel frames appear to have been reasonably effective at slowing or halting further distortion of the walls (although this is difficult to establish for certain without long term monitoring), however the bracing arrangements inhibit the use of the spaces and are unsightly.</p> <p>It is proposed to improve the stability arrangements using a combination of methods:</p> <p>a)</p> <ul style="list-style-type: none"> At least 1 and possibly all 3 of the braced steel frames to be replaced with engineered 2-storey 'moment frames' providing a similar function in a more discrete manner. Frames to comprise 152UC columns and 203UC beams at 3 levels including concrete encased 'ground beam'. 		<ul style="list-style-type: none"> Detailed designs to be developed, including direct fixing of new frames to floors / roofs / front & rear walls. New stability frames most likely to be installed near to existing ones but not in exactly the same positions, to facilitate sequencing (new frames installed and pre-loaded prior to carefully removing extg ones while monitoring deflections). New stability frames to have large cruciform pattress plates on external elevations similar/same as extg ones.

11.30b			<p>b)</p> <ul style="list-style-type: none"> Repaired first floor deck to incorporate a 2-layer plywood diaphragm, screwed to all joists and beams. Pitched roof also to incorporate an equivalent plywood diaphragm screwed to all rafters. The purpose of these lateral diaphragms is to enable the whole length of the 2 elevations to benefit from the stability provided locally by the 3 steel cross frames and the end walls. 		Detailed specs to be developed.

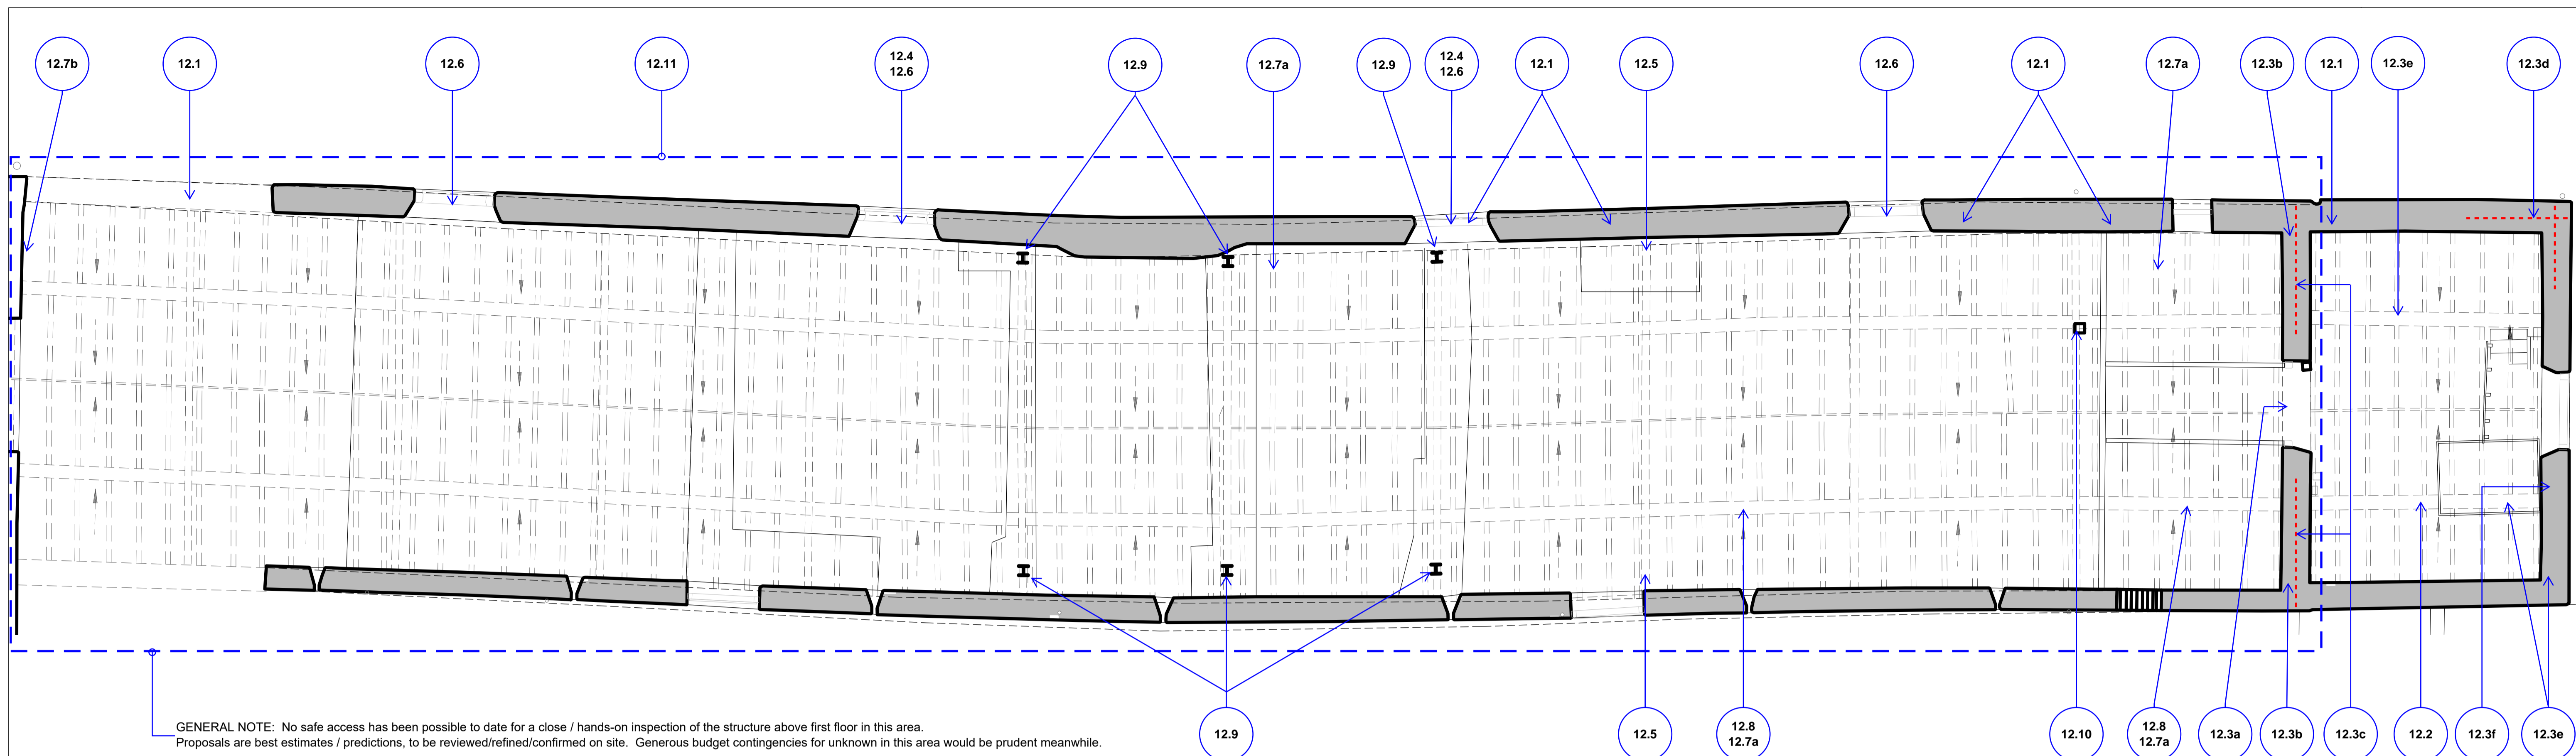
PROJECT WEST BARN - ABOVE 1st FLOOR - PAGE 1/2						STATUS PRELIMINARY					
		PROJECT 10854	DRAWING SK12-1	REV P1									
		F:PRELIMINARY		T:TENDER		CONSTRUCTION							
		PROJECT: ASTON HALL BARN

Reference	Defect Description	Photo	Repair Description	Indicative Sketch	Notes
12.1	Length of wall plate locally decayed		Locally replace with equivalent oak section, typically circa 190x100 TBC. Fix new to extg using half-lap scarf joints either end, with s/s coach screws.		Provisionally allow for 8no. instances, average length 1.5m + laps. Actual requirements TBC on site.

12.2	Purlin locally severely decayed		Partner with new oak purlin alongside, provisionally 150x200, grade THA.		<ul style="list-style-type: none"> Provisional size assumes roof finishes in this area to remain as corrugated metal.

12.3a	Rubble masonry bulging and cracking over doorway		Carefully take-down and rebuild local area over doorway x ~0.8m high (full thickness).	-	<ul style="list-style-type: none"> All work to use lime mortar. Temporary propping & needling required.

12.3b	Holes and loose areas of masonry.		Carefully take-down and rebuild local areas as required.	-	<ul style="list-style-type: none"> Allow for areas approx. 0.5m sq at wall junction with east elevation, & approx. 0.3m sq just above junction with west elevation, both x full wall thickness.

Reference	Defect Description	Photo	Repair Description	Indicative Sketch	Notes
12.3c	Fractures at original gable end junctions with front and rear walls, indicative of spreading & lack of bonding.		Cintec anchor wall junctions at both elevations and make good associated cracks by deep raking out and repointing.	-	<ul style="list-style-type: none"> Number and spec of anchors tbc. Anchor heads recessed. Repairs will also assist with general enhancement of building's sway stability.

12.3d	Masonry fractures at corner (formerly filled) due to lack of effective bonding and tying to rubble walls.	-	Cintec anchors installed from outside face in pairs to cross-bond corner.	-	<ul style="list-style-type: none"> As per ground floor. Number and spec of anchors tbc. Anchor heads recessed. Alternative approach could be to use RC elbow ties. Result is less subtle, but allows work to be done from inside face.

12.3e	Locally deficient rubble masonry e.g. holes and loose stones	Examples 	Local rebuild to infill holes and make good / consolidate as required.	-	<ul style="list-style-type: none"> All work to use lime mortar. Areas include: <ul style="list-style-type: none"> Around both ends of both purlins Around north-east corner, just above and below eaves level (inside & outside faces)

12.3f	Raking fracture in masonry		Stitch crack using Helibar in coursed rubble joints and make good crack by repointing.	-	<ul style="list-style-type: none"> Helibar detailed spec tbc. Provisionally allow for installing 3no. 8mm dia bars x 1.2m long each, in both inner and outer wall faces.

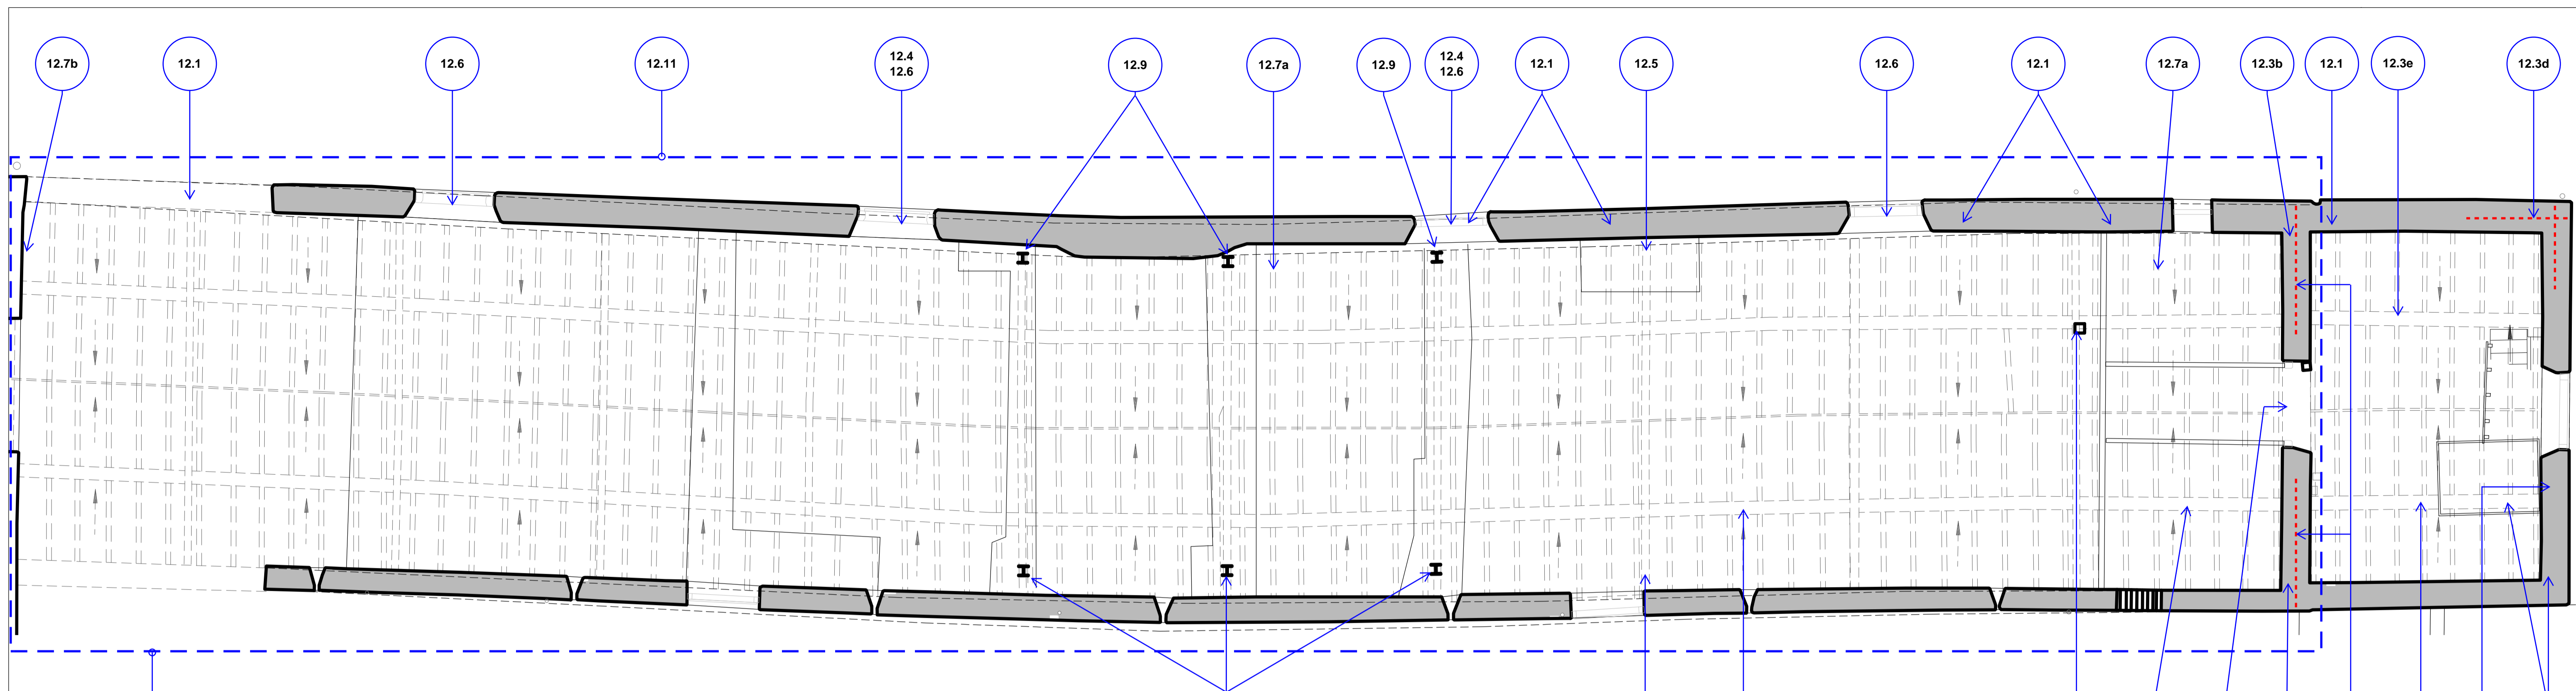
PROJECT WEST BARN - ABOVE 1st FLOOR - PAGE 2/2	DRAWING SK12-2	REV P1	STATUS PRELIMINARY

Reference	Defect Description	Photo	Repair Description	Indicative Sketch	Notes
12.4	Decayed lintels		Renew lintels using reclaimed oak of matching size (estimated circa 150x300). Also remove decayed cills and make good masonry by stoning up scars at base of reveals.	-	<ul style="list-style-type: none"> Applies to 2no. windows. Lintel bearings to match extg. All work to use lime mortar. Temporary propping likely required.

12.5	Possible decay of truss bearing ends		If necessary, install steel shoe	 ELEVATION SECTION	<ul style="list-style-type: none"> Requires closer hands-on inspection to confirm requirement and if necessary detail design. Provisionally allow for 2no. (TBC)

12.7b	Failed / split common rafters	-	Replace with new oak equivalent (approx. 90x80)	-	Only 1no. identified so far, but provisionally allow for up to, say, 5no.

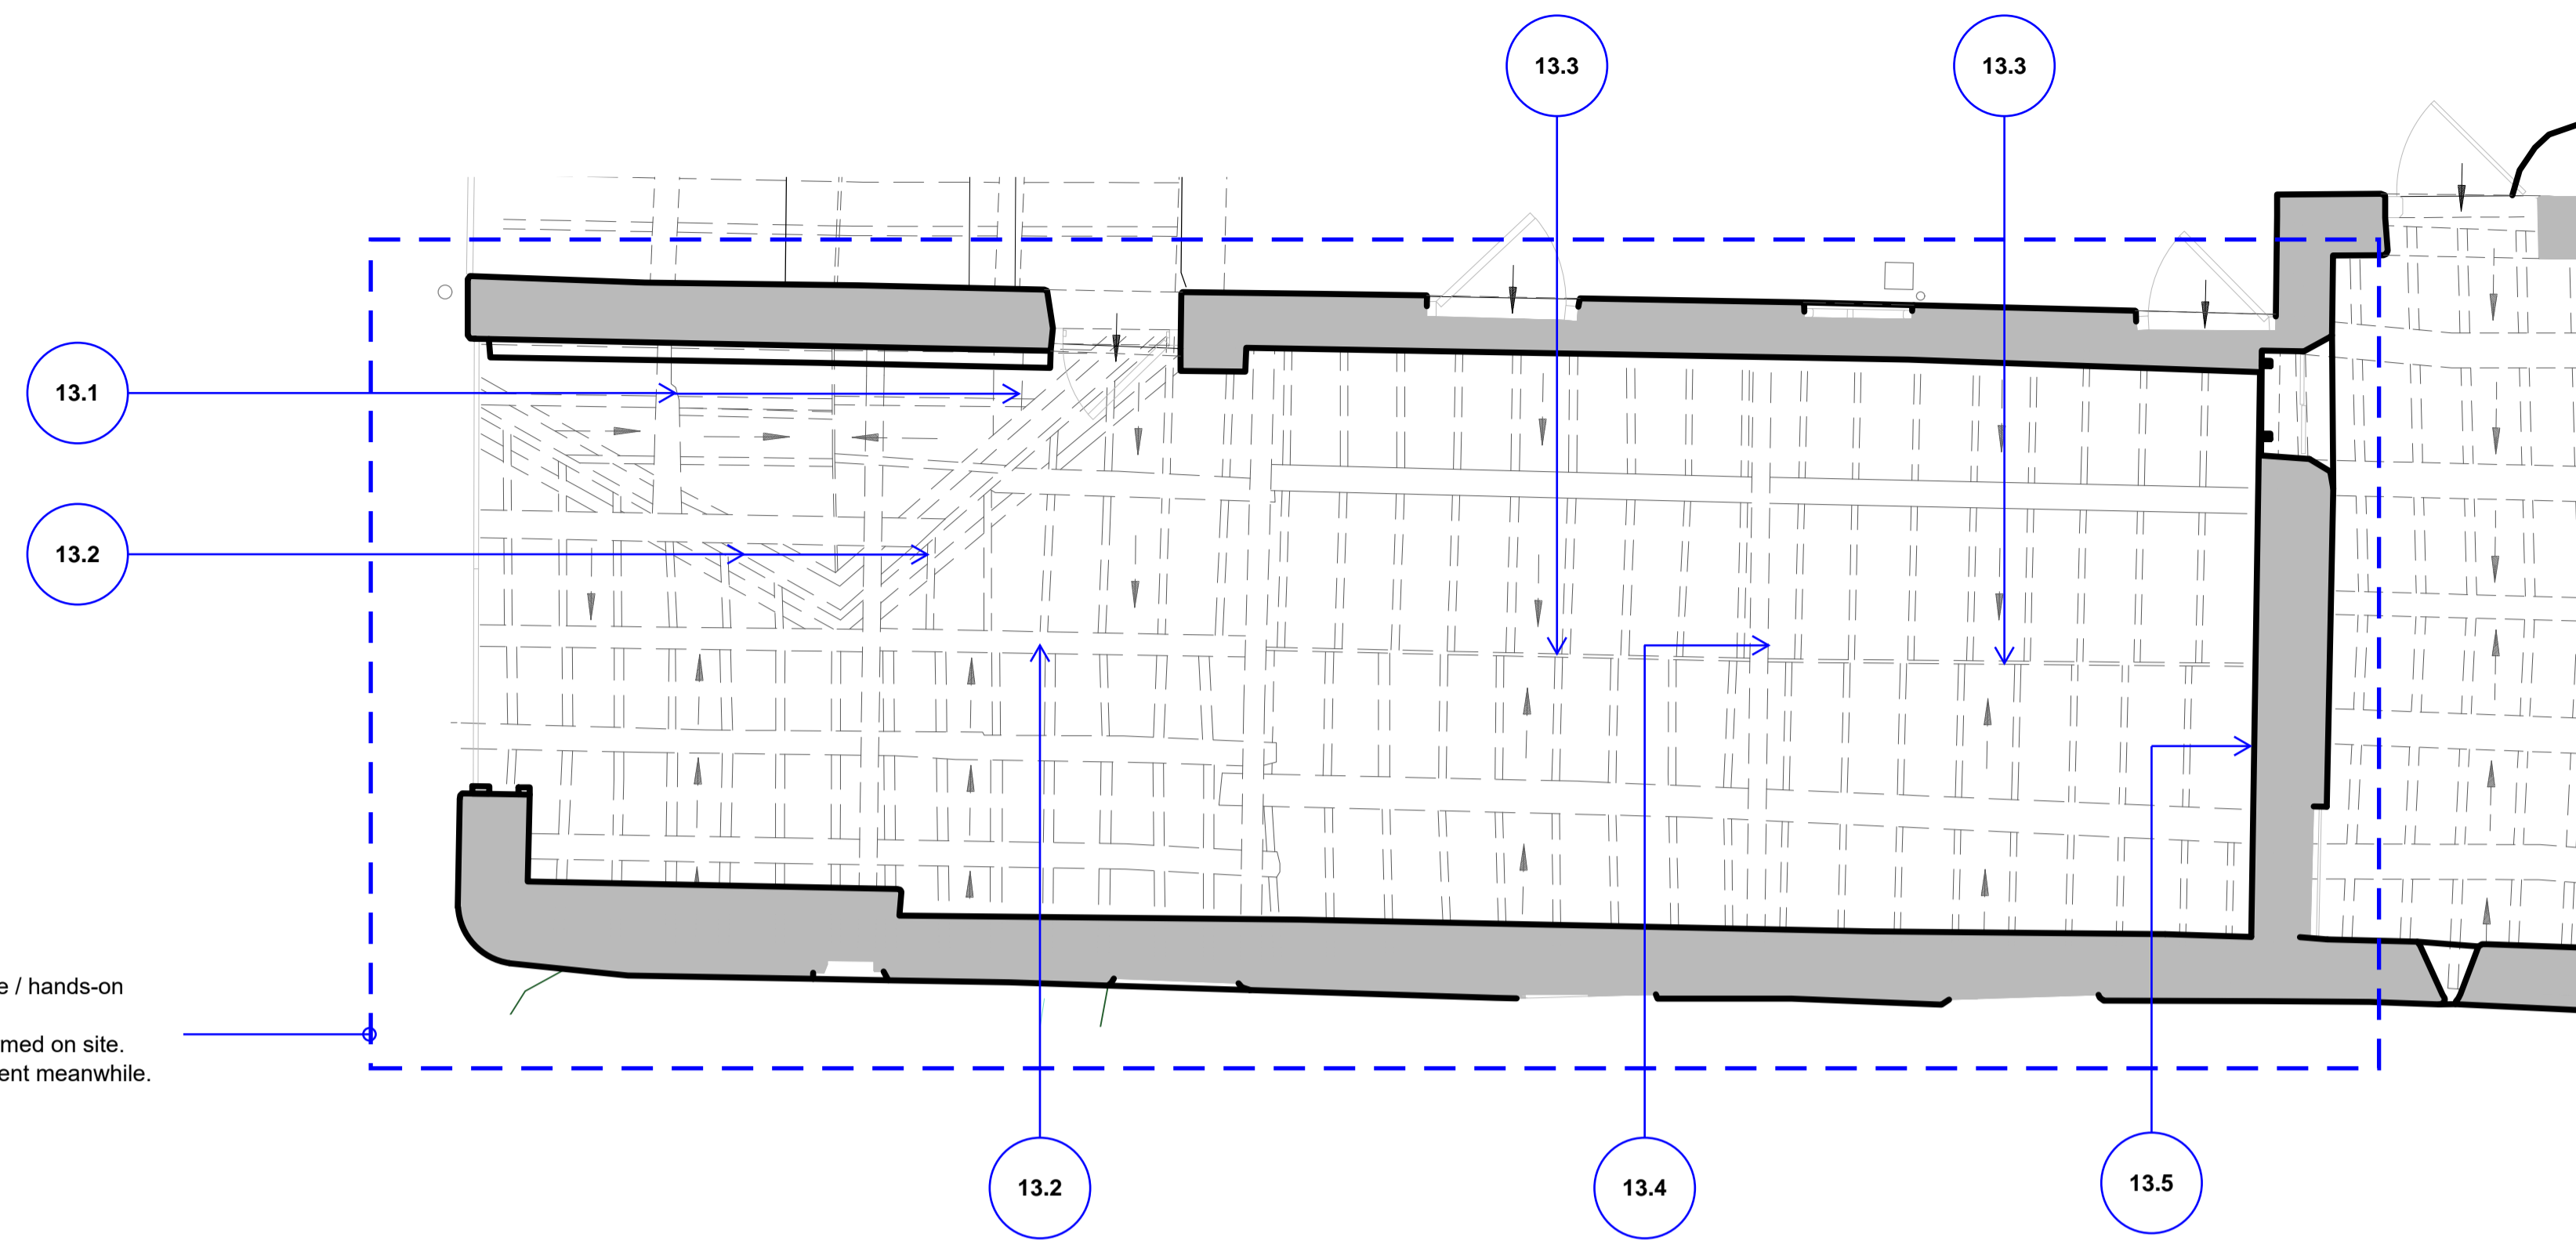
Reference	Defect Description	Photo	Repair Description	Indicative Sketch	Notes
13.1	2x purlins have poor connection to supporting valley beams		Build-up adjacent rubble wall "gable" to provide improved support to purlins where they pass through	-	Rubble masonry to match extg

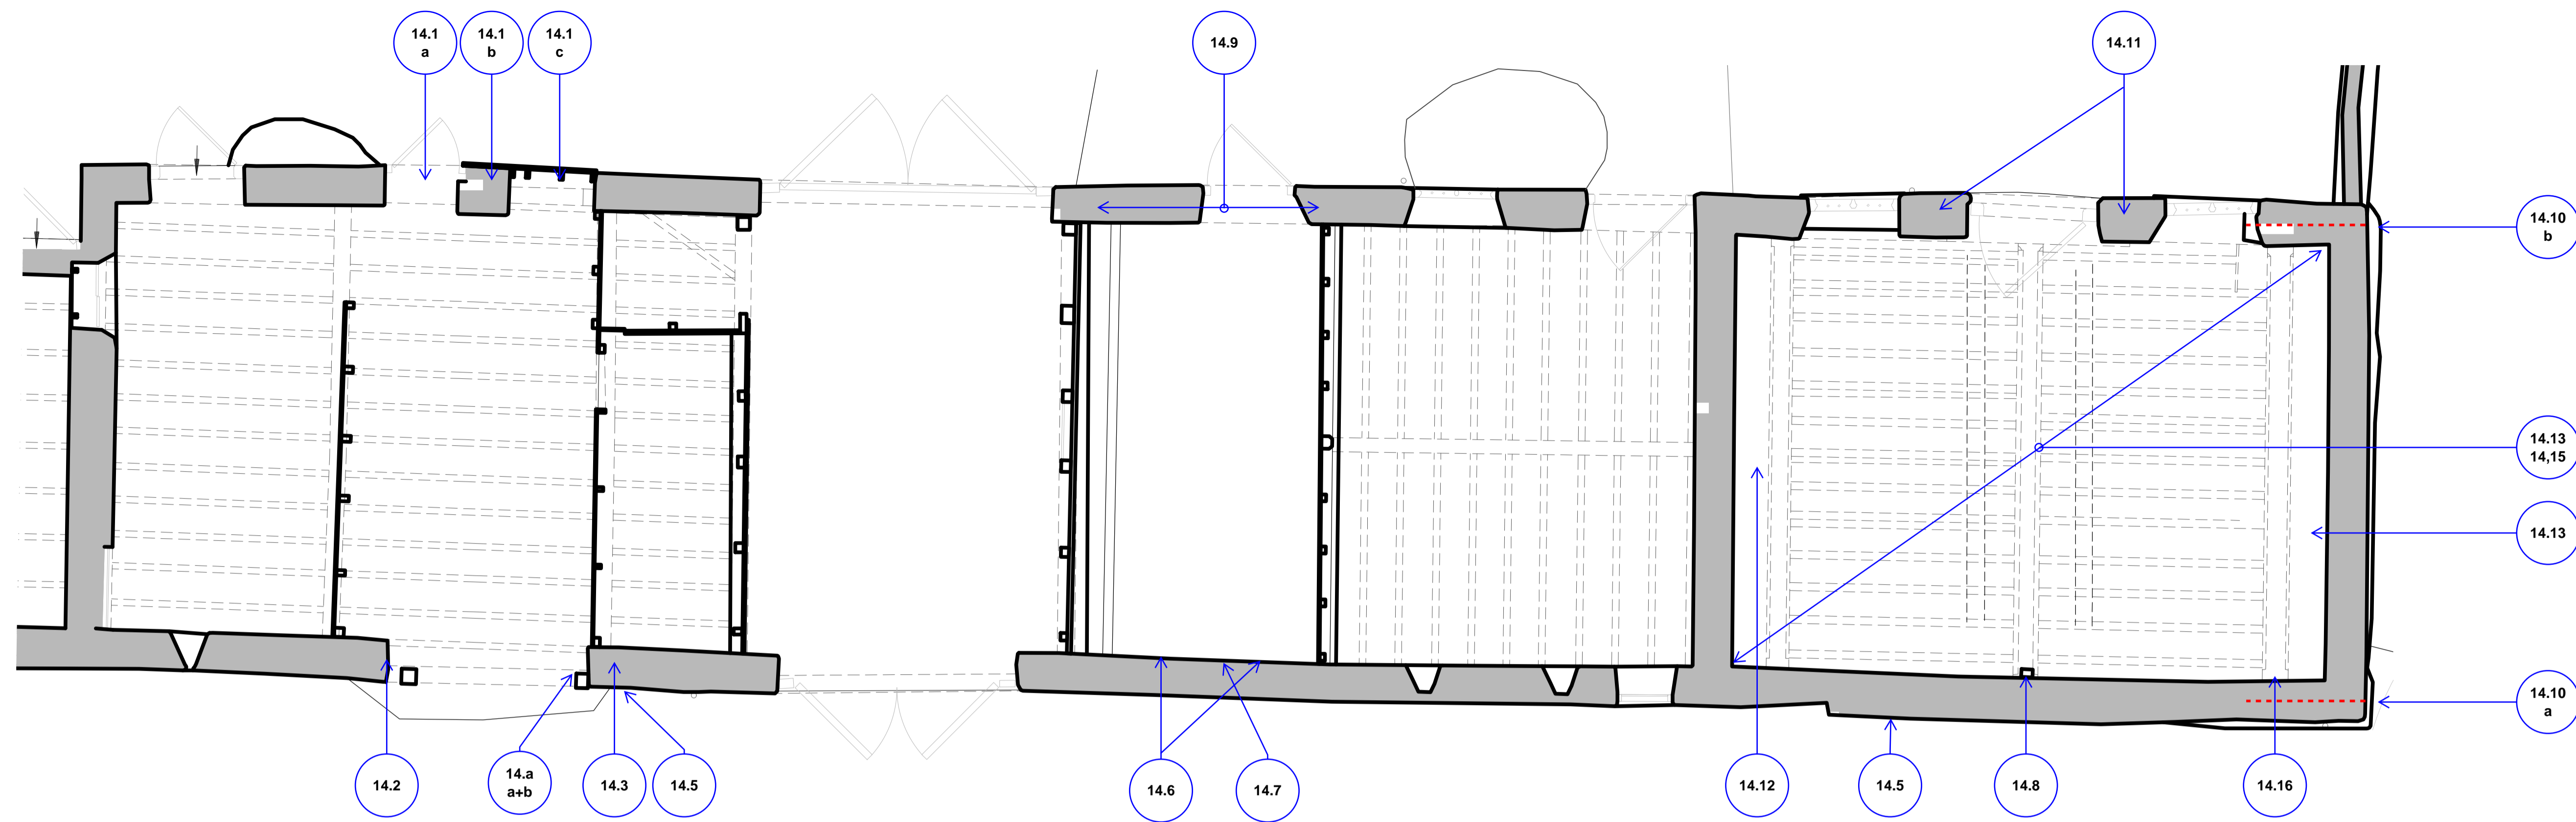
Reference	Defect Description	Photo	Repair Description	Indicative Sketch	Notes
14.1a	Decayed and failed wall plate / lintel. Modern steel beam alongside supported prop to failed truss bearing above.		Failed/decayed section of wall plate / spanning lintel to be removed locally and replaced with new section from reclaimed oak, with pegged tenon connection to truss post above (and any other posts along the section replaced) and spliced to adjoining sections of wall plate using half-lap scarf joints with s/s coach screws.	-	<ul style="list-style-type: none"> Section size of new timber circa 230mm sq TBC following detailed design (greater than original which was inadequate to carry the principal truss). Temporary propping required and work must be undertaken in conjunction with the repairs to the truss bearing above (item 15.4) Modern steel beam will become redundant and can be removed once the repairs to the truss bearing above have been completed.

14.1b	Blockwork pier (former repair) is functional but detrimental to character of the building.		Remove pier and rebuild section of wall in rubble stone matching existing.	-
