Aston Hall Barns, Shropshire

Schedule of Structural Repairs

Project Number: 10854

Date: September 2021

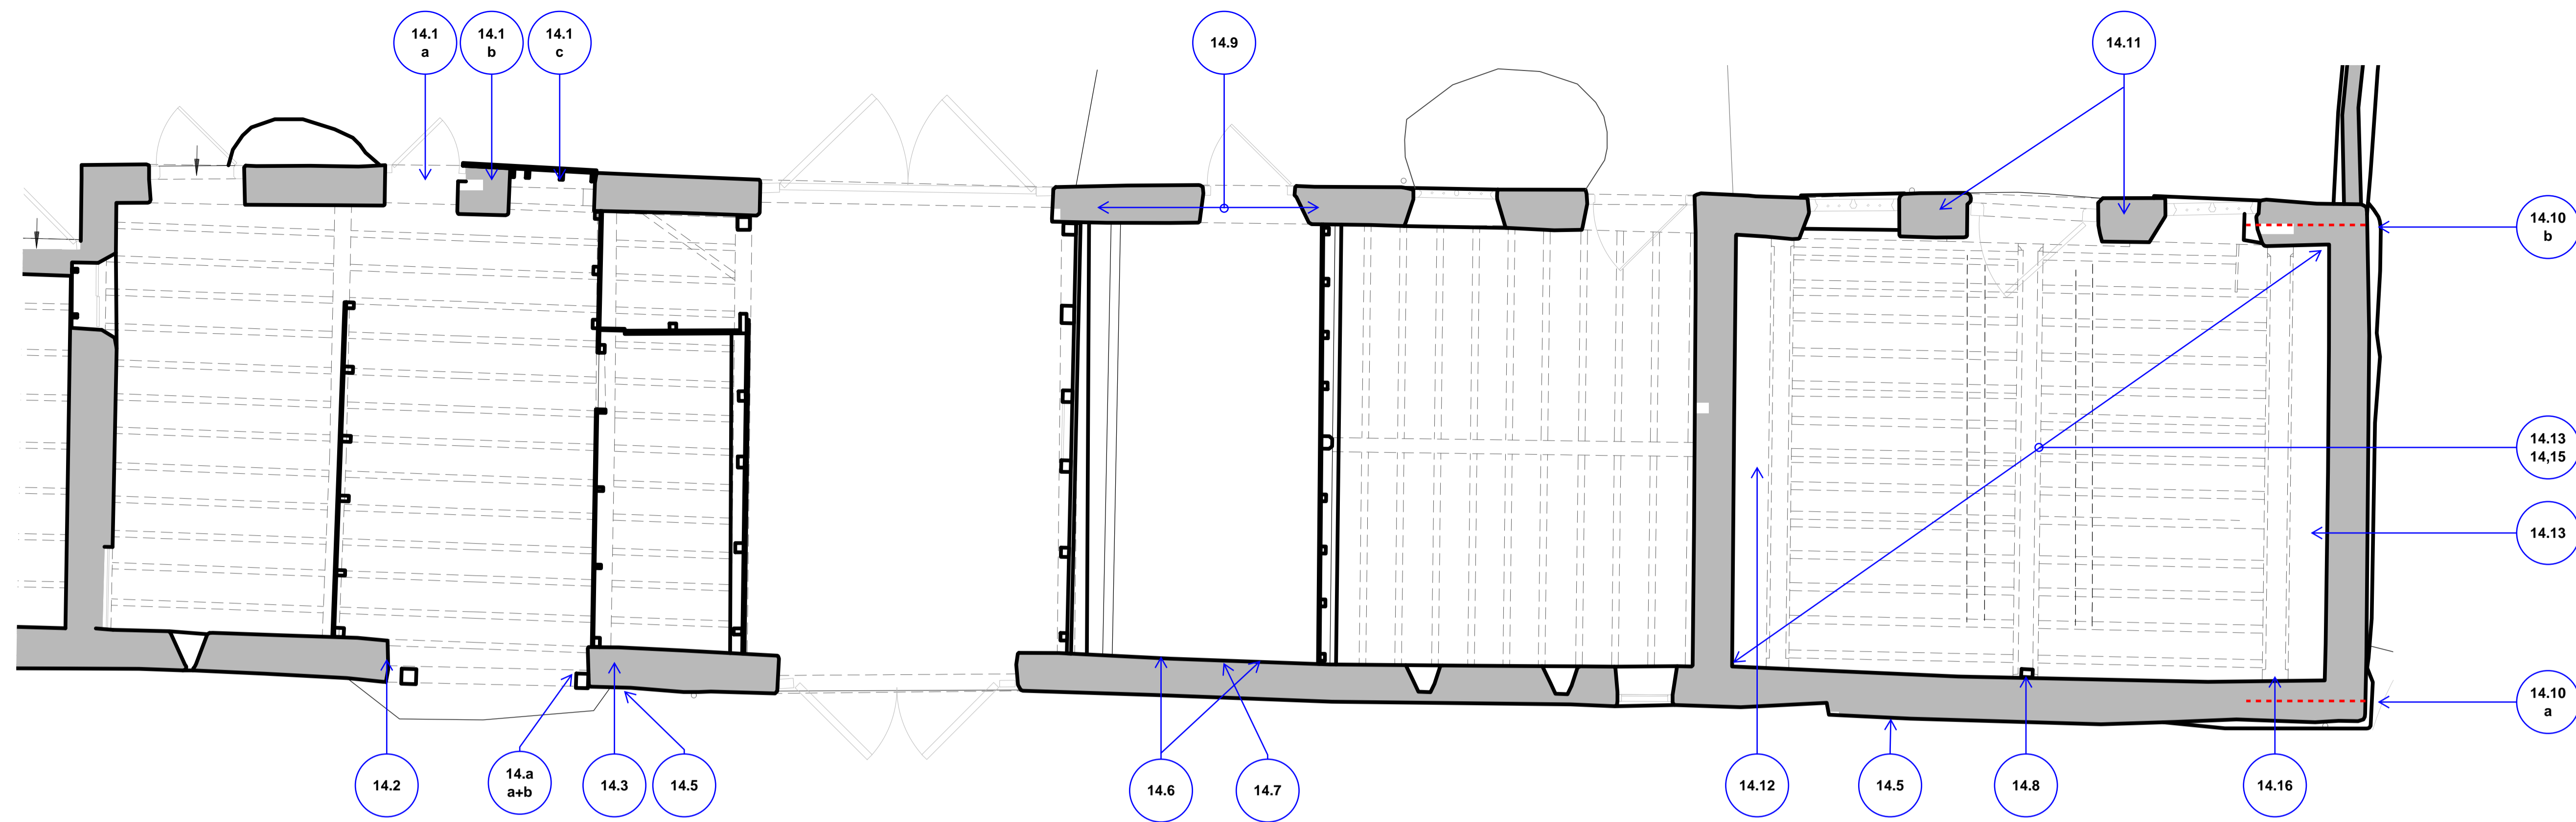
TITLE OUTLINE STRUCTURAL REPAIR PROPOSALS - SHEET 9 SOUTH-EAST BARN - UP TO 1ST FLOOR - PAGE 2/3						STATUS PRELIMINARY	PROJECT 10854	DRAWING SK14-2	REV P1

Reference	Defect Description	Photo	Repair Description	Indicative Sketch	Notes
14.7	Decayed sill beam at mid height, including compromised mortices. Appears to affect full section locally.		Replace section using new heartwood oak, matching existing section size (circa 200x150 tbc). Spliced to adjoining sections of wall plate using half-lap scarf joints with s/s coach screws. To allow insertion with wall in-situ, affected post/bracing tenons (2-3 no.) will need to be cut and joints made good using steel bracketry and screws. Also make good top course of rubble masonry where weathered on outside face.		<ul style="list-style-type: none"> Extents of replacement TBC following full exposure. If only decayed on one face re-facing half thickness of timber will be preferable to complete replacement. Affected length circa 1m long TBC. Architects to consider a flashing detail / improved arrangement at btm of timber cladding to reduce wetting of plate.

14.8	Existing remedial prop to be "formalised"		Review prop requirements and install new concrete pad footing if necessary.		<ul style="list-style-type: none"> Footing take to same formation level as existing walls.

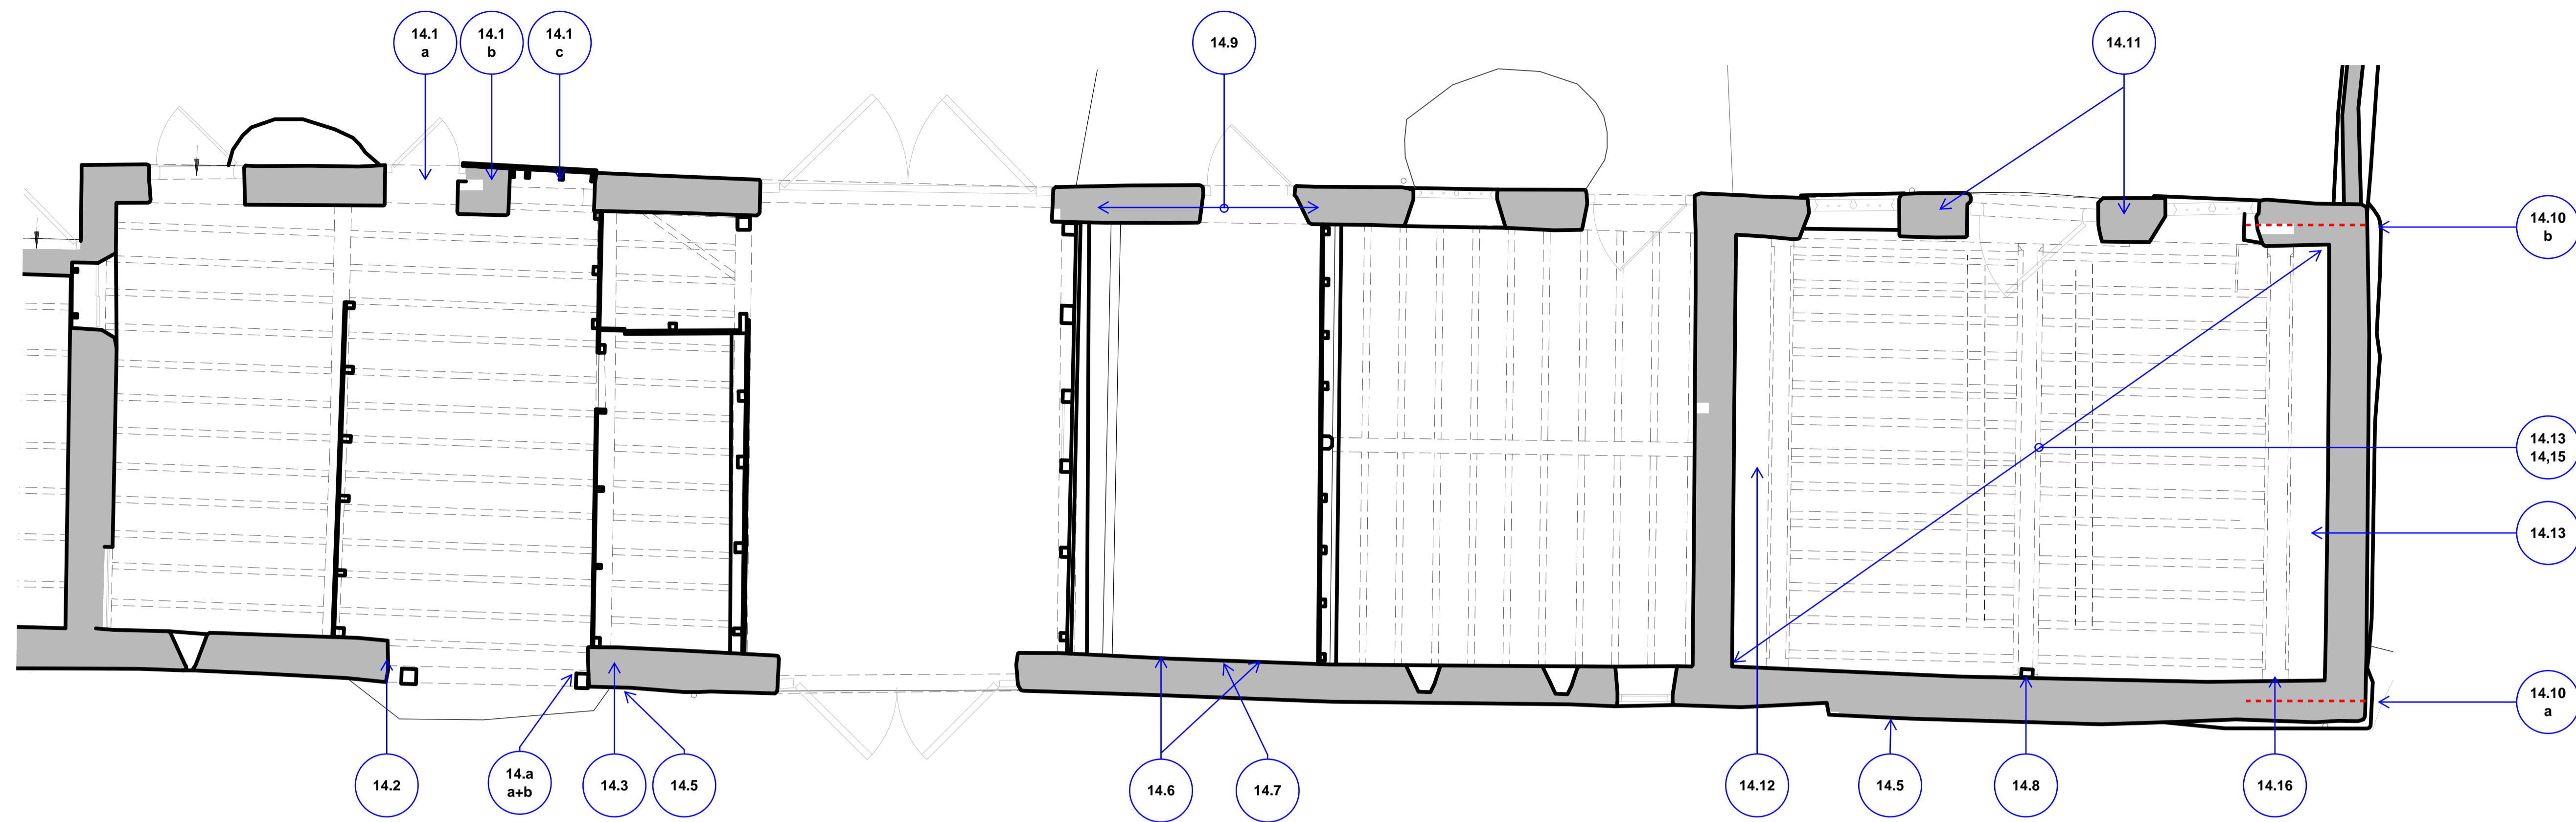
Reference	Defect Description	Photo	Repair Description	Indicative Sketch	Notes
14.14	Joists too slender to support domestic use at first floor.		<ul style="list-style-type: none"> Remove existing partner joists where applicable, and replace with new partners to every joist. Use new oak, grade TH1, minimum 90mm wide x 140mm deep. Connection details for new joists TBC. Provisionally allow for using concealed proprietary joist hangers e.g. Simpson Strongtie ETB90-B or equiv. approved. New joists to be screwed alongside existing bowed joists but set level / not profiled to match. 		<ul style="list-style-type: none"> Recommendations assume that 1st floor gym loading requirements will be no greater than / equiv. to domestic type loading (e.g. use as private exercise / yoga room OK, but not heavy "resistance" machines or dynamic/crowd use). Perimeter of joists hangers potentially require protection with intumescent mastic – TBC.

14.15	3 primary floor beams too slender to support domestic use at first floor		Either introduce props (with foundations) to reduce spans, or strengthen/stiffen beams with heavy steel flitch plates.		<ul style="list-style-type: none"> Propping option is structurally preferable if it can be accommodated architecturally. This is because flitching irreversibly damages the beams, and the plates required will be very heavy (approx. 40mm thick) so installation will be very difficult. Propping will also be more effective. Recommendations assume that 1st floor gym loading requirements will be no greater than / equiv. to domestic type loading (e.g. use as private exercise / yoga room OK, but not heavy "resistance" machines or dynamic/crowd use).

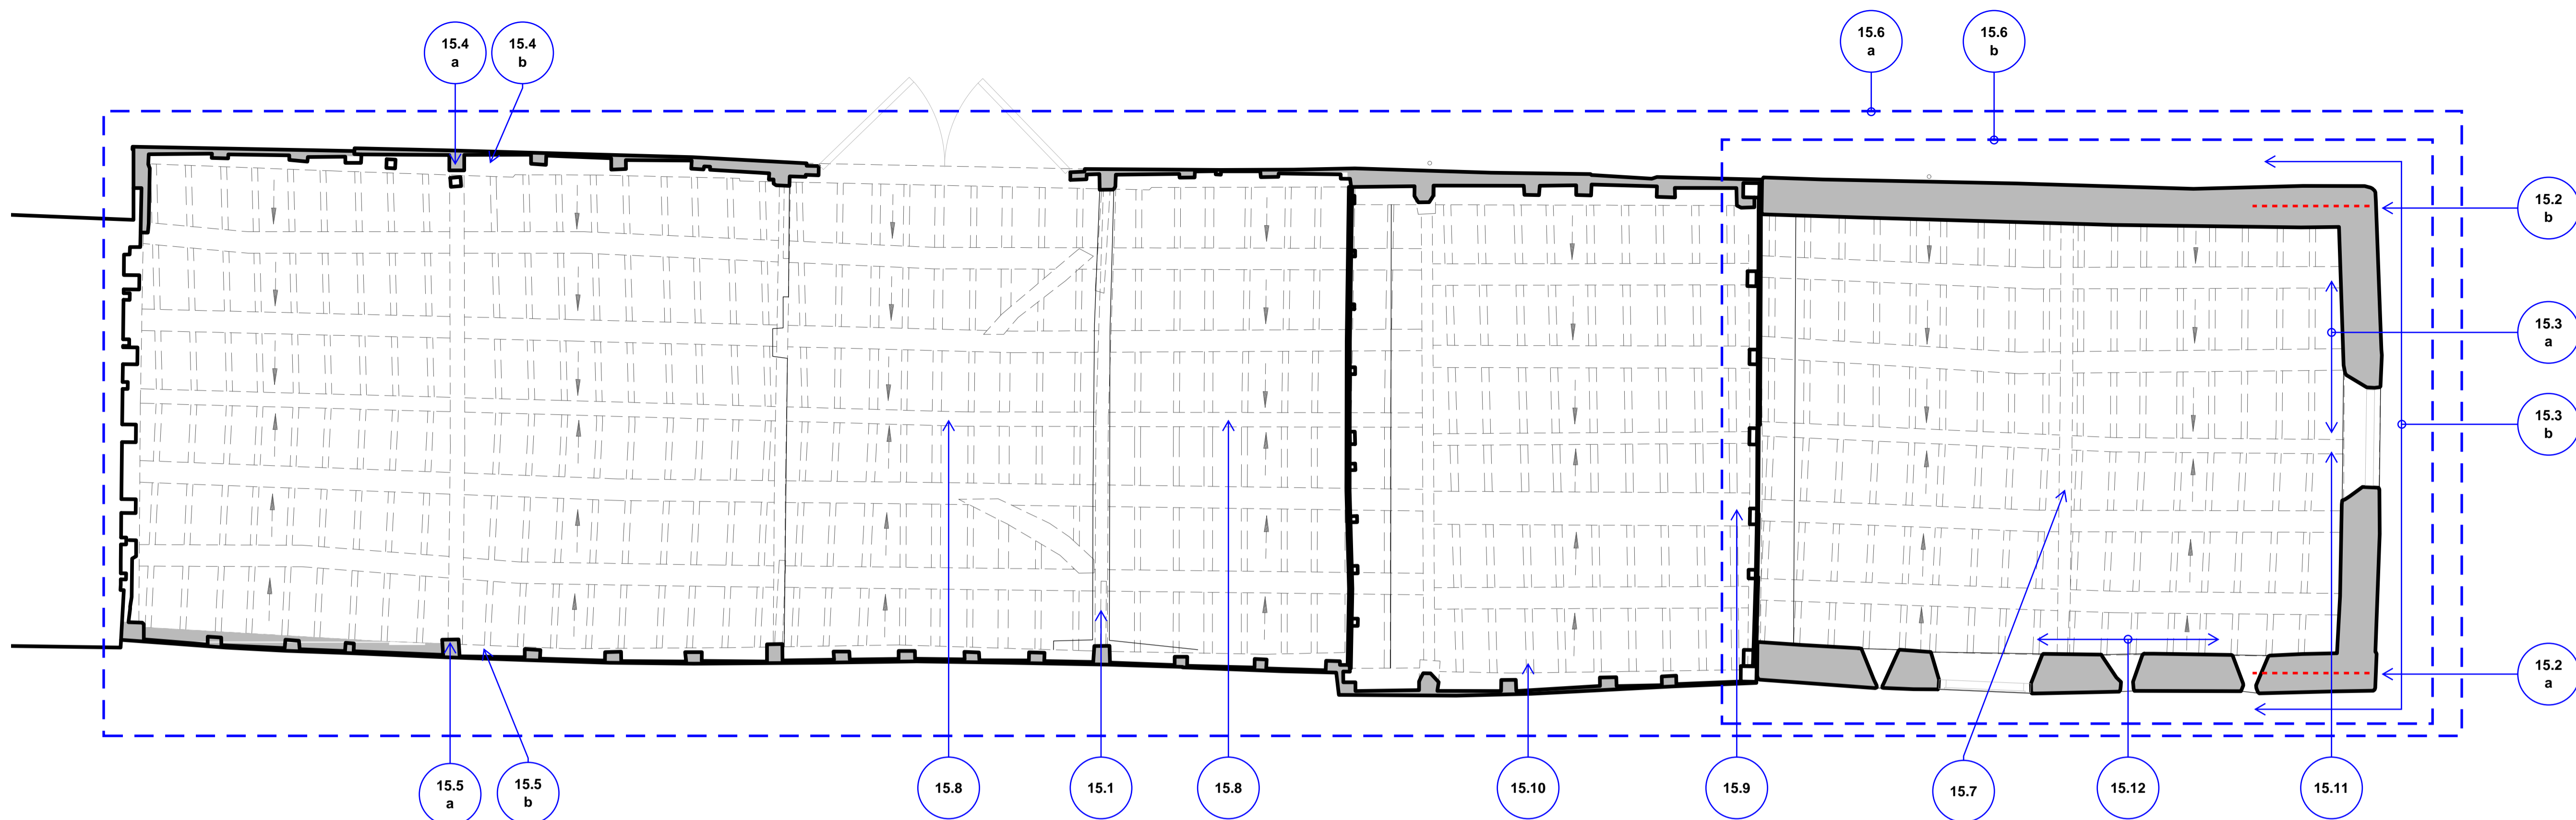
TITLE OUTLINE STRUCTURAL REPAIR PROPOSALS - SHEET 11	PROJECT SOUTH-EAST BARN - ABOVE 1ST FLOOR - PAGE 1/2	STATUS PRELIMINARY	PROJECT 10854	DRAWING SK15-1		REV P1

Reference	Defect Description	Photo	Repair Description	Indicative Sketch	Notes
15.1	Raking strut missing (inadequate modern replacement)		Replace using new or reclaimed oak, section size matching opposing strut. Connect using existing mortice holes / traditional detailing.		<ul style="list-style-type: none"> Screwed & glued half-lap splice joint near one end of new strut probably necessary to enable installation into extg mortice holes.

15.2 a+b	Fractures in front and rear walls where gable end is pulling away.		Cintec anchor wall junctions at both elevations and make good associated cracks by deep raking out and repointing. Loose rubble may require local rebuilding prior to anchoring.		<ul style="list-style-type: none"> Applies to full height of walls. Number and spec of anchors tbc. Anchor heads recessed.

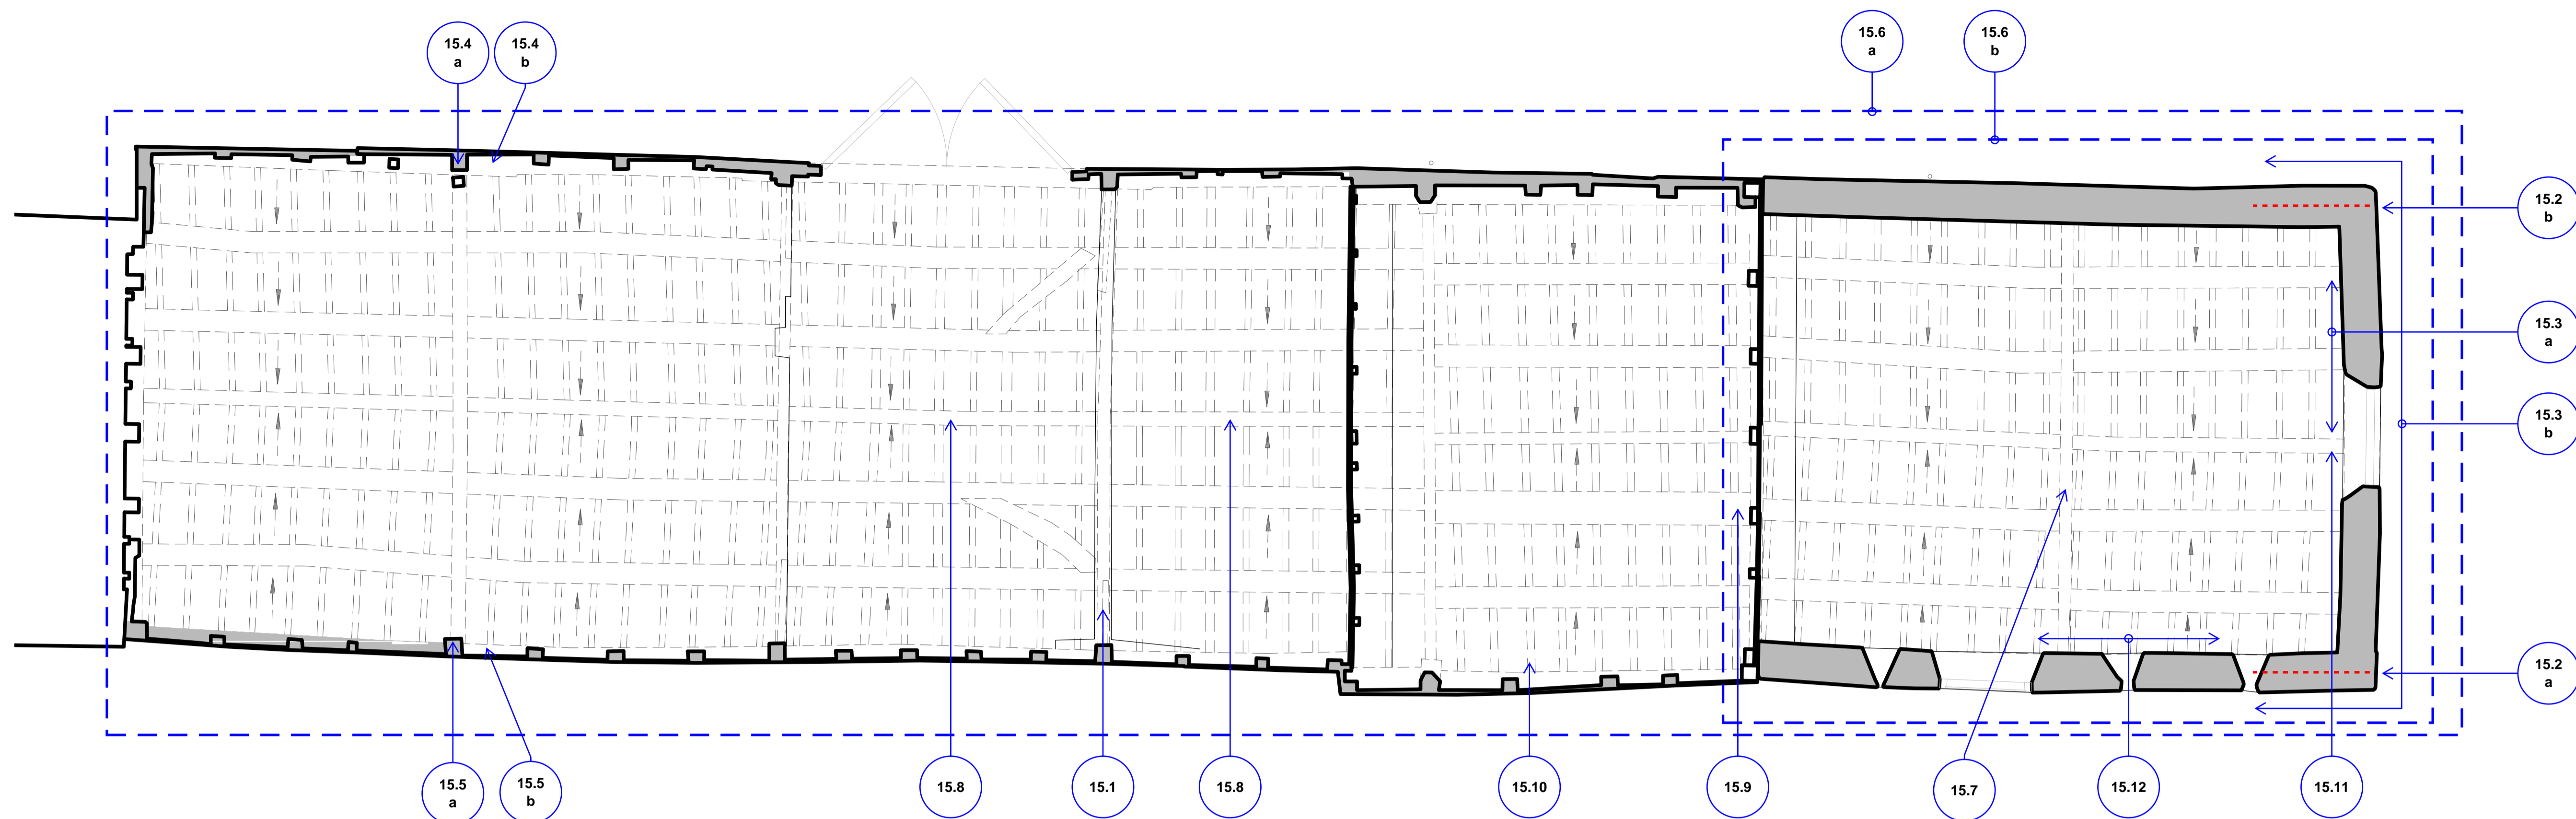
Reference	Defect Description	Photo	Repair Description	Indicative Sketch	Notes
15.6a	Gable end wall leaning & inadequately restrained		<ul style="list-style-type: none"> Full pitched roof to incorporate a 2-layer plywood diaphragm screwed to all rafters to enhance overall structural stiffness and resilience. Also ensure common rafters are well secured to wall plates generally. Strengthen connections (e.g. using Expamet HD9090 brackets) where necessary. 		<ul style="list-style-type: none"> Detailed specs to be developed.

15.6b			Fixings between roof the masonry wall heads to be improved: <ul style="list-style-type: none"> Fixings wall plates at eaves level down into the wall head, provisionally using M12 s/s threaded bar resin anchors @ 0.9m ctrs. Provide a new pitched "wall plate" on the gable end, resin anchored into the wall head (provisionally using M12 s/s threaded bar resin anchors @ 0.6m ctrs) and tied into the new plywood diaphragm. Also resin anchor purlins / ridge beam bearings into wall. Additionally allow for local consolidation of masonry along the gable wall heads. 		<ul style="list-style-type: none"> Detailed specs to be developed. Recommend trial of wall head anchors to ensure wall head not excessively voided, especially on rubble side.
