Aston Hall: Investigation of structural timber elements – South range barns

Site note 1 for March 2021, job no. 153.32

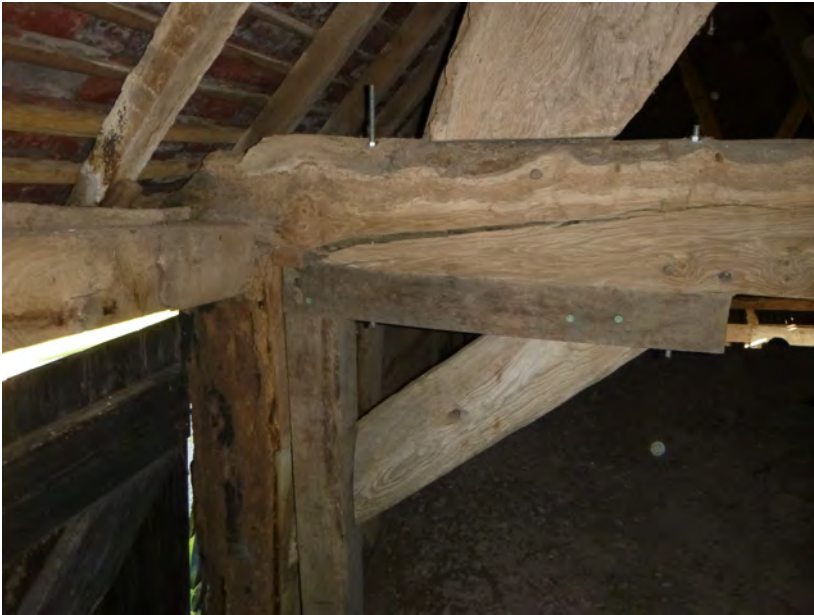
Structural issues were identified at the north and south bearing ends of truss 6 (T6) where persistent water penetration from defective rainwater guttering had caused localised timber decay in the past, and was likely to continue to cause timber decay from both wet rot and wood-boring beetle infestation. This was particularly evident when seen from ground floor below, where introduction of a large concrete pillar formed from concrete blockwork laid face up was supporting the failed wall plate. A

steel angle bracket had been positioned below the tie-beam and stainless steel threaded rods drilled into the beam to fix in position. This method of strengthening the joint may not be structurally sound. A large fracture at the head of the south post had developed suggesting that northwards movement of the tie-beam may be ongoing, and had caused adjacent wall plate jointing, located to the east, to also fail by snapping the retention pins

Bay 7; showing the large fracture in the tie-beam at the north bearing end of truss 6. This was considered most likely a result of failure of structural elements below, particularly in the main post and the supporting plate, primarily from persistent rain water penetration and subsequent decay. Note remediation in the recent past using steel angle bracket, threaded rods, and softwood bracing

No chemical treatment required. Structural Engineer to comment on suitability of previous repairs to tie-beam of truss 6 at north end. Significant strengthening works with steel required to repair head of post at south end of truss 6. Every effort should be made to re-direct water away from the building to prevent further structural decay affecting vulnerable timber elements. Allowance should be made for strengthening/repairing the failing wall plate joints to the east of truss 6 at both the north and south sides

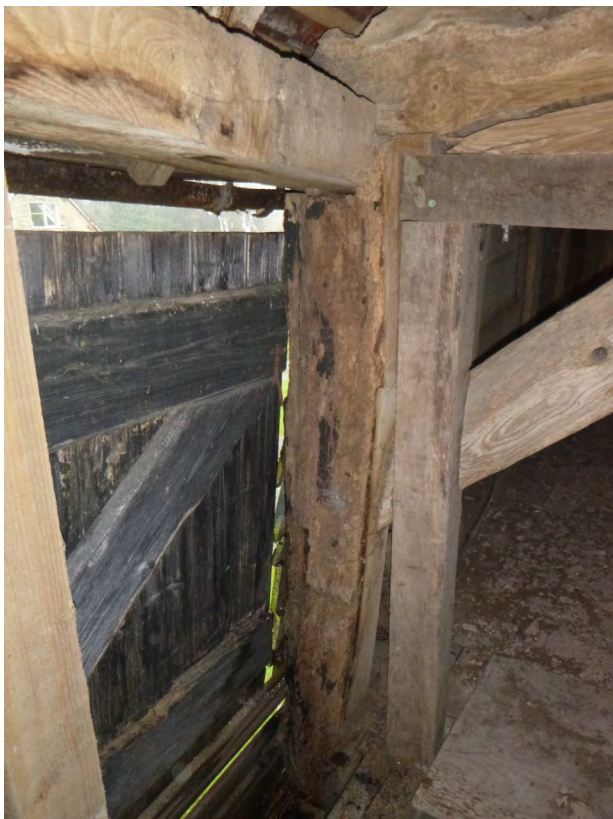
Bay 6; showing failure of the rainwater drainage system at the time of survey resulting in saturation of external cladding and structural timber elements within

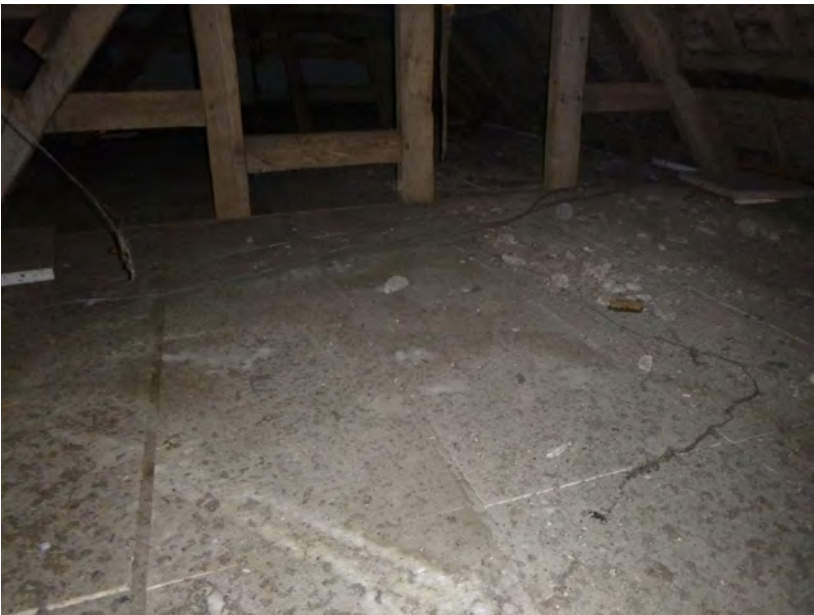
Fig 85:

West part of south barn; showing the extreme west gable end where there were indications of water penetration, but no suggestion of structural timber decay as a result

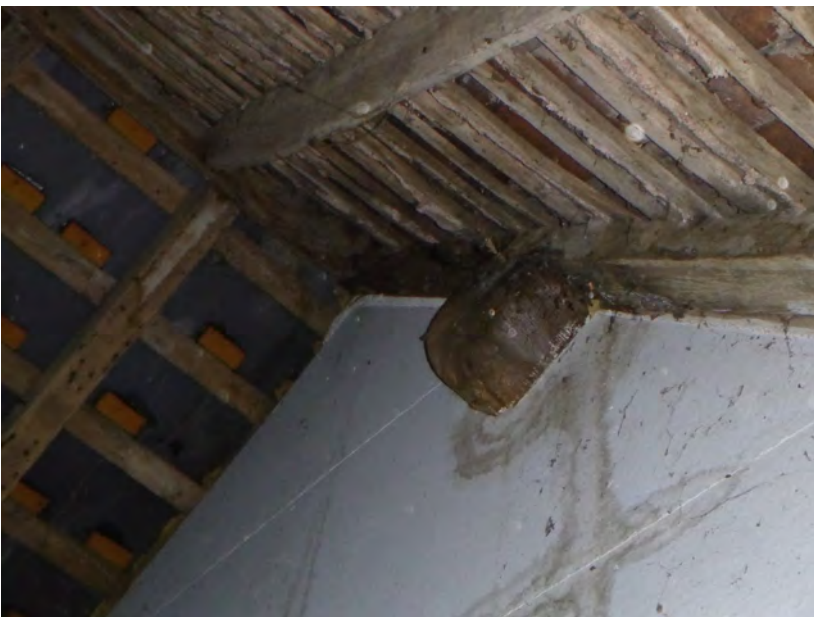
West part of south barn; showing large area of nesting material in south-east corner of roof void, again, limiting ventilation to vulnerable structural timbers and providing the conditions conducive to wood-boring beetle infestation and decay

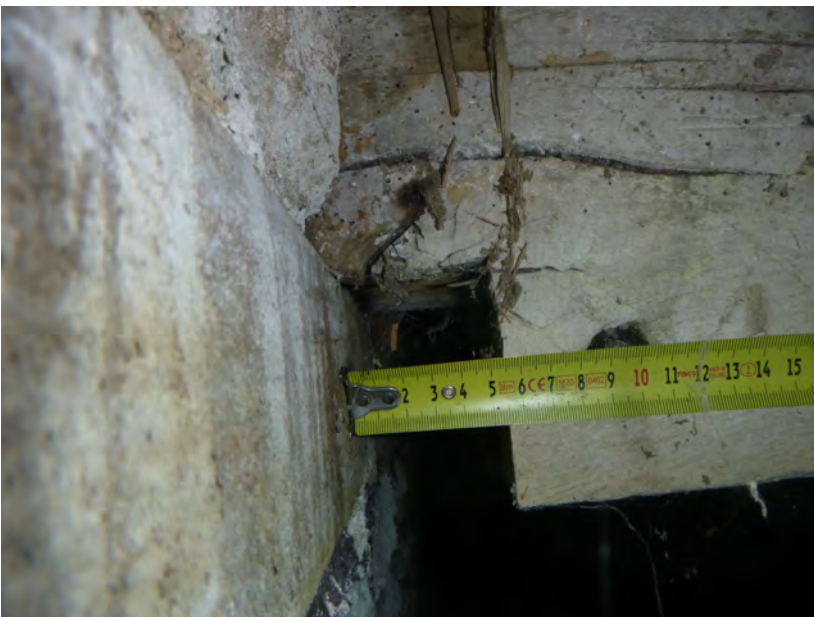
Ground floor; showing one of the decayed lintels on the west side. Note the two-part build-up and decay of the outermost element by wet rot and subsequent wood-boring beetle infestation

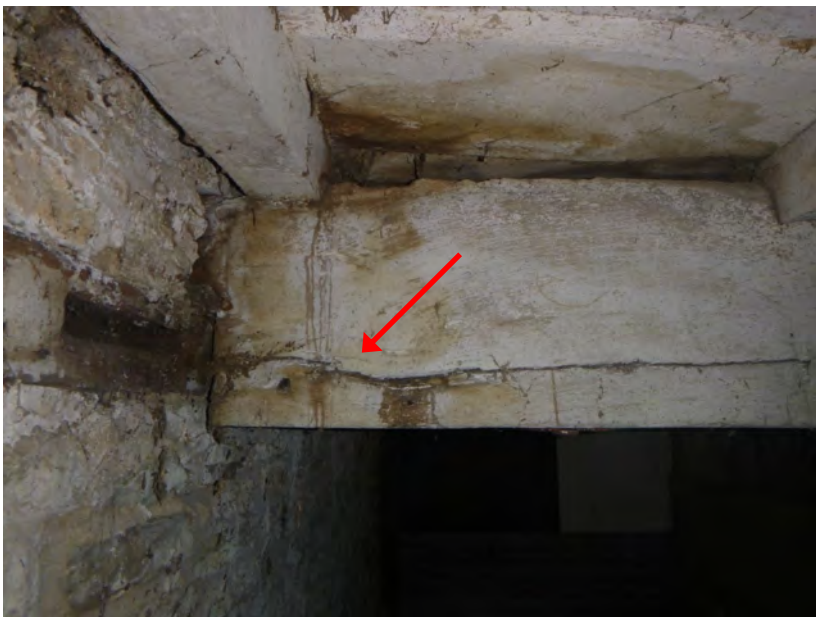
Ground floor; showing another of the decayed lintels on the west side. The innermost section was decayed by active wet rot and wood-boring beetle infestation

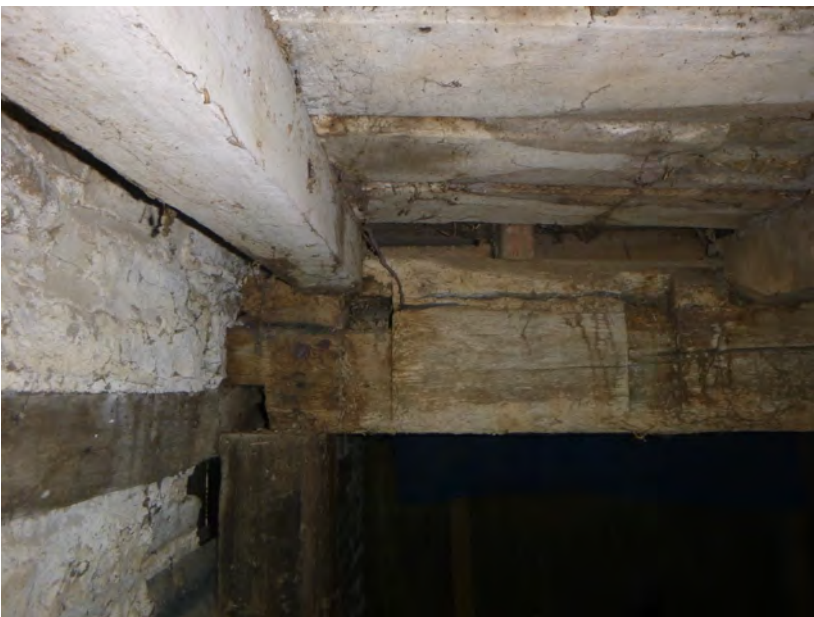
Ground floor; showing opposite side of beam in previous image, with crack clearly evident on both north and south sides

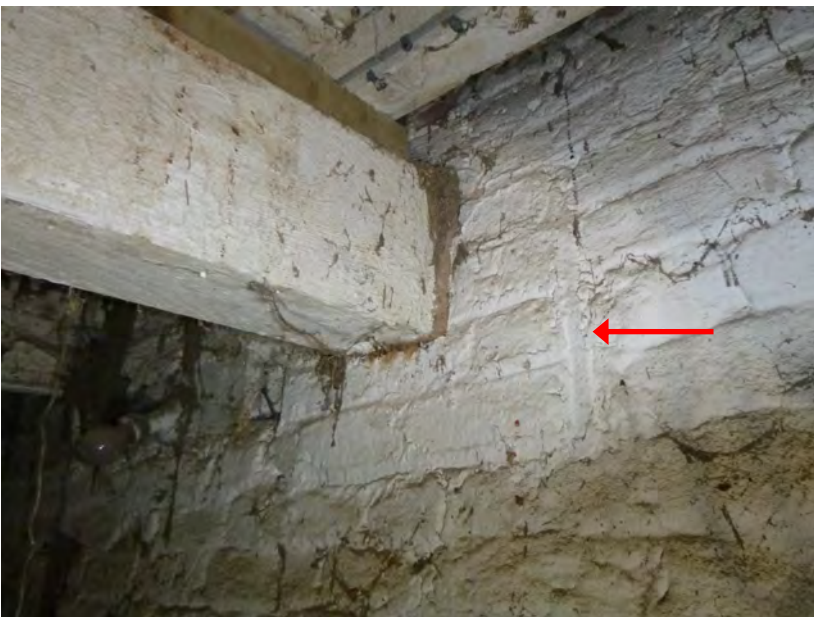
Floor structure; showing timber decay to the base of a supporting timber post of the primary beam in Fig50 above, affecting up to ~50 per cent of the cross section (arrowed)

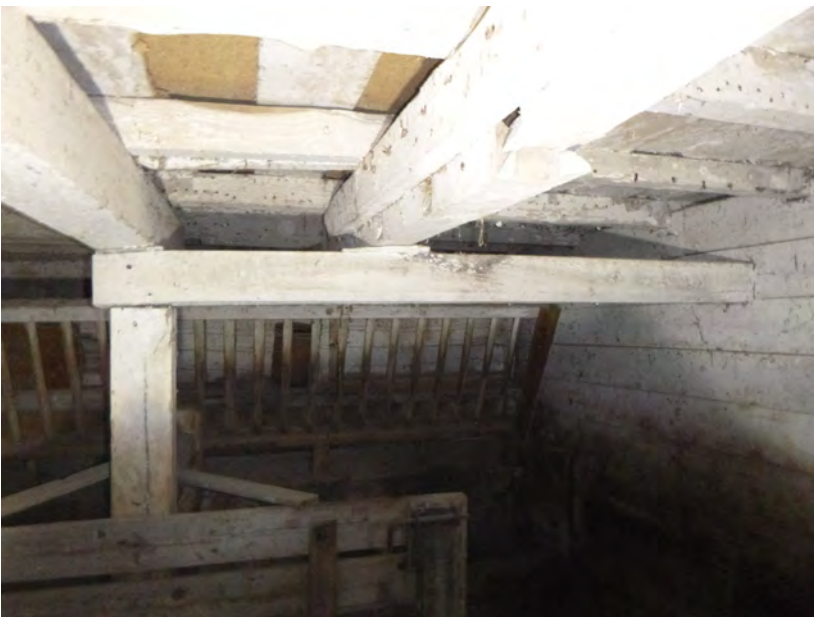
Note this fracture has occurred at an old mortice where the beam is weaker, and has been subject to remedial partner repairs along the face of the beam

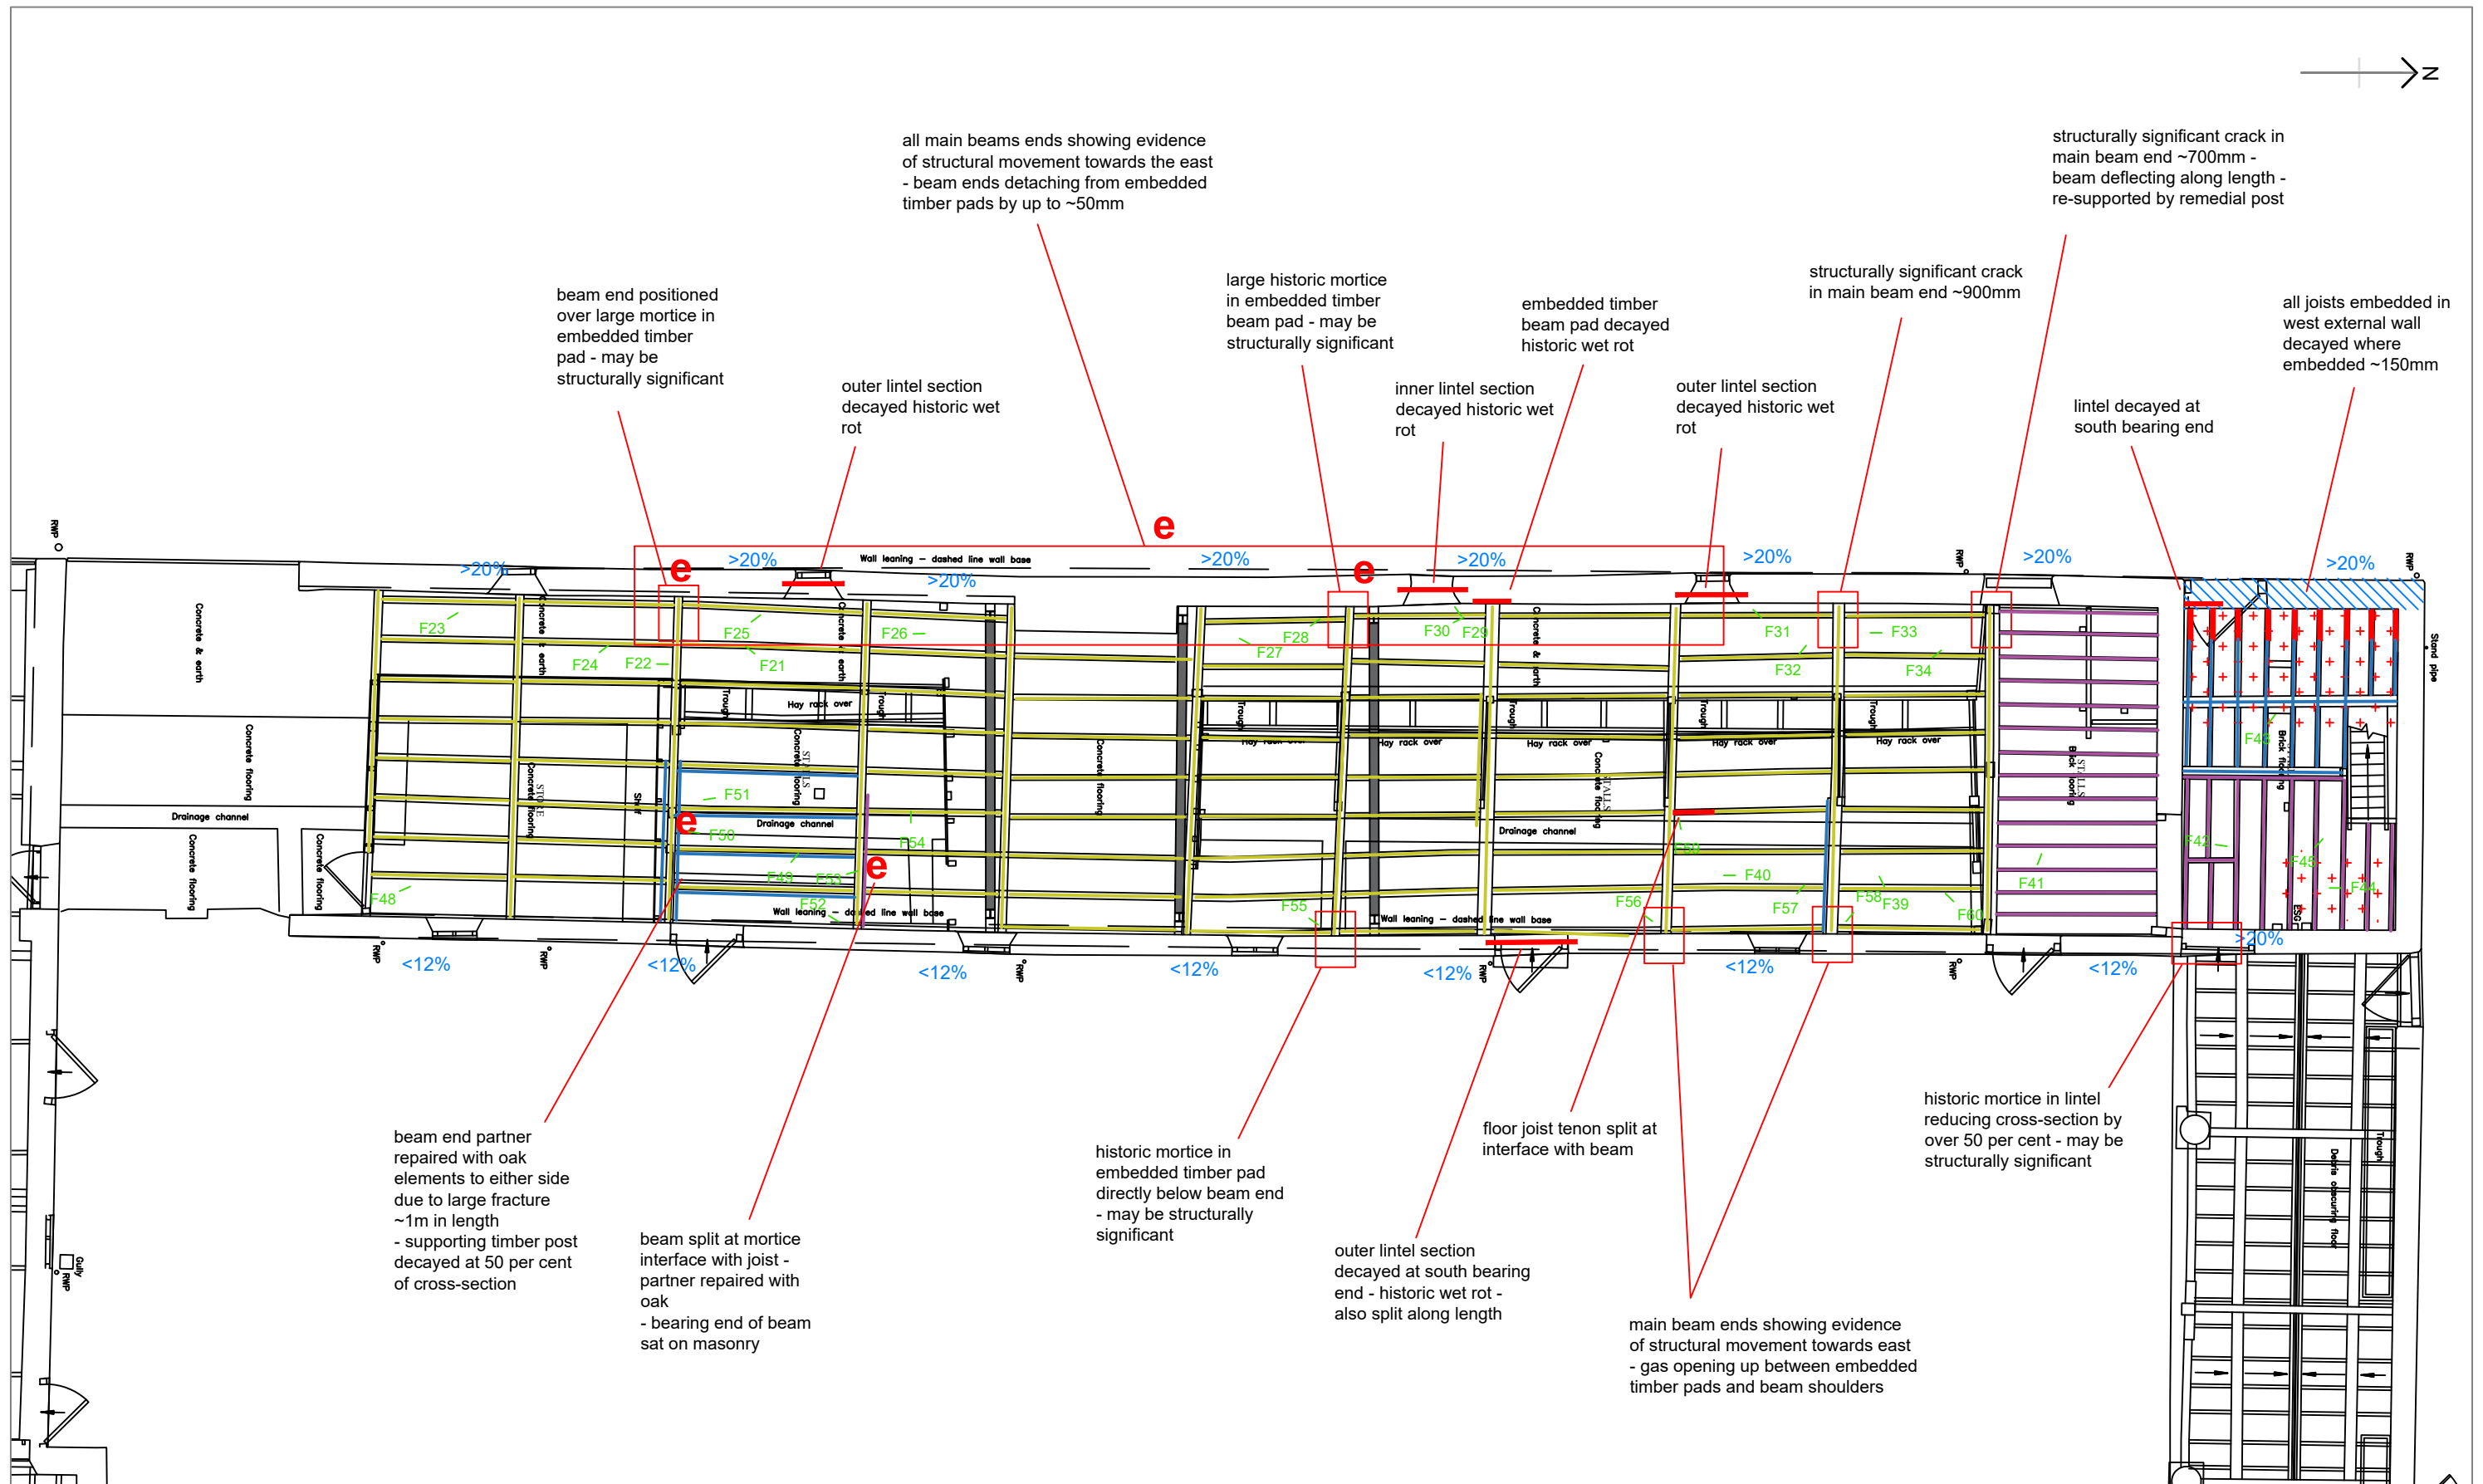
all main beams ends showing evidence of structural movement towards the east - beam ends detaching from embedded timber pads by up to ~50mm

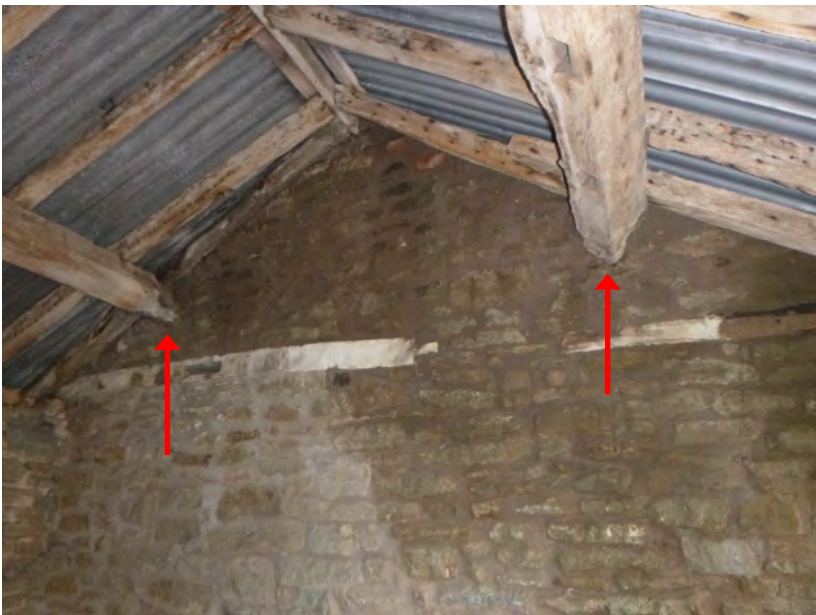
North stable block; showing widespread wood-boring beetle flight holes on post at south eaves of truss 8. No structurally significant timber decay detected on drilling

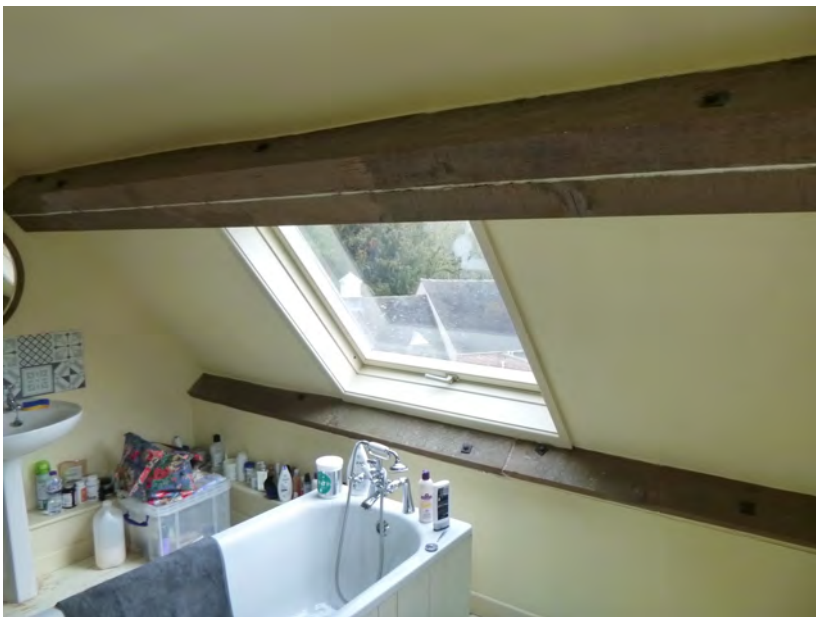
Note roof finishes had likely failed in the past, allowing water penetration providing the conditions for decay to the upper face

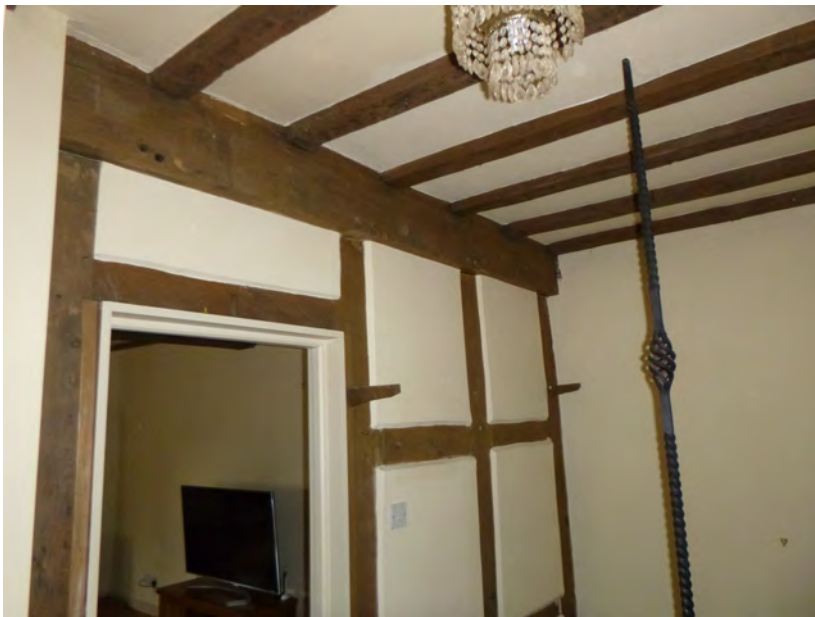
Interior, first floor; showing hairline cracking to plaster near to the timber stud wall. Subtle movement of timbers and the plaster skim finished without a movement gap was thought to be the cause
