# **Tree Condition Report Arboricultural Impact Assessment Tree Protection Plan and Method Statement**

**Land at Aston Hall, Aston Munslow, Shropshire**

**AIA Full (3rd Iteration) 10.9.2021**

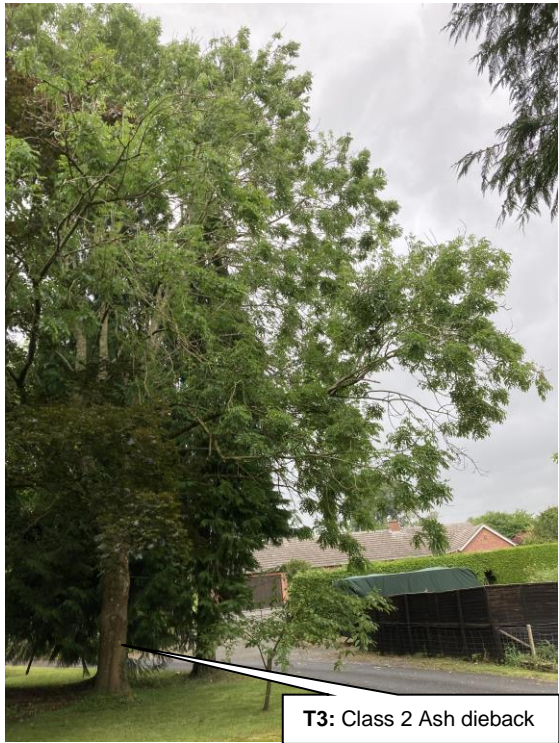
<b>Identification No.</b>	<b>T3</b> not tagged, growing on neighbouring property. No access to neighbouring property.
<b>Species</b>	Common ash <i>Fraxinus excelsior L.</i>
<b>Current Height (M)</b>	22m
<b>Ultimate Height (M)</b>	22m
<b>Current Stem Dia (cm) at 1.5m</b>	60cm estimated
<b>Crown clearance</b>	1m
<b>Crown Spread (M)</b>	Radius N = 2.5m; E = 2.5m; S = 2.5m; W = 2.5m
<b>Growth stage</b>	Mature
<p><b>Tree Condition:</b>  <b>Root:</b> No evidence of soil movement or perennial fungi where visible  <b>Stem:</b> no evidence of bark necrosis where visible  <b>Crown:</b> No evidence of recent breakouts. Infected with Class 2 ash dieback (ADB) 75% to 51% of live foliage remains. Foliage retention estimated at 70% at date of inspection.  <b>Risk assessment:</b> timber embrittlement with advance of disease.  <b>Tree Quality Assessment:</b> Ref.BS5837 (2012) 4.5.1 <b>Category C2:</b> 'trees with limited safe, useful life expectancy, subject to climatic stressors.'  <b>Water Demand NHBC 4.2-B: moderate</b>  <b>Root Protection Area RPA:</b> for tree of 60cm diameter at 1.5m (0.60m x 12) = <b>7.2m Radius</b>  Total RPA required at current stage of growth = 163m<sup>2</sup>  <b>Arboricultural Impact Assessment AIA:</b></p> <ul style="list-style-type: none"> <li>• 20% of the RPA is covered by the existing drive</li> <li>• The proposed new boundary wall, driveway and parking area falls within the extended RPA perimeter</li> <li>• RPA. 'BS 7.7.2.1: The design should not require excavation into the soil, including the lowering of levels and/or scraping, other than the removal, using hand tools, of any turf layer or other surface vegetation'.</li> </ul> <p><b>Method Statement:</b> Construction of new boundary wall, driveway and parking area</p> <ul style="list-style-type: none"> <li>• Advise neighbouring owner of tree condition and potential for collapse onto Aston Hall property and neighbouring Drive</li> </ul>

**T3: Class 2 Ash dieback**

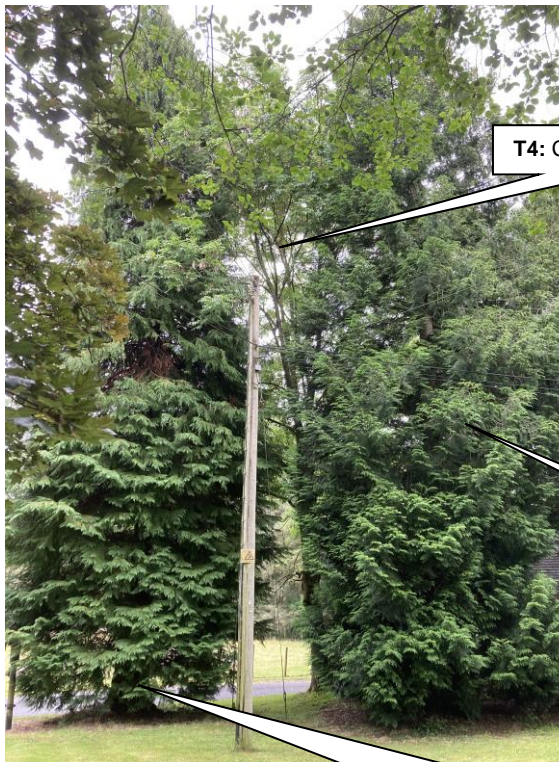
<b>Identification No.</b>	<b>T4</b> growing on neighbouring property. No access to neighbouring property.
<b>Species</b>	Common ash <i>Fraxinus excelsior L.</i>
<b>Current Height (M)</b>	20m
<b>Ultimate Height (M)</b>	22m
<b>Current Stem Dia (cm) at narrowest point below fork</b>	45cm estimated
<b>Crown clearance</b>	4m
<b>Crown Spread (M)</b>	Radius N = 5m; E = 5m; S = 5m; W = 4m
<b>Growth stage</b>	Early-Mature
<p><b>Tree Condition:</b>  <b>Root:</b> No evidence of soil movement or perennial fungi where visible  <b>Stem:</b> no evidence of bark necrosis where visible  <b>Crown:</b> No evidence of recent breakouts. Infected with Class 1 ash dieback (ADB) 100% to 76% of live foliage remains. Foliage retention estimated at 90% at date of inspection.  <b>Risk assessment:</b> timber embrittlement with advance of disease.  <b>Tree Quality Assessment:</b> Ref.BS5837 (2012) 4.5.1 <b>Category C2:</b> 'trees with limited safe, useful life expectancy, subject to climatic stressors.'  <b>Water Demand NHBC 4.2-B: moderate</b>  <b>Root Protection Area RPA:</b> for tree of 45cm diameter at narrowest point below fork (0.45m x 12) = <b>5.4m Radius</b>  Total RPA required at current stage of growth = 92m<sup>2</sup>  <b>Arboricultural Impact Assessment AIA:</b></p> <ul style="list-style-type: none"> <li>• 30% of the RPA is covered by the existing drive</li> <li>• The proposed new boundary wall falls within the extended RPA perimeter.</li> <li>• RPA. 'BS 7.7.2.1: The design should not require excavation into the soil, including the lowering of levels and/or scraping, other than the removal, using hand tools, of any turf layer or other surface vegetation'.</li> <li>• The protective barrier cannot be positioned at the perimeter of the RPA on the south side</li> <li>• Geogrid tiles require a compacted foundation for security and are unsuitable for use within the extended RPA</li> <li>• An above-ground Cellular Confinement System CCS (Raft) will raise the ground level by at least 300mm.</li> <li>• A 3-dimensional No-Dig cellular confinement system (CCS) with a permeable surface is proposed for the new drive section within the RPA e.g., <a href="http://www.geosyn.co.uk/product/cellweb-tree-root-protection">www.geosyn.co.uk/product/cellweb-tree-root-protection</a></li> </ul> <p><b>Method Statement:</b> <u>Construction of new boundary wall, driveway and parking area</u></p> <ul style="list-style-type: none"> <li>• Utilize a metal railing boundary fence to avoid strip foundation within the extended RPA.</li> <li>• Excavate post holes with a soil auger to minimise root damage within the extended RPA.</li> <li>• Utilize dry-mix concrete to minimise root damage from alkaloids in wet concrete mix.</li> <li>• Ramping on and off the above-ground CCS section must be constructed outside of the RPA</li> <li>• The CCS should be designed by an engineer to carry the maximum anticipated loading for site construction traffic and future use</li> <li>• The CCS must be constructed before vehicles cross the RPA using the 'rolling out' system of installation.</li> <li>• The permeable surface within the RPA and compensatory area should be protected with a temporary sacrificial surface laid over a geotextile separator to ensure permeability is retained (i.e., interstices should not become blocked by the passage of construction vehicles). No excavation for haunching is permitted on side of the CCS closest to the tree/s within the RPA. The CCS edge must be supported e.g., by above-ground retaining boards/blocks secured with road pins to minimise damage to the lateral roots.</li> <li>• Install section of Heras fence as indicated on Tree Protection plan. Specification as recommended in BS5837 (2012) Fig 3 appended.</li> </ul>

**T4: Class 1 Ash dieback**

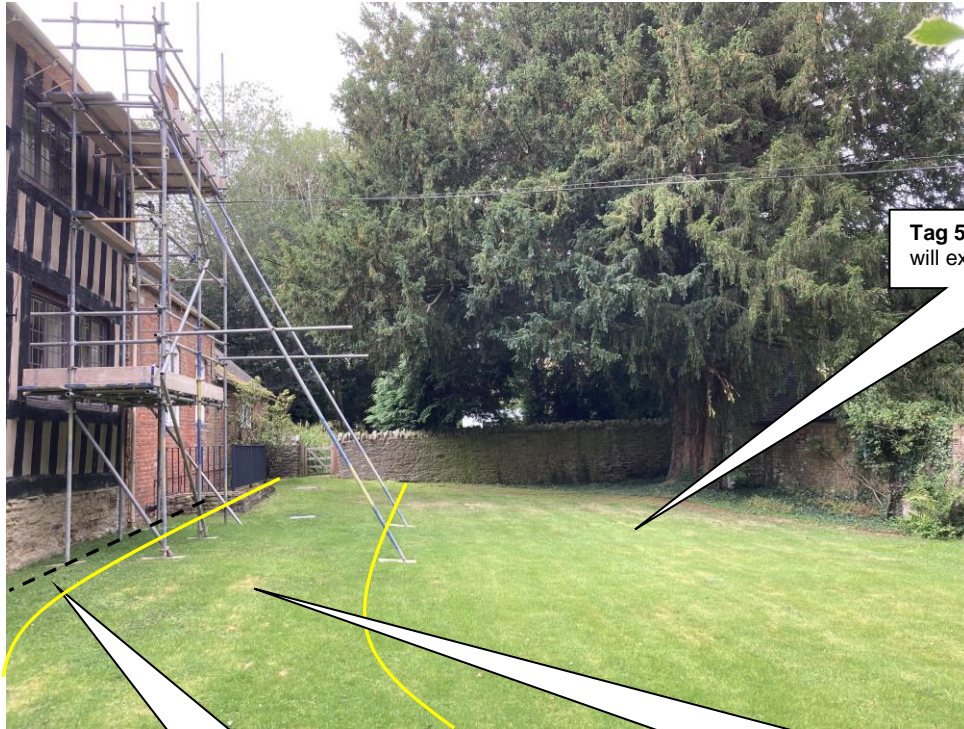
<b>Identification No.</b>	<b>Tag 541</b>
<b>Species</b>	Common yew <i>Taxus baccata L.</i>
<b>Current Height (M)</b>	18m
<b>Ultimate Height (M)</b>	18m
<b>Current Stem Dia (cm) at 1.5m</b>	46+86cm
<b>Crown clearance</b>	3m
<b>Crown Spread (M)</b>	Radius N = 7m; E = 8m; S = 5m; W = 10m
<b>Growth stage</b>	Mature
<p><b>Tree Condition:</b>  <b>Root:</b> No evidence of soil movement or perennial fungi  <b>Stem:</b> no evidence of bark necrosis  <b>Crown:</b> No evidence of recent breakouts or dieback  <b>Evaluation:</b> adequate annual shoot extension, foliage retention, colour and density are indicative of the tree maintaining vitality to grow in the prevailing conditions  <b>Tree Quality Assessment:</b> Ref.BS5837 (2012) 4.5.1 <b>Category A2, A1:</b> 'trees, groups or woodlands of visual importance in a semi-formal landscape'. <b>Safe, Useful, Life expectancy &gt;40 years</b>  <b>Water Demand NHBC 4.2-B: Moderate</b>  <b>Root Protection Area RPA:</b> for tree of 46+86cm diameter at 1.5m <math>\sqrt{(0.46^2 + 0.86^2)} \times 12 = 11.7\text{m}</math>. <b>Radius</b>  Total RPA required at current stage of growth = 430m<sup>2</sup>  <b>Arboricultural Impact Assessment AIA:</b></p> <ul style="list-style-type: none"> <li>• The proposed new boundary wall, driveway and parking area fall within the extended RPA perimeter</li> <li>• Lateral rooting will have been constrained by the presence of the boundary wall and outbuilding foundation.</li> <li>• The majority of roots will extend over the grass area.</li> <li>• FWD, SWD pipes, stopcock and inspection covers fall within the extended RPA.</li> <li>• The existing FWD is not up to standard and must be replaced.</li> <li>• It is proposed to blank off the existing system and install the new pipework situated close to the Hall side elevation to minimise trench excavation damage to the root system, while retaining access for drain maintenance.</li> <li>• A 3-dimensional No-Dig cellular confinement system (CCS) with a permeable surface is proposed for the new drive section within the RPA e.g., <a href="http://www.geosyn.co.uk/product/cellweb-tree-root-protection">www.geosyn.co.uk/product/cellweb-tree-root-protection</a></li> </ul> <p><b>Method Statement:</b> <u>Construction of new boundary wall, driveway and parking area</u></p> <ul style="list-style-type: none"> <li>• Utilize a metal railing boundary fence to avoid strip foundation within the extended RPA.</li> <li>• Excavate post holes with a soil auger to minimise root damage within the extended RPA.</li> <li>• Utilize dry-mix concrete to minimise root damage from alkaloids in wet concrete mix.</li> <li>• Ramping on and off the above-ground CCS section must be constructed outside of the RPA</li> <li>• The CCS should be designed by an engineer to carry the maximum anticipated loading for site construction traffic and future use</li> <li>• The CCS must be constructed before vehicles cross the RPA using the 'rolling out' system of installation.</li> <li>• The permeable surface within the RPA and compensatory area should be protected with a temporary sacrificial surface laid over a geotextile separator to ensure permeability is retained (i.e., interstices should not become blocked by the passage of construction vehicles). No excavation for haunching is permitted on side of the CCS closest to the tree/s within the RPA. The CCS edge must be supported e.g., by above-ground retaining boards/blocks secured with road pins to minimise damage to the lateral roots.</li> <li>• Install section of Heras fence as indicated on Tree Protection plan. Specification as recommended in BS5837 (2012) Fig 3 appended.</li> </ul>

**Tag 541:** The majority of roots will extend over the grass area.

**New FWD/SWD route**

**Existing FWD/SWD route to be sealed and covered with an above ground Cellular Confinement System raft to form the new main access Drive**

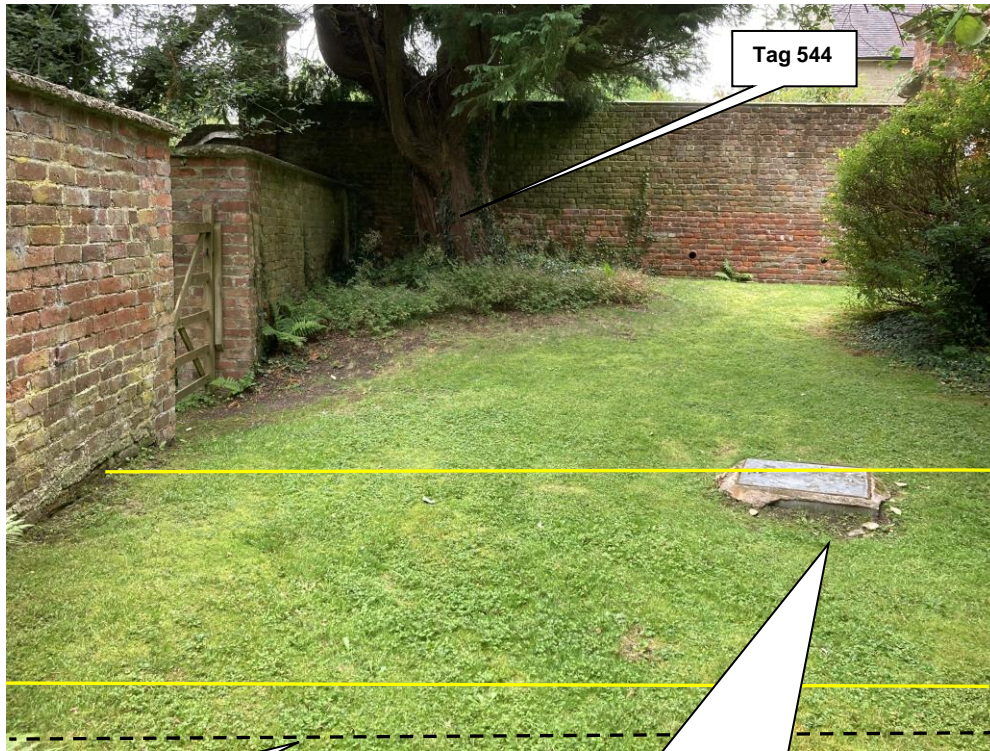
**Tag 544**

<b>Identification No.</b>	<b>Tag 544</b>
<b>Species</b>	Lawson cypress <i>Chamaecyparis lawsoniana</i> (Murr.) Parl.
<b>Current Height (M)</b>	18m
<b>Ultimate Height (M)</b>	18m
<b>Current Stem Dia (cm) at 1.5m</b>	54+68cm
<b>Crown clearance</b>	2m
<b>Crown Spread (M)</b>	Radius N = 3m; E = 3m; S = 3m; W = 3m
<b>Growth stage</b>	Mature
<p><b>Tree Condition:</b>  <b>Root:</b> No evidence of soil movement or perennial fungi  <b>Stem:</b> no evidence of bark necrosis  <b>Crown:</b> No evidence of recent breakouts or dieback  <b>Evaluation:</b> adequate annual shoot extension, foliage retention, colour and density are indicative of the tree maintaining vitality to grow in the prevailing conditions  <b>Tree Quality Assessment:</b> Ref.BS5837 (2012) 4.5.1 <b>Category A2:</b> 'trees, groups or woodlands of visual importance in a semi-formal landscape'. <b>Safe, Useful, Life expectancy &gt;40 years</b>  <b>Water Demand NHBC 4.2-B: High</b>  <b>Root Protection Area RPA:</b> for tree of 54+68cm diameter at 1.5m <math>\sqrt{(0.54^2 + 0.68^2)} \times 12 = 10.4m</math>. <b>Radius</b>  Total RPA required at current stage of growth = 340m<sup>2</sup>  <b>Arboricultural Impact Assessment AIA:</b></p> <ul style="list-style-type: none"> <li>• The proposed new drainage system falls outside the RPA.</li> <li>• The proposed new driveway falls within the extended RPA perimeter</li> <li>• Lateral rooting will have been constrained by the presence of the boundary walls.</li> <li>• The majority of roots will extend over the grass area.</li> <li>• Existing FWD, SWD pipes and inspection covers fall within the extended RPA.</li> <li>• The existing FWD is not up to standard and must be replaced.</li> <li>• It is proposed to blank off the existing system and install the new pipework situated at the extent of the RPA to minimise trench excavation damage to the root system, while retaining access for drain maintenance.</li> <li>• A 3-dimensional No-Dig cellular confinement system (CCS) with a permeable surface is proposed for the new drive section within the RPA e.g., <a href="http://www.geosyn.co.uk/product/cellweb-tree-root-protection">www.geosyn.co.uk/product/cellweb-tree-root-protection</a></li> </ul> <p><b>Method Statement:</b> <u>Construction of new boundary wall, driveway and parking area</u></p> <ul style="list-style-type: none"> <li>• Ramping on and off the above-ground CCS section must be constructed outside of the RPA</li> <li>• The CCS should be designed by an engineer to carry the maximum anticipated loading for site construction traffic and future use</li> <li>• The CCS must be constructed before vehicles cross the RPA using the 'rolling out' system of installation.</li> <li>• The permeable surface within the RPA and compensatory area should be protected with a temporary sacrificial surface laid over a geotextile separator to ensure permeability is retained (i.e., interstices should not become blocked by the passage of construction vehicles). No excavation for haunching is permitted on side of the CCS closest to the tree/s within the RPA. The CCS edge must be supported e.g., by above-ground retaining boards/blocks secured with road pins to minimise damage to the lateral roots.</li> <li>• Install section of Heras fence set back within the RPA as indicated on Tree Protection plan. Specification as recommended in BS5837 (2012) Fig 3 appended.</li> </ul>

**New FWD/SWD route**

**Existing FWD/SWD route to be sealed and covered with an above ground Cellular Confinement System raft to form the new main access Drive**

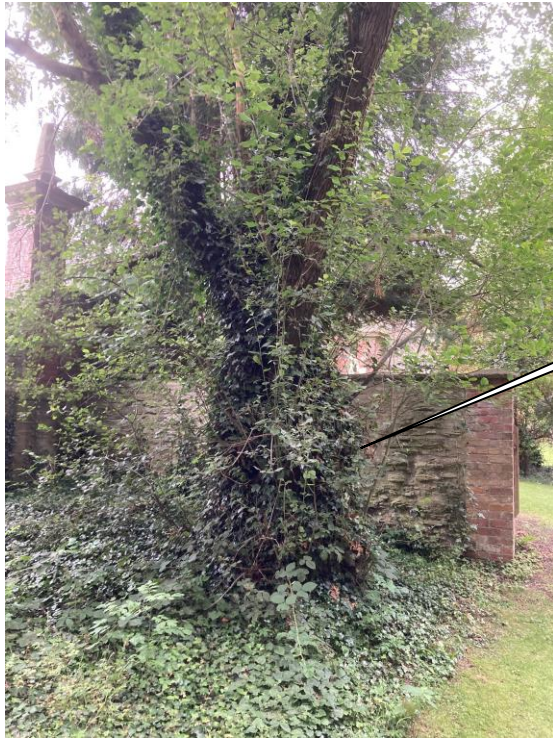
Tag 545

<b>Identification No.</b>	<b>Tag 545</b>
<b>Species</b>	Goat willow <i>Salix caprea</i> L.
<b>Current Height (M)</b>	16m
<b>Ultimate Height (M)</b>	16m
<b>Current Stem Dia (cm) at narrowest point below fork</b>	70cm estimated
<b>Crown clearance</b>	2m
<b>Crown Spread (M)</b>	Radius N = 8m; E = 4m; S = 5m; W = 6m
<b>Growth stage</b>	Mature
<p><b>Tree Condition:</b>  <b>Root:</b> No evidence of soil movement  <b>Stem:</b> Obscured by ivy and sucker growth  <b>Crown:</b> No evidence of recent breakouts or dieback  <b>Evaluation:</b> adequate annual shoot extension, foliage retention, colour and density are indicative of the tree maintaining vitality to grow in the prevailing conditions  <b>Tree Quality Assessment:</b> Ref.BS5837 (2012) 4.5.1 <b>Category B2:</b> 'trees occurring as collectives but situated as to make little visual contribution to the wider locality <b>Safe, Useful, Life expectancy &gt;20 years</b>  <b>Water Demand NHBC 4.2-B: High</b>  <b>Root Protection Area RPA:</b> for tree of 70cm diameter at narrowest point below fork (0.70m x 12) = <b>8.4m Radius</b>  Total RPA required at current stage of growth = 222m<sup>2</sup>  <b>Arboricultural Impact Assessment AIA:</b></p> <ul style="list-style-type: none"> <li>• The proposed new drainage system falls outside the RPA.</li> <li>• The proposed new driveway falls within the extended RPA perimeter</li> <li>• Lateral rooting will have been constrained by the presence of the boundary walls.</li> <li>• The majority of roots will extend over the grass area.</li> <li>• Existing FWD, SWD pipes and inspection covers fall within the extended RPA.</li> <li>• The existing FWD is not up to standard and must be replaced.</li> <li>• It is proposed to blank off the existing system and install the new pipework situated at the extent of the RPA to minimise trench excavation damage to the root system, while retaining access for drain maintenance.</li> <li>• A 3-dimensional No-Dig cellular confinement system (CCS) with a permeable surface is proposed for the new drive section within the RPA e.g., <a href="http://www.geosyn.co.uk/product/cellweb-tree-root-protection">www.geosyn.co.uk/product/cellweb-tree-root-protection</a></li> </ul> <p><b>Method Statement:</b> <u>Construction of new boundary wall, driveway and parking area</u></p> <ul style="list-style-type: none"> <li>• Ramping on and off the above-ground CCS section must be constructed outside of the RPA</li> <li>• The CCS should be designed by an engineer to carry the maximum anticipated loading for site construction traffic and future use</li> <li>• The CCS must be constructed before vehicles cross the RPA using the 'rolling out' system of installation.</li> <li>• The permeable surface within the RPA and compensatory area should be protected with a temporary sacrificial surface laid over a geotextile separator to ensure permeability is retained (i.e., interstices should not become blocked by the passage of construction vehicles). No excavation for haunching is permitted on side of the CCS closest to the tree/s within the RPA. The CCS edge must be supported e.g., by above-ground retaining boards/blocks secured with road pins to minimise damage to the lateral roots.</li> <li>• Install section of Heras fence set back within the RPA as indicated on Tree Protection plan. Specification as recommended in BS5837 (2012) Fig 3 appended.</li> </ul>

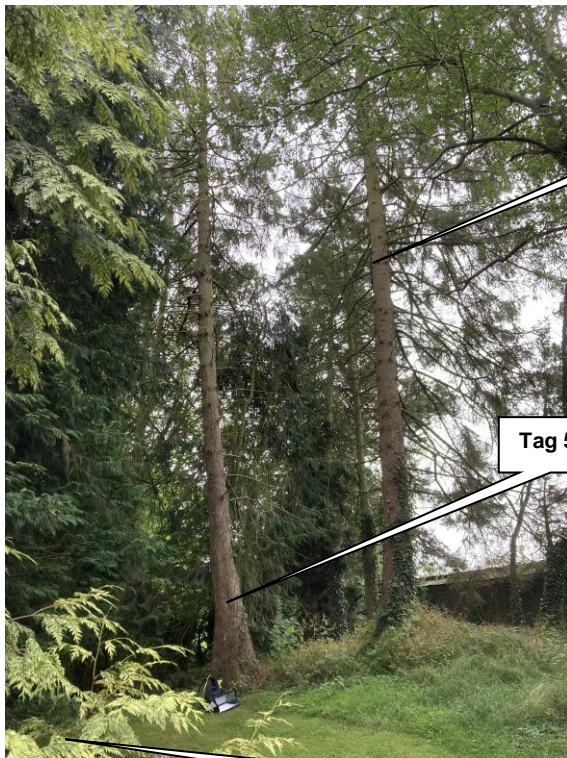
Tag 546

<b>Identification No.</b>	<b>Tag 546</b>
<b>Species</b>	Norway spruce <i>Picea abies</i> (L.) Karst.
<b>Current Height (M)</b>	20m
<b>Ultimate Height (M)</b>	20m
<b>Current Stem Dia (cm) at 1.5m</b>	55cm
<b>Crown clearance</b>	3m
<b>Crown Spread (M)</b>	Radius N = 4m; E = 2m; S = 4m; W = 4m
<b>Growth stage</b>	Mature
<p><b>Tree Condition:</b>  <b>Root:</b> No evidence of soil movement  <b>Stem:</b> no evidence of stem bleeds  <b>Crown:</b> No evidence of recent breakouts or dieback  <b>Evaluation:</b> adequate annual shoot extension, foliage retention, colour and density are indicative of the tree maintaining vitality to grow in the prevailing conditions  <b>Tree Quality Assessment:</b> Ref.BS5837 (2012) 4.5.1 <b>Category B2:</b> 'trees occurring as collectives but situated as to make little visual contribution to the wider locality <b>Safe, Useful, Life expectancy &gt;20 years</b>  <b>Water Demand NHBC 4.2-B: Moderate</b>  <b>Root Protection Area RPA:</b> for tree of 55cm diameter at 1.5m (0.55 x 12) = <b>6.6m Radius</b>  Total RPA required at current stage of growth = 137m<sup>2</sup>  <b>Arboricultural Impact Assessment AIA:</b></p> <ul style="list-style-type: none"> <li>• The proposed new drainage system falls outside the RPA.</li> <li>• The proposed new driveway falls within the RPA perimeter</li> <li>• A 3-dimensional No-Dig cellular confinement system (CCS) with a permeable surface is proposed for the new drive section within the RPA e.g., <a href="http://www.geosyn.co.uk/product/cellweb-tree-root-protection">www.geosyn.co.uk/product/cellweb-tree-root-protection</a></li> </ul> <p><b>Method Statement:</b> <u>Construction of new boundary wall, driveway and parking area</u></p> <ul style="list-style-type: none"> <li>• Ramping on and off the above-ground CCS section must be constructed outside of the RPA</li> <li>• The CCS should be designed by an engineer to carry the maximum anticipated loading for site construction traffic and future use</li> <li>• The CCS must be constructed before vehicles cross the RPA using the 'rolling out' system of installation.</li> <li>• The permeable surface within the RPA and compensatory area should be protected with a temporary sacrificial surface laid over a geotextile separator to ensure permeability is retained (i.e., interstices should not become blocked by the passage of construction vehicles). No excavation for haunching is permitted on side of the CCS closest to the tree/s within the RPA. The CCS edge must be supported e.g., by above-ground retaining boards/blocks secured with road pins to minimise damage to the lateral roots.</li> <li>• Install section of Heras fence set back within the RPA as indicated on Tree Protection plan. Specification as recommended in BS5837 (2012) Fig 3 appended.</li> </ul>

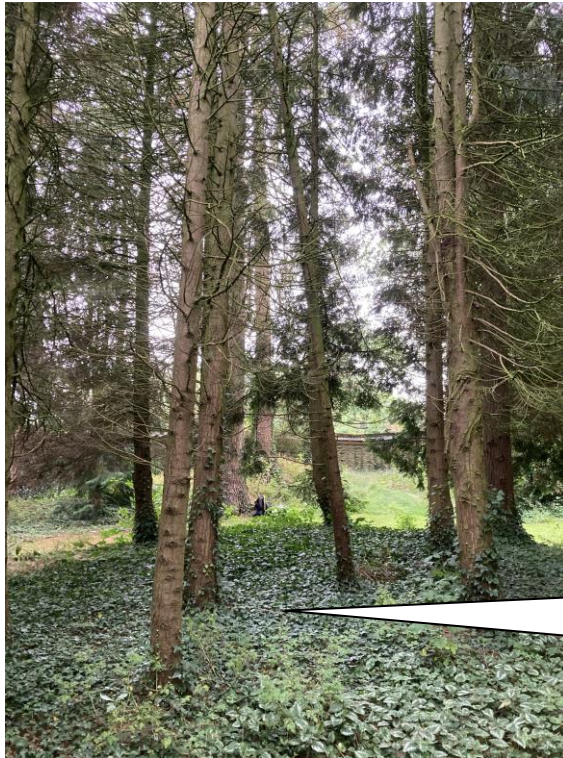
<b>Identification No.</b>	<b>G1</b> group of 10 trees
<b>Species</b>	Lawson cypress <i>Chamaecyparis lawsoniana</i> (Murr.) Parl.
<b>Current Height (M)</b>	16m
<b>Ultimate Height (M)</b>	20m
<b>Current Stem Dia (cm) at 1.5m</b>	12cm average of 10 trees
<b>Crown clearance</b>	3m
<b>Crown Spread (M)</b>	Radius N = 1m; E = 1m; S = 1m; W = 1m
<b>Growth stage</b>	Young
<p><b>Tree Condition:</b>  <b>Root:</b> No evidence of soil movement  <b>Stem:</b> no evidence of stem bleeds  <b>Crown:</b> No evidence of recent breakouts or dieback  <b>Evaluation:</b> adequate annual shoot extension, foliage retention, colour and density are indicative of the tree maintaining vitality to grow in the prevailing conditions  <b>Tree Quality Assessment:</b> Ref.BS5837 (2012) 4.5.1 <b>Category B2:</b> 'trees occurring as collectives but situated as to make little visual contribution to the wider locality <b>Safe, Useful, Life expectancy &gt;20 years</b>  <b>Water Demand NHBC 4.2-B: Moderate</b>  <b>Root Protection Area RPA:</b> for tree of 12cm diameter at 1.5m (0.12 x 12) = <b>1.4m Radius</b>  Total RPA required at current stage of growth = 6m<sup>2</sup> /tree  <b>Arboricultural Impact Assessment AIA:</b></p> <ul style="list-style-type: none"> <li>• The majority of stems fall within the footprint of the proposed new driveway</li> <li>• RPA. 'BS 7.7.2.1: The design should not require excavation into the soil, including the lowering of levels and/or scraping, other than the removal, using hand tools, of any turf layer or other surface vegetation'.</li> </ul> <p><b>Method Statement:</b> <u>Construction of new driveway</u></p> <ul style="list-style-type: none"> <li>• The group of trees is proposed for removal by the developer and replacements included in the new native woodland planting.</li> </ul>

**G1 and all trees in the conifer plantation:**  
Propose to remove all trees and utilise the area currently occupied by the conifer plantation for the construction of the new main access drive using a conventional foundation

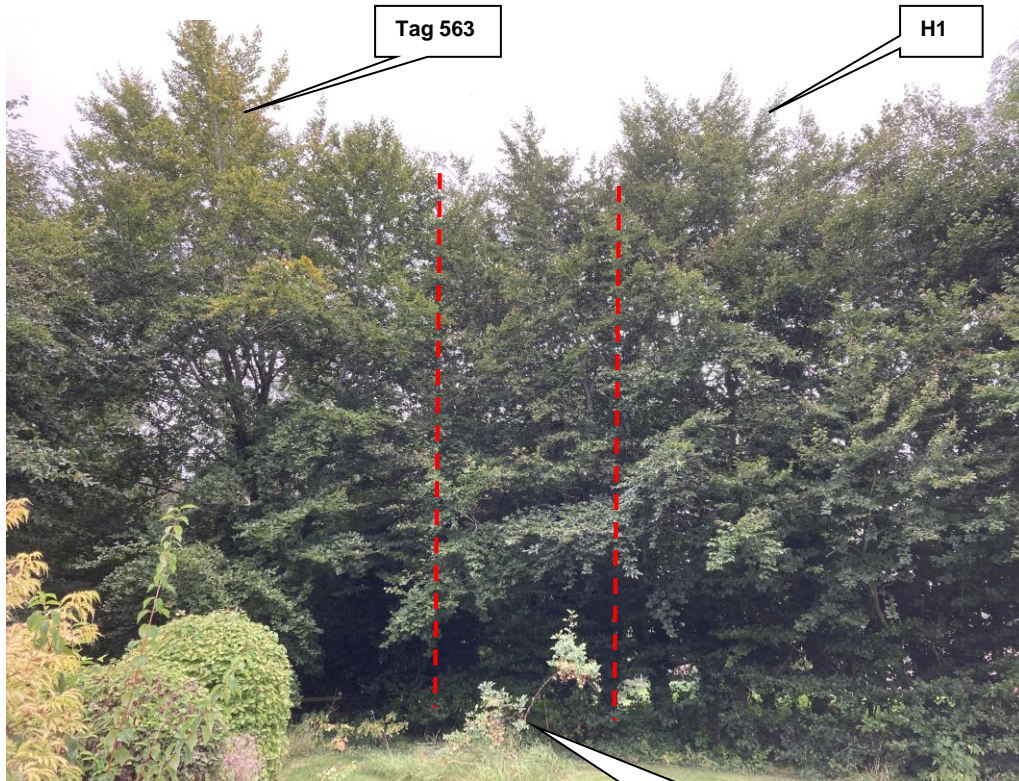
<b>Identification No.</b>	<b>H1: 45m of lapsed hedge</b>
<b>Species</b>	Common beech <i>Fagus sylvatica L.</i> Common ash <i>Fraxinus excelsior L.</i>
<b>Current Height (M)</b>	14m
<b>Ultimate Height (M)</b>	20m
<b>Current Stem Dia (cm) at 1.5m</b>	35cm largest stem
<b>Crown clearance</b>	2m
<b>Crown Spread (M)</b>	Radius N = 5m; E = 1m; S = 5m; W = 1m
<b>Growth stage</b>	Young
<p><b>Tree Condition:</b>  <b>Root:</b> No evidence of soil movement  <b>Stem:</b> no evidence of bark necrosis  <b>Crown:</b> No evidence of recent breakouts or significant dieback. No evidence of ADB  <b>Evaluation:</b> adequate annual shoot extension, foliage retention, colour and density are indicative of the tree maintaining vitality to grow in the prevailing conditions  <b>Tree Quality Assessment:</b> Ref.BS5837 (2012) 4.5.1 <b>Category B2:</b> 'trees occurring as collectives but situated as to make little visual contribution to the wider locality <b>Safe, Useful, Life expectancy &gt;20 years</b>  <b>Water Demand NHBC 4.2-B: Moderate</b>  <b>Root Protection Area RPA:</b> for tree of 35cm diameter at 1.5m (0.35 x 12) = <b>4.2m Radius</b>  Total RPA required at current stage of growth = 55m<sup>2</sup> /tree  <b>Arboricultural Impact Assessment AIA:</b></p> <ul style="list-style-type: none"> <li>• The proposed new drainage route bisects H1 at the northern end</li> <li>• 4 trees are proposed for removal to allow 3m width for trench excavation</li> <li>• The remaining trees fall outside the proposed new driveway footprint</li> <li>• RPA. 'BS 7.7.2.1: The design should not require excavation into the soil, including the lowering of levels and/or scraping, other than the removal, using hand tools, of any turf layer or other surface vegetation'.</li> </ul> <p><b>Method Statement:</b> <u>Construction of new drainage route</u></p> <ul style="list-style-type: none"> <li>• Install the section of Heras fence barrier, positioned as indicated on the tree protection plan. Specification as recommended in BS5837 (2012) fig 3 appended</li> </ul>

**H1: 3m width proposed for removal to accommodate new FWD/SWD route**
