MOSSLEY

Stuart Baxter
Kerr Baxter and Associates
Conc: Sauchiehall Street and Rose Street

27 February 2014

Rose St and Sauchiehall Street

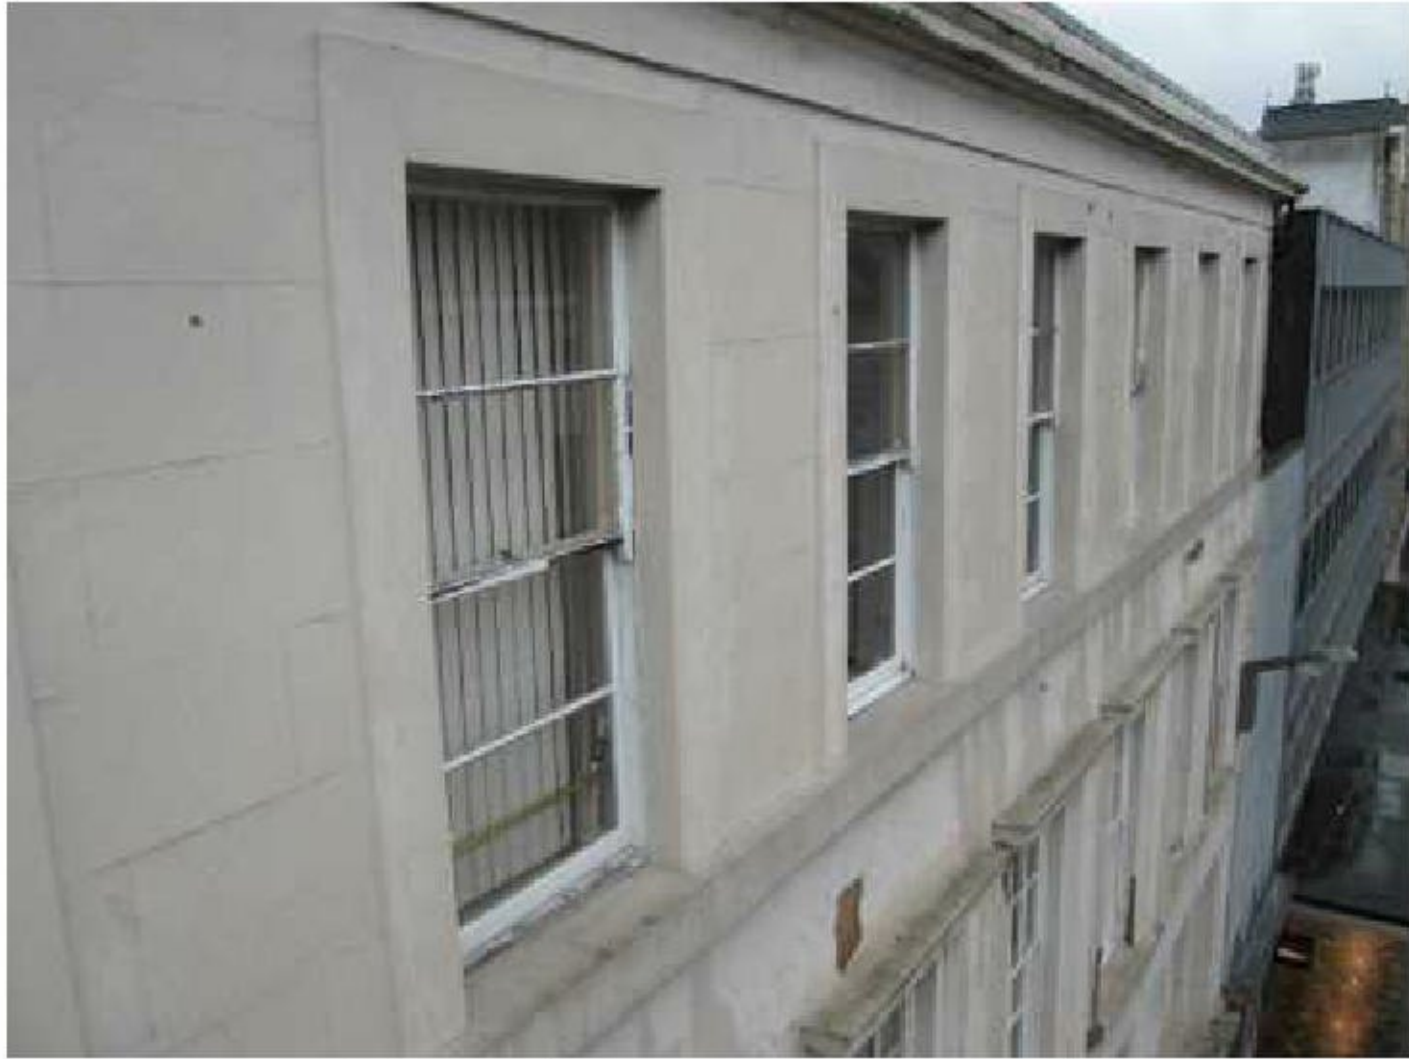
Upon close inspection and hammer testing it is obvious that numerous cement render repairs have been applied in the past both at 3rd and 1st floor levels.

High Level Cement Render Repairs

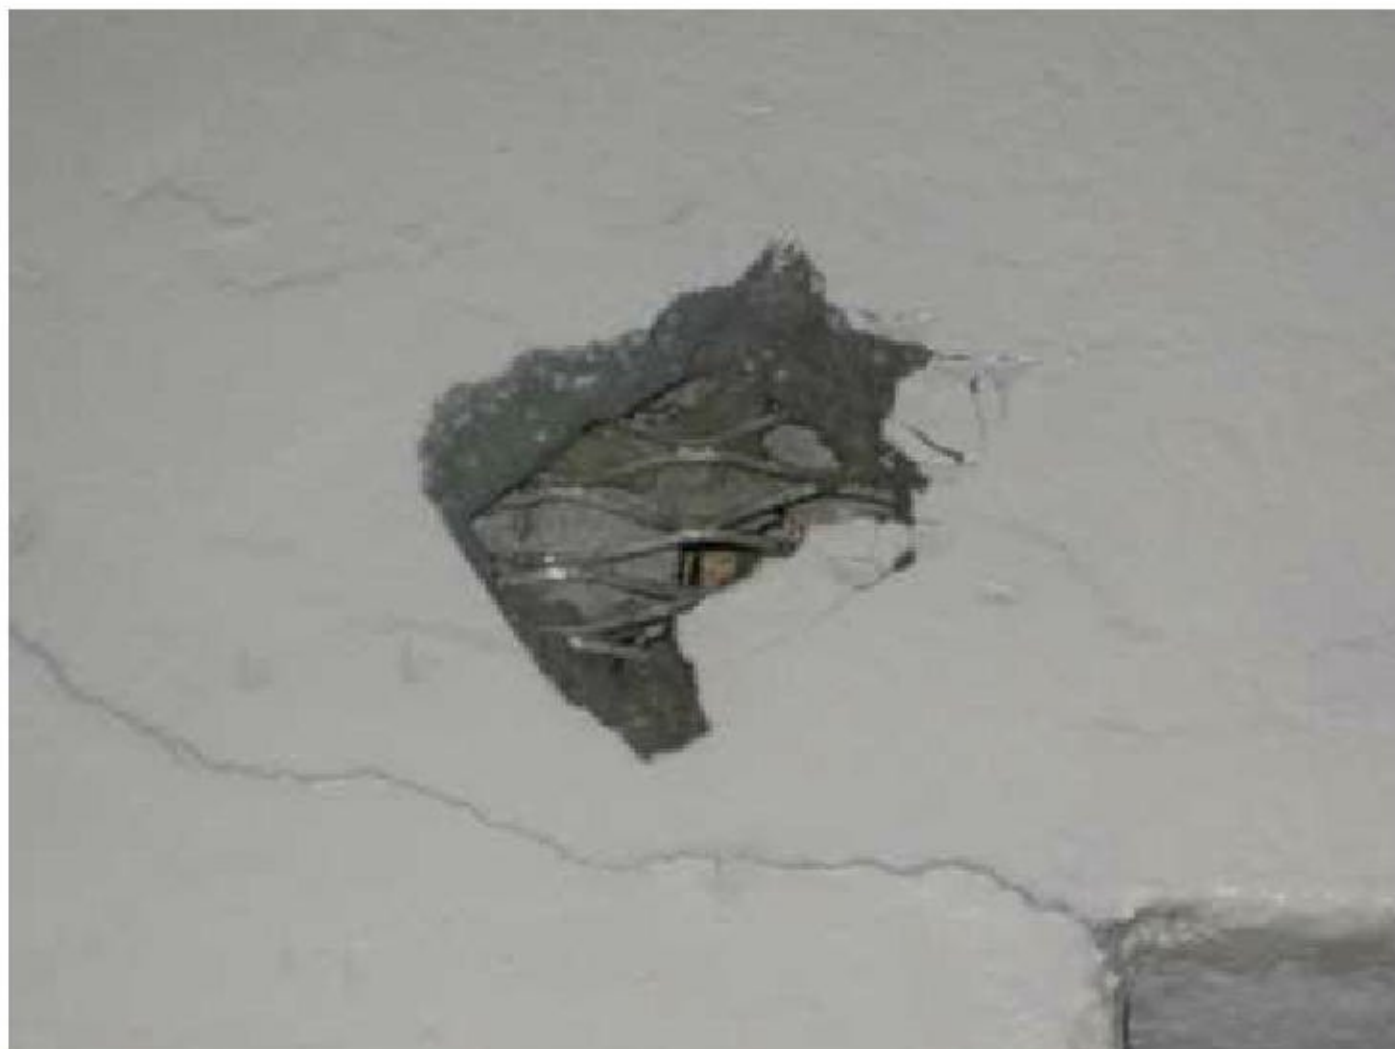
The existing render appears to be applied onto a galvanised mesh which has been fixed to the underlying sandstone.

Evidence of Galvanised Mesh

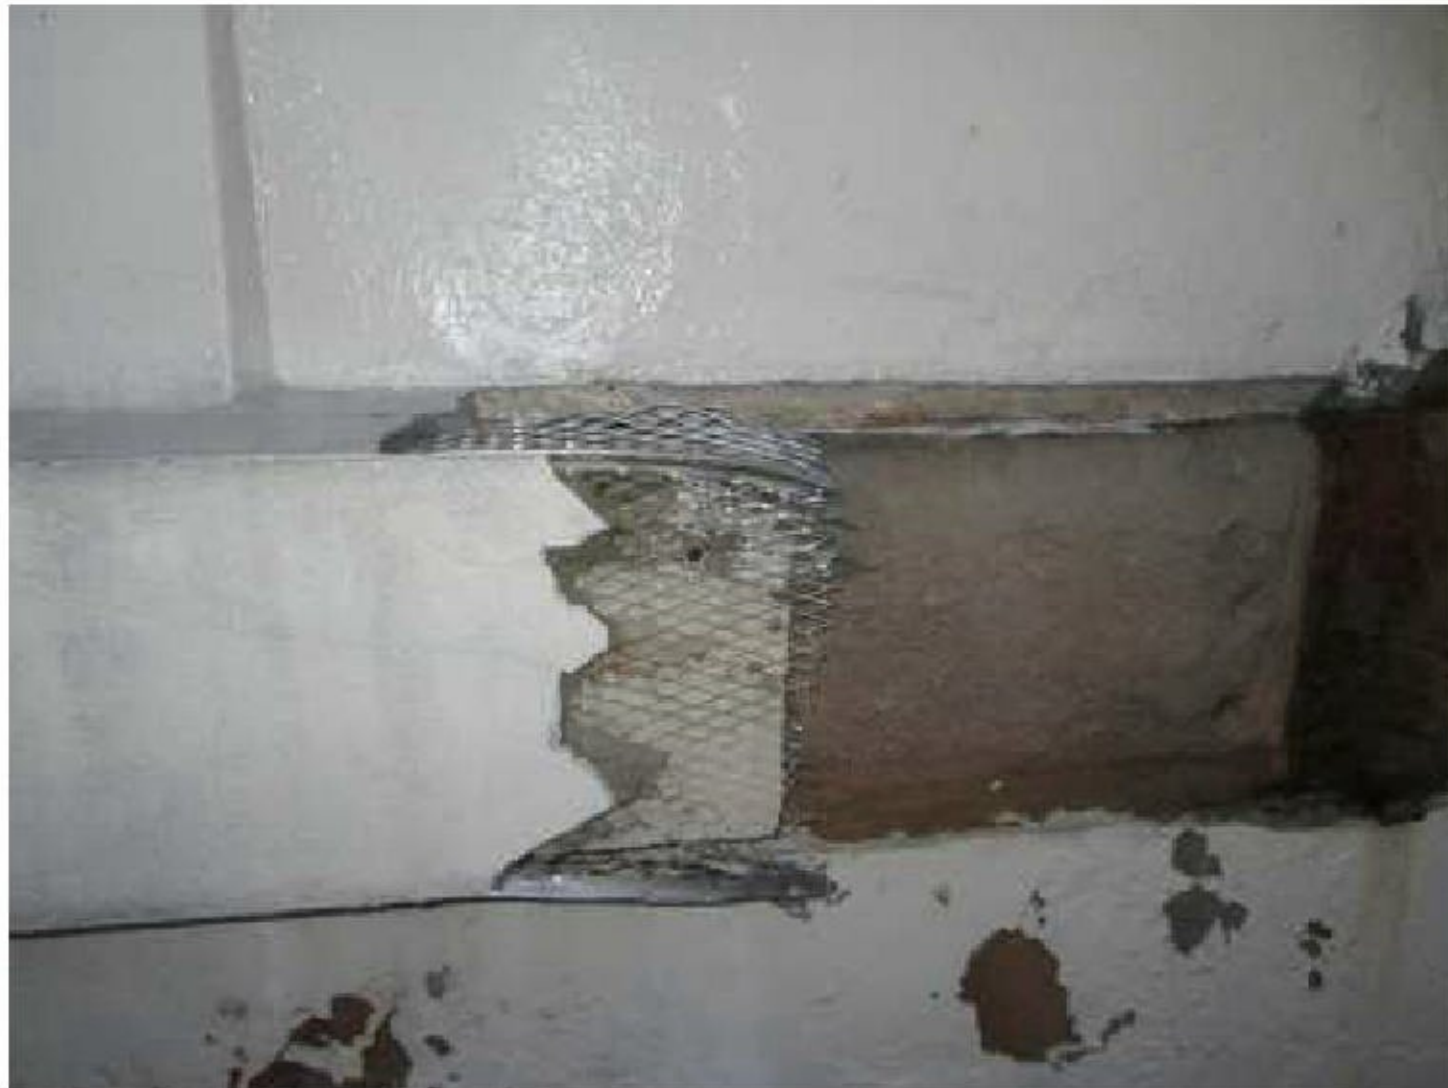
The existing projecting cill course appears to have been formed using some sort of fibreboard, overlaid with galvanised stop beads and mesh, and I would recommend testing this board for the presence of asbestos, prior to undertaking any further works.

Fibreboard and Mesh

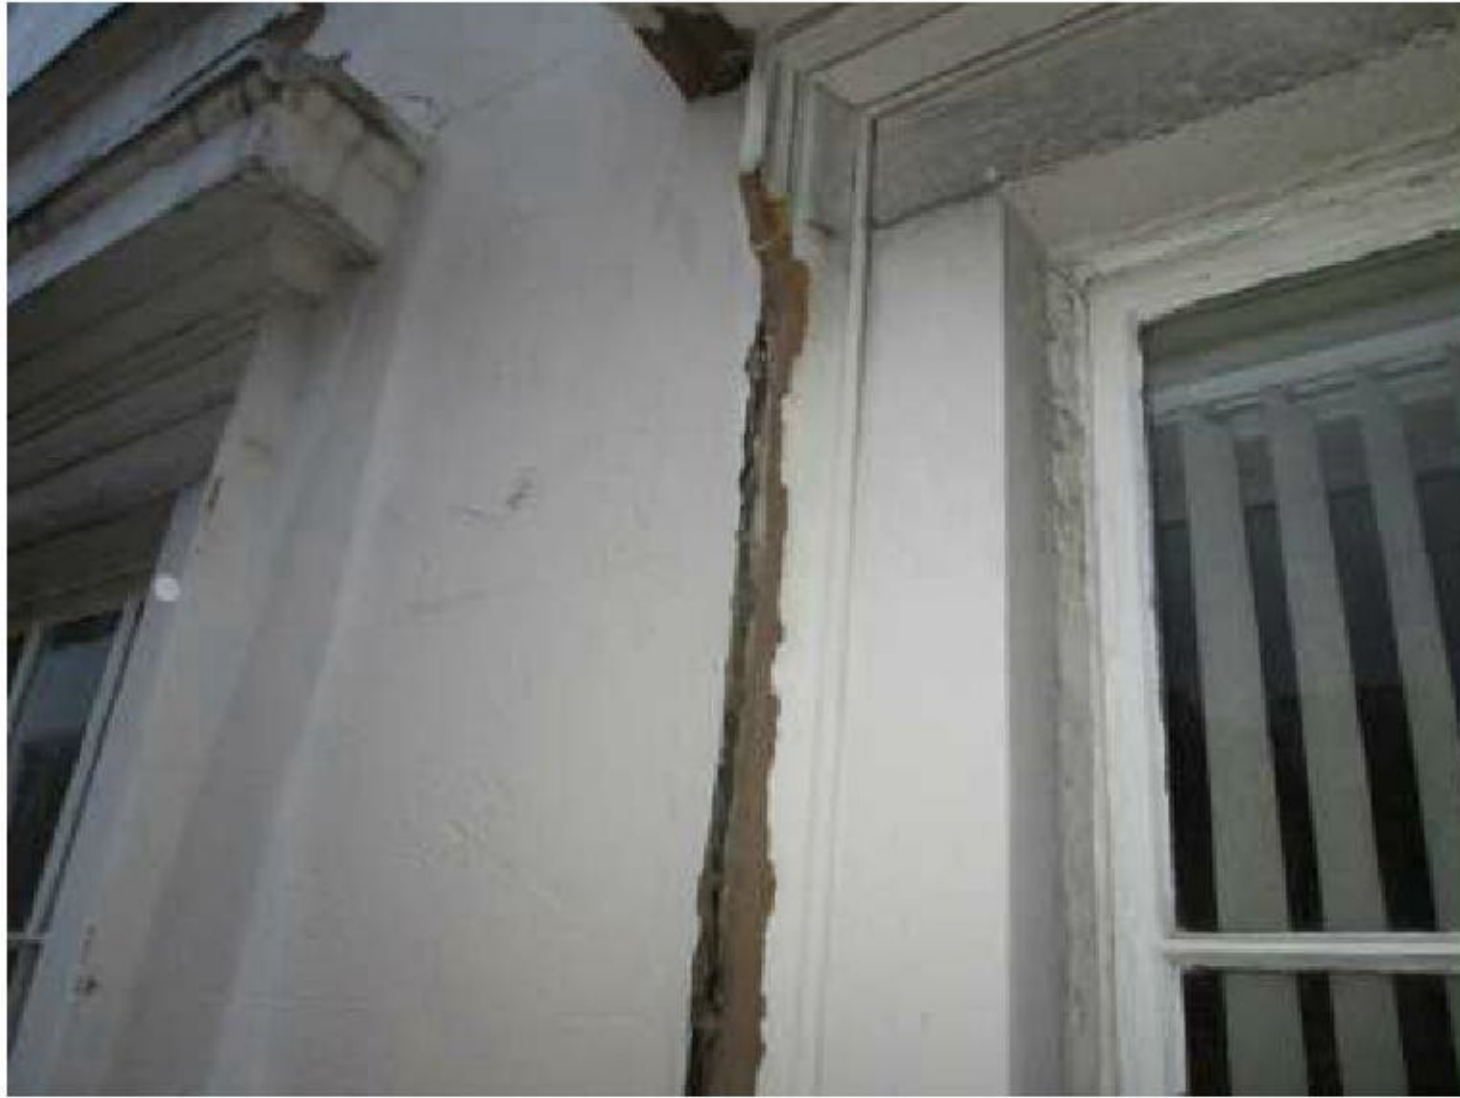
There are many of the existing projecting features, most notably moulded architraves, that have failed and been removed by others, and there appears to be numerous small test holes throughout the elevations from a previous survey.

Missing Architraves

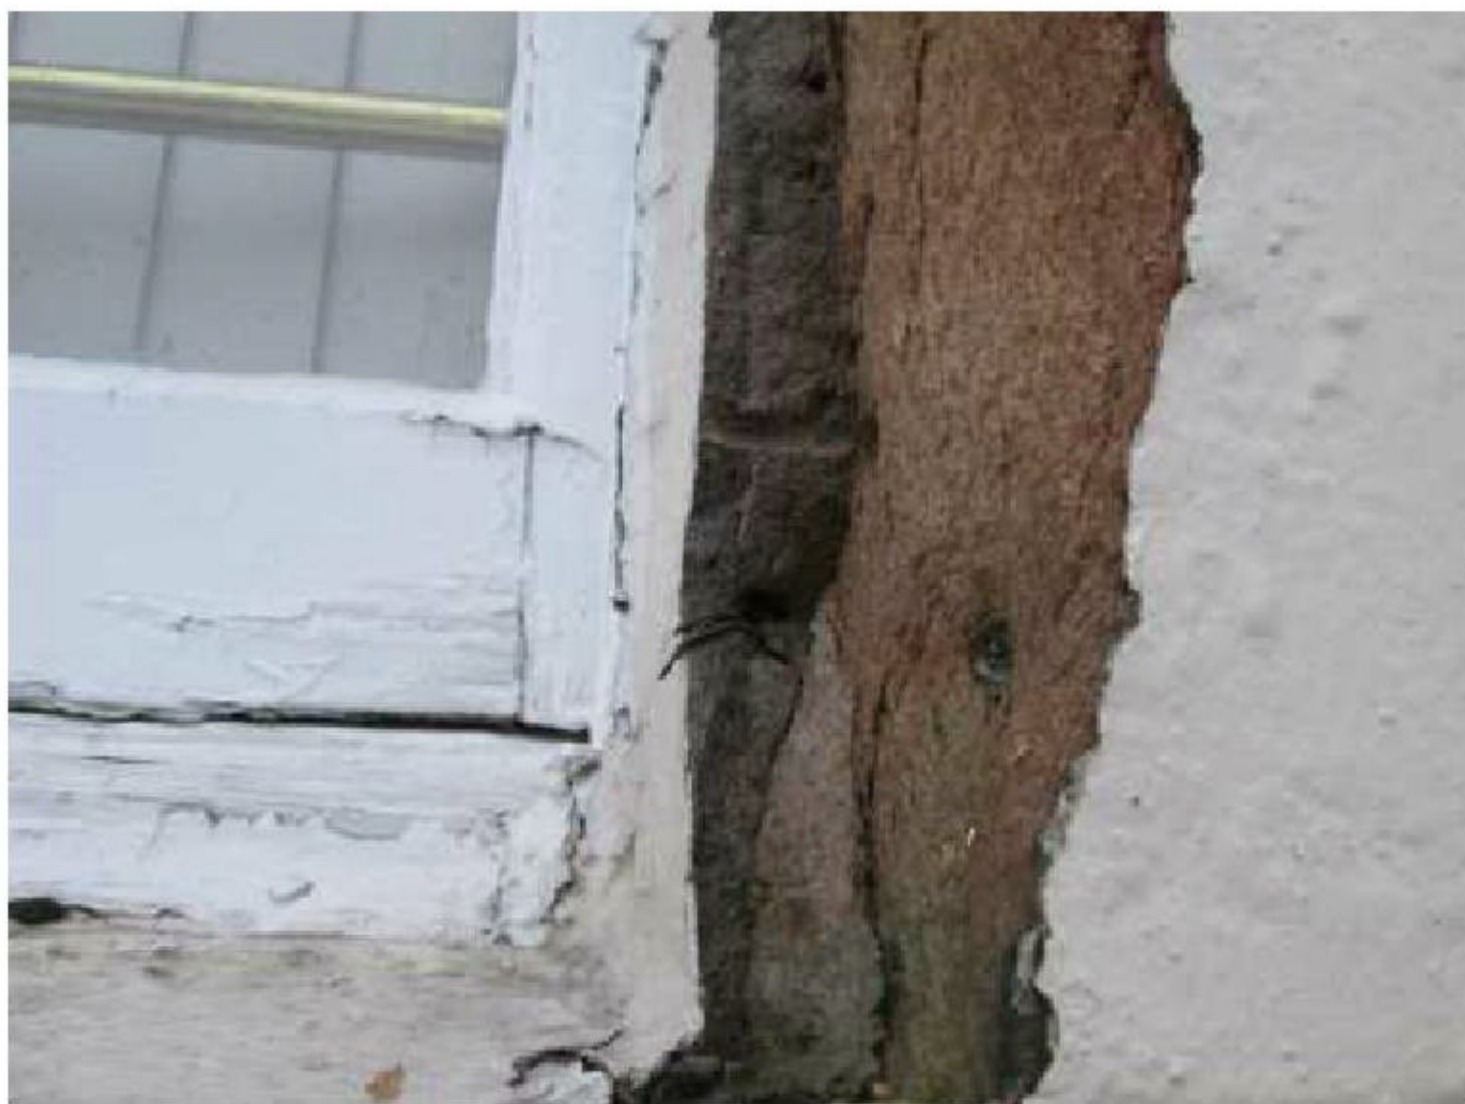
Existing Render

The existing render appears extremely soft in places, and I could not determine the number or type of fixings used to secure the mesh, neither could I determine the condition of the underlying sandstone that the mesh is secured into, although all areas are ringing "bossed" when hammer tested.

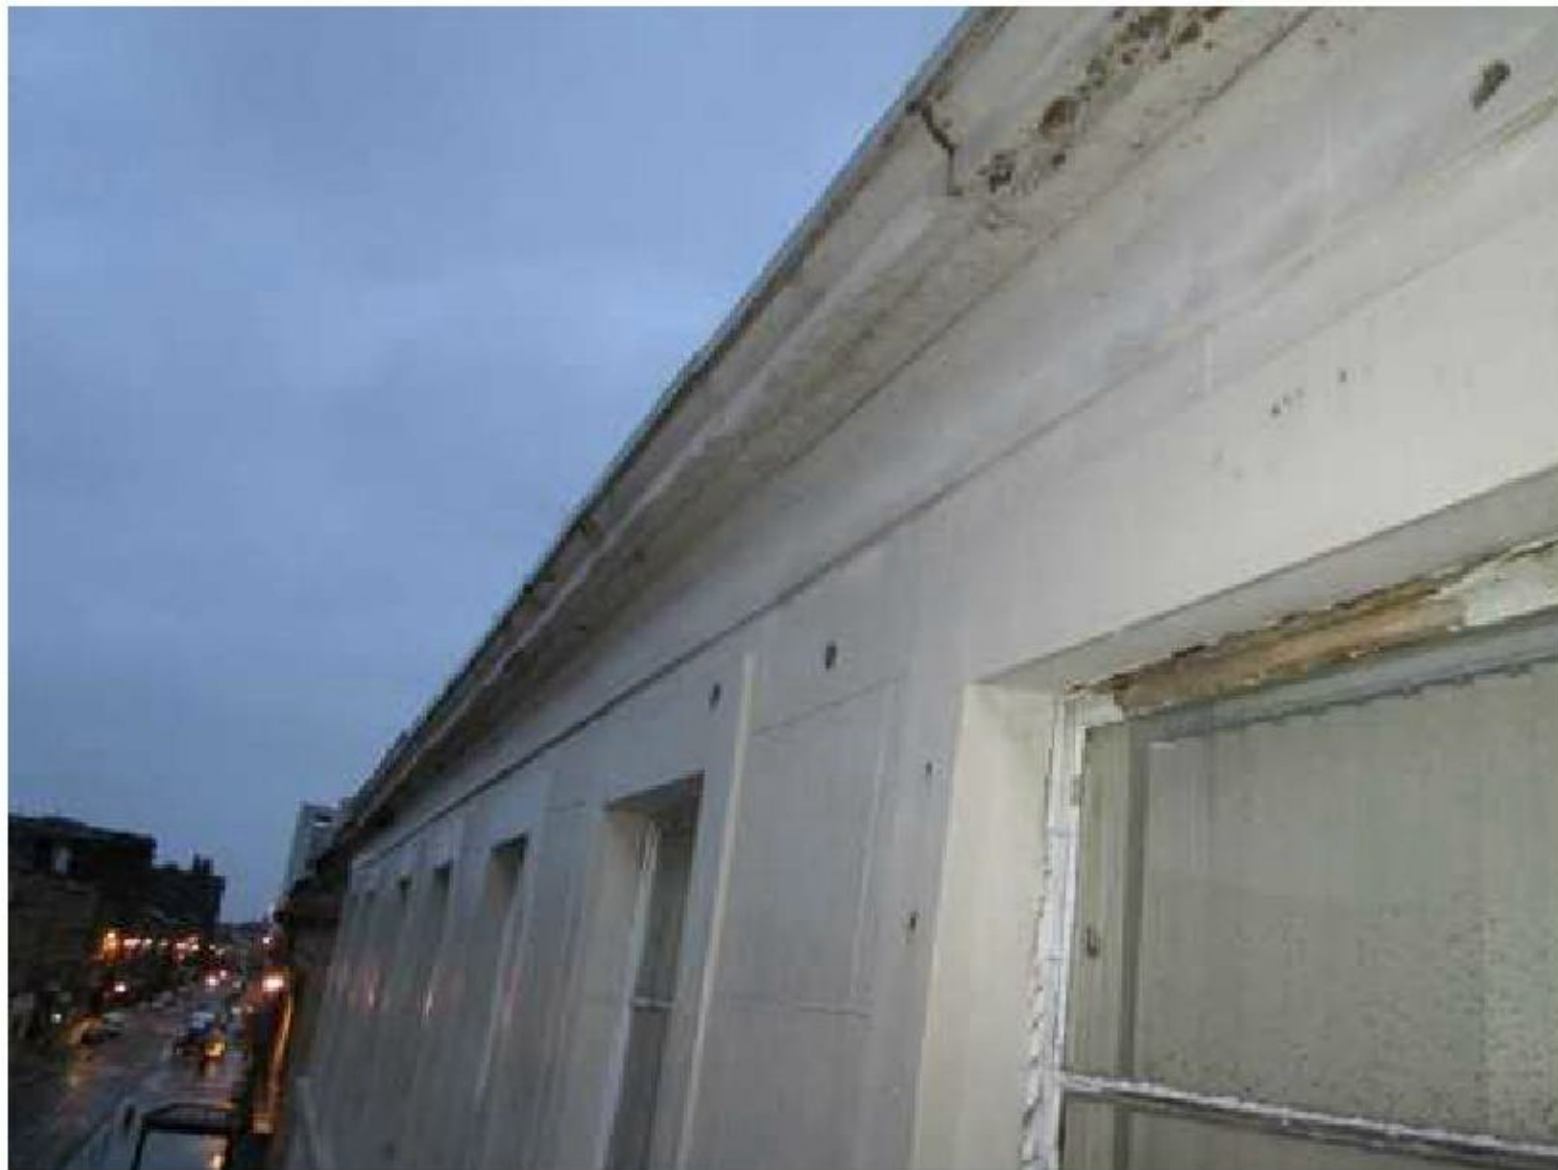
Previous Inspection Holes.

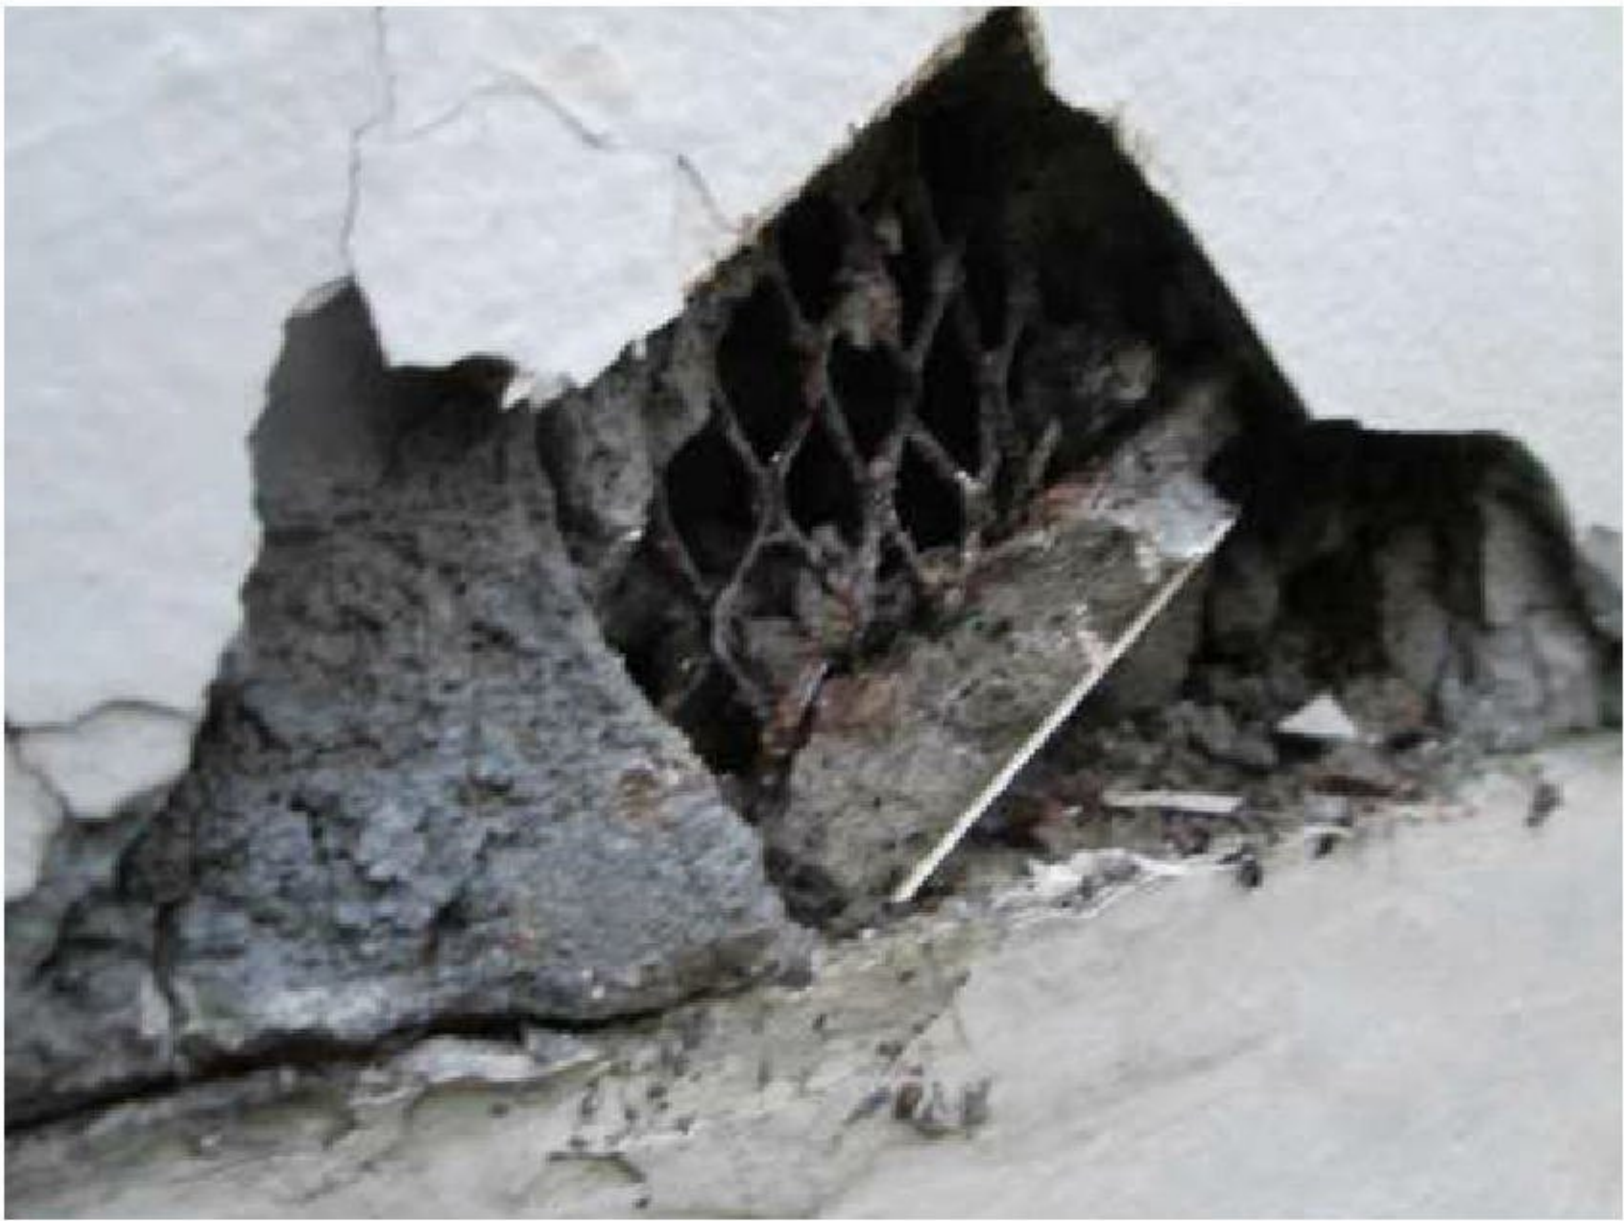
A number of the rendered panels are showing signs of cracking or crazing, and I would assume that rainwater has ingressed the surface and may well have affected the existing reinforcing, and as the mesh appears to be galvanised may well be corroded internally, again affecting the stability of the render and fixings.

Corroded Galvanised Mesh

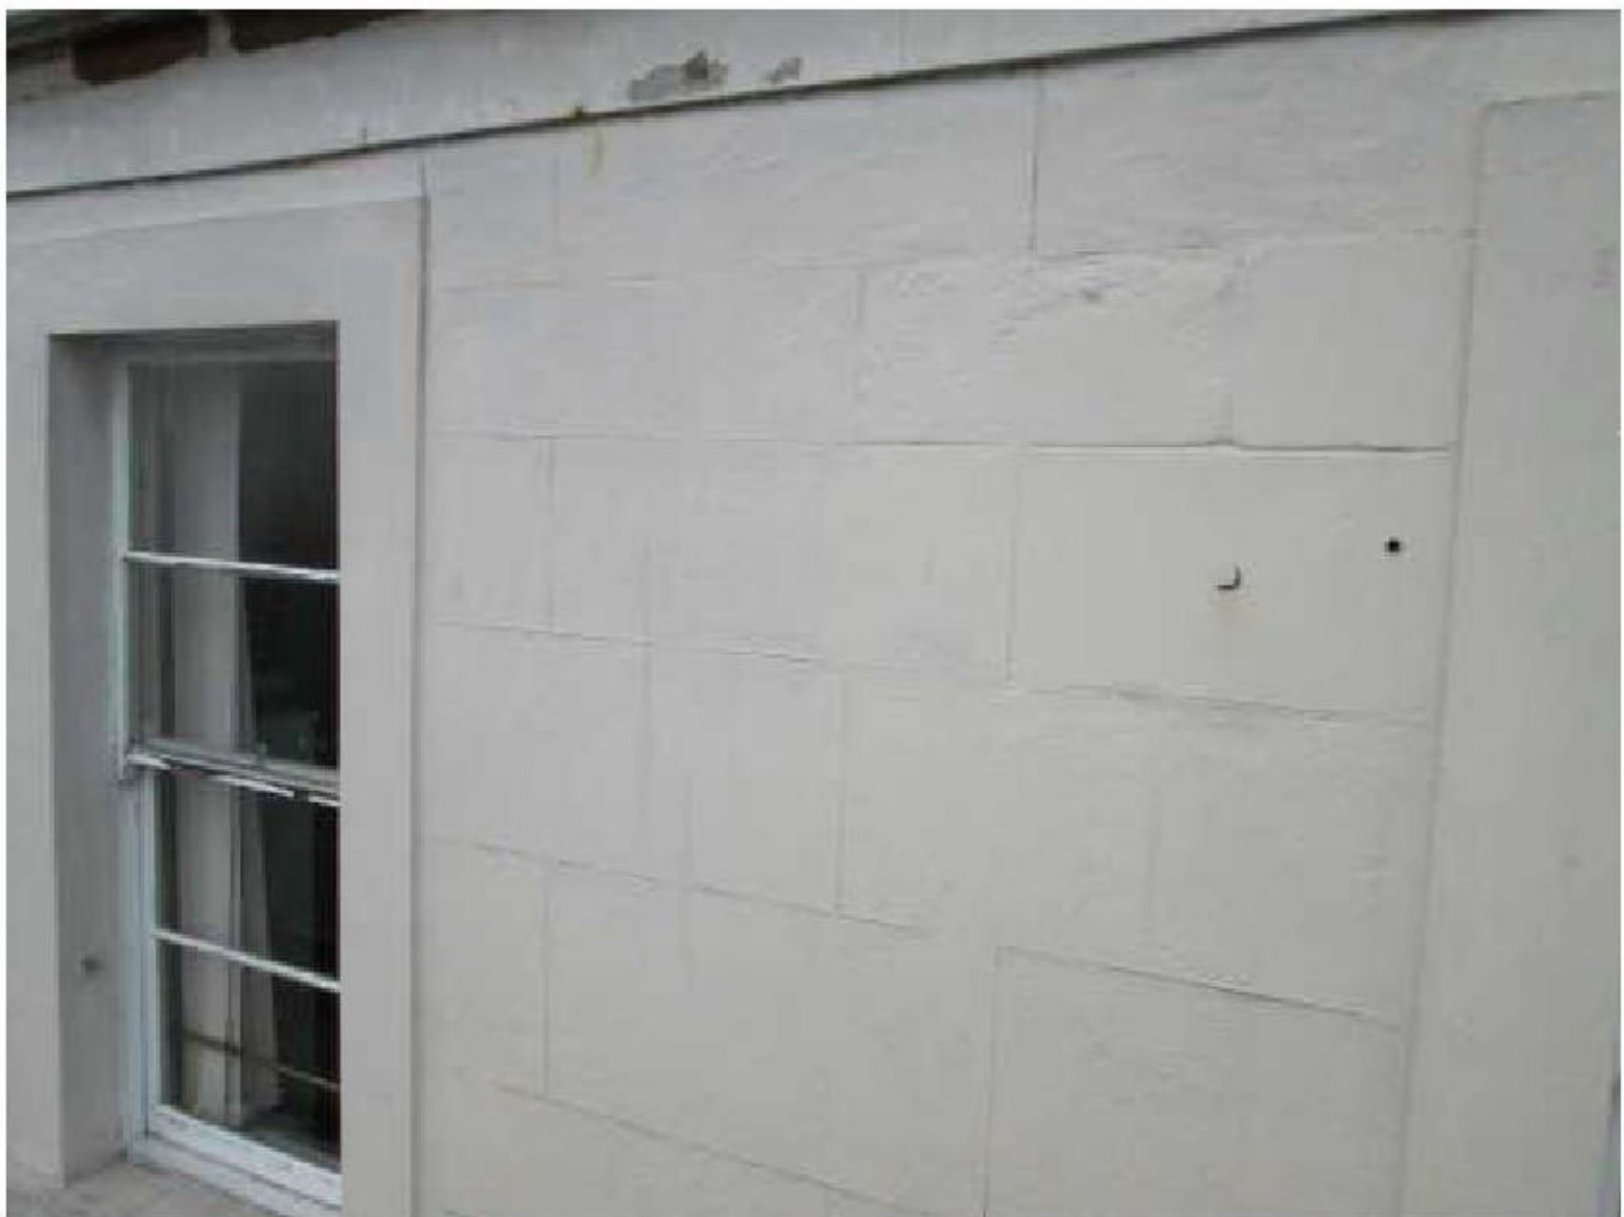
Crazed Render

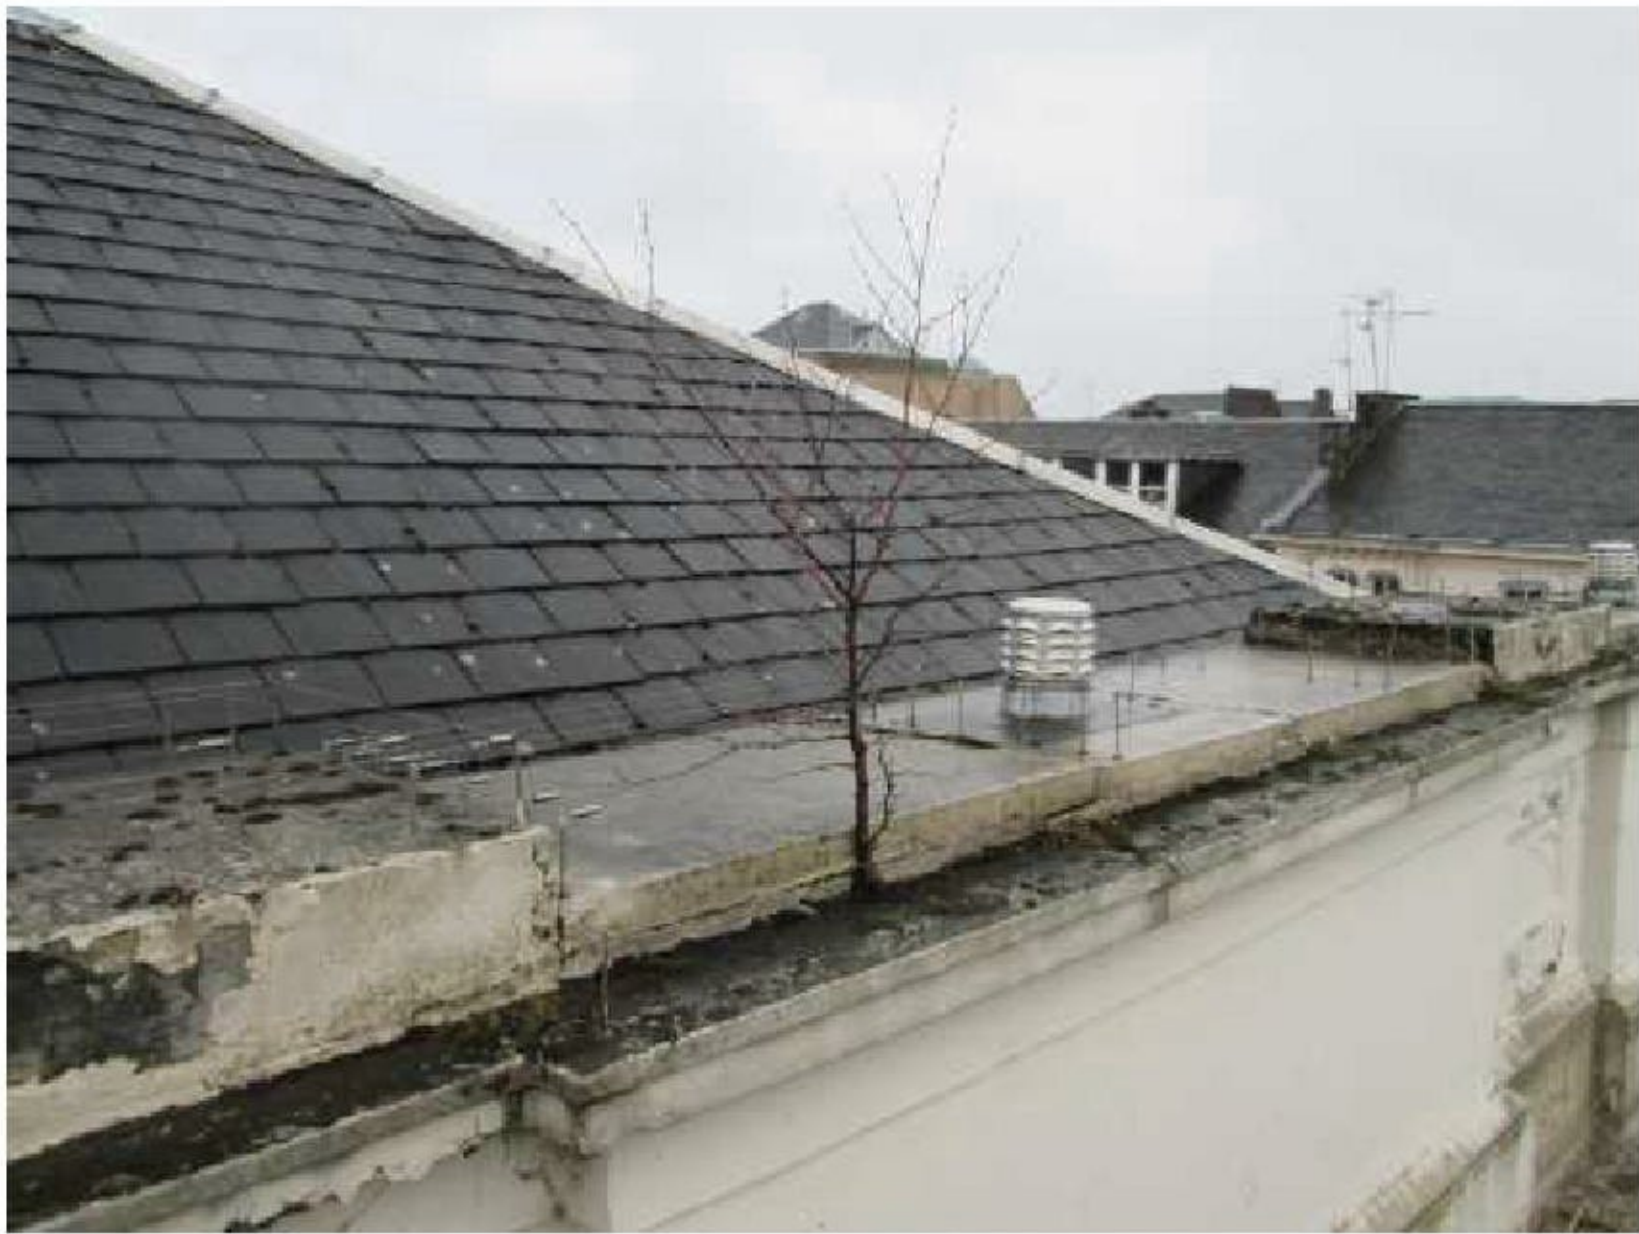
The roofs and moulded string courses appear to be in reasonably good condition although there is foliage well established on the Rose Street facade, and the roots appear to be affecting the existing joints.

Foliage and Root System

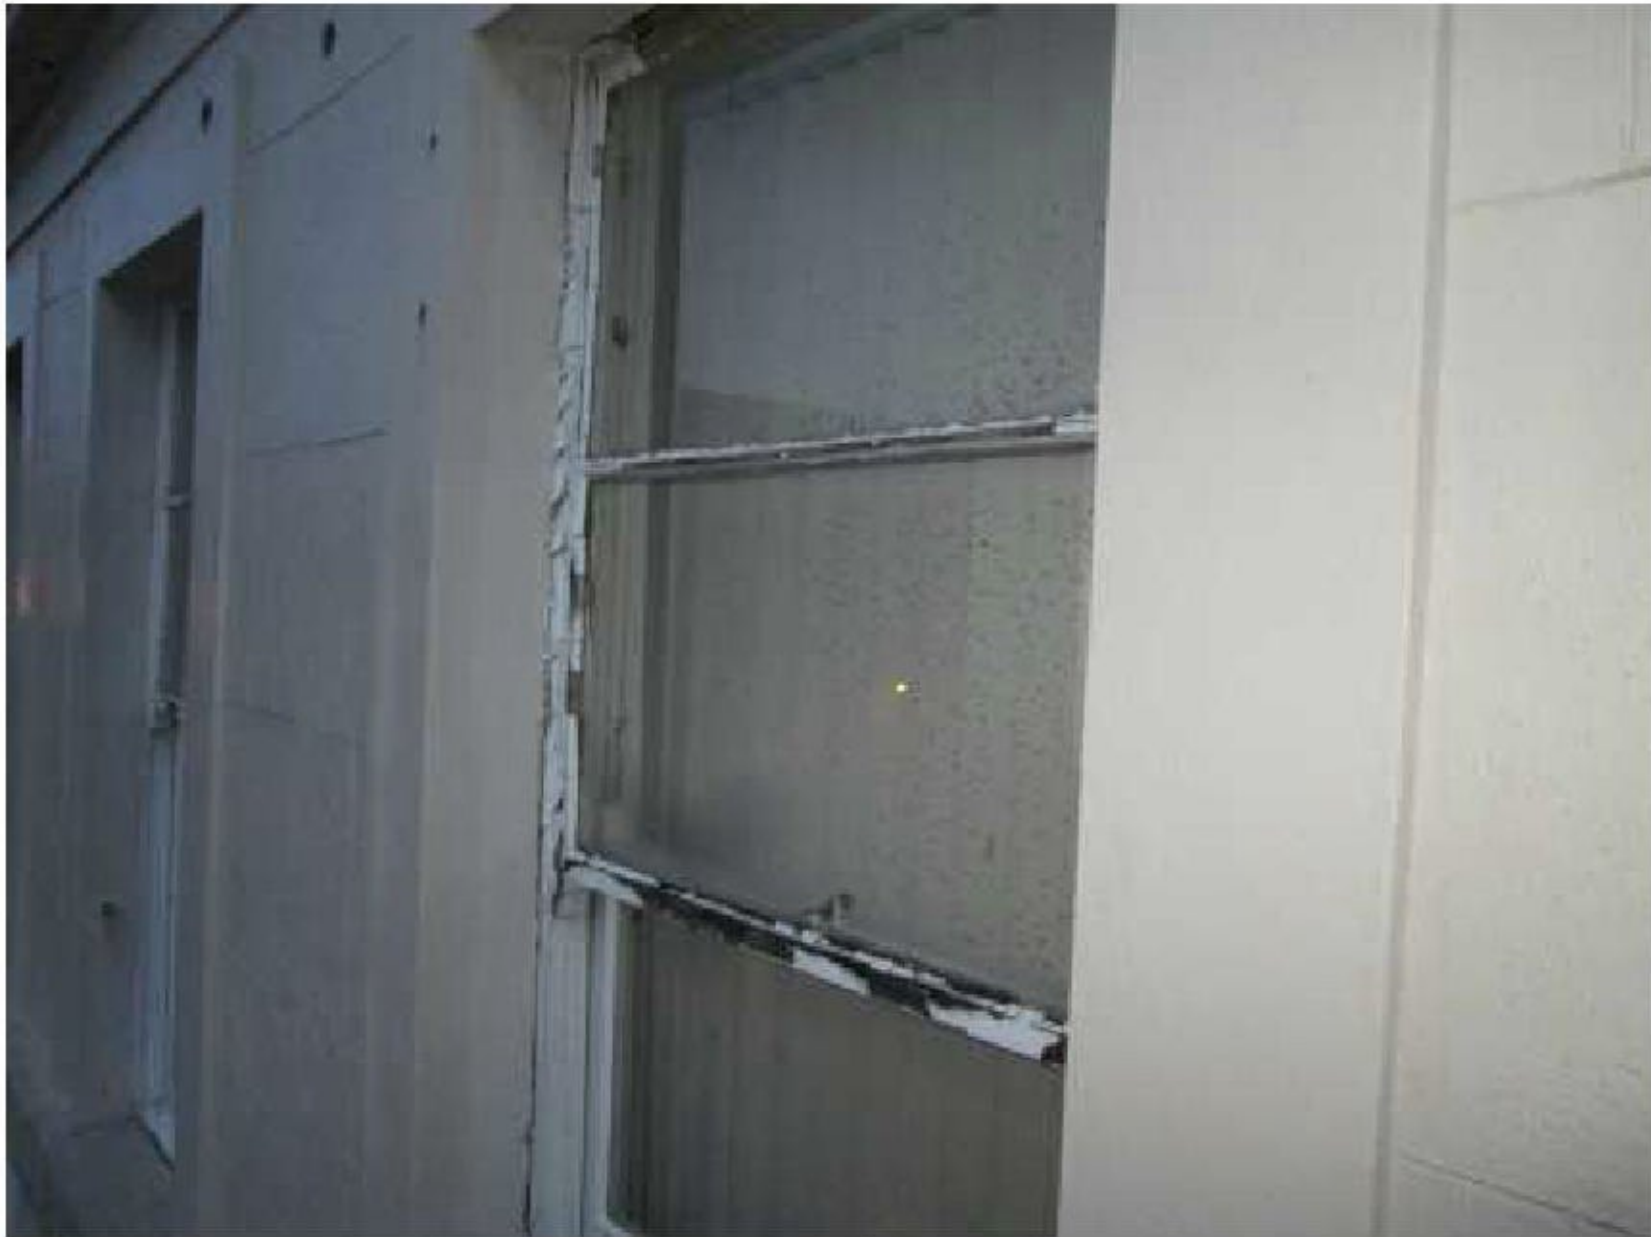
The existing decoration of the windows is extremely poor overall with numerous exposed bare timbers and missing putty throughout the frames.

Poor Decoration and Defective Putty

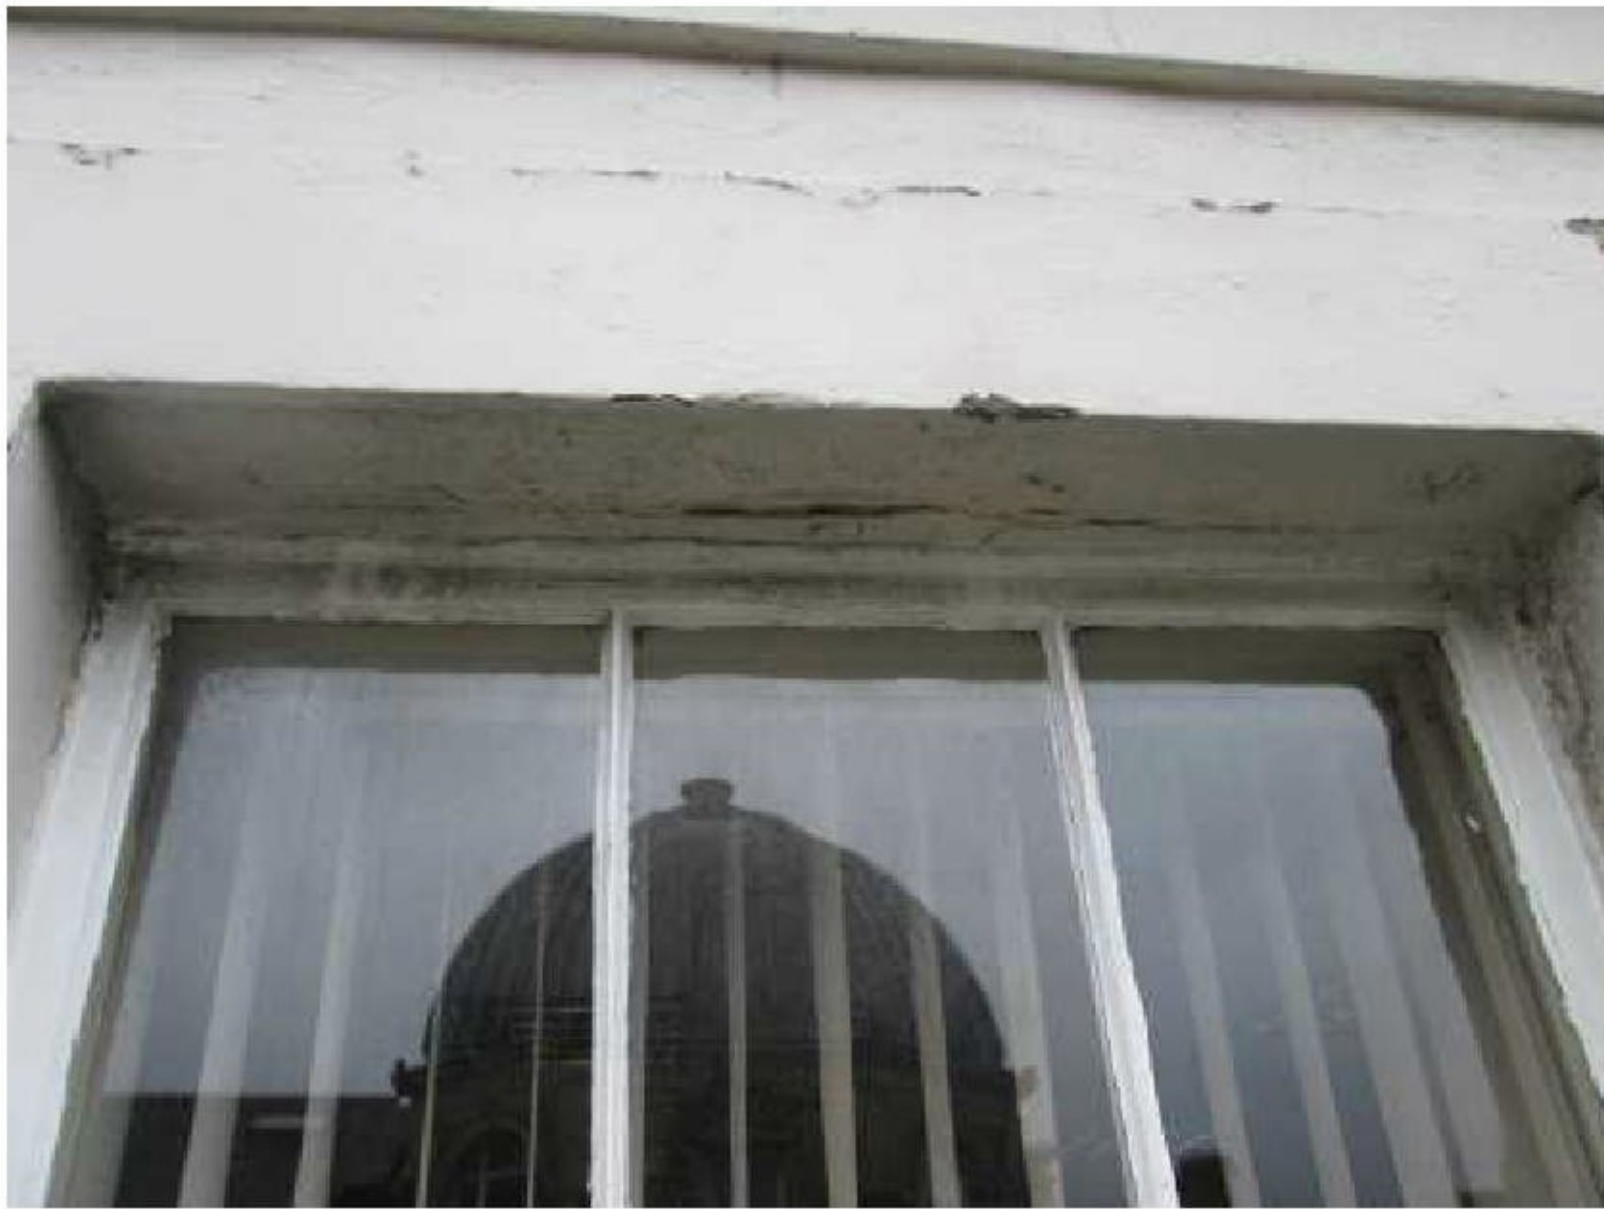
Many of the windows are painted shut and the condition of the existing mastics must be called into question.

Window "Painted Shut"
