2021  
Visual Tree Assessment

59 St. Georges Road  
Cheltenham  
GL50 3DU

**Site:** 59 St. Georges Road, Cheltenham, GL50 3DU

**Assessment Date:** Wednesday 29<sup>th</sup> September 2021

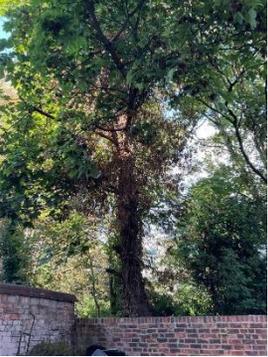
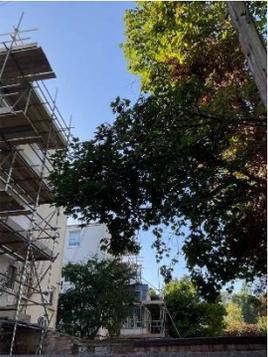
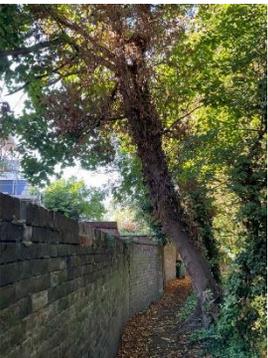
<p><i>Figure 3</i></p>	Sycamore (Acer Pseudoplatanus)	21	12	69	<p>Over mature tree located to the rear of the property. The tree and crown are overhanging the residents right of way, the River Chelt, the neighbours garden and the rear boundary wall. The stem base was free of visible defects, although difficult to facilitate a full stem base inspection, due to ivy infestation. To the North is the retaining riverbank wall. Due to the trees location, I would imagine that there is severe root pressure on the adjacent riverbank wall, which cannot be calculated but is almost certainly happening. This could lead to complete failure.</p> <p>The tree has an historic lean to the South (fig.3). I believe that this is a phototropic tendency and the tree is growing out towards the available light. The crown to the South is</p>	<p>Complete removal by sectional dismantling, leaving the stump at 1.5m in height and treated with Eco plug max growth inhibitor.</p> <p>Includes planning application to Cheltenham Borough Council for these works and this Visual Tree Assessment (VTA).</p>	H	2

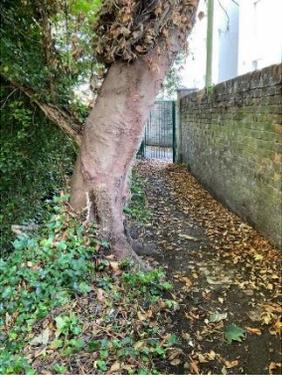
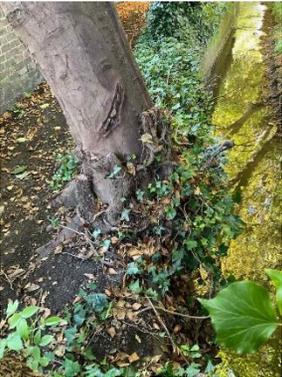
<p data-bbox="296 1117 386 1141"><i>Figure 5</i></p>					<p data-bbox="1066 245 1423 821">widespreading and puts the rear garden in complete shade. Hard to facilitate a full crown inspection due to dead ivy, which is making the amenity situation a lot worse. I note that there is lots of squirrel damage within the crown, this will only lead to sporadic branch failure with a high risk to any static infrastructure or occupants to the rear garden.</p> <p data-bbox="1066 867 1423 976">In my opinion, the tree has outgrown its location and needs to be removed.</p>
