# **‘Barn 3’ at Bower Hall Pentlow, Essex**

## **Historic Building Record ECC Site Code PLBHb21**

# **‘Barn 3’ at Bower Hall, Bower Hall Lane, Pentlow, Essex**

## **Historic Building Record**

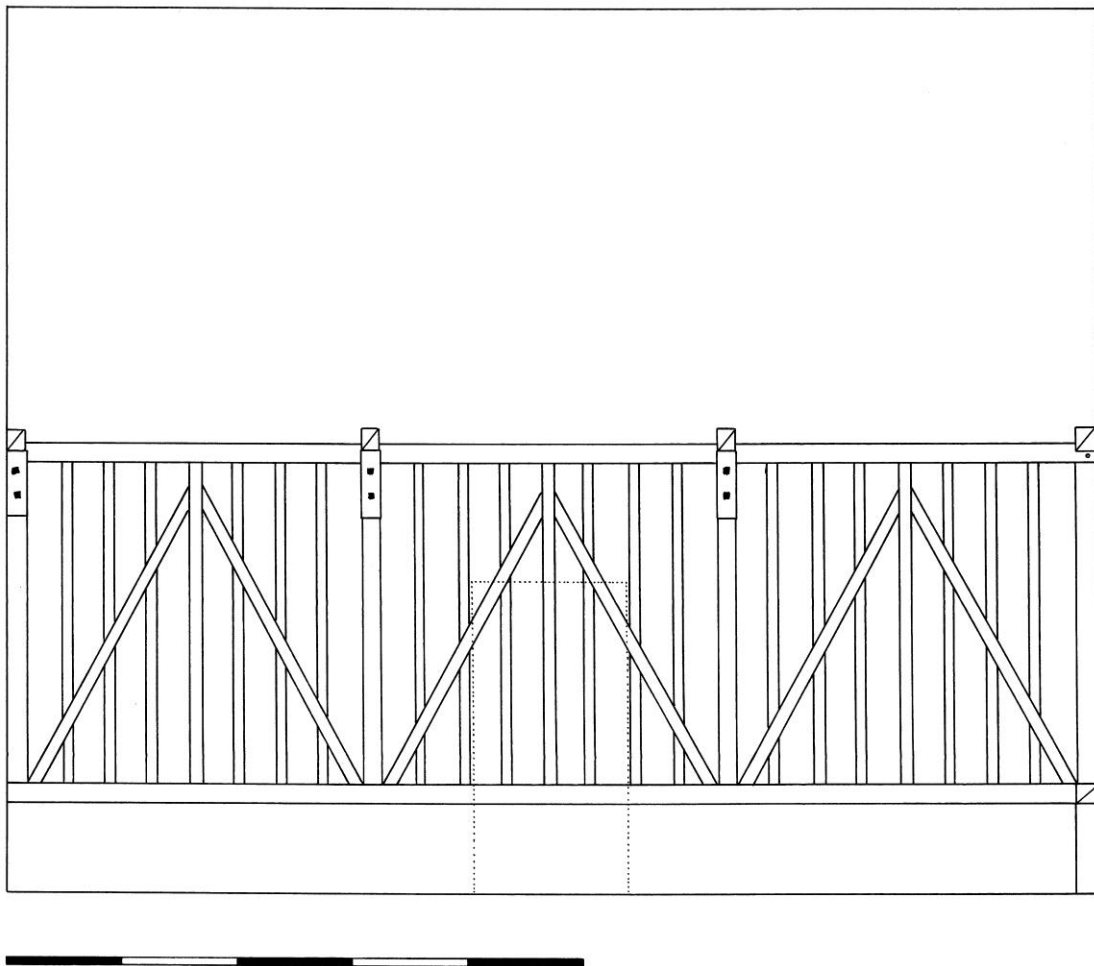
**Figure 13**

**Internal elevation of the rear (southern) wall showing the outline of the inserted connecting door to the lean-to with a dotted line (partial reconstruction). The northern wall was identical initially. The absence of original doors in the side elevations demonstrates that the surviving structure was not a threshing barn in its own right, but may have formed part of one that continued further to the east.**

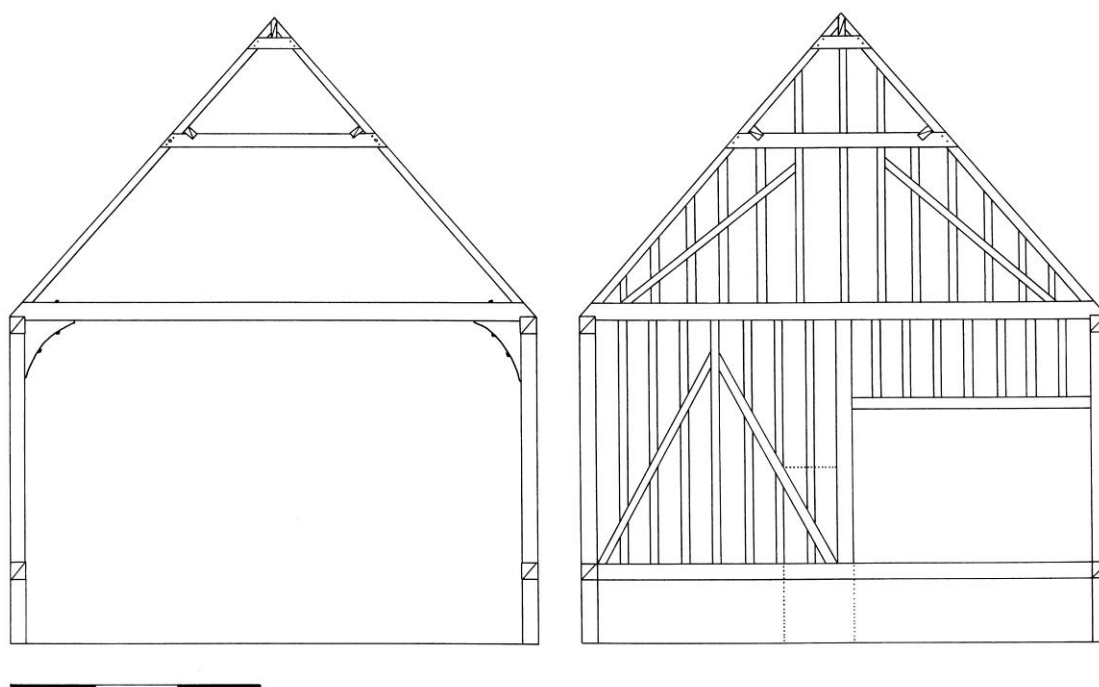
**Figure 14**

**Internal elevations of the eastern (left) and western gables showing the open truss of the former demonstrating that the structure either continued further or adjoined a pre-existing building. It is unclear whether the long lintel in the right-hand (northern) half of the western gable is an original feature or a later insertion as the tie-beam is a re-used timber and both the ground sill and the short studs above have been disturbed. The framing may have been identical to that of the left-hand section initially. The outline of a small central inserted door shown on the aerial photograph is also indicated, the lintel of which cuts an original wall brace.**

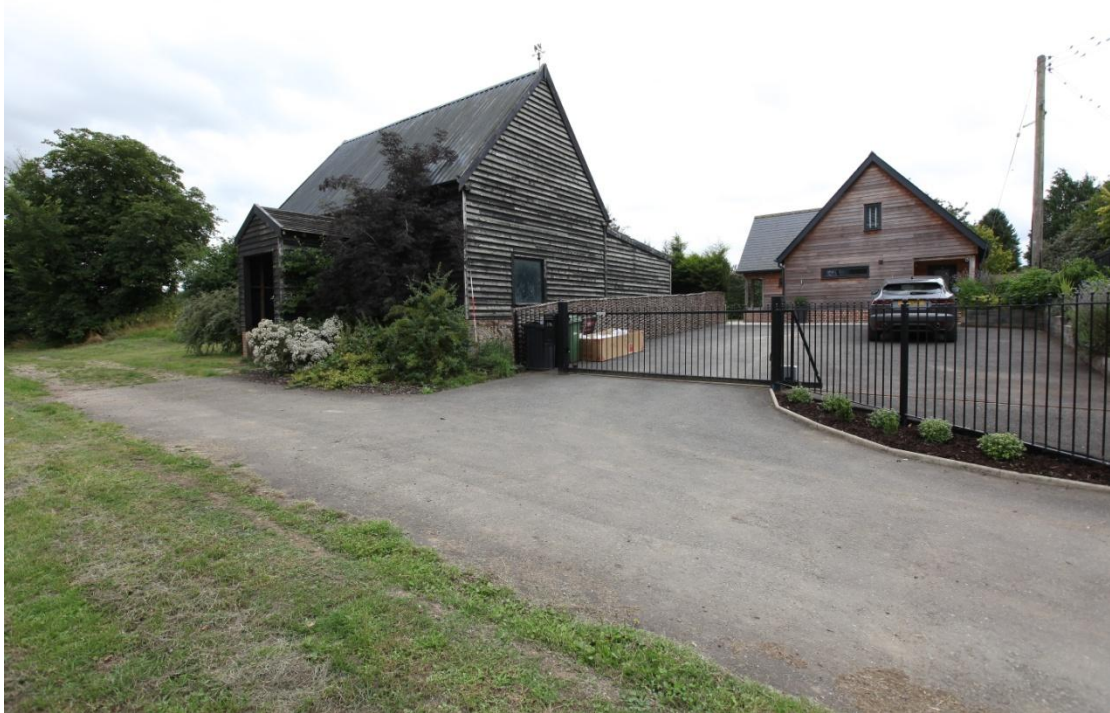
**Illus. 3. Barn 3 from the north-west showing its close proximity to the recently built dwelling known as Bower Hall Cottage on the right. The listing description of 1983 refers to an entrance in the western gable but there is no longer any trace of this in the weatherboarding or plinth which have since been renewed (see illus. 13)**

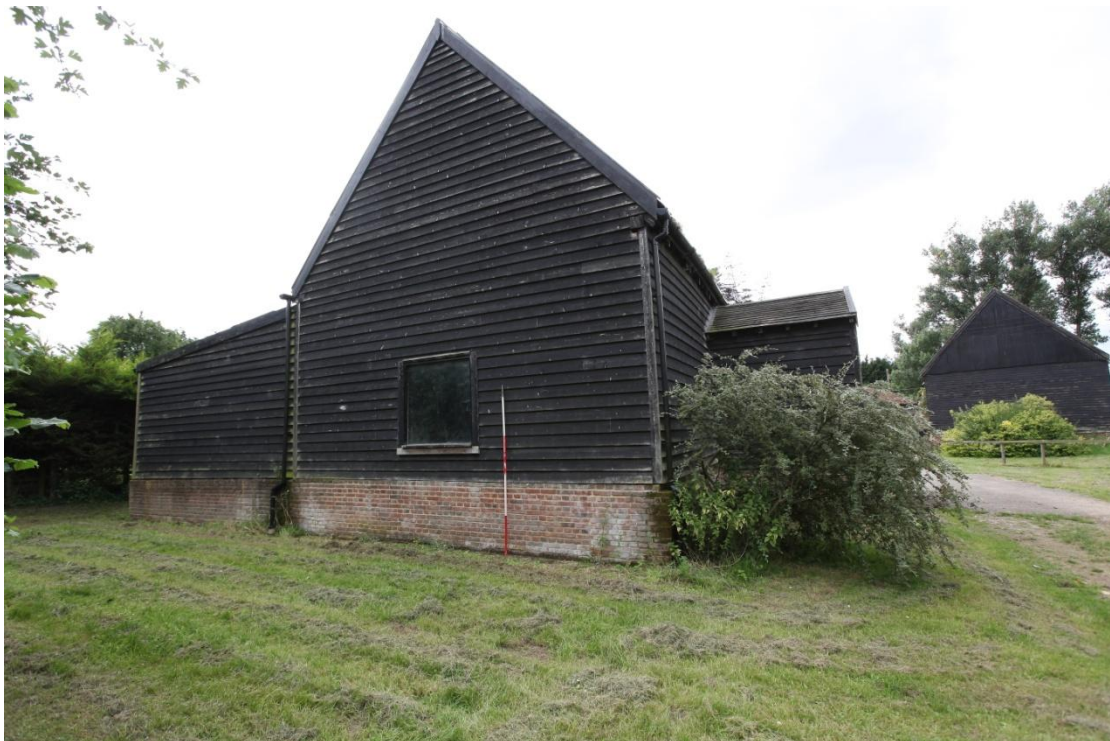
**Illus. 6. The external eastern gable with the lean-to rear extension of 2003 on the left. The English Bond brick plinth of the main barn is integral to that of the lean-to, evidently having been replaced when the latter was built, and the weatherboarding of both structures is also identical. The original gable is open-framed and the remaining building either continued into the foreground or adjoined an earlier structure in this position as shown on 19<sup>th</sup> century maps.**

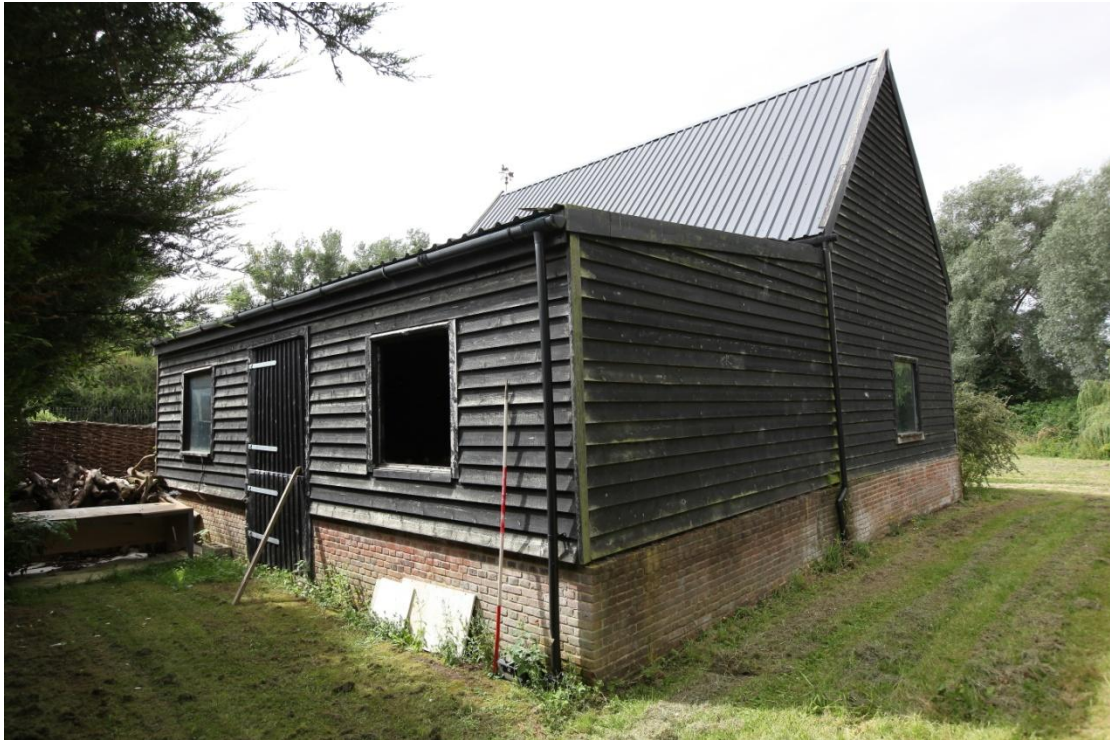
**Illus. 7. Barn 3 from the south-east showing its recently built lean-to rear addition designed as loose boxes for horses. The plinth and cladding of the new structure are identical to those of the barn which was extensively renovated and altered at the same time.**

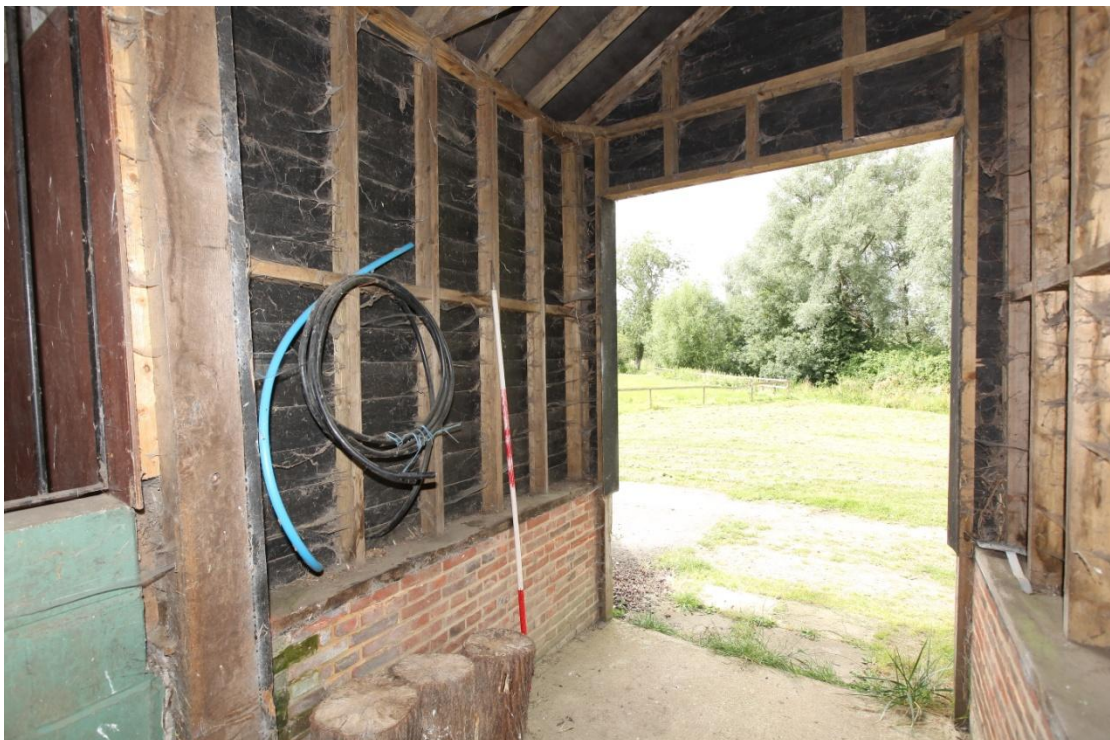
**Illus. 8. The western interior of the northern porch of 2003 showing its modern softwood studs and brick plinth laid in traditional English Bond. The listing description refers only an entrance in the western gable and the surviving framing above suggests that no doorway existed in this position when the barn was first built (illus. 9).**

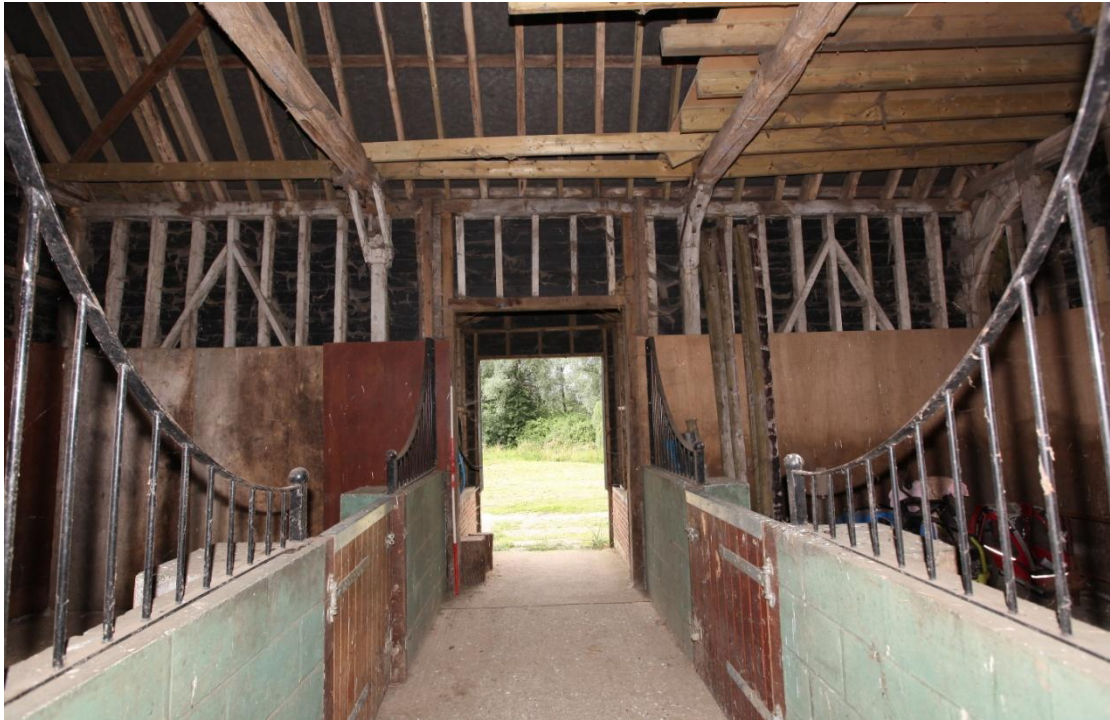
**Illus. 9.** The northern interior showing its whitewashed original studwork which originally consisted of three bays of identical length with symmetrical framing and no evidence of an entrance. The jambs and lintels of the present porch are insertions of 2003. The short studs above the lintel have been altered, and the central stud bears paint scars and nails for missing diagonal primary braces identical to those of the end bays.

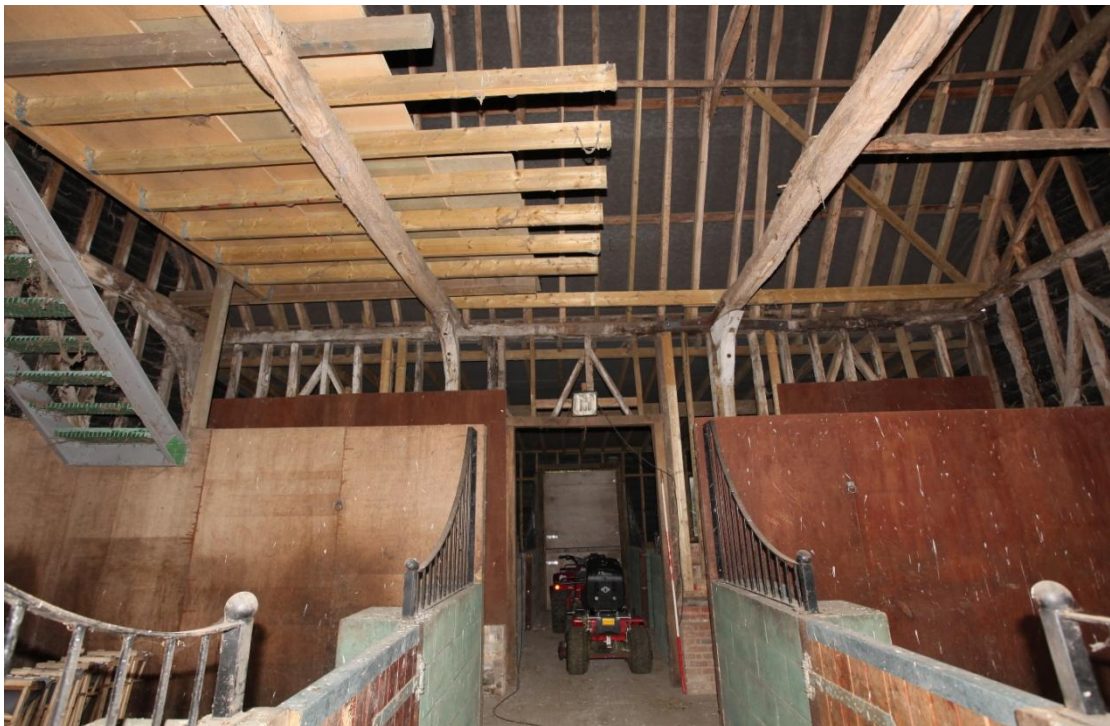
**Illus. 10.** The rear (southern) interior of the barn showing identical framing to the northern wall, with seven studs interrupted by diagonal primary braces in each bay. The studs of the central bay have been cut by the entrance to the modern lean-to addition. The braces are highly unlikely to have been nailed to a central stud that was original cut by a door lintel, indicating that no doors existed in this bay initially.

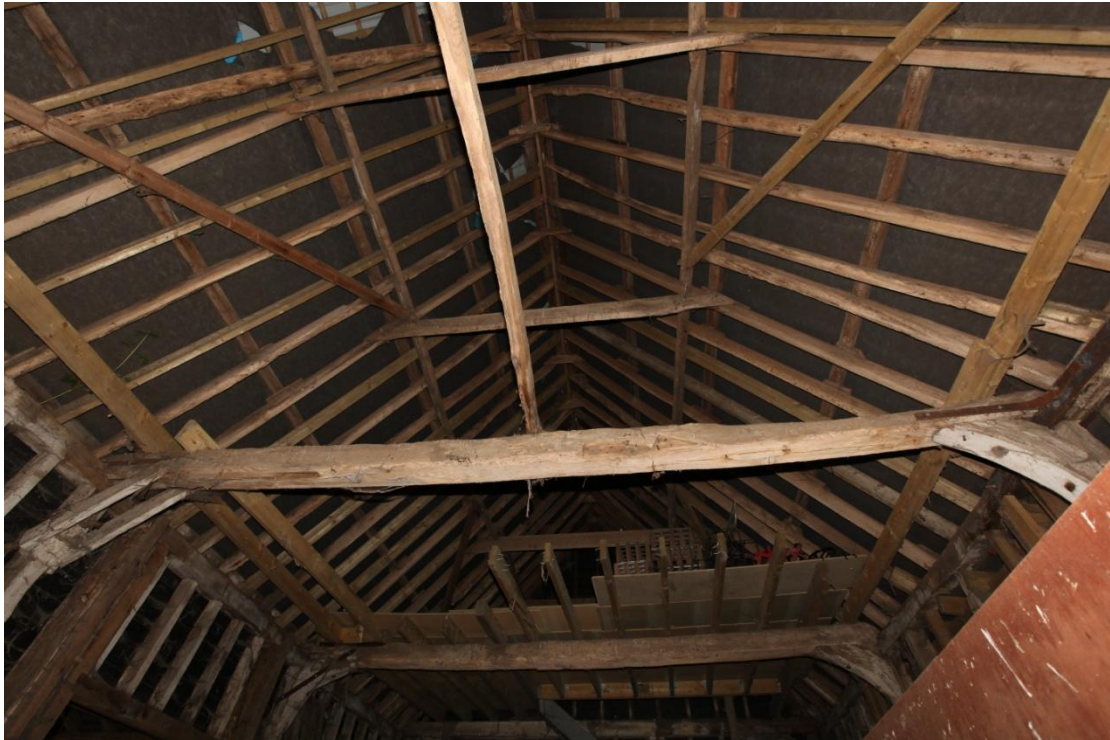
**Illus. 11. The roof structure from the west showing the empty arch-brace mortices in the re-used western tie-beam with the same features in the eastern tie beam beyond. The collars of the clasped-purlin structure are both pegged and nailed in an apparently original arrangement and the purlins are narrow-sectioned. Some rafters were re-used when new while others are modern replacements but the ridge-board is original.**

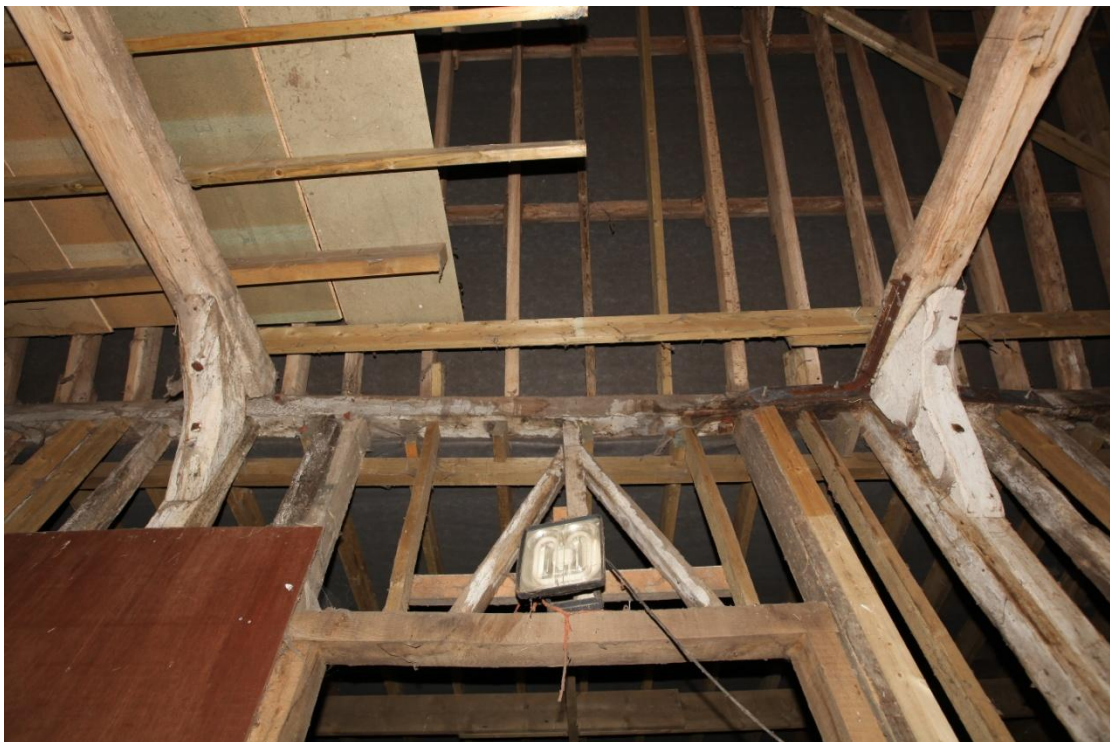
**Illus. 12. A detail of the rear (southern) roof-plate of the central bay showing its original central stud and primary braces with replaced studs on both sides. The knee-braced tie-beams are original to the structure but re-used as they contain pegged mortices for arch-braces while the posts lack both jowls and arch-brace mortices.**

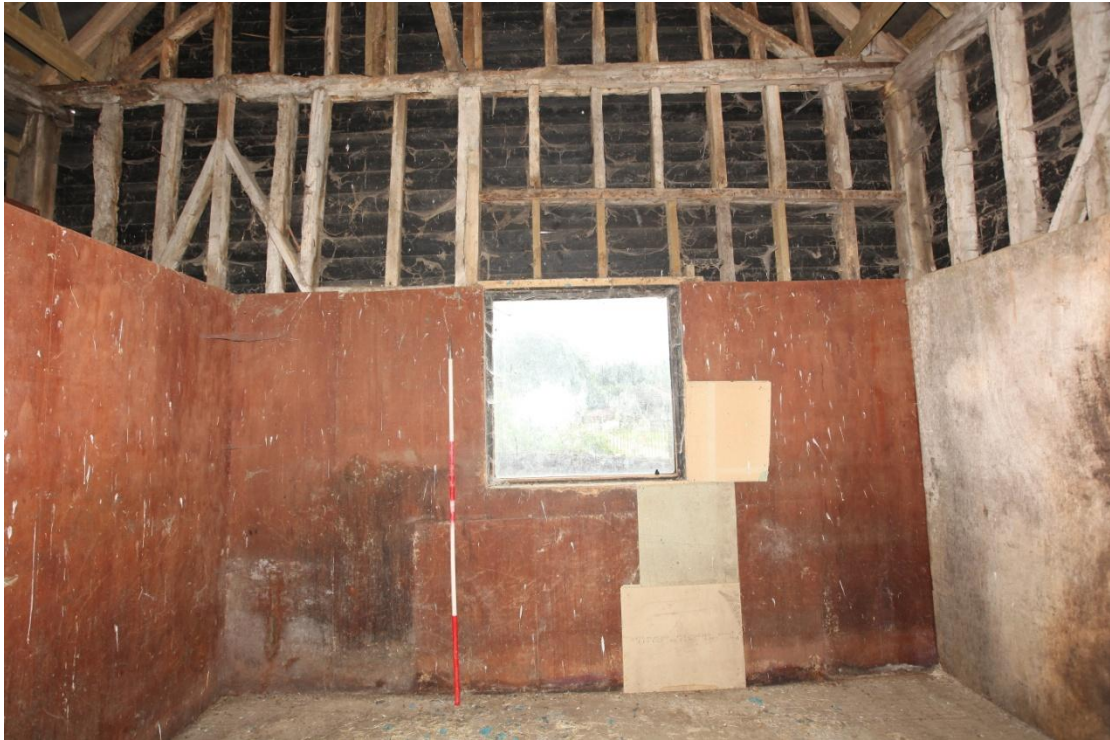
**Illus. 13. The western internal gable showing the re-used tie-beam with empty pegged mortices for substantial flat-sectioned studs in the manner of the 17<sup>th</sup> century and before. The short horizontal lintel ostensibly of the gable door mentioned in the 1984 listing survives to the left of the central post while the lintel of a tall, wide entrance lies to the right. The nails in the latter indicate it too was re-used and as the plinth has been rebuilt it is impossible to establish whether this entrance was original or an insertion.**

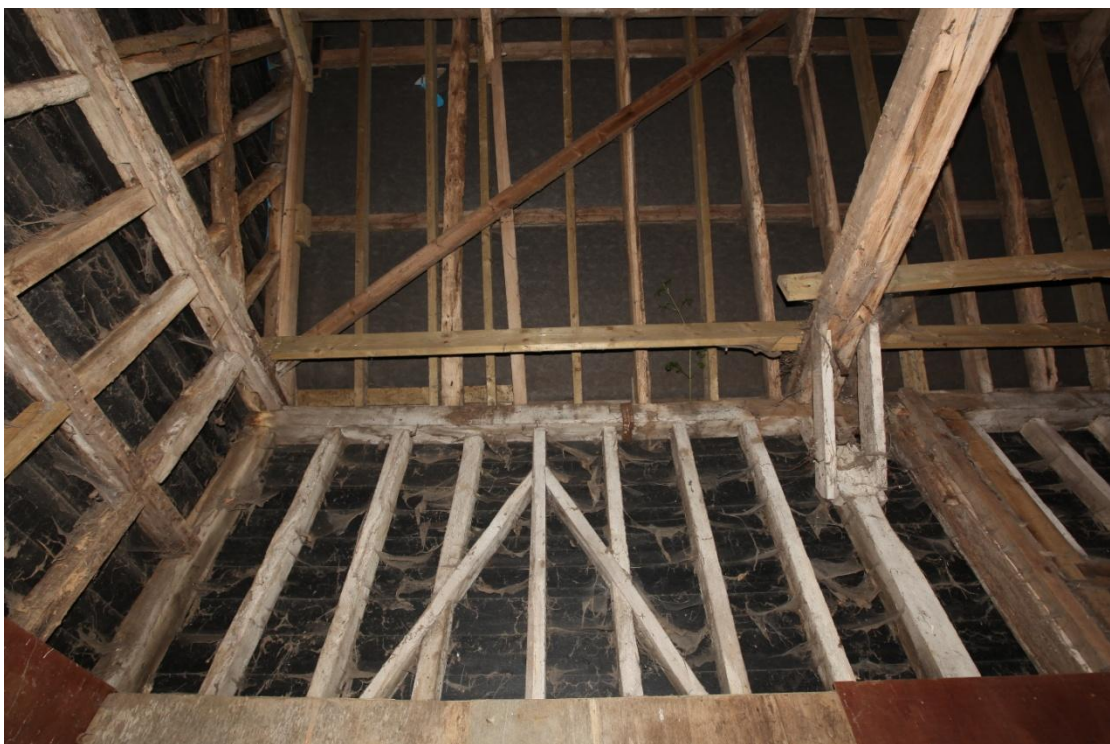
**Illus. 14. A detail of the original framing of the western bay's northern interior showing its narrow-sectioned timbers and nailed braces along with the twin plank-sectioned braces that replaced an original knee-brace to the wall post on the right.**

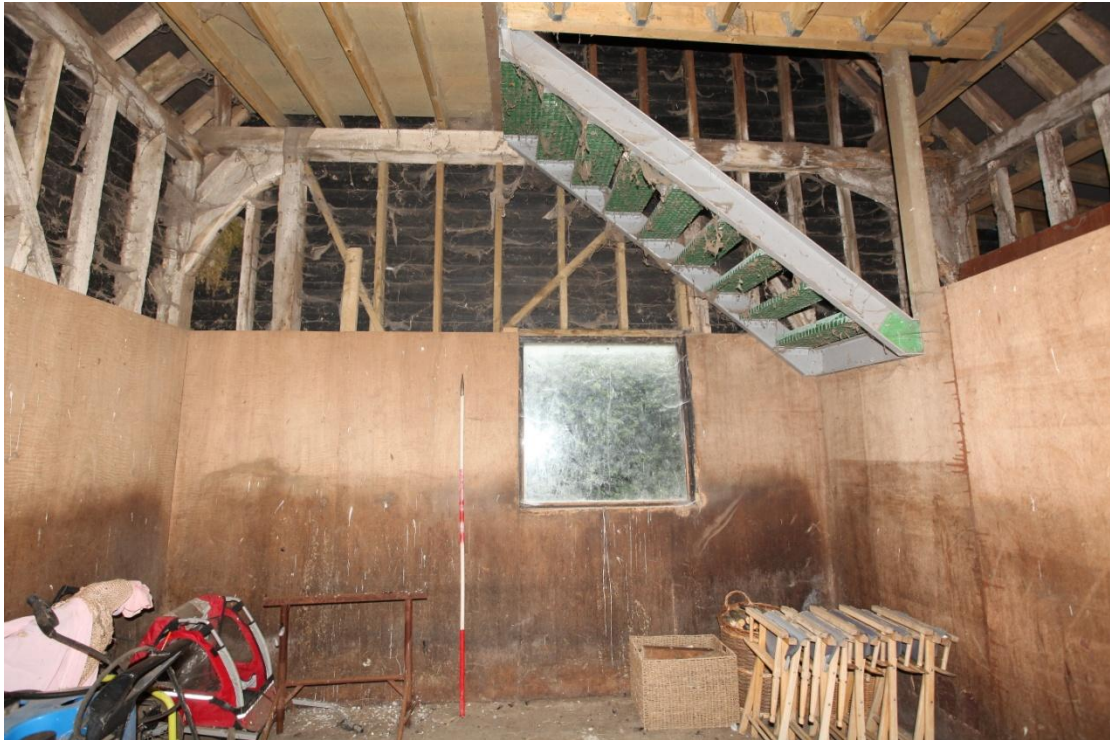
The eastern gable was originally open-framed as shown by the presence of original knee-braces at both ends of its tie-beam which lacks the stud mortices seen in the western tie-beam and roof-plates (illus. 15-17). Unlike its western counterpart this tie-beam is not a re-used timber. The absence of an original solid wall in this gable indicates either that the structure formerly continued further to the east or was built against a pre-existing building in this direction. This is confirmed by the cartographic evidence in figures 3-5, all of which depict a much longer building that extended further to the east before being truncated between 1920 and 1958 (figures 6 and 7). The changing proportions suggest that at least two and possibly even three bays were lost. These missing bays may have contained a threshing floor in the bay

**Illus. 15. The eastern internal gable showing the original knee-braces of an open truss with inserted studs beneath the tie-beam. Most of these studs consist of modern softwood but some appear older and *in situ* so the truncation occurred before the barn was refurbished in 2003 – as confirmed by the 1984 listing description which refers to the present three bays.**

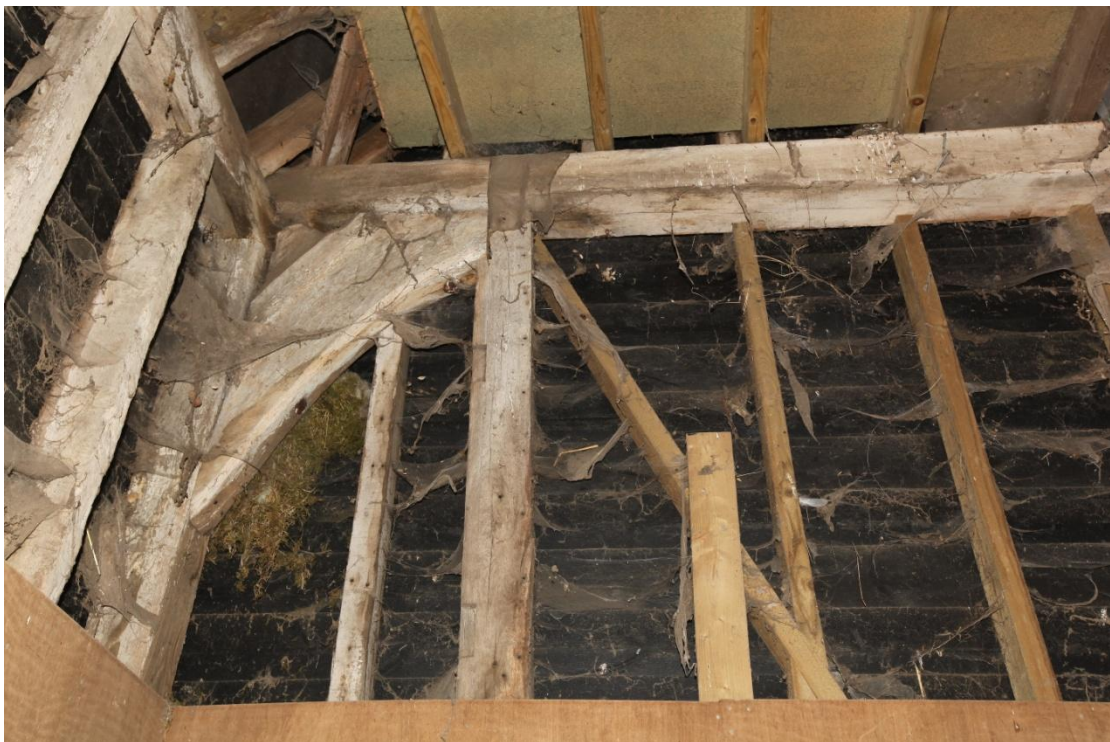
**Illus. 16. The original bolted knee-brace in the barn's north-eastern corner with no stud mortices in the tie-beam, proving that either a fourth bay has been lost or the present three-bay structure was designed as an extension to a pre-existing building on the east. The unpainted studs to the right date only from 2003.**

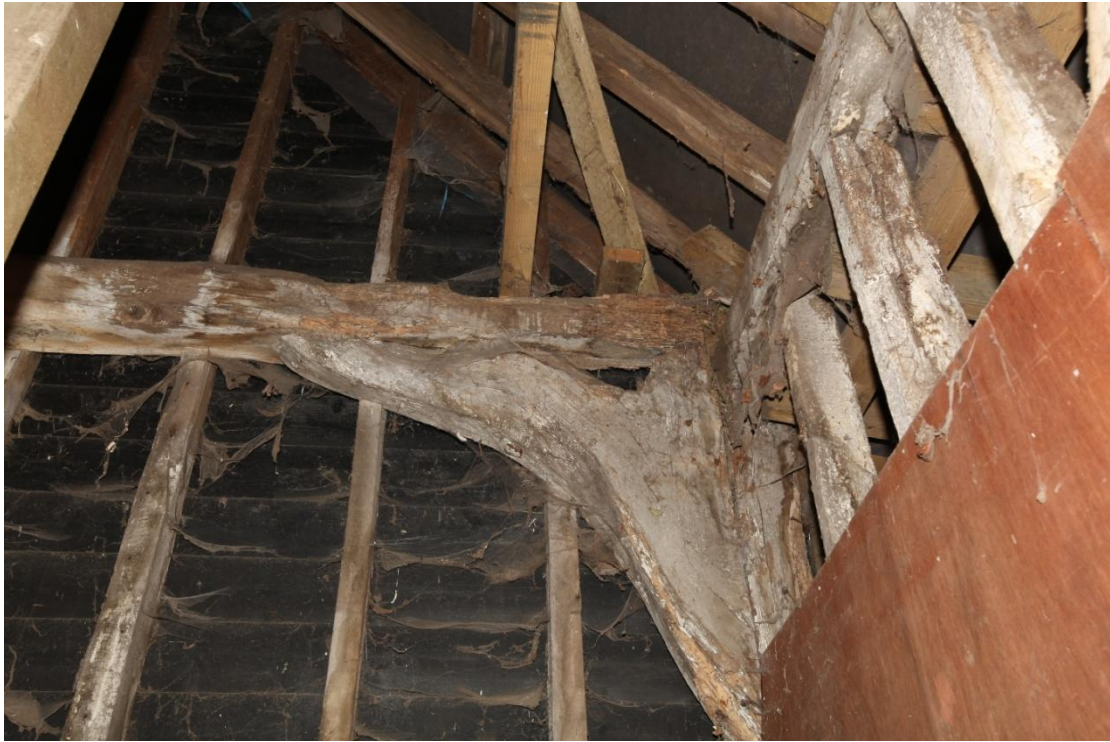
**Illus. 17. The original bolted knee-brace in the barn's south-eastern corner with no mortices in the tie-beam. With its counterpart on the north (illus. 16) this demonstrates that the structure lacked a solid wall on the east and either continued or was designed as an extension to an older building.**

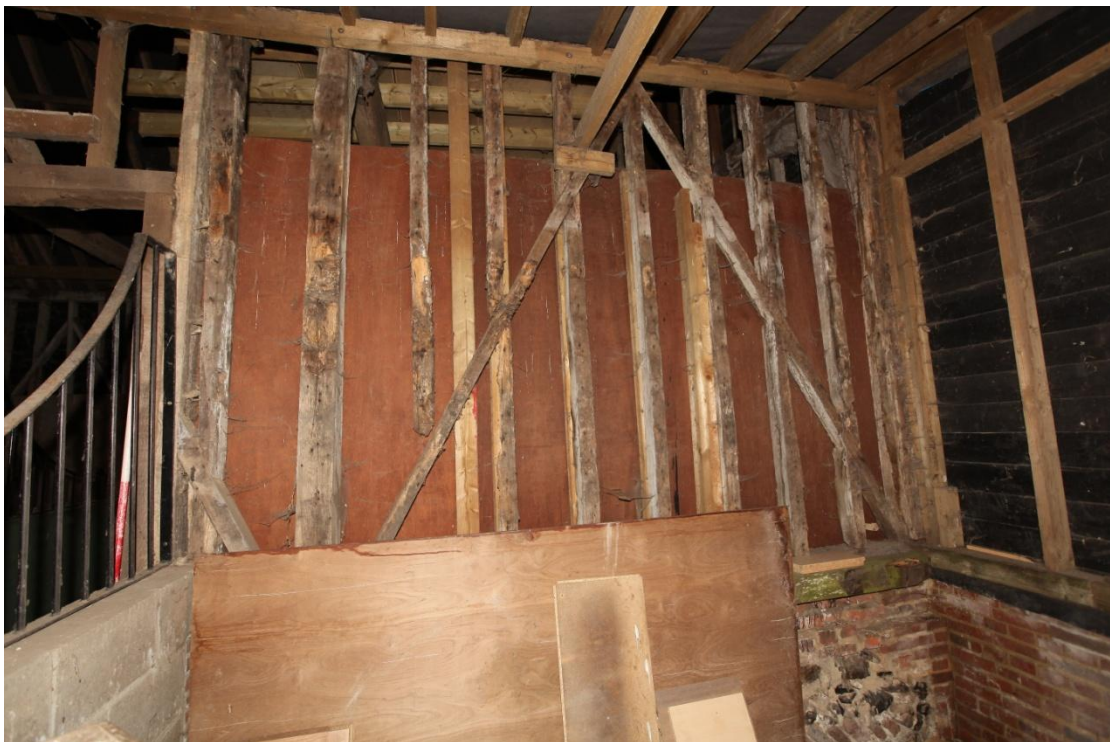
**Illus. 18. The southern exterior of the main barn's eastern bay from the modern lean-to extension showing its intact framing and flint-rubble plinth. This feature is mentioned in the listing description but the plinth has since been largely rebuilt in brick. Combinations of flint and diagonal brickwork of this kind are typical of Victorian rather than Georgian work.**

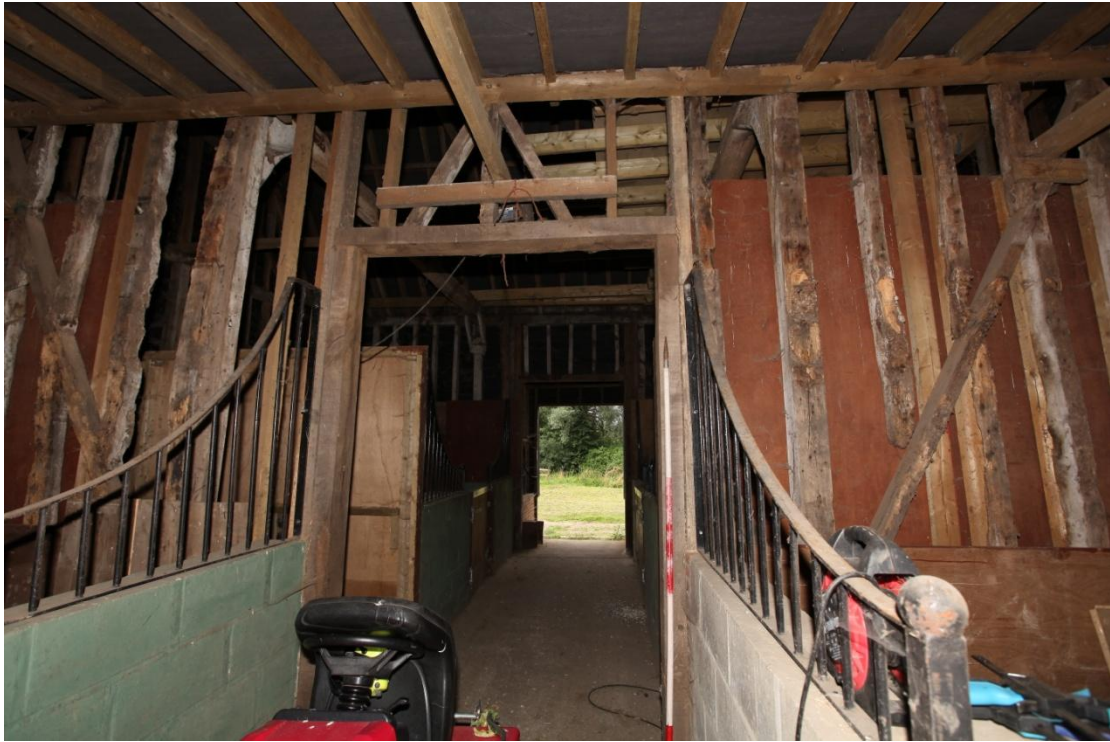
**Illus. 19. The southern exterior of the central bay from the lean-to showing the modern door frame cutting the original central stud and braces with the intact studs and diagonal primary bracing of the outer bays on each side.**
