Subject Property: **Sommerville, Hargate Drive, WA15 0NL**

Ref No: **24300**

- ✦ Inspect Ground floor & Upper floors for Damp & Associated Timber defect.

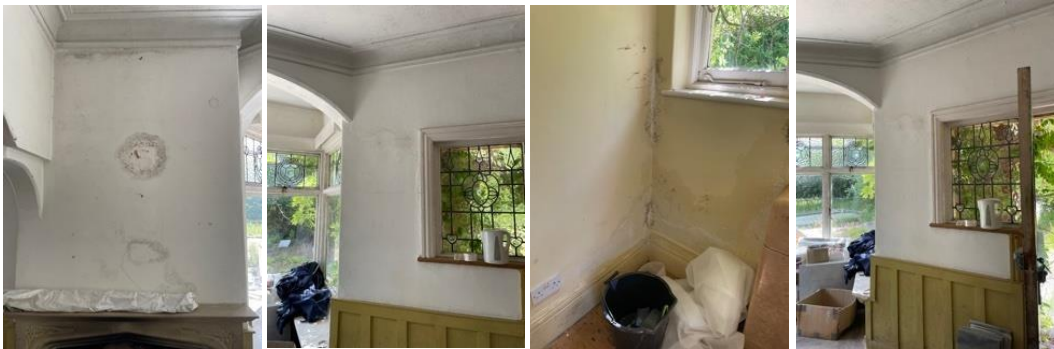
- Wall plaster condition is consistent with rising damp. Ground salts are known to be highly hygroscopic which means they can attract natural & excessive moisture (condensation) from the air and plasterwork will delaminate from the substrate as a result. The plaster in the property is hollow to a level of 1.5m – 2.0m which would indicate significant failure.

Damp affected wall plaster

- Internal plaster and timbers should be removed as a matter of course to prevent further damp transmission. Given the condition of the plaster/ level of mould growth within the property we would recommend plaster to all internal / external walls be removed. Replacement of affected wall plaster should be carried out using a Cavity Membrane Tanking with a dry-line plaster skim finish. This will fully prevent the transmission of ground salts or damp penetration and will also create a better surface temperature helping with potential condensation related problems.
- Poor room ventilation & adequate back ground heating as mentioned should be improved throughout the property. Replacement windows should be fitted with trickle ventilation and air bricks in the property replaced where appropriate.

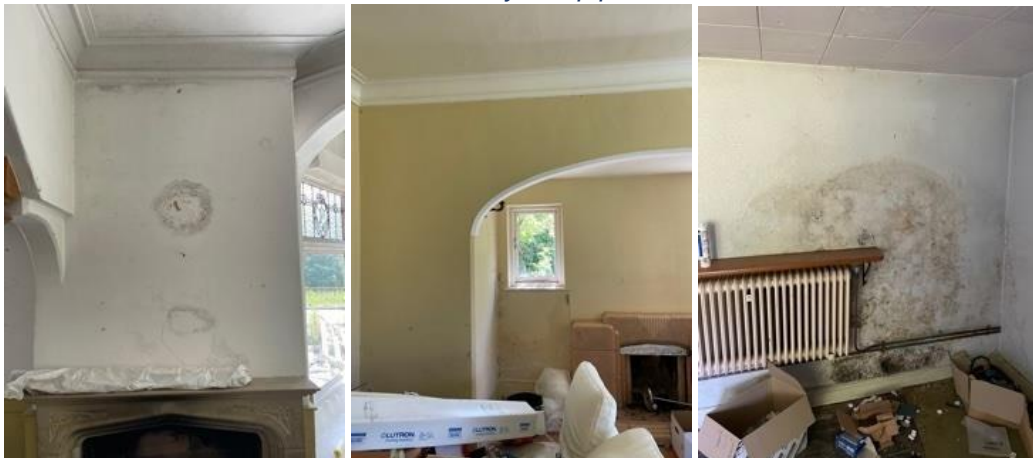
Plaster affected by damp penetration

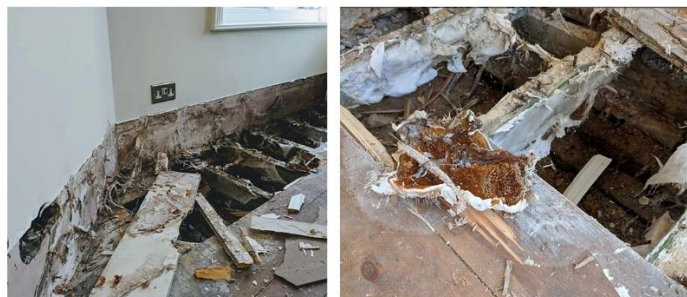
- The timbers exposed and inspected on the ground floor were found to be severely decayed and affected by *Serpula lacrymans* (dry rot). **See photo**
- 4no. Endoscopic images taken reveal presence of extensive dry rot in floor timbers at floor/external wall junction. **See photo**
- Substantial 'spring' in the ground floor consistent with deterioration in wall plate and floor timbers.
- Extent of fungal infection and long term exposure to damp through the absence of a DPC to the building's perimeter would suggest more widespread failure.
- Sub floor ventilation around the perimeter of the building was found to be inadequate, air bricks few in number and blocked with debris to all areas.

Dry rot in floor Joists

- Pending more detailed investigation, provisional allowance will need to be made for the replacement of all supporting timber beams and floor joists to ground floor suspended floors.
- Internal wall plaster will need to be removed to assess the extent of fungal spread. Treatment of non-affected areas will be necessary to prevent further infestation.
- Sub floor ventilation will require improvement with the installation of 10 No. 9x3" high flow bricks to allow a complete change of air per hour to under floor areas.
- Ventilation ports/bricks should be cleared on a regular routine basis to maintain sub floor airflow. It is also advisable to have sub floor timbers checked on a routine basis

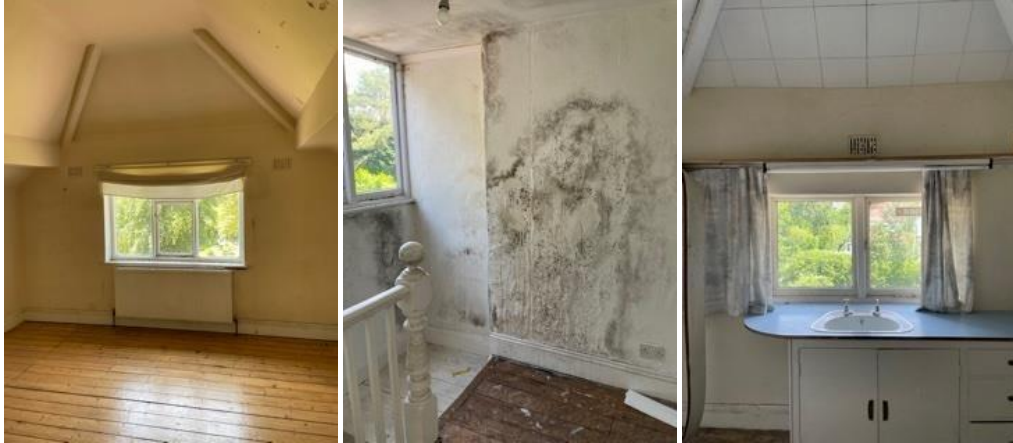
- Damp was detected to many of the bedroom walls below the windows. External walls showed elevated readings & were cold when touched.
- Ventilation throughout the upper floor rooms was seen to be inadequate which can invariably lead to heavy condensation & mould.

External walls affected by damp penetration

1. Roofing contractor to assess condition of main roof & rainwater goods – a low-level visual assessment suggested renewal of both.
2. Render was seen to be in poor condition and allowing rainwater to hold against porous brickwork – render contractor to assess & quote for full re-render.
3. Install replacement stone sills.
4. Replace damp affected wall plaster to affected bedroom walls & chimney breasts using 'tanking' membrane with dry-line plaster finishes.

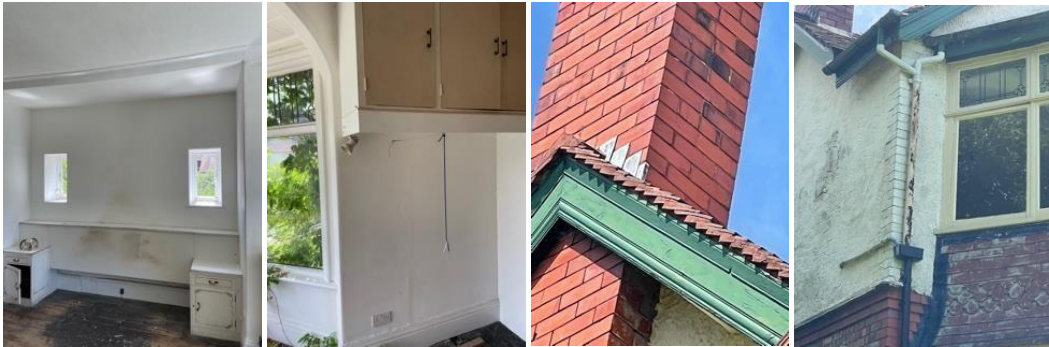
- Timber suspended floors appeared stable and showed no significant signs of 'spring'.
- Area of floor joisting exposed to principal bay (over affected area to ground floor) showed no signs of fungal growth or wood boring insect
- Patchy damp staining & sporadic moisture readings to upper chimney breasts in the bedrooms suggests soot (sulphate salt) contamination from the inner chimney breast flue. These soot / salts are highly hygroscopic (draws moisture from the air) have likely migrated into plaster due to past/present leak from chimney above.

Chimney breasts affected by soot/salt

Defective chimneys & rainwater goods

- Roofing contractor to confirm condition of chimney to ensure water tight (by others)
- Soot/salt affected plaster to chimney breasts to be hacked off and replaced with Cavity Membrane Tanking with a dry-line plaster skim finish. This will fully prevent the migration of soot/salts and will also create a better surface temperature helping with potential condensation related problems.

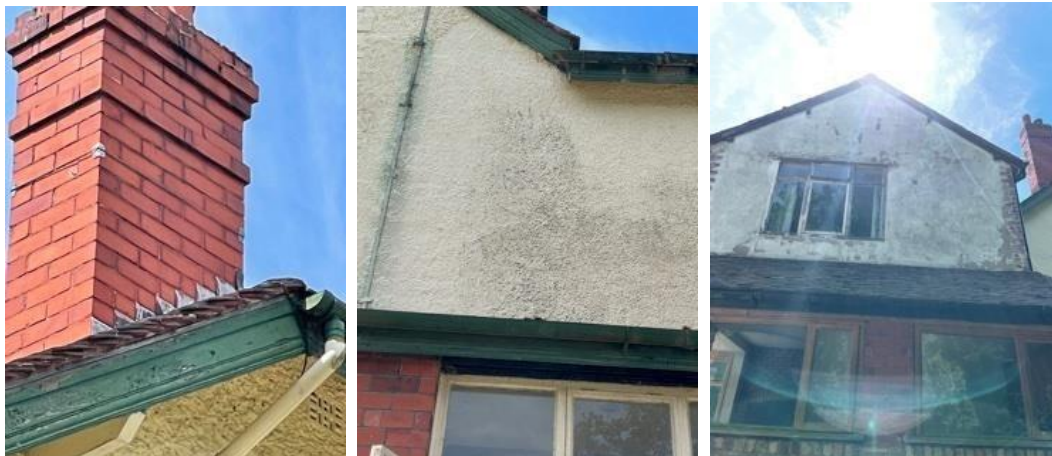
- Rainwater staining local to gutters/downpipes suggests leaks (mentioned earlier).
- Porous & frost bitten brickwork & cement render to upper walls have allowed damp to penetrate or create 'cold-spot' internally.
- Staining below the front middle rear bedroom window suggests erosion of the rainwater drip beneath the stone sill – this can contribute to internal damp penetration.
- Significant deterioration to property's render coat suggests removal will be necessary.

Weathered stacks & poor external render coverings

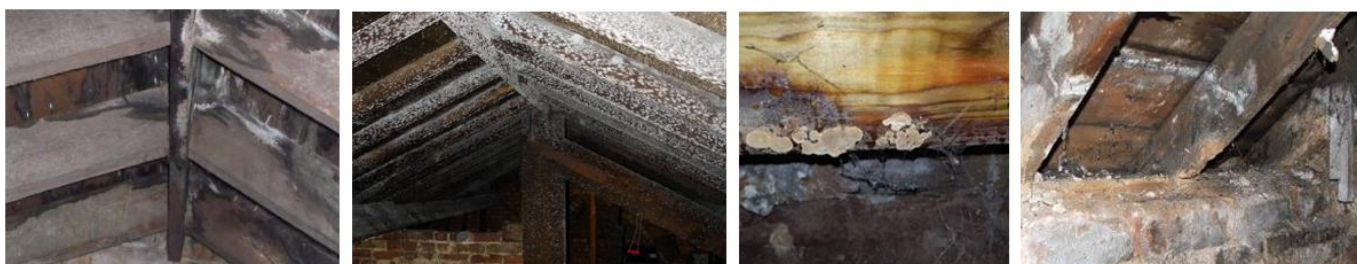
- Daylight visible through sections of the roof with significant moisture ingress to chimney stack and ridge line at junction with primary hip rafters on the Southern elevation.
- Elevated moisture levels recorded to all inspected timbers
- Absence of ventilation
- Absence of rolled or other insulation.
- The timber elements – purlins and wallplates - supporting the roof structures in contact with the brickwork at the head of the external walls contained significantly elevated levels of moisture together with widespread fungal infestation.
- The rafter feet in contact with the effected wall plate showed signs of early fungal decay, although the level of infestation was not as extensive as that to the supporting elements.
- Evidence of 'shaling' to the underside of the rosemary tile roof covering and an absence of roofing felt.

Wet rot in roof timbers

- Removal of roof coverings to assess full extent of roofing timbers – this will need to be conducted under a dry awning to mitigate further damp ingress
- Removal or treatment of affected timbers based in structural engineer's comments.
- Reinstatement of roof coverings together with suitable substrate
- Installation of vent slates to provide adequate ventilation to roof void.
