Schedule of Works For Listed Building Condition 3

Grange Farm, Potash Ln, Wyverstone, Stowmarket IP14 4SL

September 2021

Introduction

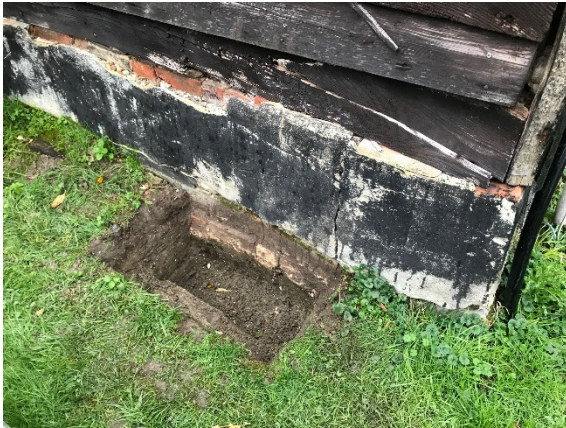
Photo 1

Trial holes were dug in two locations during December 2020 which determined the barn had little no foundations capable of supporting the proposed renovation works, see photo 1. New underpinning details have been designed by Morrish Consulting Engineers, see appendix 1, to support the replacement ground floor and structural frame improvement works. The appointed contractor is to ensure any temporary works and the excavation of the walls is undertaken in a phased approach to not undermine existing structure.

Trial holes to northeast corner. 4-5No. brick courses below ground level with no foundations discovered, structural engineer has recommend underpinning to perimeter walls, refer to appendix 1.

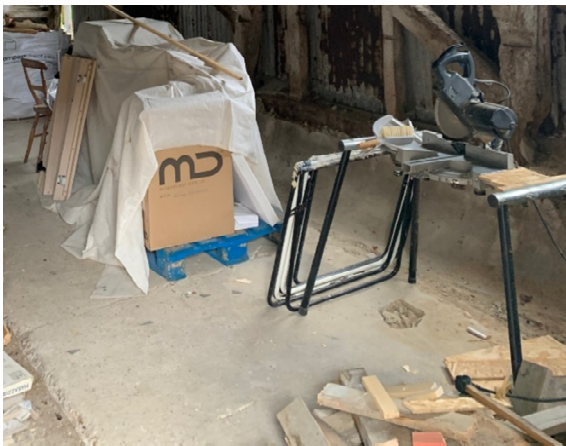
Photo 2

The existing floor is constructed from roughly 100mm of concrete, with a later 50mm poured to a section believed to be used as the animal feed area, see photo 2. This section has also been cast up the eastern (internal) plinth wall to create a trough. The existing concrete slab is to be broken out along with careful removal of the concrete trough. A new insulated ground bearing slab with screed finish is to be installed over a blinding and hardcore base, refer to floor type 01 on architects drawing 301.

Existing concrete floor with curved upstand to internal plinth brickwork face (east elevation). Concrete floor to be broken out and upstand removed.

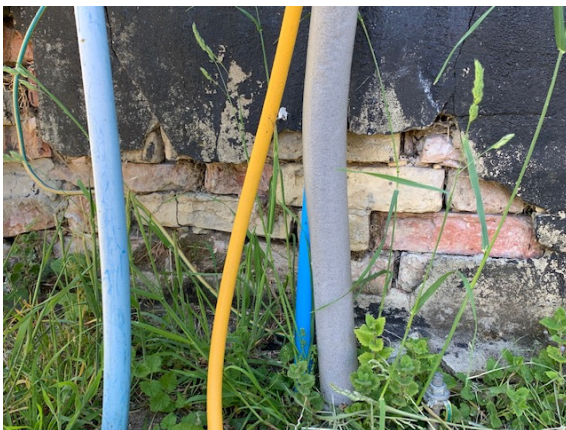
Photo 3

The barn's plinth is constructed from solid brickwork (215mm) and externally finished in painted render. The brickwork is generally in poor condition and requires repair to replace all mortar joints with the worst sections completely removed and rebuilt, see photo 02. All new mortar to be lime based 1:2:9 cement: lime: sand/aggregate mix with flush pointing.

Exposed external brickwork face to the South/East corner of the barn's plinth (black render over). Sections where the bricks have significantly moved, the bricks to be removed and re-laid.

The existing external render is to be chipped off the brick faces and the surface made good with lime repairs (as above). A new lime based render to be reapplied and painted black to match the existing.

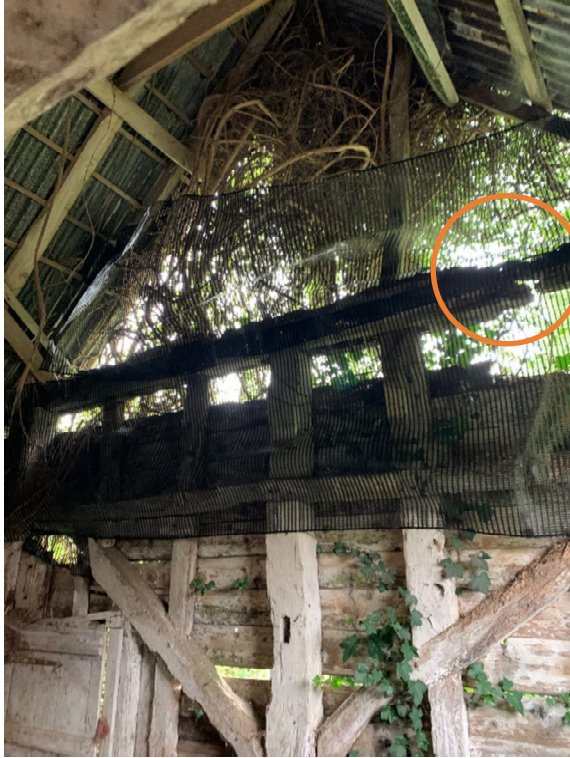
Photo 3

All vegetation growing (predominantly western elevation) to be removed and timber frame treated for damage, damp or wood rot. The structural timbers from the north gable wall have collapsed causing rainwater ingress, this high level section of the gable is to be rebuilt with new timber post constructed off a replacement cross beam. Refer to photo 3 illustrating the extent of the damage.

Missing timber posts to gable (northern) wall. Water ingress has damaged the cross beam causing extensive rot. Cross beam to be carefully removed and replaced with new oak to match existing profile.

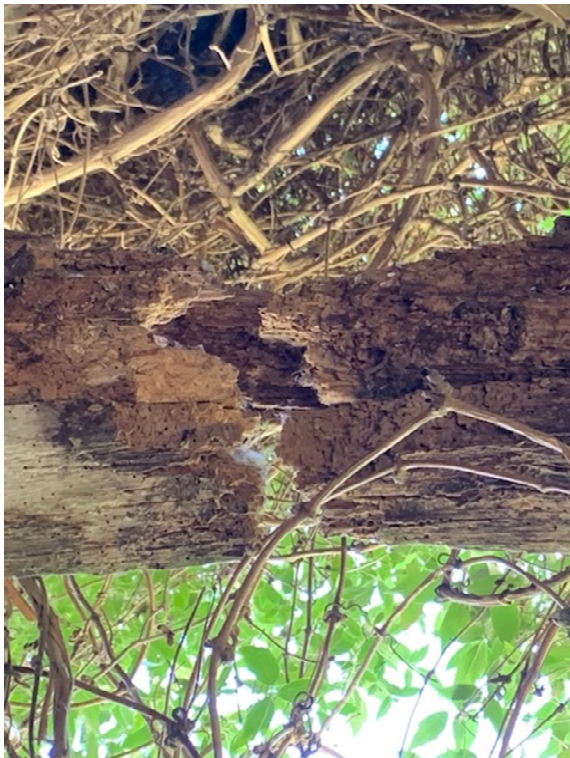
Photo 4 – Cross beam

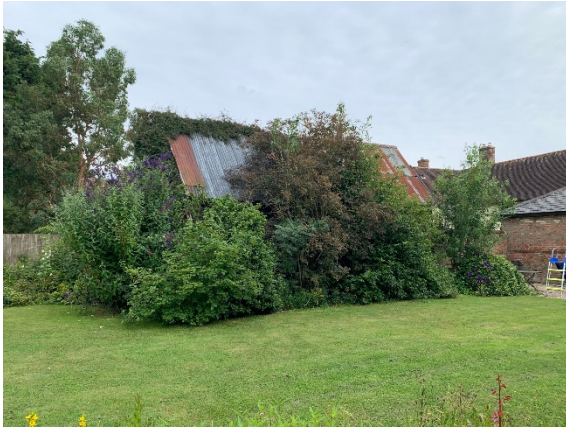
Photo 05

Overgrown vegetation to western elevation/boundary. Access agreed with neighbour to remove shrubs growing within close proximity to barn wall prior to commencing underpinning.

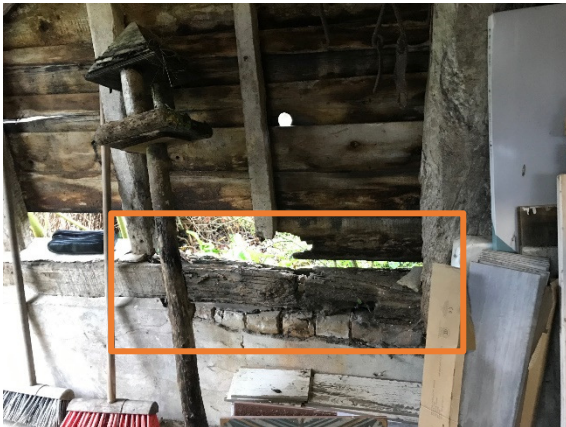
Photo 06

Example of rotten sole plate which requires removal. Section to be cut out and replaced with seasoned oak and match size/profile.

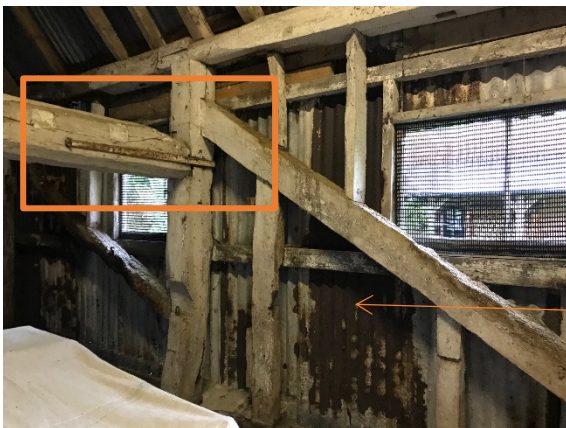
Photo 07

Existing steel strapping to be removed and replaced with steel fitch plates as to engineers details.

Friction fit, breathable insulation to be installed between timber post/membranes. Refer to architects drawing 2017-PL.301 for specification.
