REMEDIAL WORKSMETHOD STATEMENT

BLAKE HOUSE
BLAKE END
RAYNE
BRAINTREE
CM77 6RA

Report Title: Remedial Works Method Statement

Project Name: W H & J Harvey Partnership, Braintree

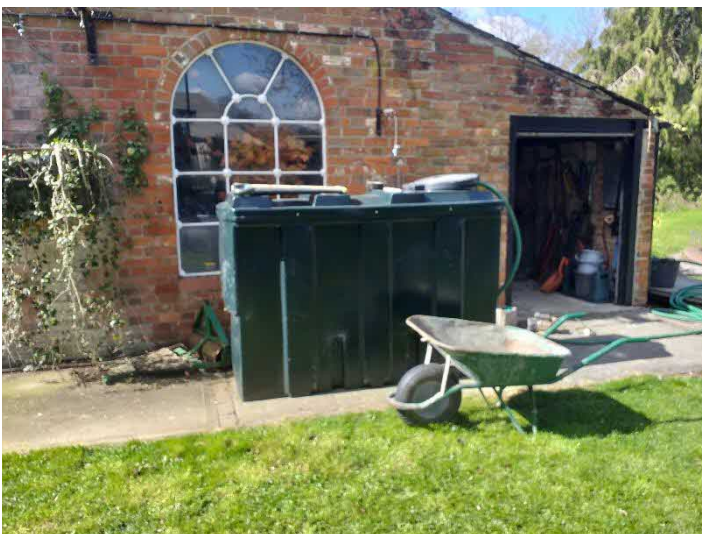
Photo 3: Temporary OST installed to maintain a supply of fuel to the boiler. Boiler located through garage door on the right.

- The boiler within the boiler room is to be temporarily relocated by an OFTEC registered engineer to allow access to the contaminated soils below the spill origin. The temporary OST will also require relocating by an OFTEC registered engineer to allow the concrete and soils to be removed from below its current location.

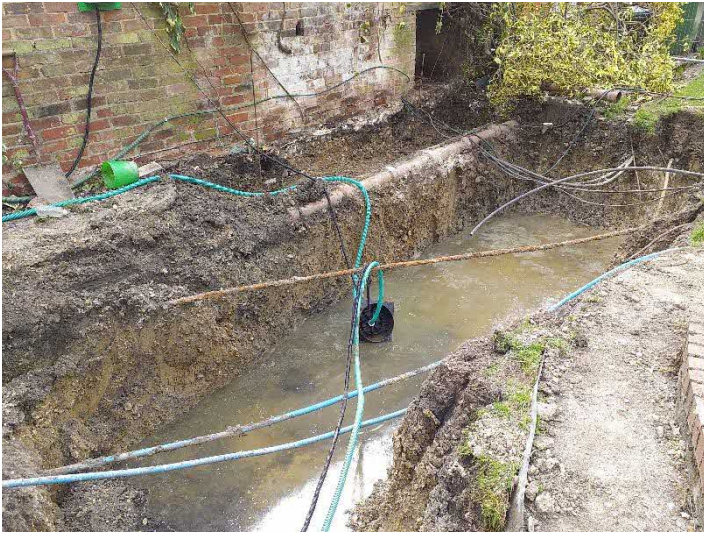
Photo 4: Extent of current remedial excavation to the north of the garage.

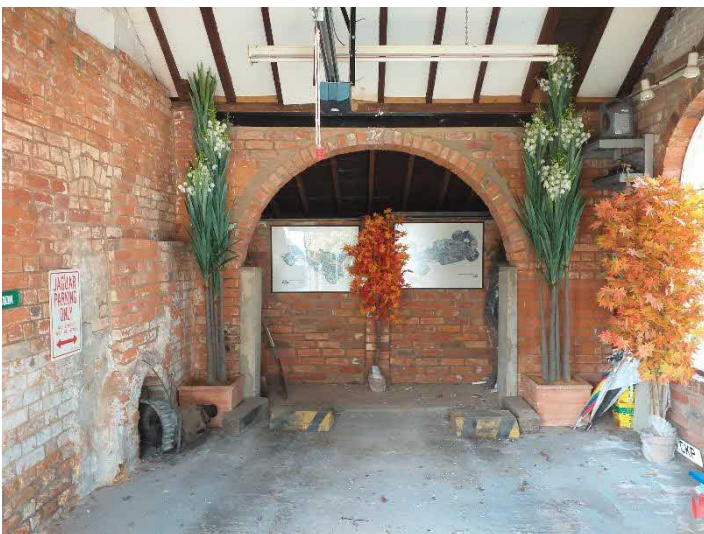
Photo 6: View inside of room 1 and view of brick archway towards the back. The roof beyond is that of the boiler room.

- The concrete floor slab will be broken out over the entire footprint of the room measuring approximately 18 m². The soils below will be excavated to the depth of the footings and stepped out at a 45° slope if found to be shallower than 1.0 m bfl.
- Care will be taken when excavating in the vicinity of the brick archway as the below ground construction / foundation is not known.

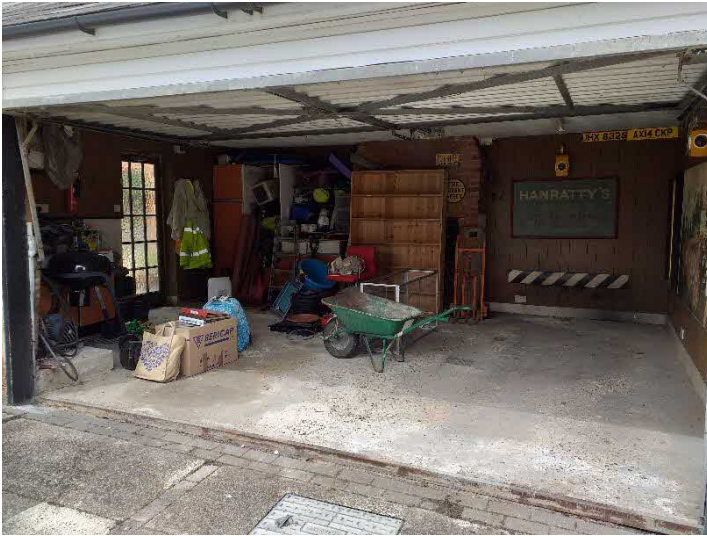
Photo 7: View inside room 2. A fireplace is located behind the wooden bookshelf at the back.

- The concrete floor slab will be broken out over the entire footprint of the room measuring approximately 30 m². The soils below will be excavated to the depth of the footings and stepped out at a 45° slope if found to be shallower than 1.0 m bfl.
- It is at this point that OEE will attend site and undertake a detailed probehole survey of all exposed below ground structures. It is anticipated that sub floor structures may require replacement or in situ treatment and therefore a structural engineer will be appointed at this stage to comment on the safe procedure for removal of the contaminated structures.

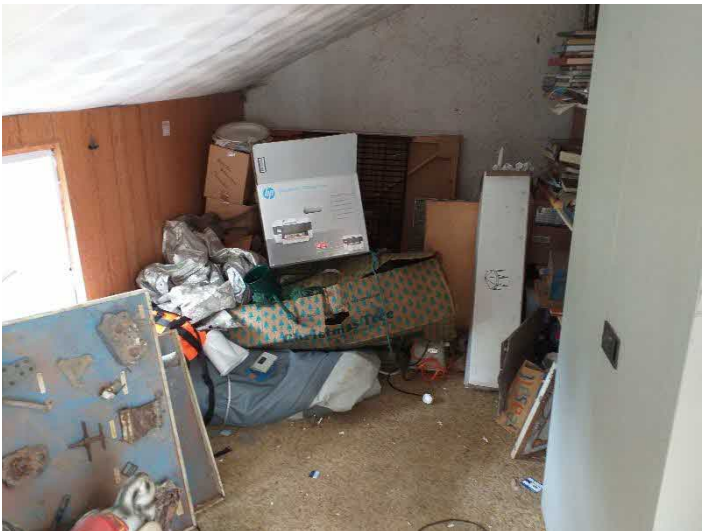
Photo 8: View inside of the office.

- The carpet and underlay in the office will be lifted and removed from site for appropriate disposal.
- It is anticipated that power cables are passing below the office floor therefore great care will be taken when breaking out the concrete and excavating below. The floor should be scanned using a CAT and Genny by an appropriately trained person.
- The concrete floor slab will be broken out over the entire footprint of the room measuring approximately 13 m². The kerosene contaminated soil below will be excavated to a provisional depth of the footings known to be approximately 0.9 m bfl on the dividing wall with the boiler room. The sides of the excavation with the external walls will be excavated to the depth of the footings thought to be 0.4 m bfl or unless deeper footings are encountered.

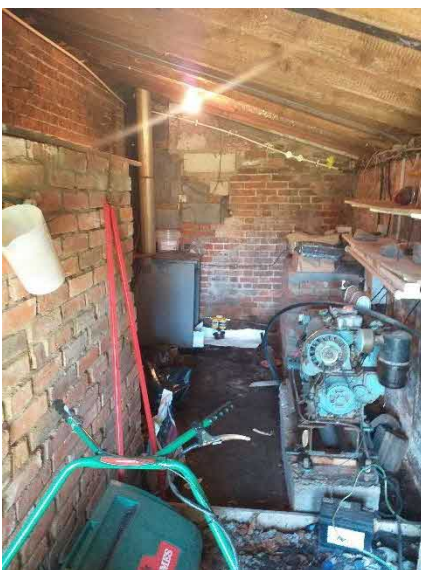
Photo 9: View inside the boiler room which houses the boiler (far left back corner).

- The concrete floor of the boiler room will be broken out over the entire footprint of the boiler room measuring approximately 10 square metres (m²). The kerosene contaminated soils below will be excavated to the depth of the footings at 0.9 m below floor level (bfl) at the dividing wall between the boiler room and the office.
- The footings of the north western wall are much shallower at 0.4 m bfl and will be excavated to this depth against this wall and stepped out at a 45° to maintain stability of the wall. The contaminated arisings will be transferred to the skip for appropriate disposal.

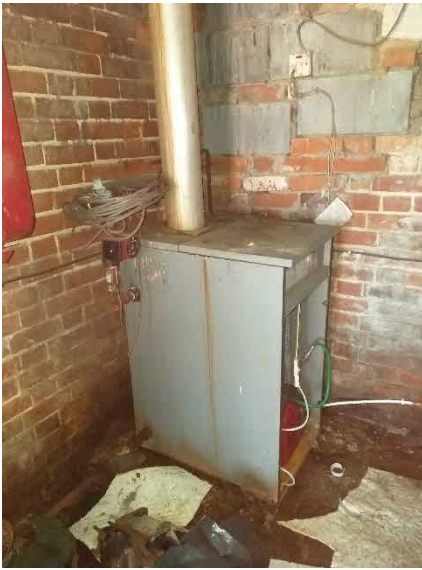
Photo 10: View of the boiler and location of the spill origin.

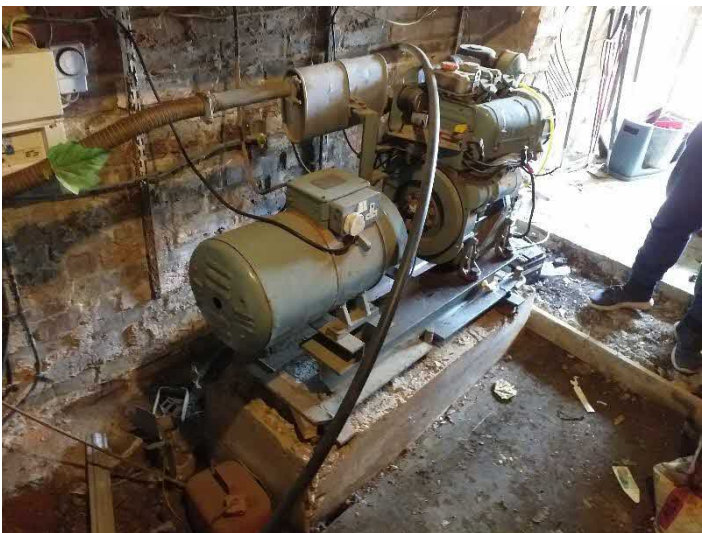
Photo 11: View of generator which will require removal to allow access to the soils below.

- The generator within the boiler room is to be removed and placed into temporary storage for the duration of the works by a suitably trained electrician.

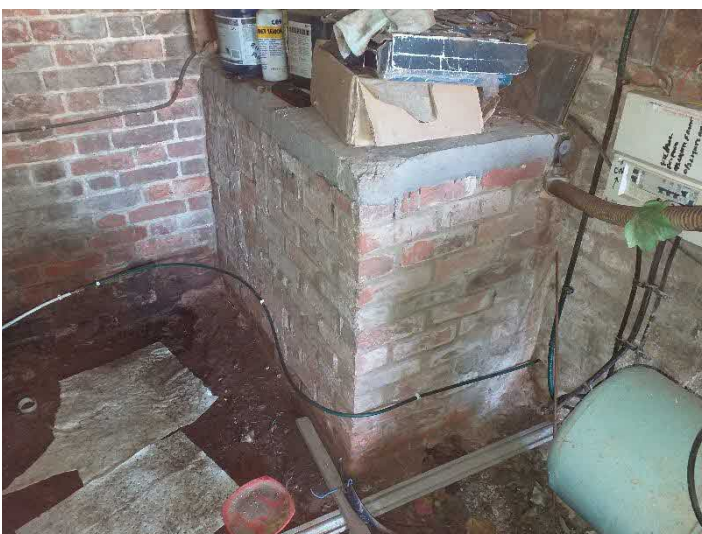
Photo 12: Brick structure within the boiler room.

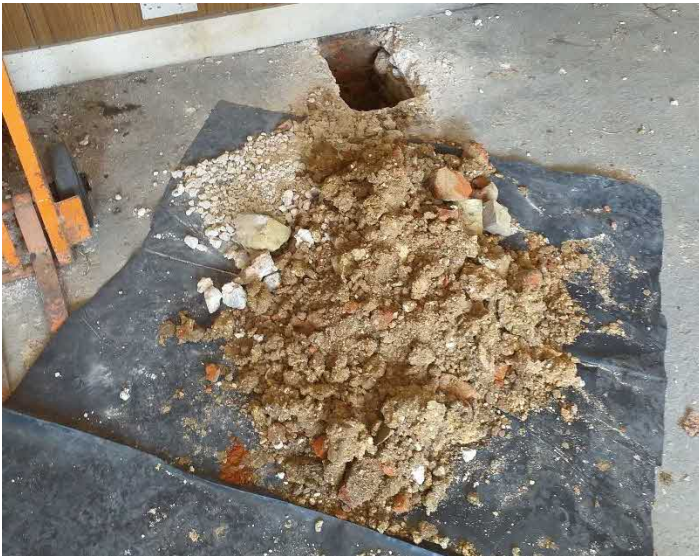
Photo 13: View of soil arisings hand dug from trial pit TP-3.

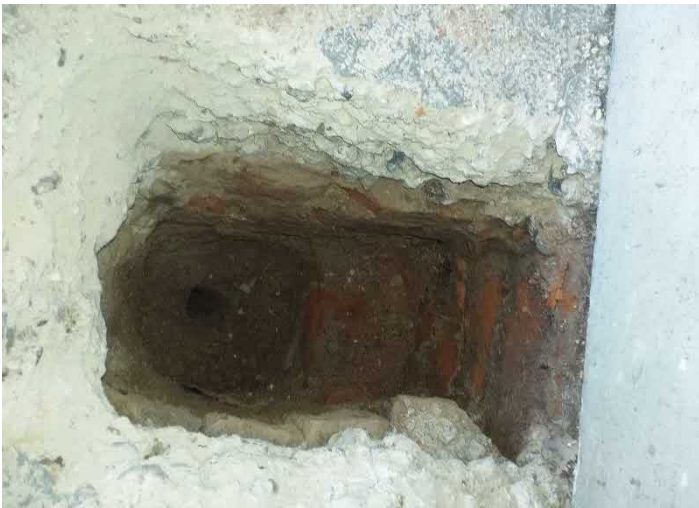
Photo 14: View of below ground brickwork exposed within TP-3.

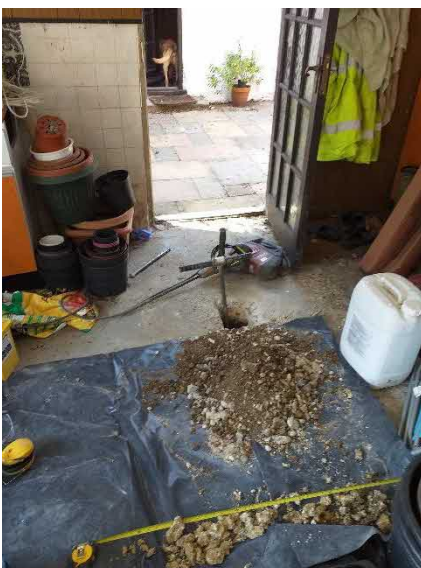
Photo 15: View of location of TP-5. Note doorway leads out to paved area and door to main dwelling observed left of plant pot.
