Application for Discharge of conditions

Properties 3 and 4, The Street Boxted. IP29 4JP

Application Reference DC/20/03230

Timber frame and Infill findings Following the removal of the render from the rear(north) elevation of the properties.

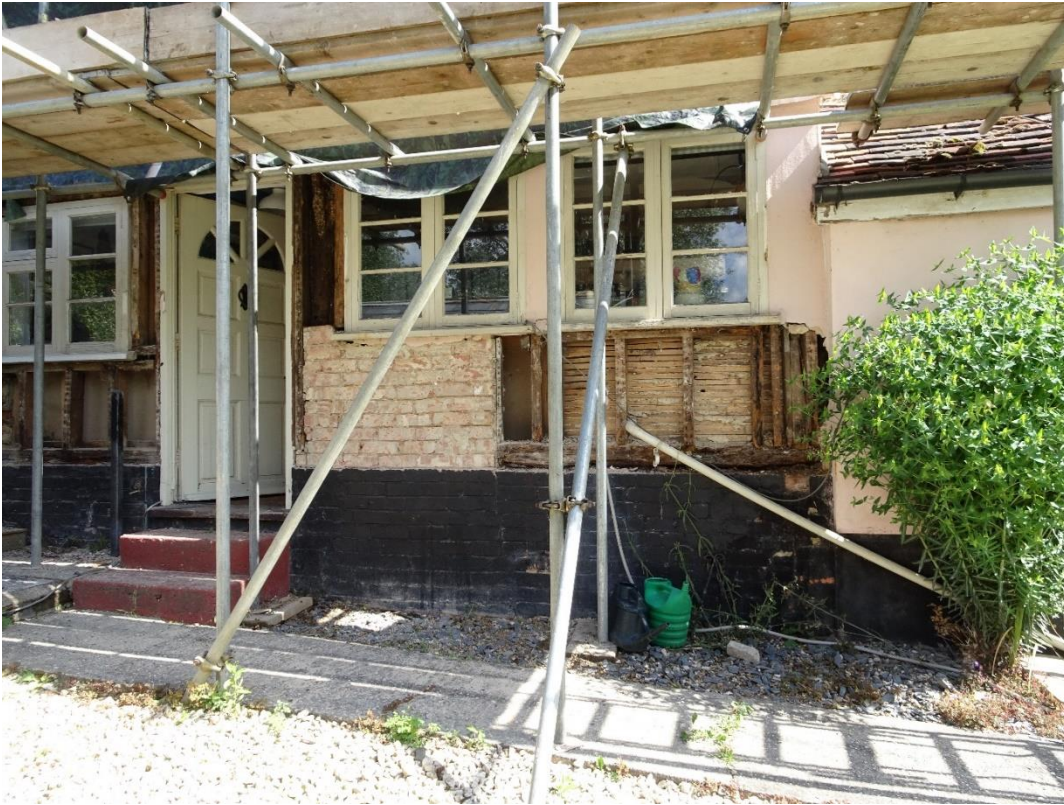
The upper (first floor) level is all wattle and daub. The ground level infill consists of brick, wattle and daub, lathe and plaster and an area of boarded infill. The only cavity that will need to be insulated is below the kitchen windows.

1. Rear elevation showing below kitchen windows

Infill cavity below rear elevation kitchen windows using natural sheepswool insulation. Fix Laths and Apply lime plaster as per original application.

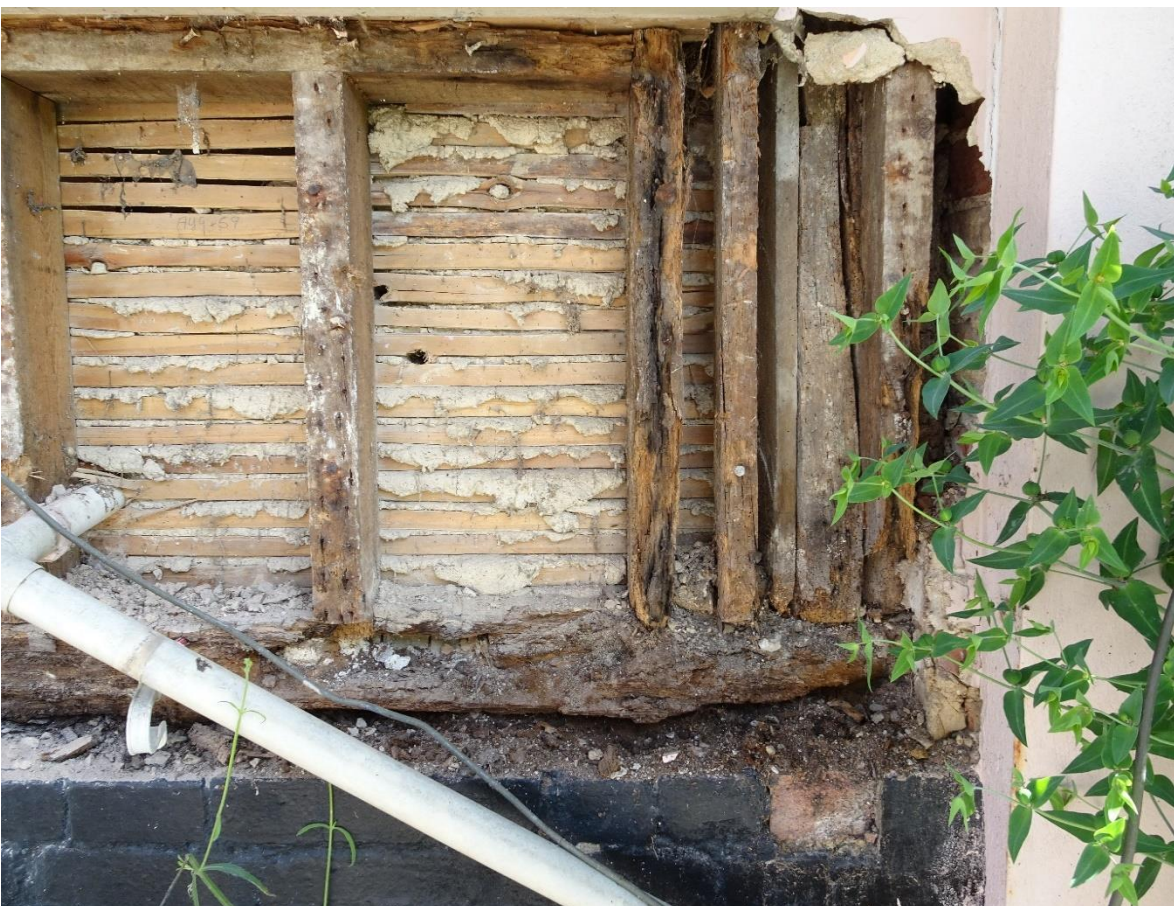
The Timber frame is sound in all areas throughout the building. We have not detected any signs of rot or worm damage except below the rear elevation kitchen windows where there is an area of rot to the plate in the corner. There is evidence of modern alterations to this area of the building, the rear wall has been extended out and the original frame is visible behind the modern timbers, a newspaper dated from the 1970s was found in the infill beneath the kitchen window, which may indicate when these alterations were carried out. We will not be carrying out any repairs to the original frame.

Plate beneath north elevation window RH side of door

2. Showing Rear elevation below kitchen window – close up of corner of plate which needs to be replaced.

Support weight load above window with Strongboys and Acro's. Cut timber plate

Cut rotten timber where it becomes solid, removing all the rotten section (see photo) splice in new oak timber using traditional pegged Scarf joint. (see illustration). Re-tie in existing studs to new plate using coach bolts.

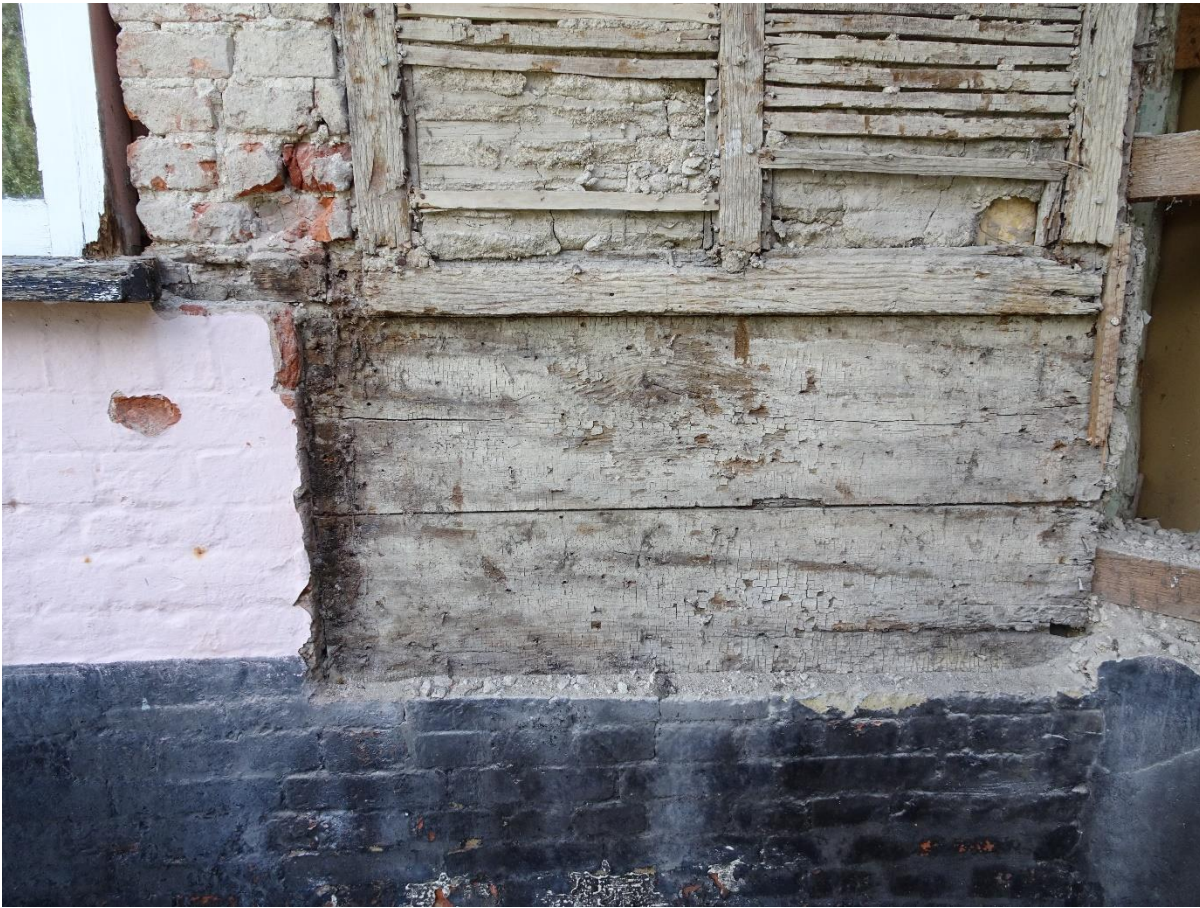
3. showing area of boarded infill

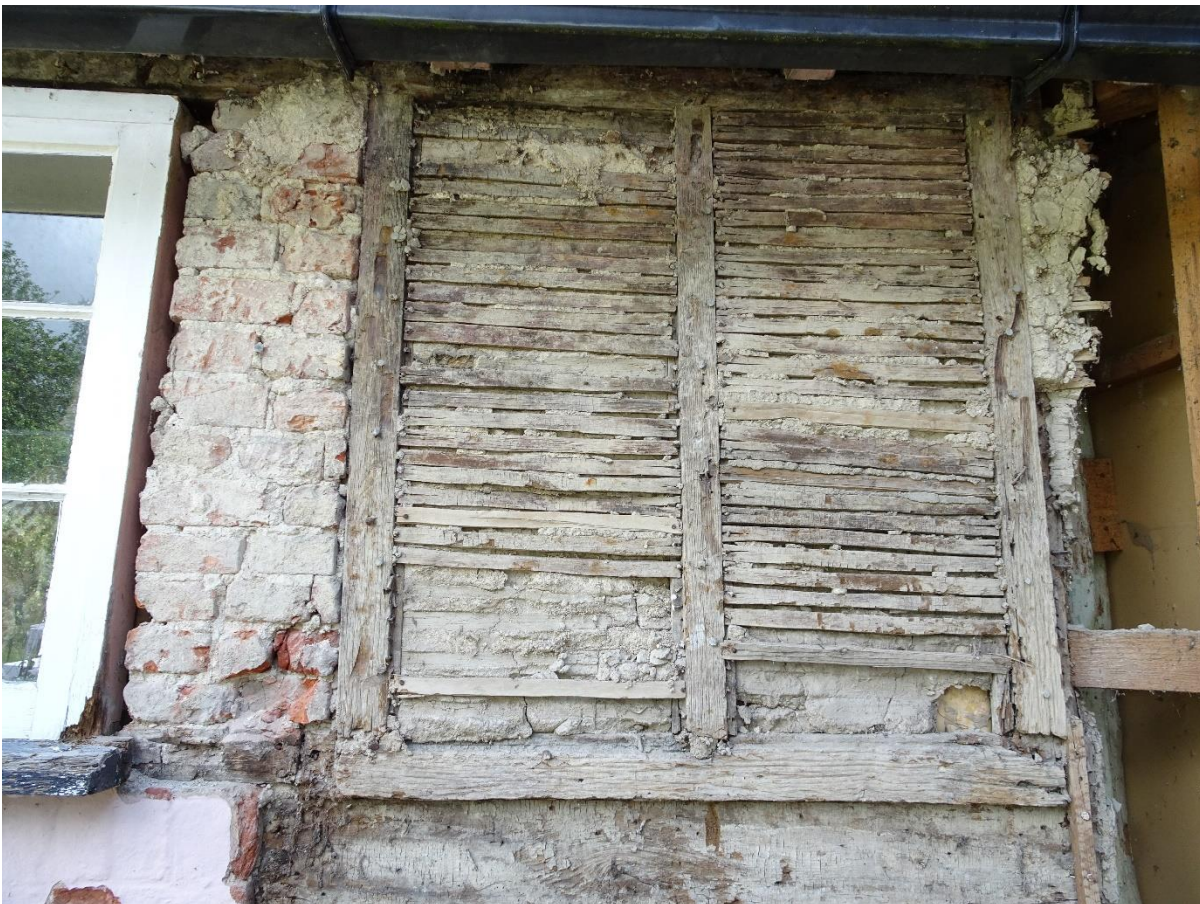
4. Showing original laths

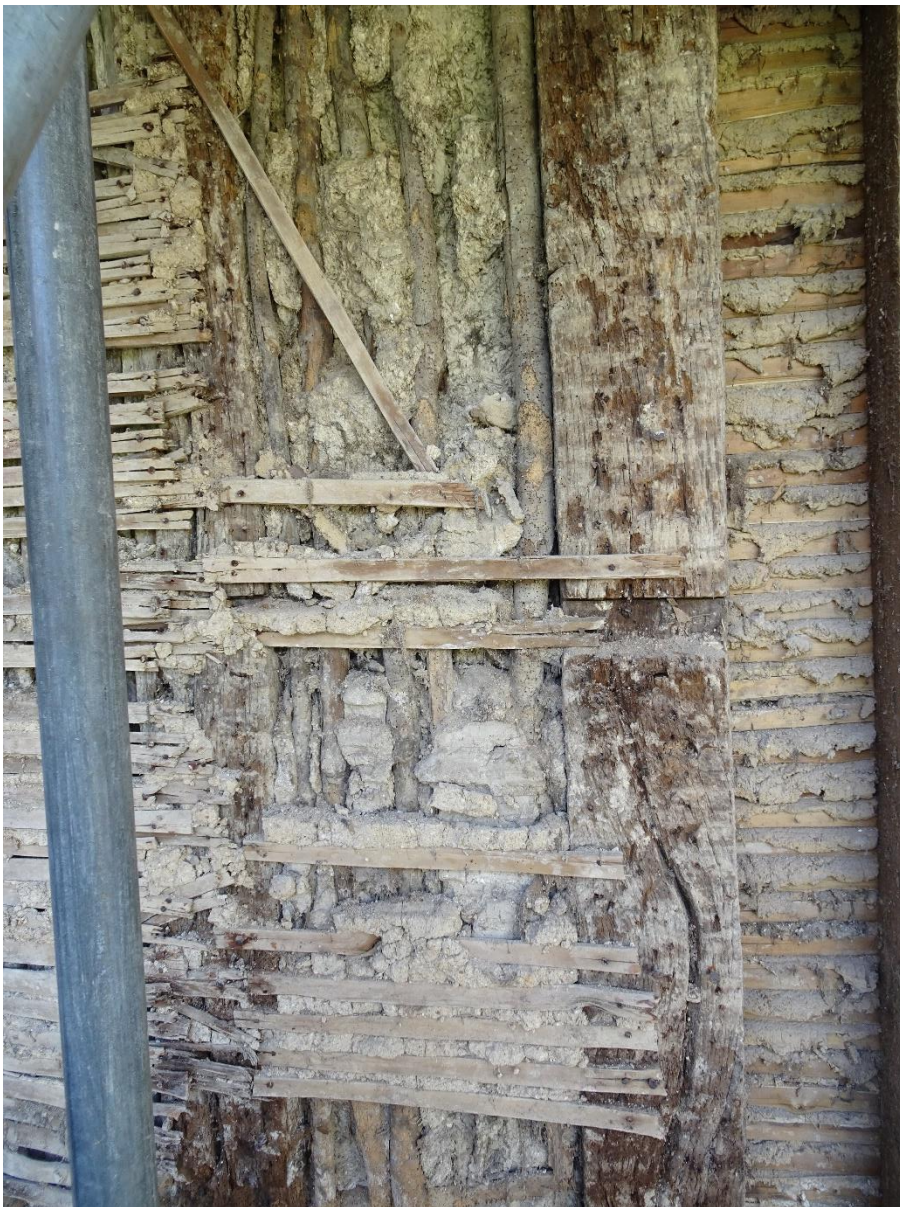
5. Showing wattle and daub infill
