**STRUCTURAL AND BUILDING METHODOLOGY STATEMENT
FOR THE RESIDENTIAL CONVERSION OF GRANARY BARN
AT**

**Trelash Farm
Warbstow
Launceston
PL15 8RL**

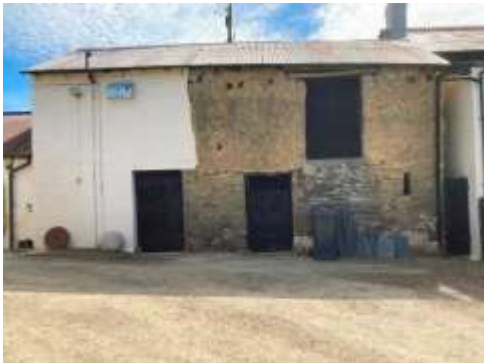
Fig 1

- concrete block infill repair - these have been necessary where the cob has failed either through ingress of rainwater or past lateral pressure caused by spreading roof trusses when a heavier roof was in place, The repaired areas are suitable for re-use in the proposed conversion - Figs 1 & 10

- un-rendered cob walls at 1st floor level. (Figs 1 & 4). These have been adequately repaired where necessary and there are further areas in need of repair - in particular the south corner has fallen out at 1st floor level (Fig 14) so installation of the new door there will need to be preceded by further concrete block repairs and insertion of a suitable lintel to support the roof truss. Also stitching repairs to the west gable end will be required (Figs 9 & 13)

- render, retain & extend concrete block infill repair
- treat & retain (or renew where necessary) sawn timber floor joists and boards
- insulate dry-line & retain massive rubble stone retaining wall

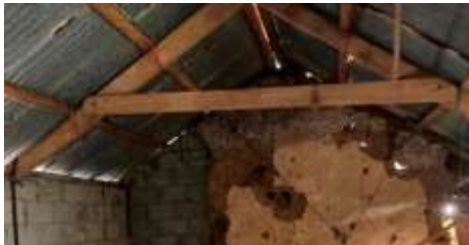
- sawn timber floor joists and boards - most of the boards should be replaced and some of the joists - Fig 12
 - massive rubble stone retaining wall - these are in reasonable repair and the joints only will require raking out and re-pointing - Fig 12

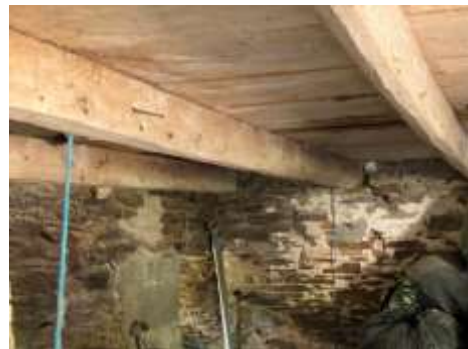
Fig 9

- corrugated steel sheet roof cladding – galvanising has failed (particularly on south elevation) and will need replacement throughout - Figs 15 & 16
 - sawn timber purlins - adequate condition, but undersized - sufficient for a lightweight roof covering - Figs 5 & 9

- treat & retain (or renew where necessary) sawn timber purlins
- treat & retain (or renew where necessary) sawn timber rafters
- re-position/renew sawn timber tie beam to reduce lateral pressure to the tops of the long-walls

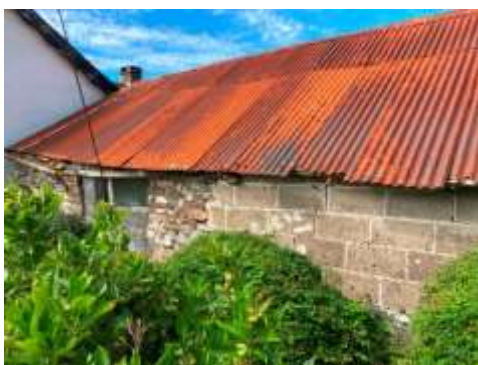
- 2.3 Described below are the main elements, their condition and their suitability for reuse in the proposed residential conversion.
- steel ridge cap - Fig 16

- Install new ventilated steel ridge cap
- new domestic grade profile steel roof cladding
- install insulation leaving air-gap with air flow ventilated at ridge & soffit
