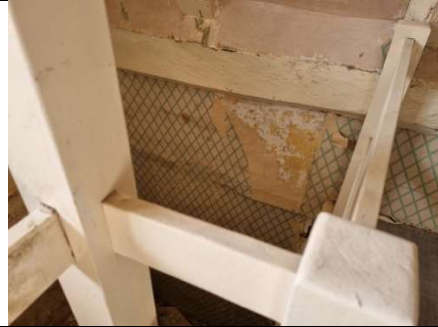
Stairway wallpaper removed showing limewashed lime plaster beneath and also sections of gypsum plastered wall/ceiling. All in good condition and no repairs required. Location C.

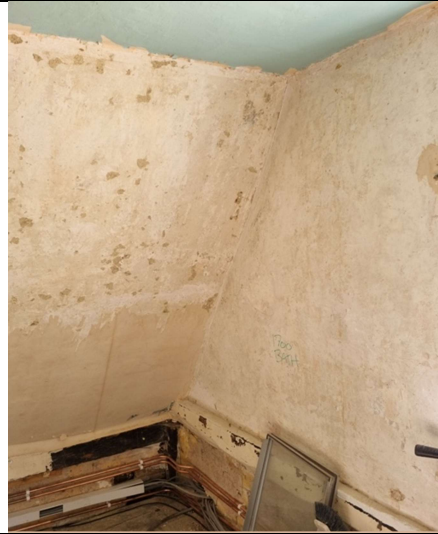
Bathroom wallpaper removed showing limewashed lime plaster and areas of gypsum plaster beneath. All in good condition and no repairs required. Location D.

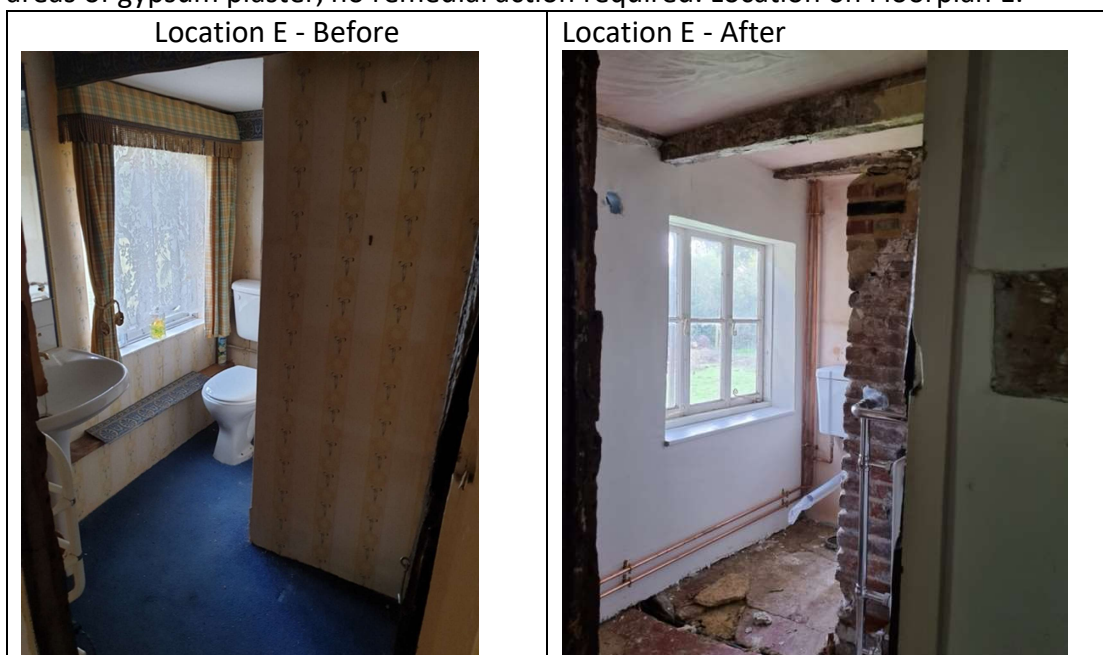
Photo showing Parlour WC before with fibreboards lining the walls and subsequent photo of exposed walls with fibreboards and boxing removed. No damage to underlying fabric, walls in good condition, composed of lime, bare brick and some areas of gypsum plaster, no remedial action required. Location on Floorplan E.

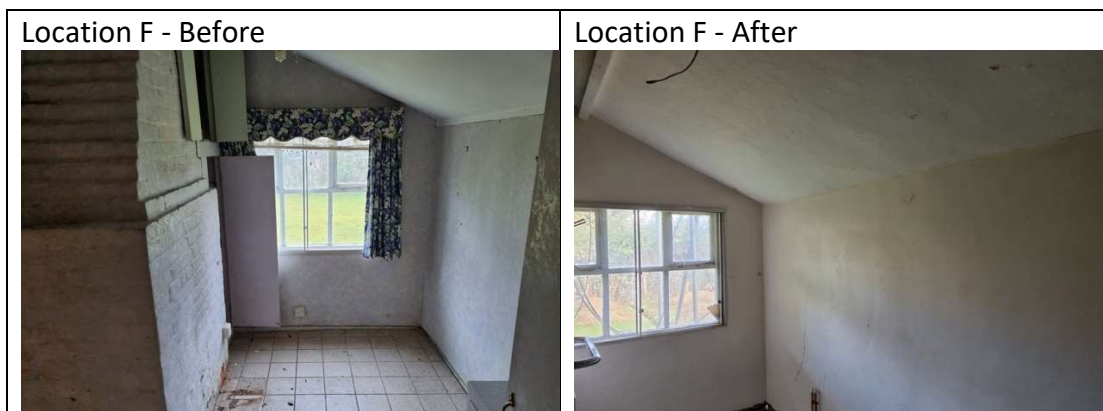
Photo showing Downstairs Bathroom/Service end before with fibreboards lining the walls and subsequent photo of exposed walls with fibreboards removed. No damage to underlying fabric, walls in good condition, composed of lime and no remedial action required. Location on Floorplan F.

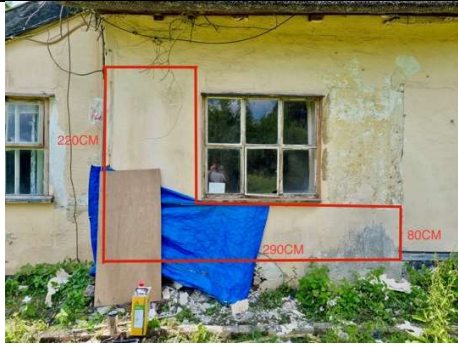
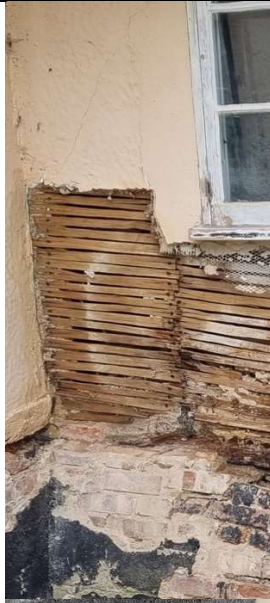
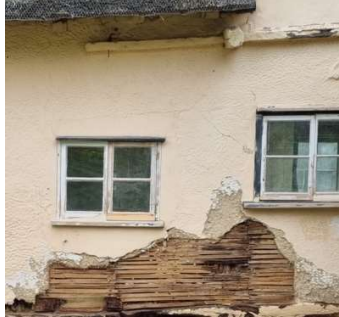
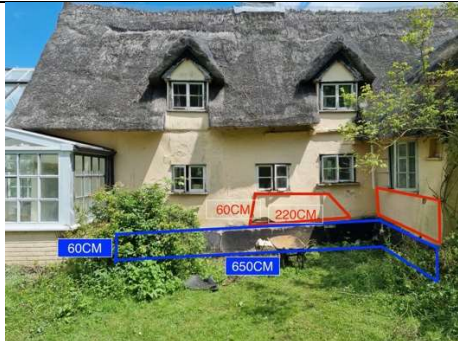
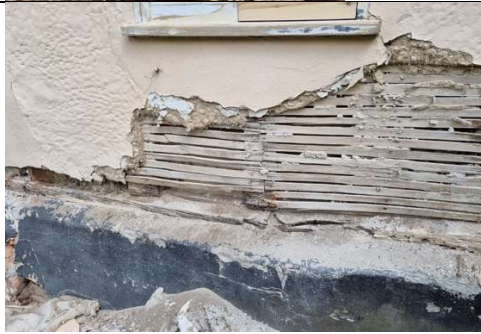
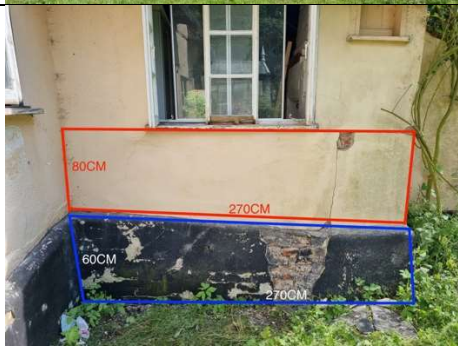
Photos showing areas of concrete render to be removed and photos of render removed. Location on Floorplan G, H and I. Most existing Riven Chestnut laths in good condition, brickwork plinth in good condition.
