The owner of the tree, Mr Andrew Ashworth has concerns over the condition of the tree and its location to a neighbouring house and has requested a visual tree assessment (VTA).

The tree was inspected on the 15th October 2021 by Aaron Bailey of AB Forestry, Hull. The weather conditions were slightly overcast and dark.

The location of the tree is in the rear garden of 4 Walnut Close, Cottingham. East Riding. HU16 4PR.

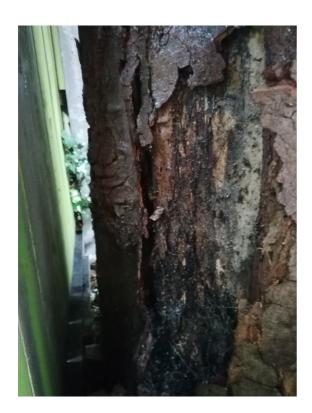
On the eastern side of the stem from ground level up to approximately 1.5 metres high is an area of complete bark stripping. Upon removing some sections of loose bark it is possible that Armillaria fungus was present. A small section of the white mycelium was visible and the typical black bootlace rhizomorphs associated with the fungus were present leading all the way up the damaged section. (Picture 1). (No toadstools present).

Picture 1. Possible evidence of Armillaria. Black bootlace rhizomorphs and white mycelium.

As Sycamore is a highly susceptible to Armillaria species fungus and the location of the tree with its weighted canopy to the South it would be advisable to remove the tree.

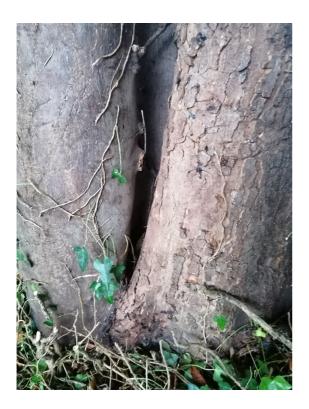
Picture 2. Tight union at base of tree with rainwater cavity forming.
