Photographic Report

Client Name	United Living
Name of Surveyor	Richard Keeley
Project Name	Mulready House
Address	Mulready House, Marsham St, London SW1P 4JL
Phone Number	079-401-2929
Email Address	Richard@opuswaterproofing.co.uk
Weather Conditions	Overcast

Pre-Work Inspection Checklist (Dormer 1)

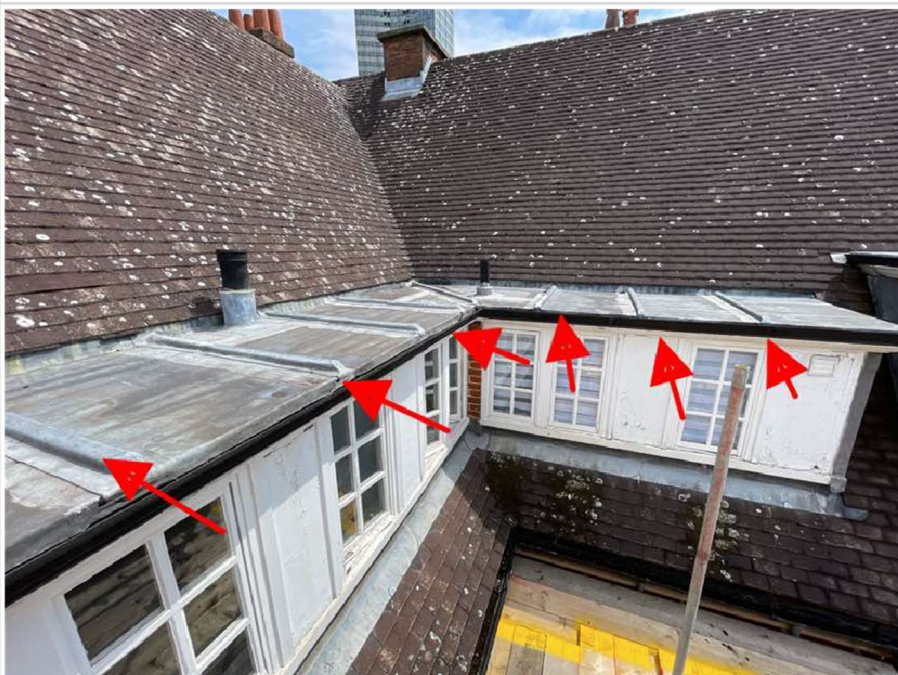
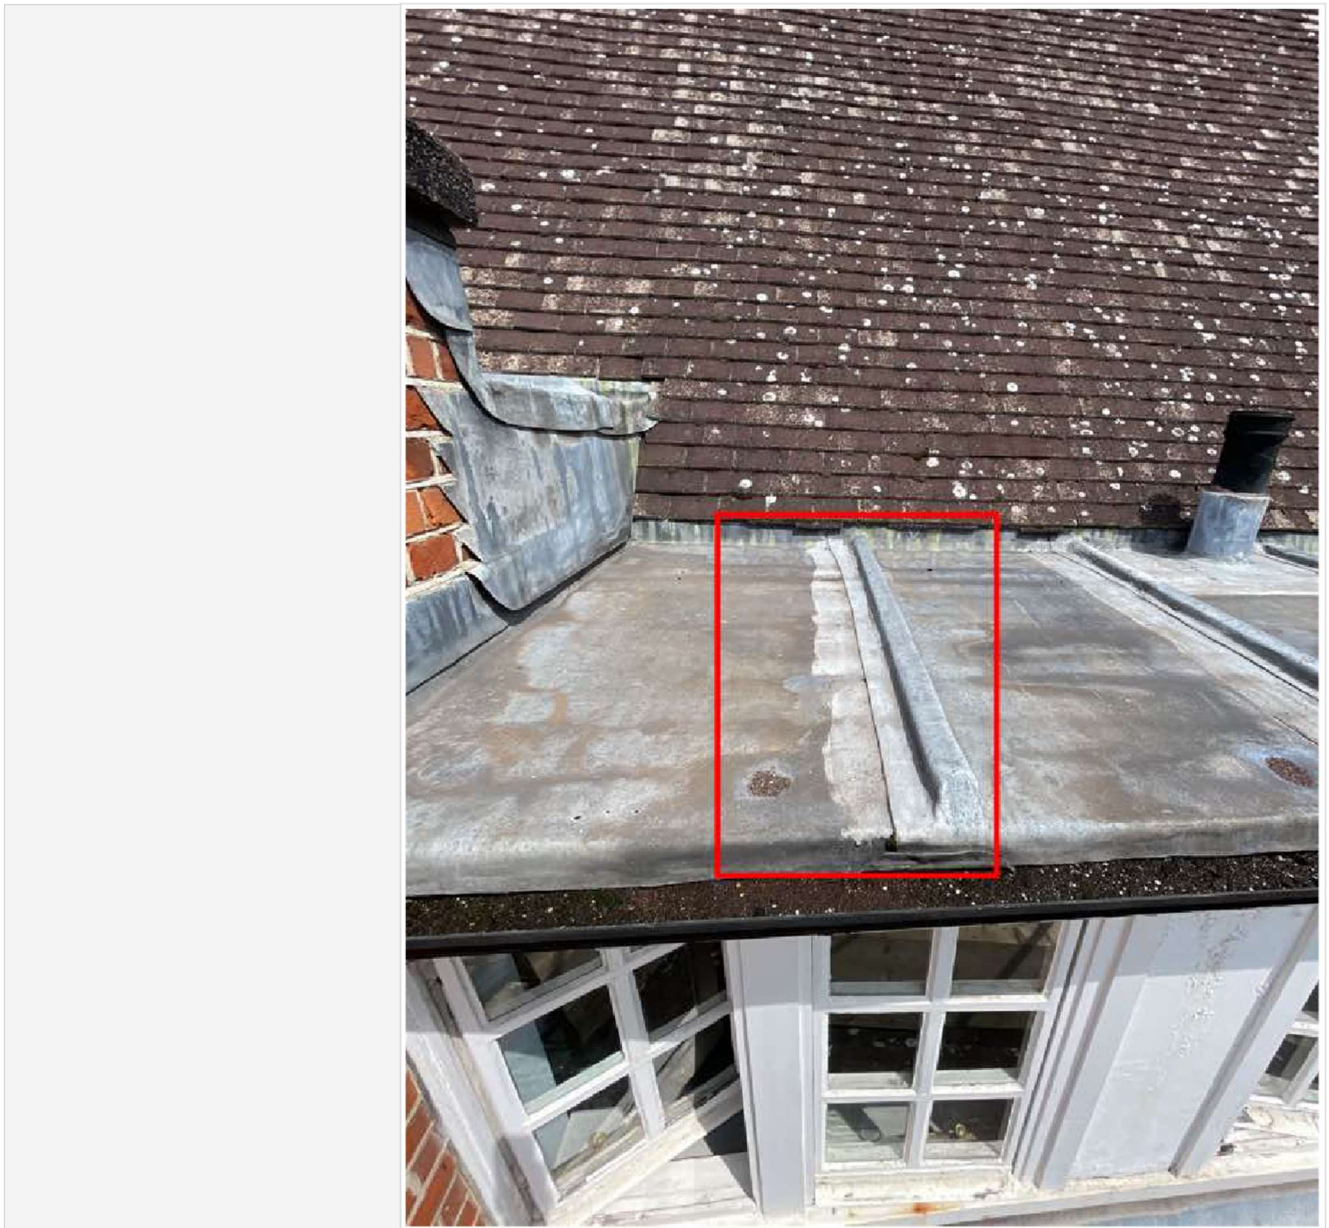
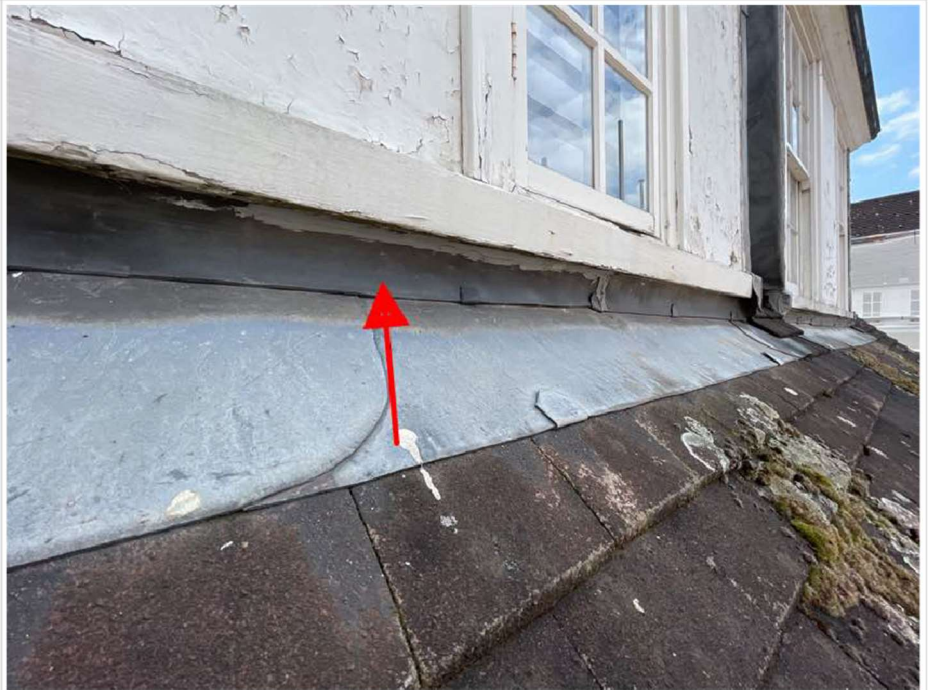
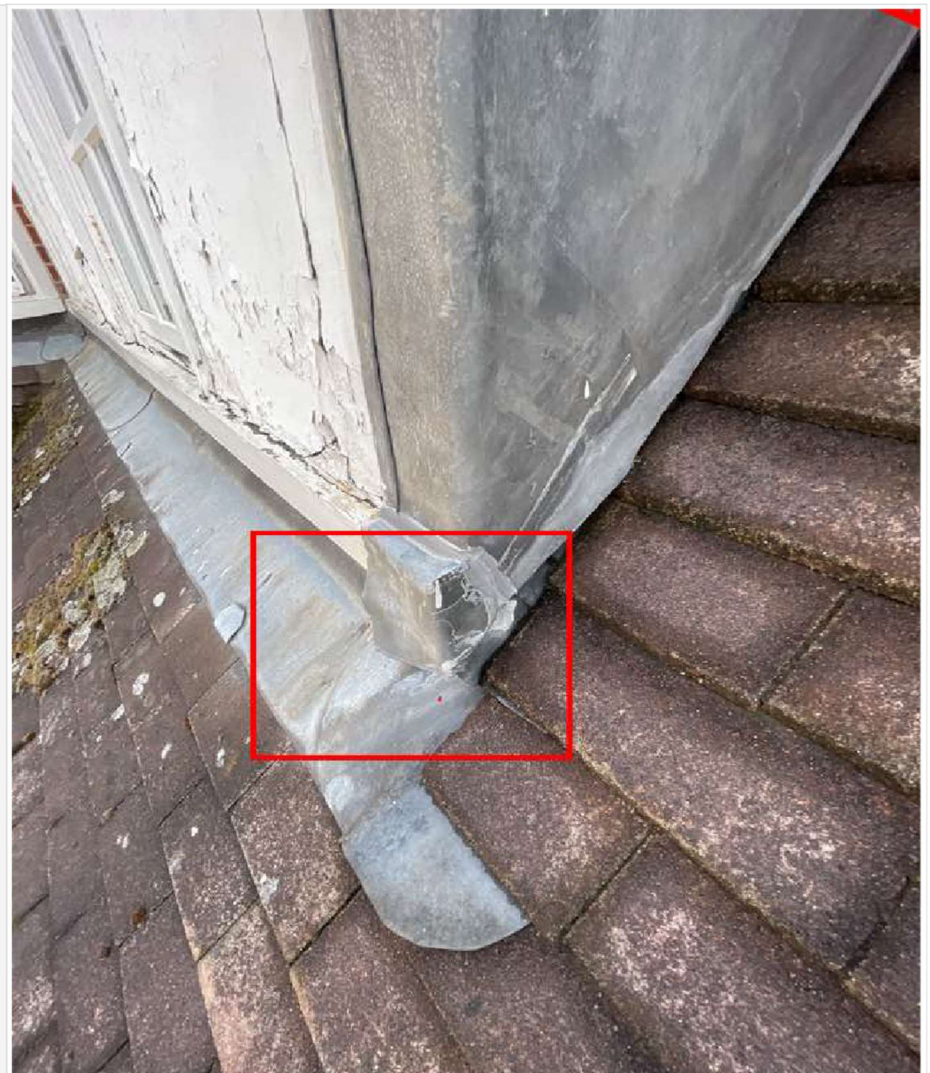
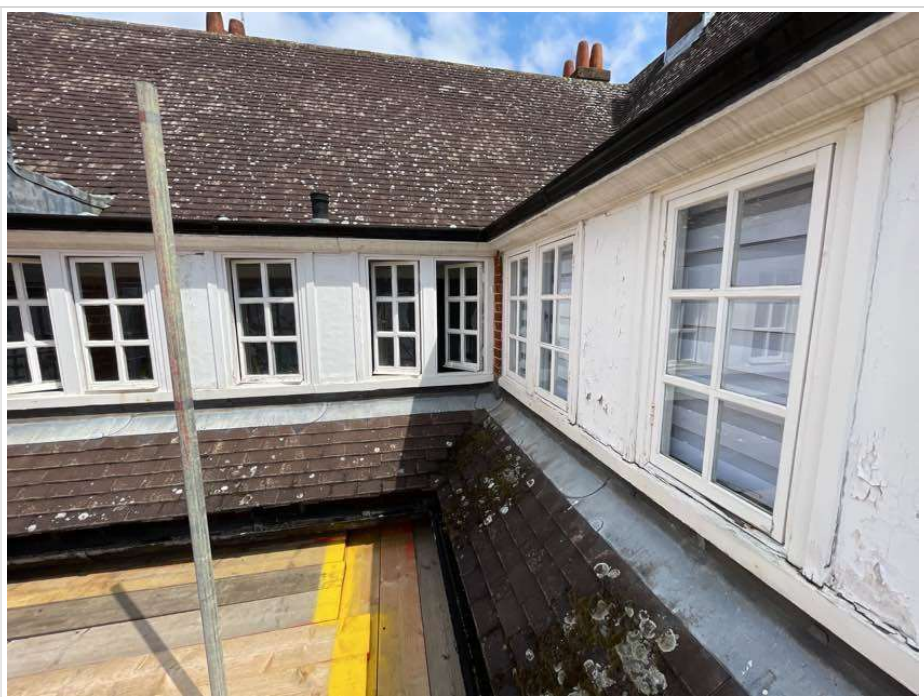
Comments	<p>The existing Lead has been repaired in multiple locations which would suggests there has been historic water ingress. There was also evidence of mastic repairs to the gussets and flashings.</p>
Proposed Works	<p>If water is found to be penetrating the building. We would recommend changing the lead on a like for like basis to the areas identified within the pictures. All lead works would be carried out in line with the current LSA guidelines. We would also recommend lining the existing aluminum gutters with a liquid applied waterproofing.</p>
Quantity of Materials	<p>10 roof bays 1200mm x 2000mm (code 6 lead sheet) - 1lm 100mm flashing (code 5lead) - 1 no lead gusset (code 6 lead) - liquid seal 9lm</p>

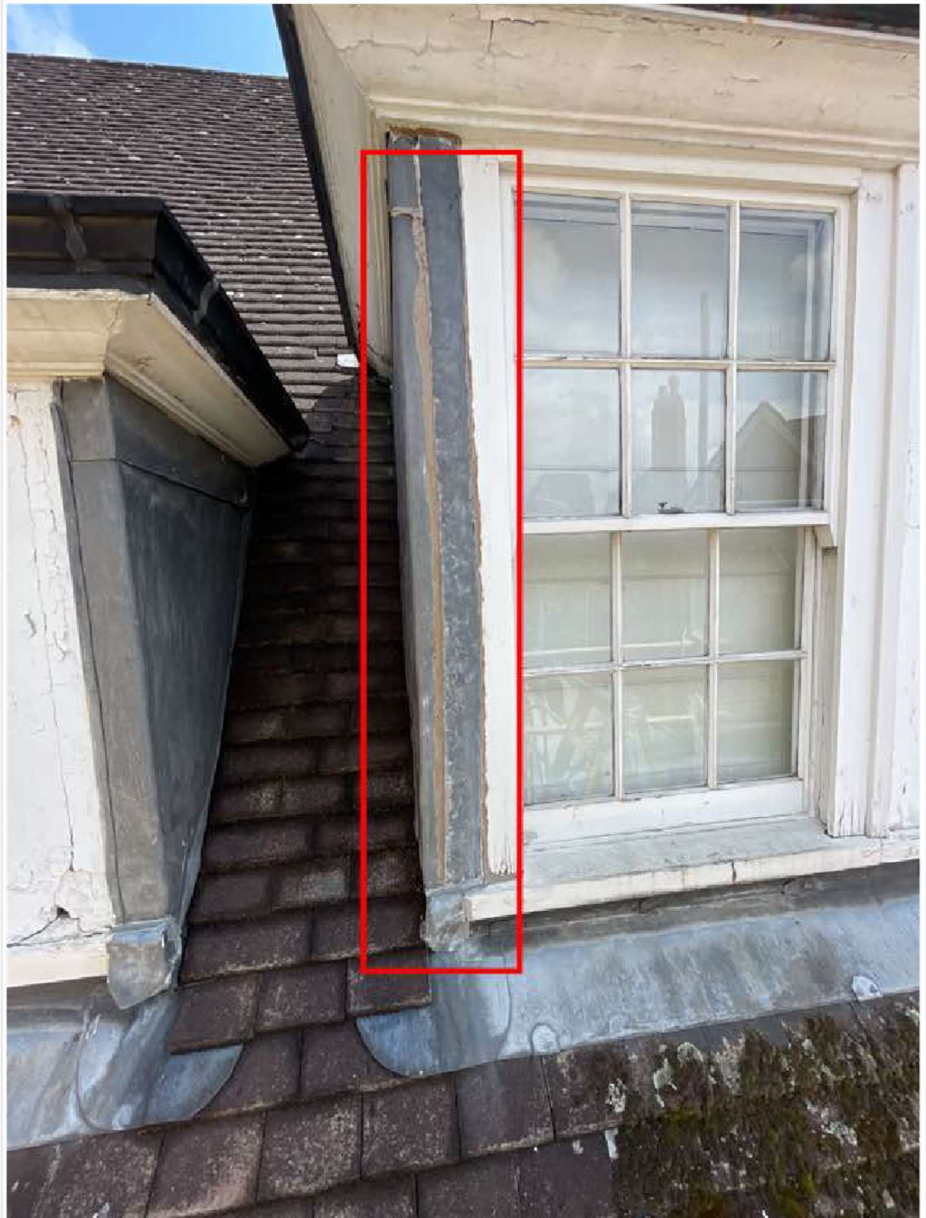
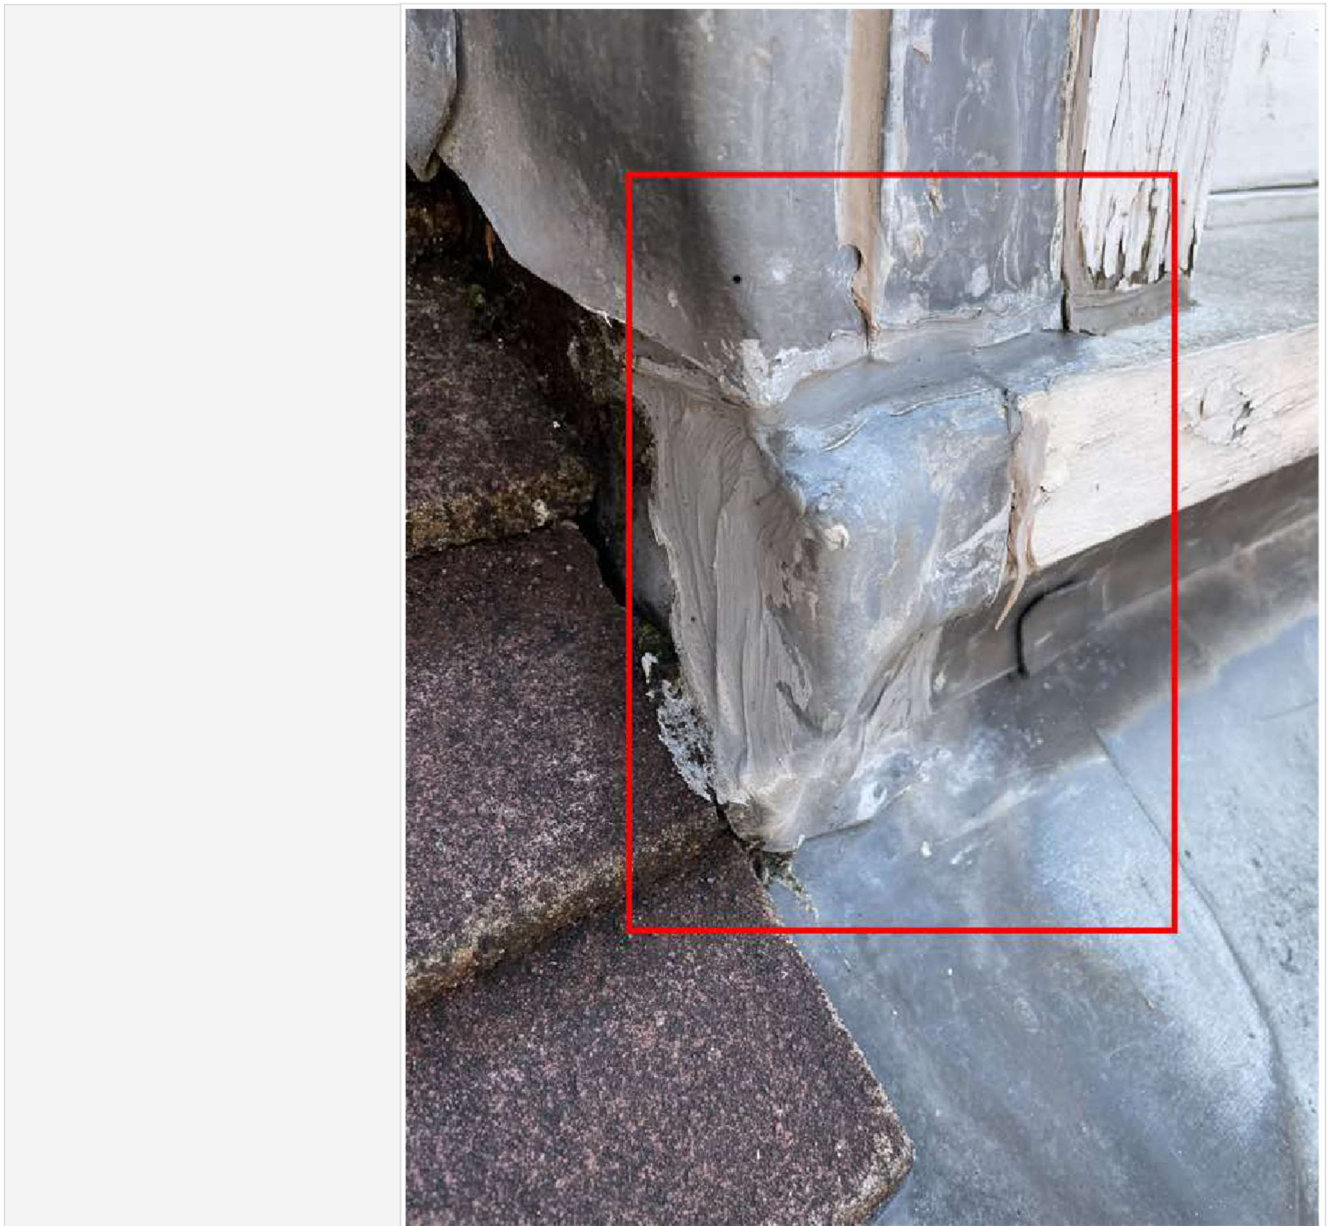
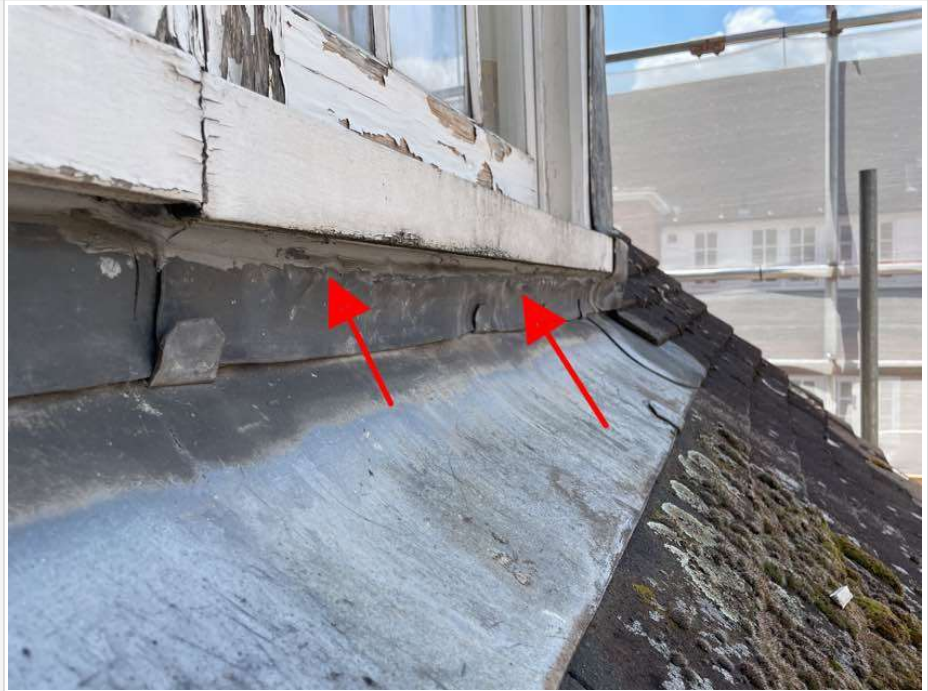
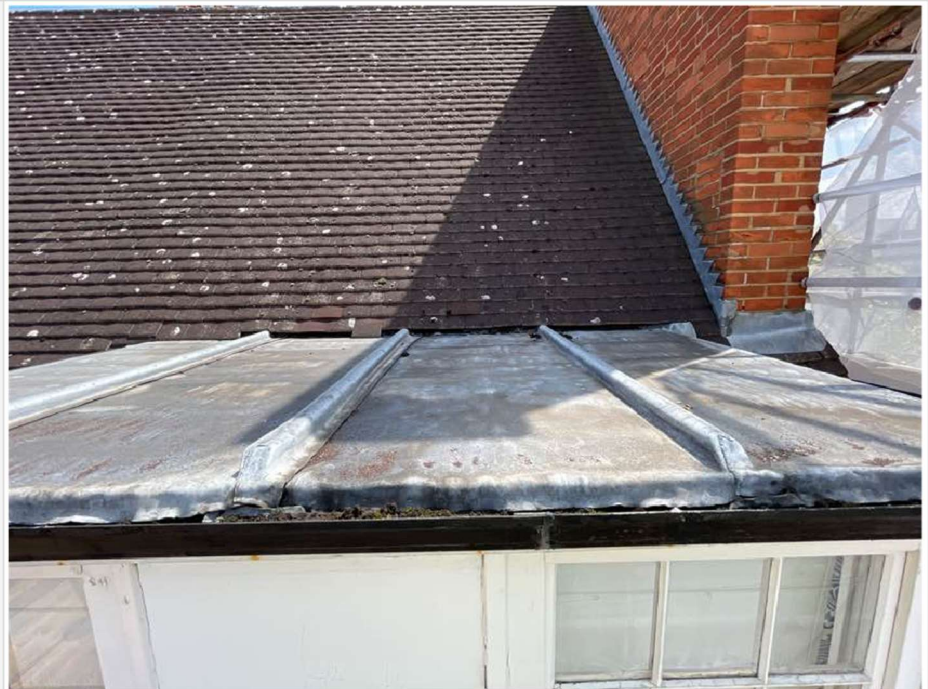
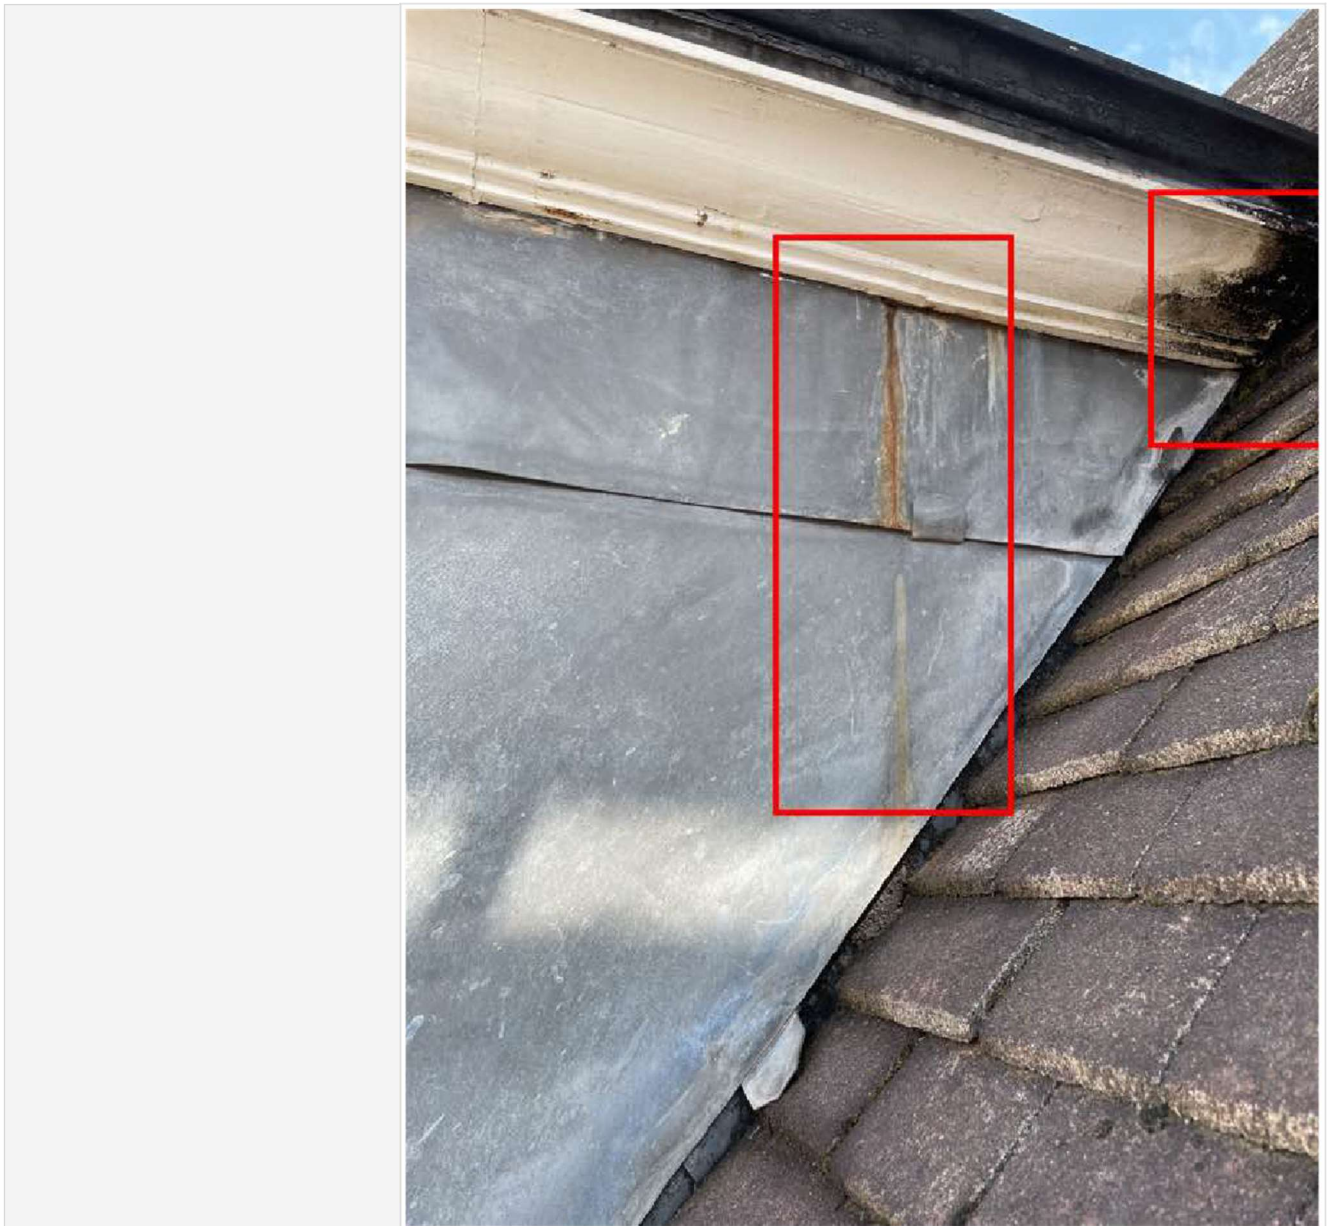
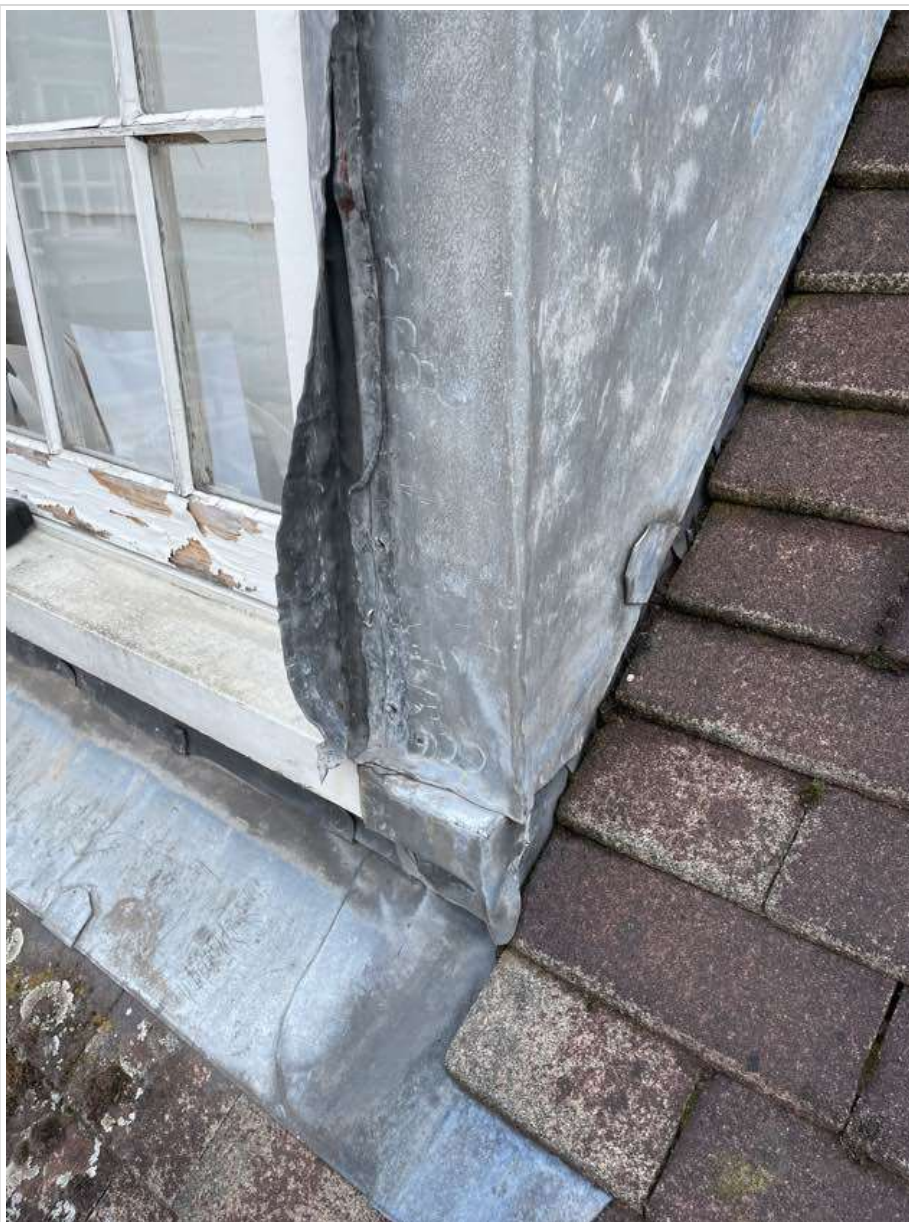
Pre-Work Inspection Checklist (Dormer 2)

Comments	<p>The existing Lead has been repaired in multiple locations which would suggest there has been historic water ingress. There was also evidence of mastic repairs to the Lead gussets and flashings. It was also noted the timber soffit Beneath the gutter is rotting in multiple locations which would suggest the existing guttering is leaking.</p>
Proposed Works	<p>We would recommend changing the lead on a like for like basis to the areas identified within the pictures. All lead works would be carried out in line with the current LSA guidelines. We would also recommend lining the existing aluminum gutters with a liquid applied waterproofing</p>
Quantity of Materials	<p>LHS & RHS Lead cheek 4m2 each (code 6 lead sheet) - 3 lm lead flashing (code 5 lead sheet) - 2 no. Lead gusset (code 5 lead sheet) liquid seal 6 lm</p>

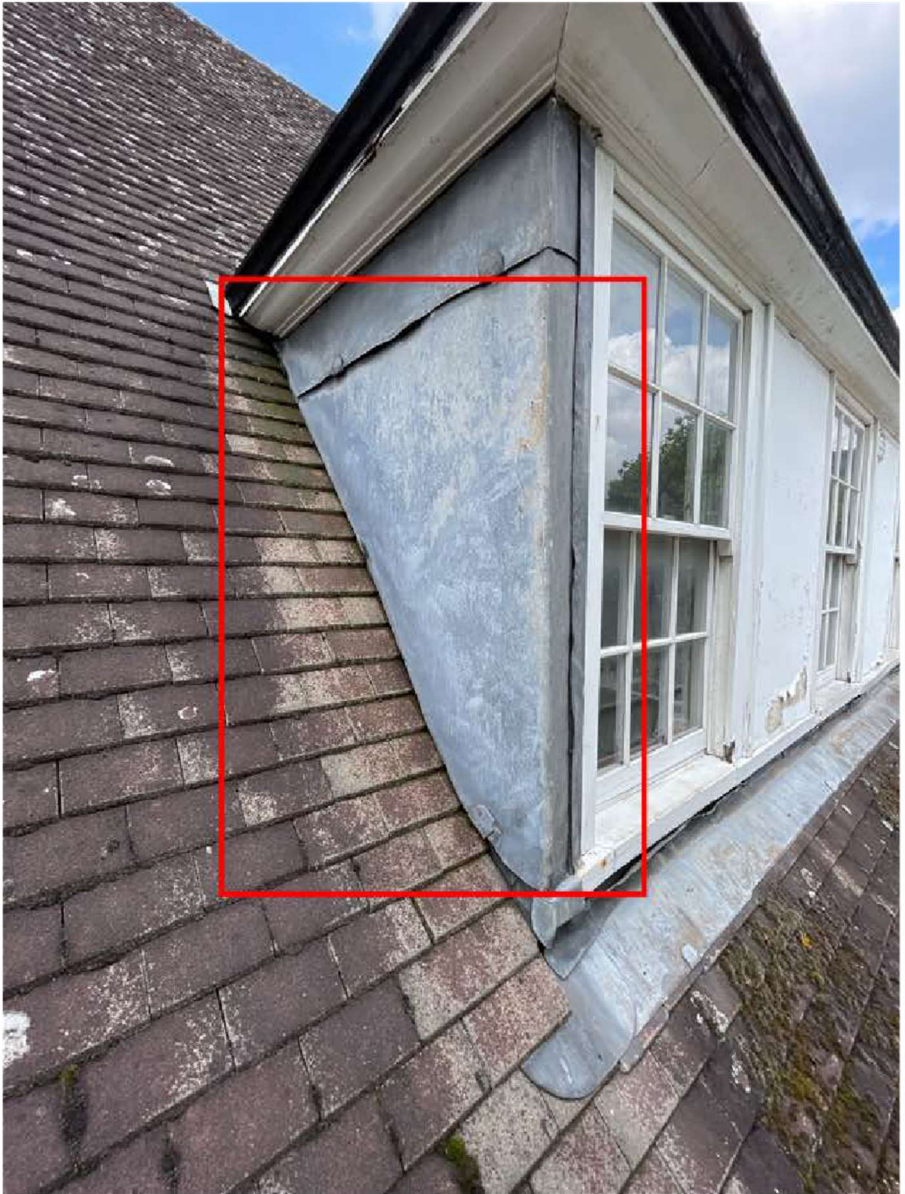
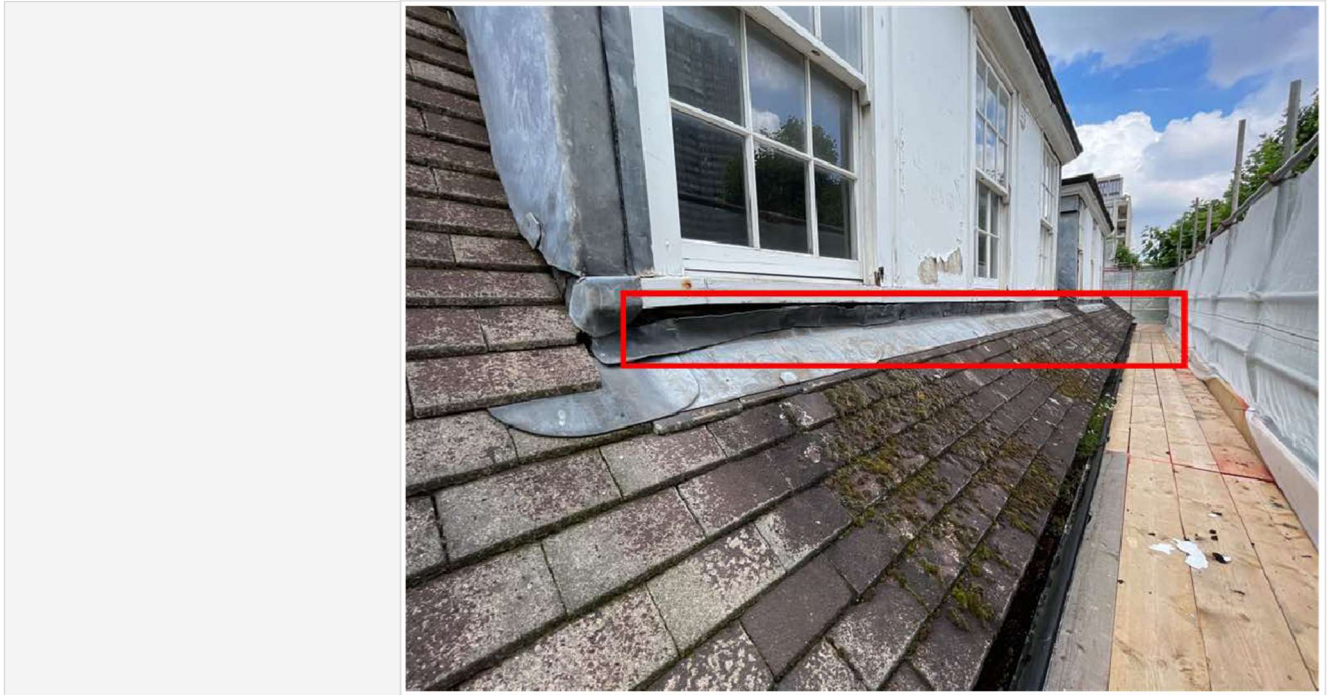
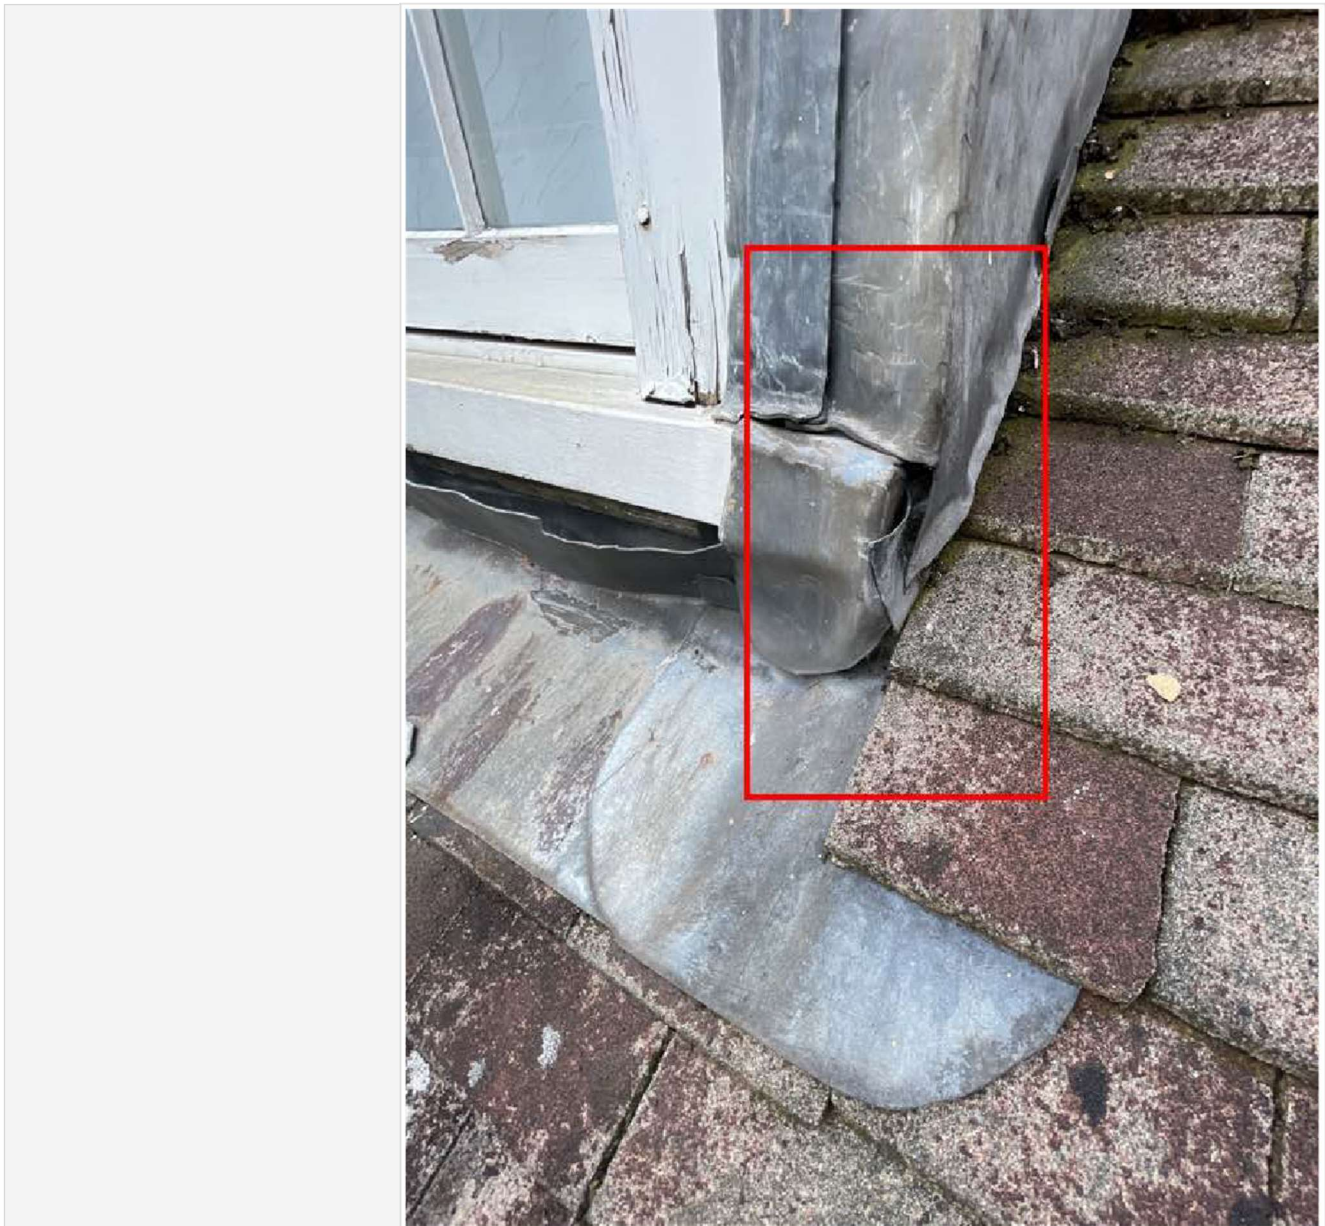
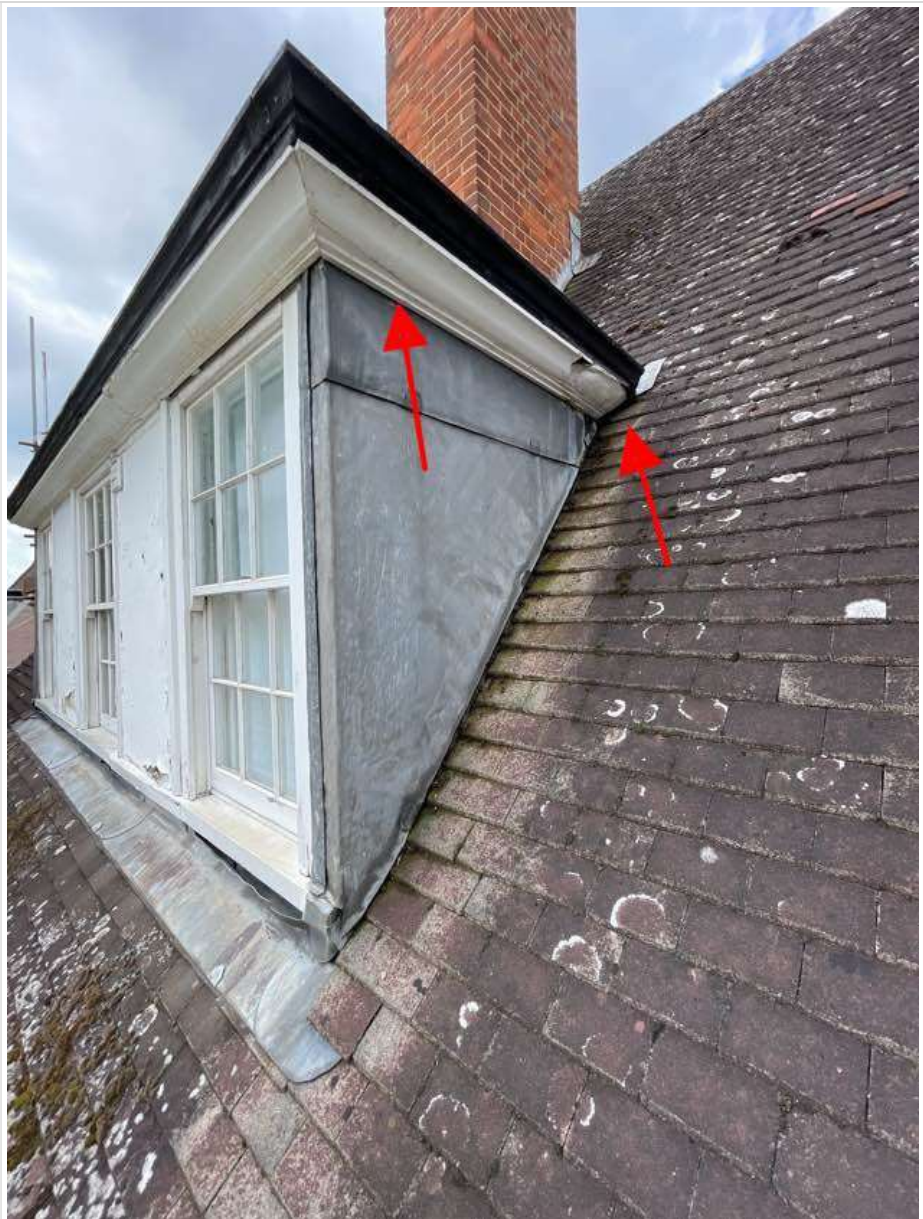
Pre-Work Inspection Checklist (Dormer 3)

Comments	The lead cheeks are showing signs of recent replacement with a poor level of workmanship. The flashings beneath the windowsill have been insufficiently fixed and will require replacement as they are no longer fit for purpose. It was also noted the timber soffit Beneath the gutter is rotting in multiple locations which would suggest the existing guttering is leaking or getting behind the timber at the drainage point.
Proposed Works	We would recommend changing or repairing the lead on a like for like basis to the areas identified within the pictures. All lead works would be carried out in line with the current LSA guidelines. We would also recommend lining the existing aluminum gutters with a liquid applied waterproofing. New Timber soffits would be recommended or repair where possible.
Quantity of Materials	LHS & RHS cheeks redress existing. 5 lm lead flashing (code 5) 2 no lead gusset (code 5) liquid seal 9lm
