Photographic Report

Client Name	United Living
Name of Surveyor	Richard Keeley
Project Name	Mulready House
Address	Mulready House, Marsham St, London SW1P 4JL
Phone Number	079-401-2929
Email Address	Richard@opuswaterproofing.co.uk
Weather Conditions	Overcast

Pre-Work Inspection Checklist (Dormer 1)

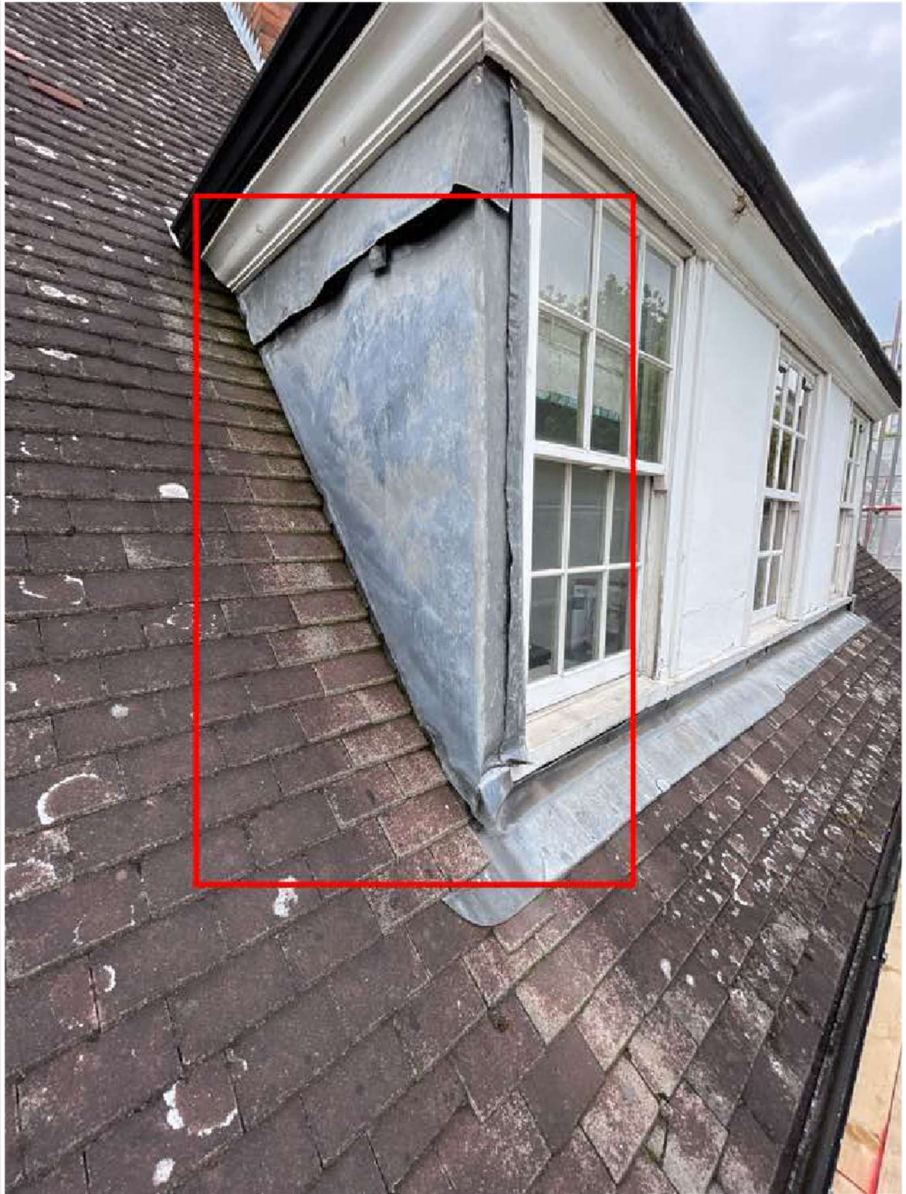
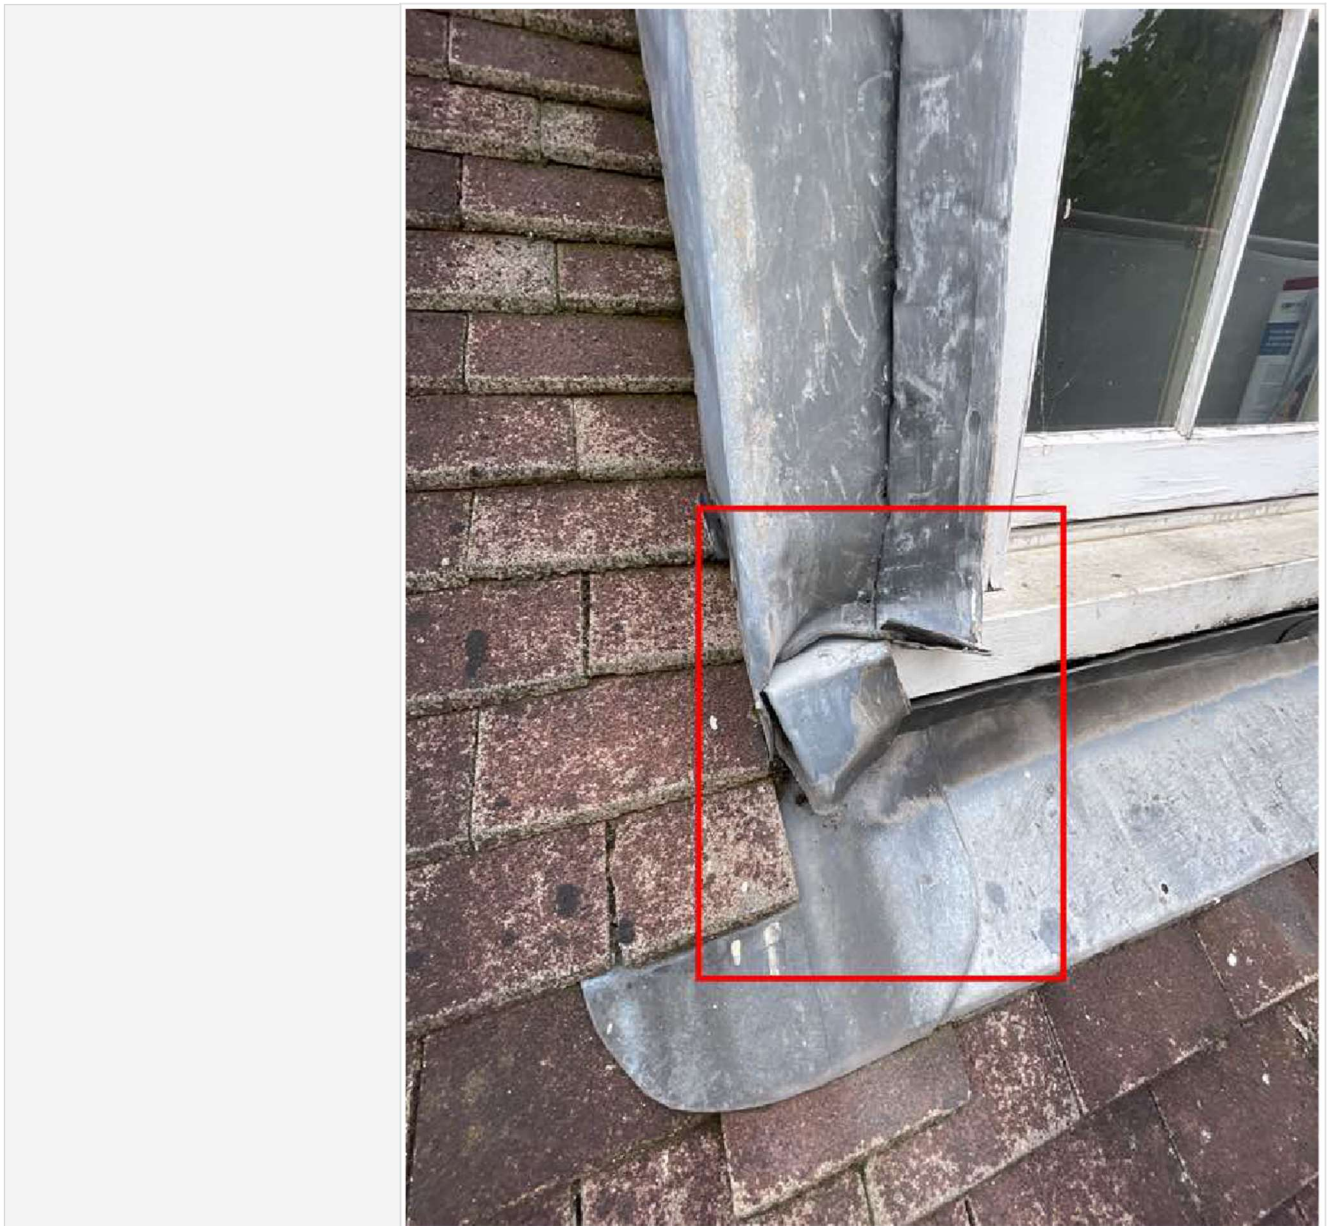
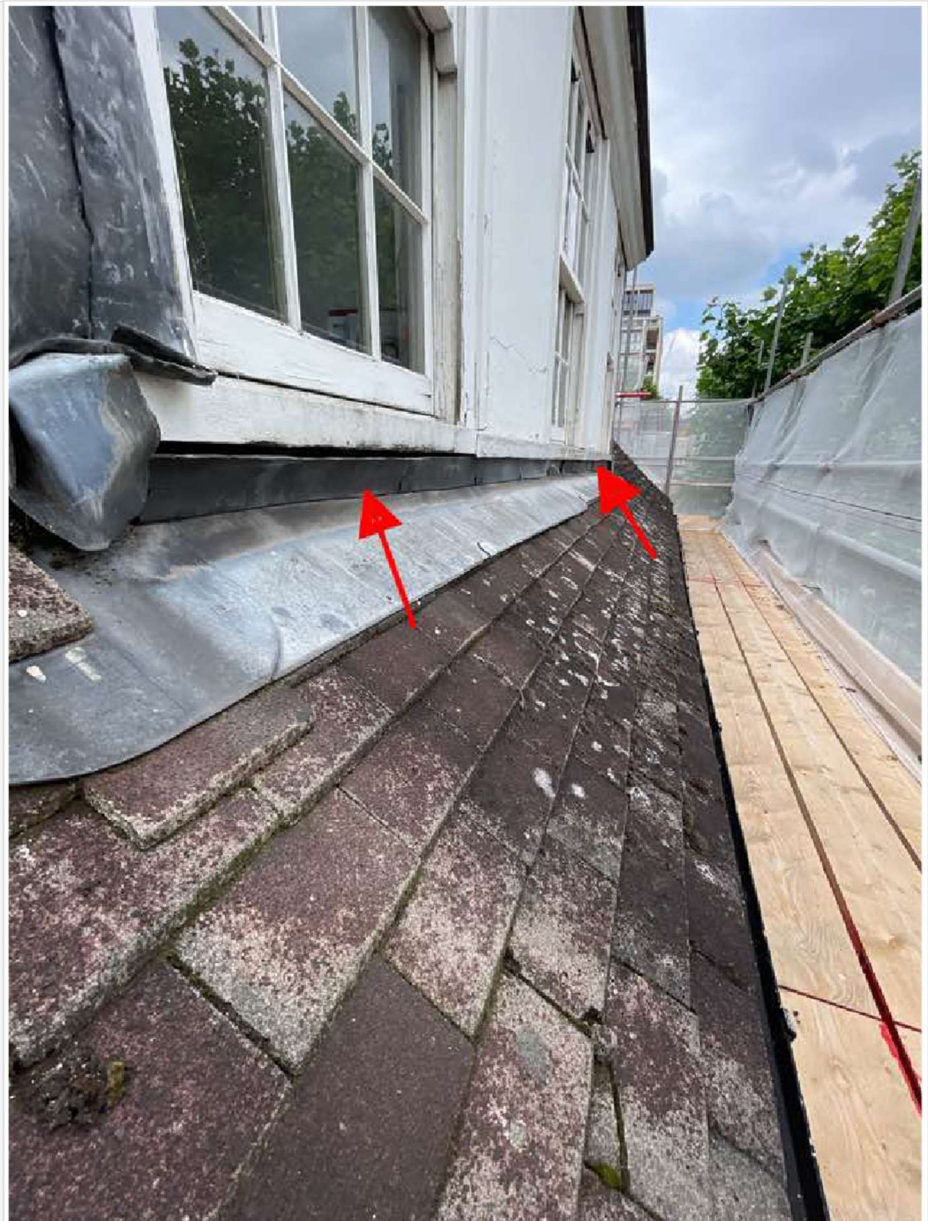
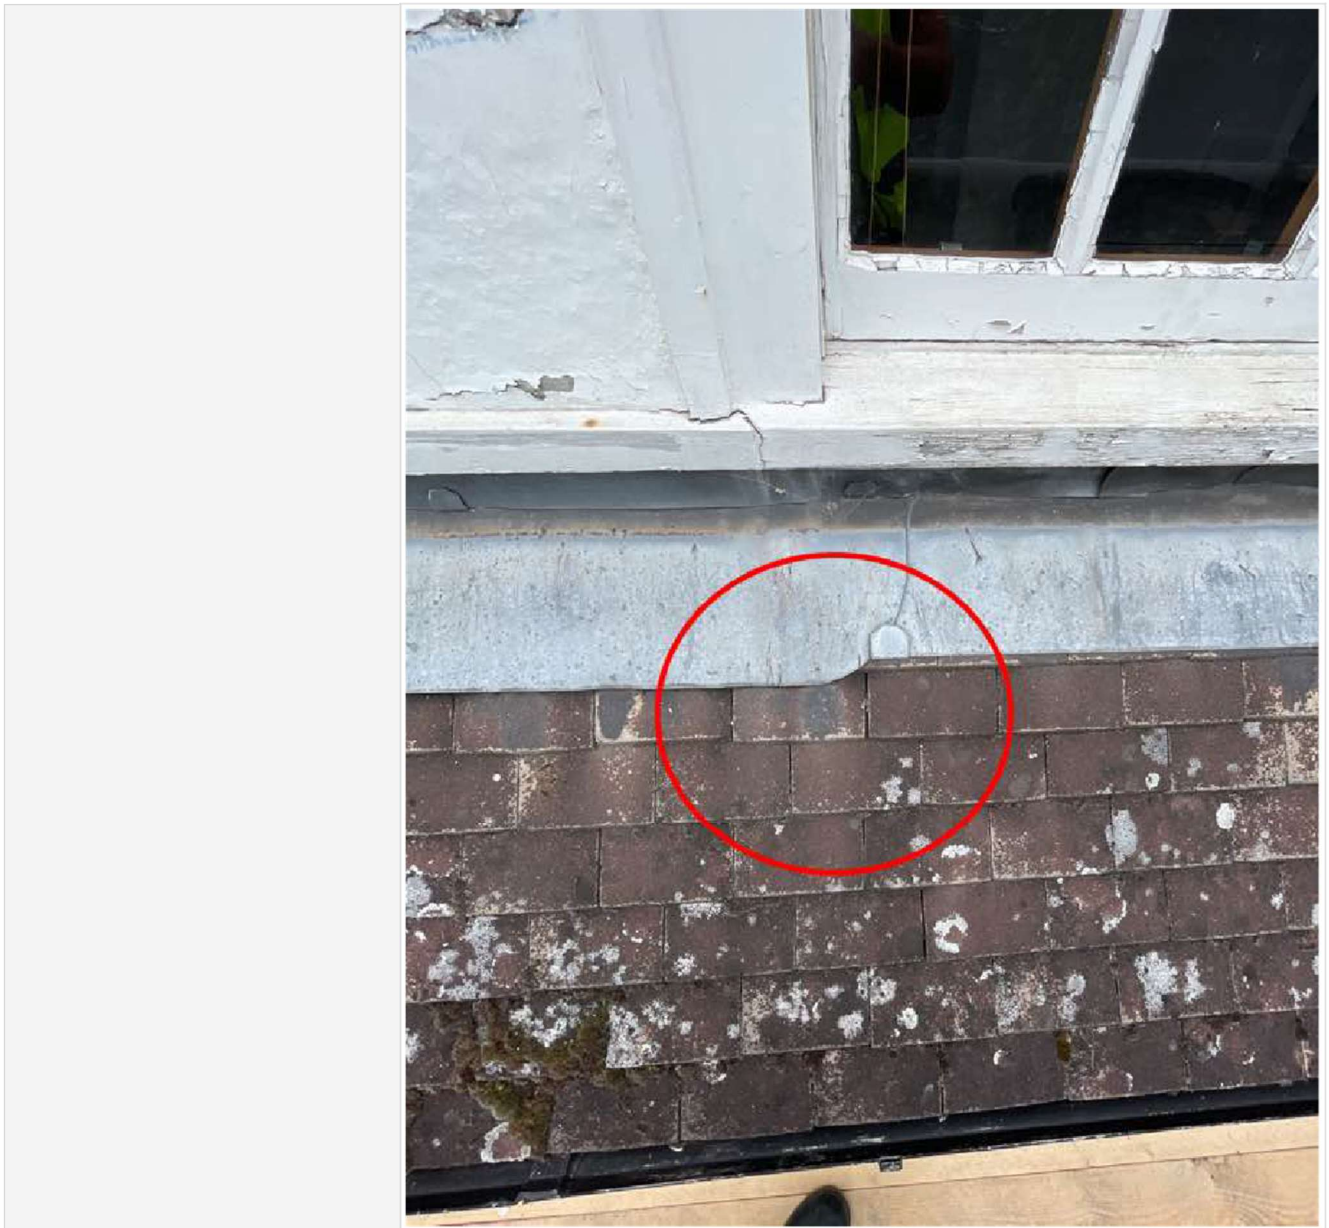
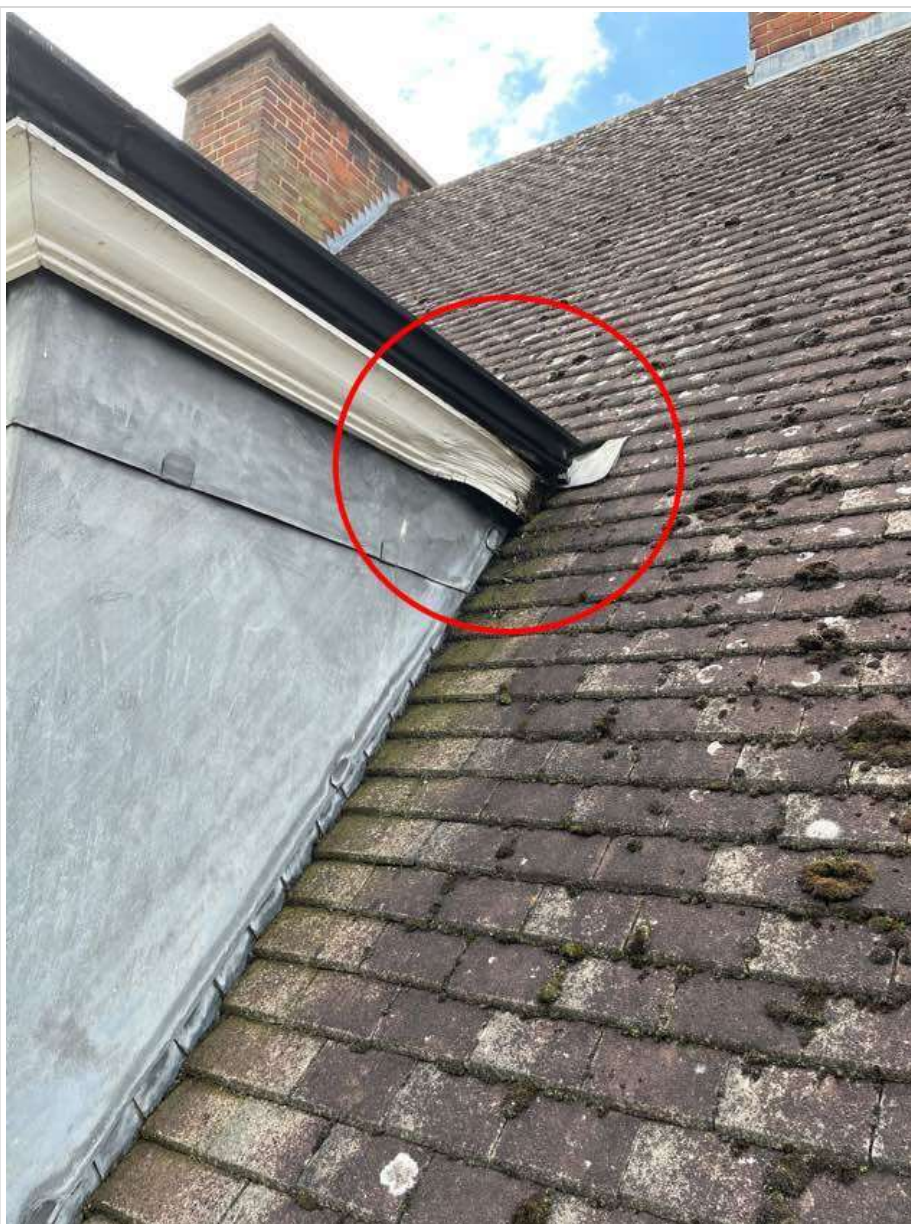
Pre-Work Inspection Checklist (Dormer 4)

Comments	The lead cheeks are showing signs of recent replacement with a poor level of workmanship. The flashings beneath the windowsill have been insufficiently fixed and will require replacement as they are no longer fit for purpose. It was also noted the timber soffit Beneath the gutter are rotting in multiple locations which would suggest the existing guttering is leaking or getting behind the timber at the drainage point.
Proposed Works	We would recommend changing the lead on a like for like basis to the areas identified within the pictures. All lead works will be carried out in line with the current LSA guidelines. We would also recommend lining the existing aluminum gutters with a liquid applied waterproofing
Quantity of Materials	LHS Lead cheek 4m ² each (code 6 lead sheet) 5 lm lead flashing (code 5 lead sheet) 2 no. Lead gusset (code 5 lead sheet) liquid seal 9lm

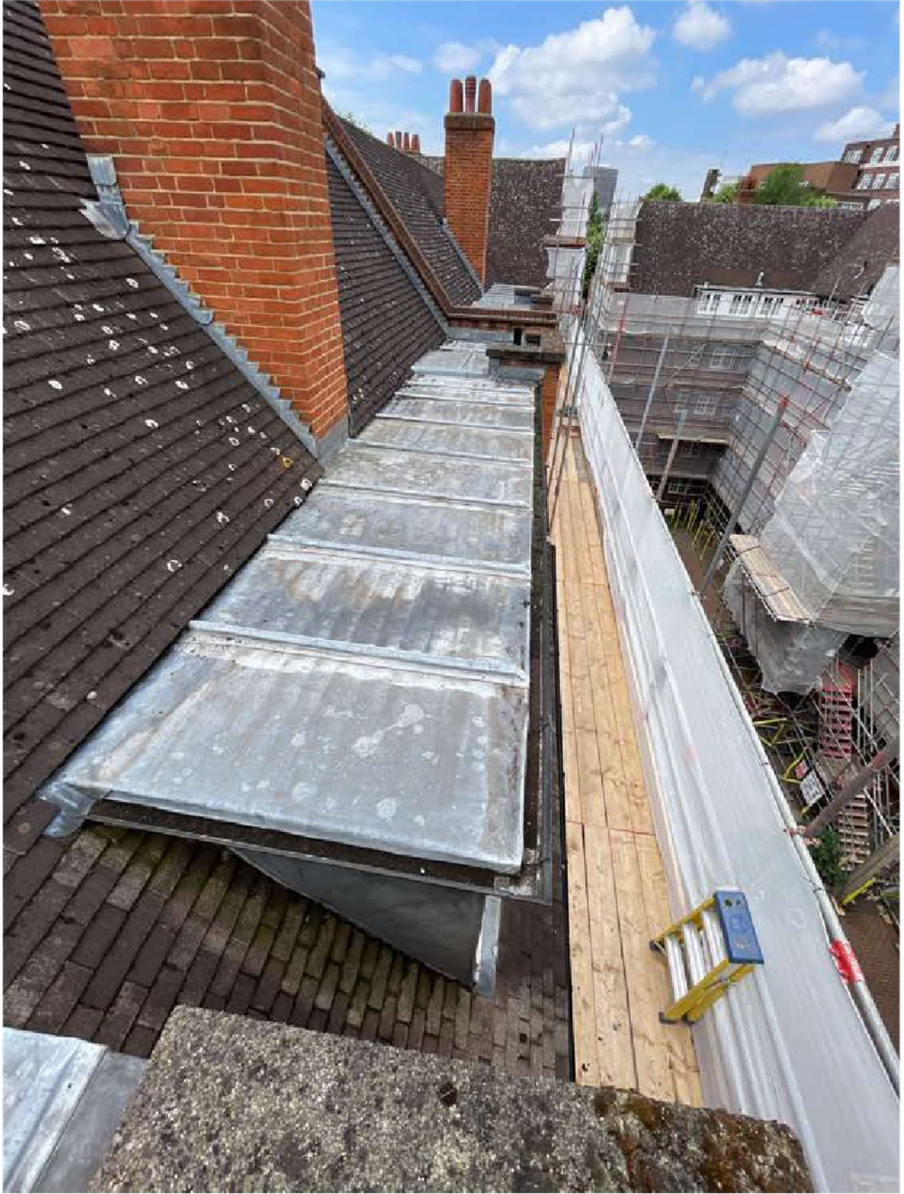
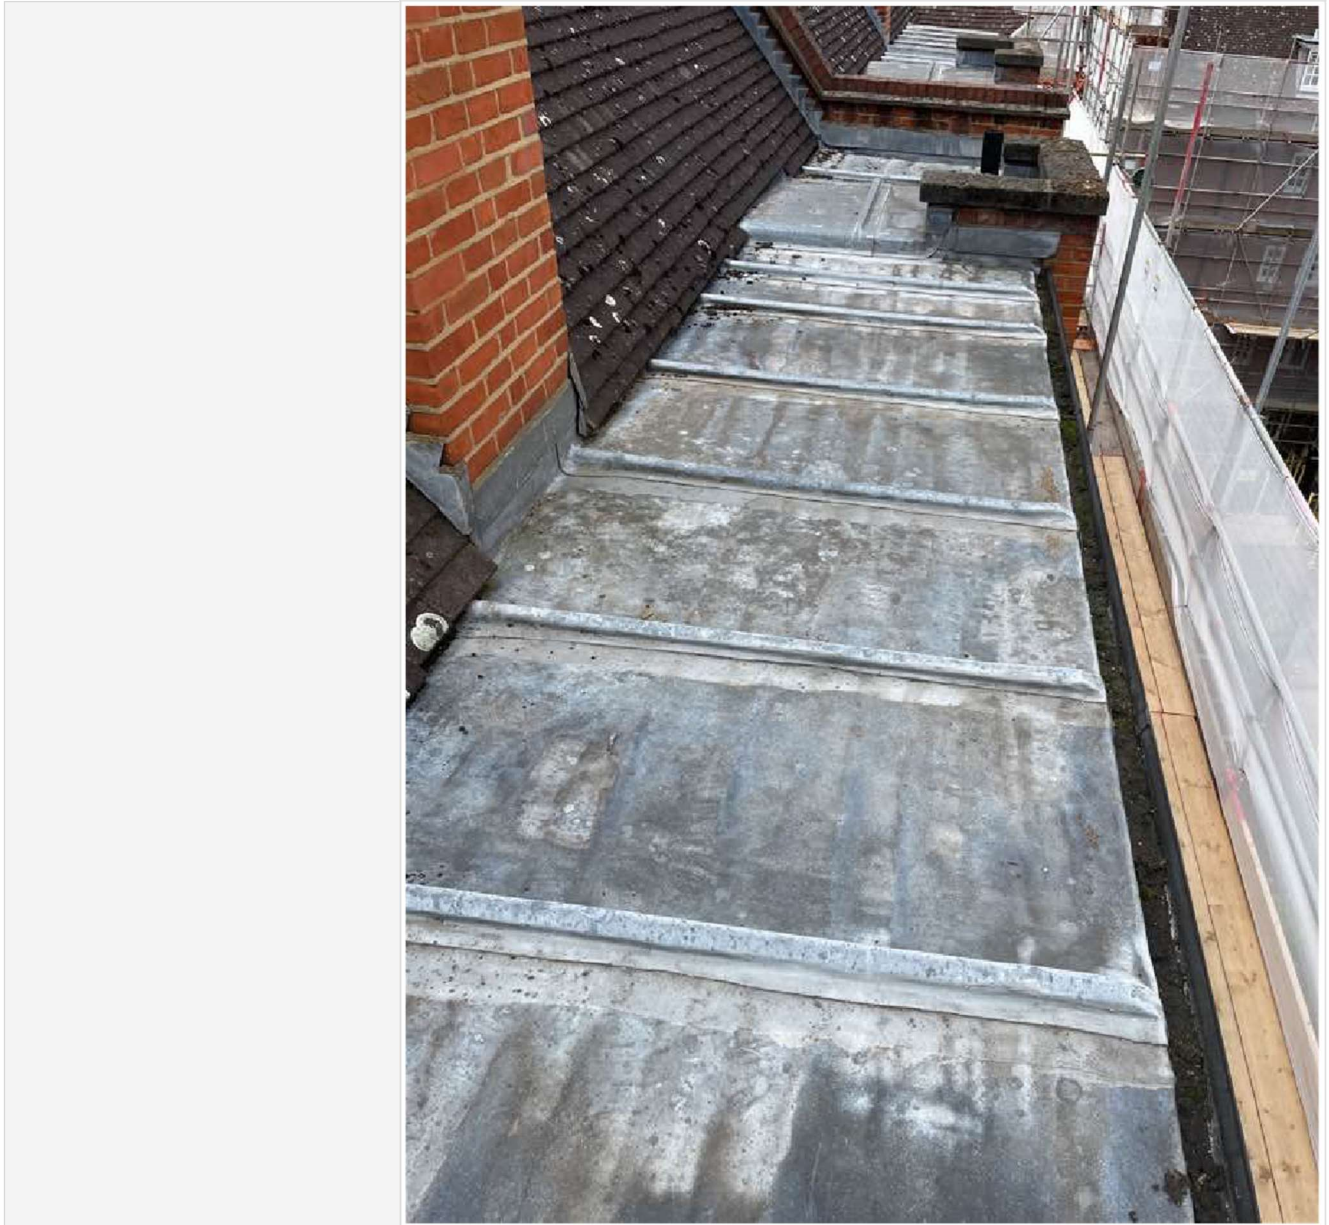
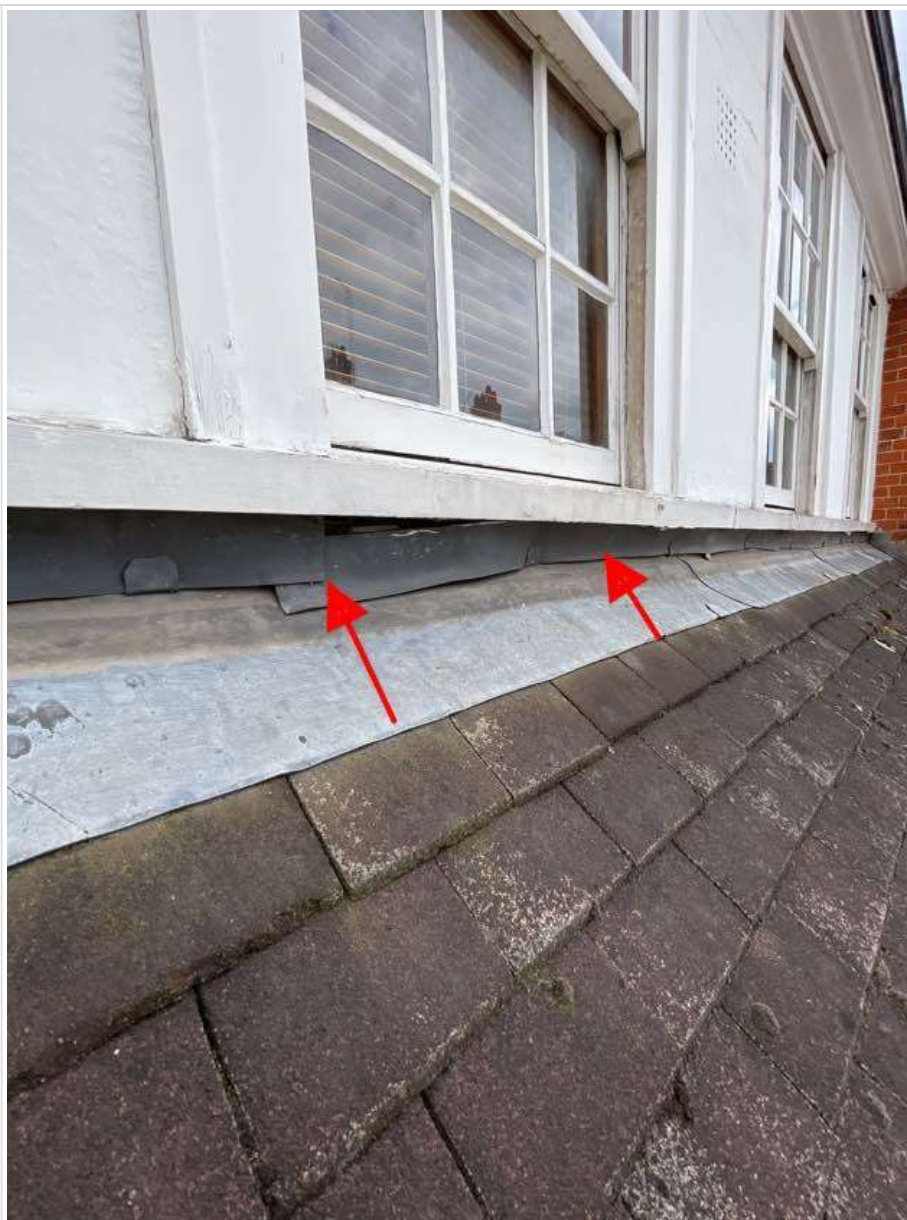
Pre-Work Inspection Checklist (Dormer 5)

Comments	The existing Lead roof has been repaired in multiple locations which would suggests there has been historic water ingress. The flashing beneath the window seal has become loose and requires re-fixing. The gutters where also blocked and showing signs of leakage.
Proposed Works	If water is found to be penetrating the building. We would recommend changing the lead on a like for like basis to the areas identified within the pictures. All lead works would be carried out in line with the current LSA guidelines. We would also recommend lining the existing aluminum gutters with a liquid applied waterproofing.
Quantity of Materials	10 no. Lead bays (Code 6 Lead) 3 lm flashing (Code 4 Lead) 6lm Liquid seal

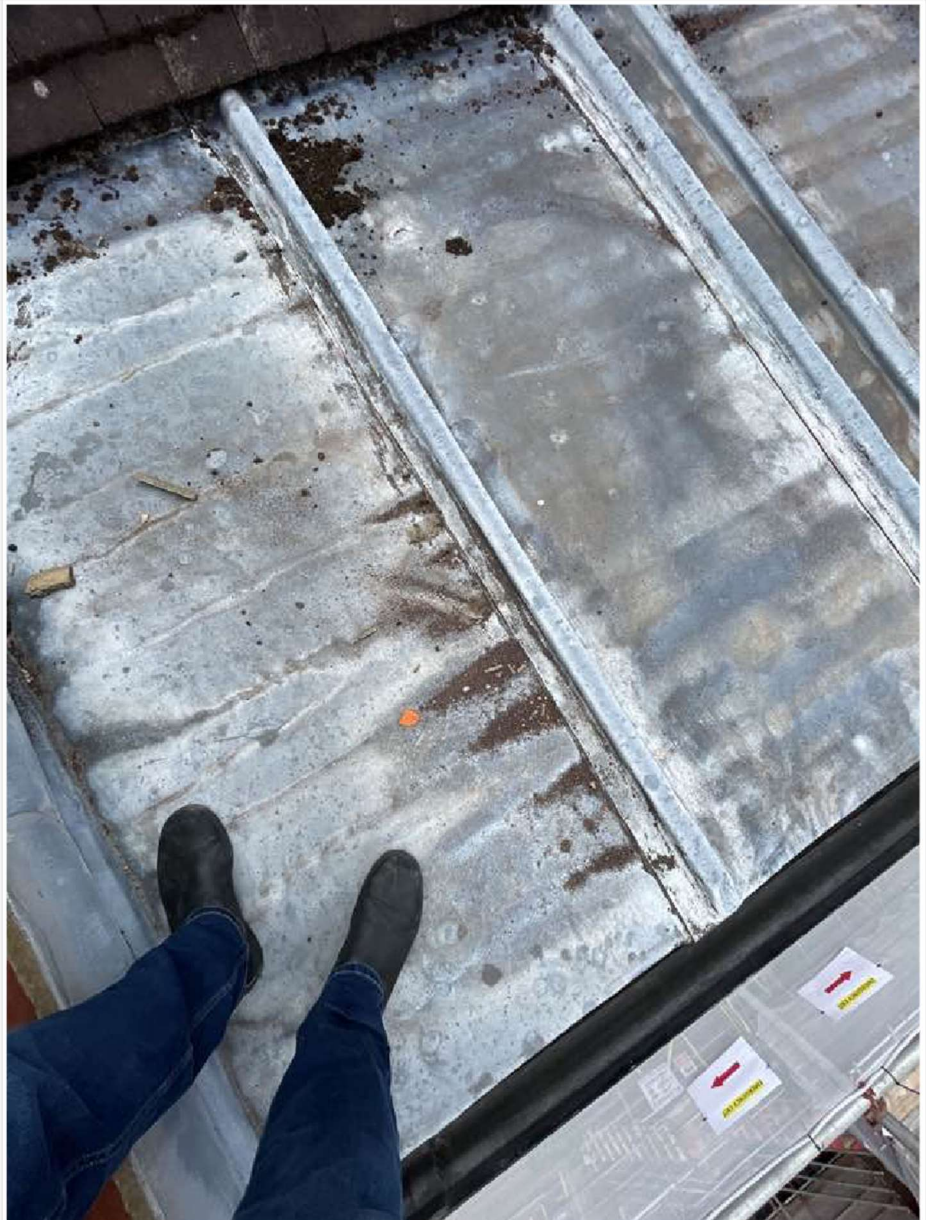
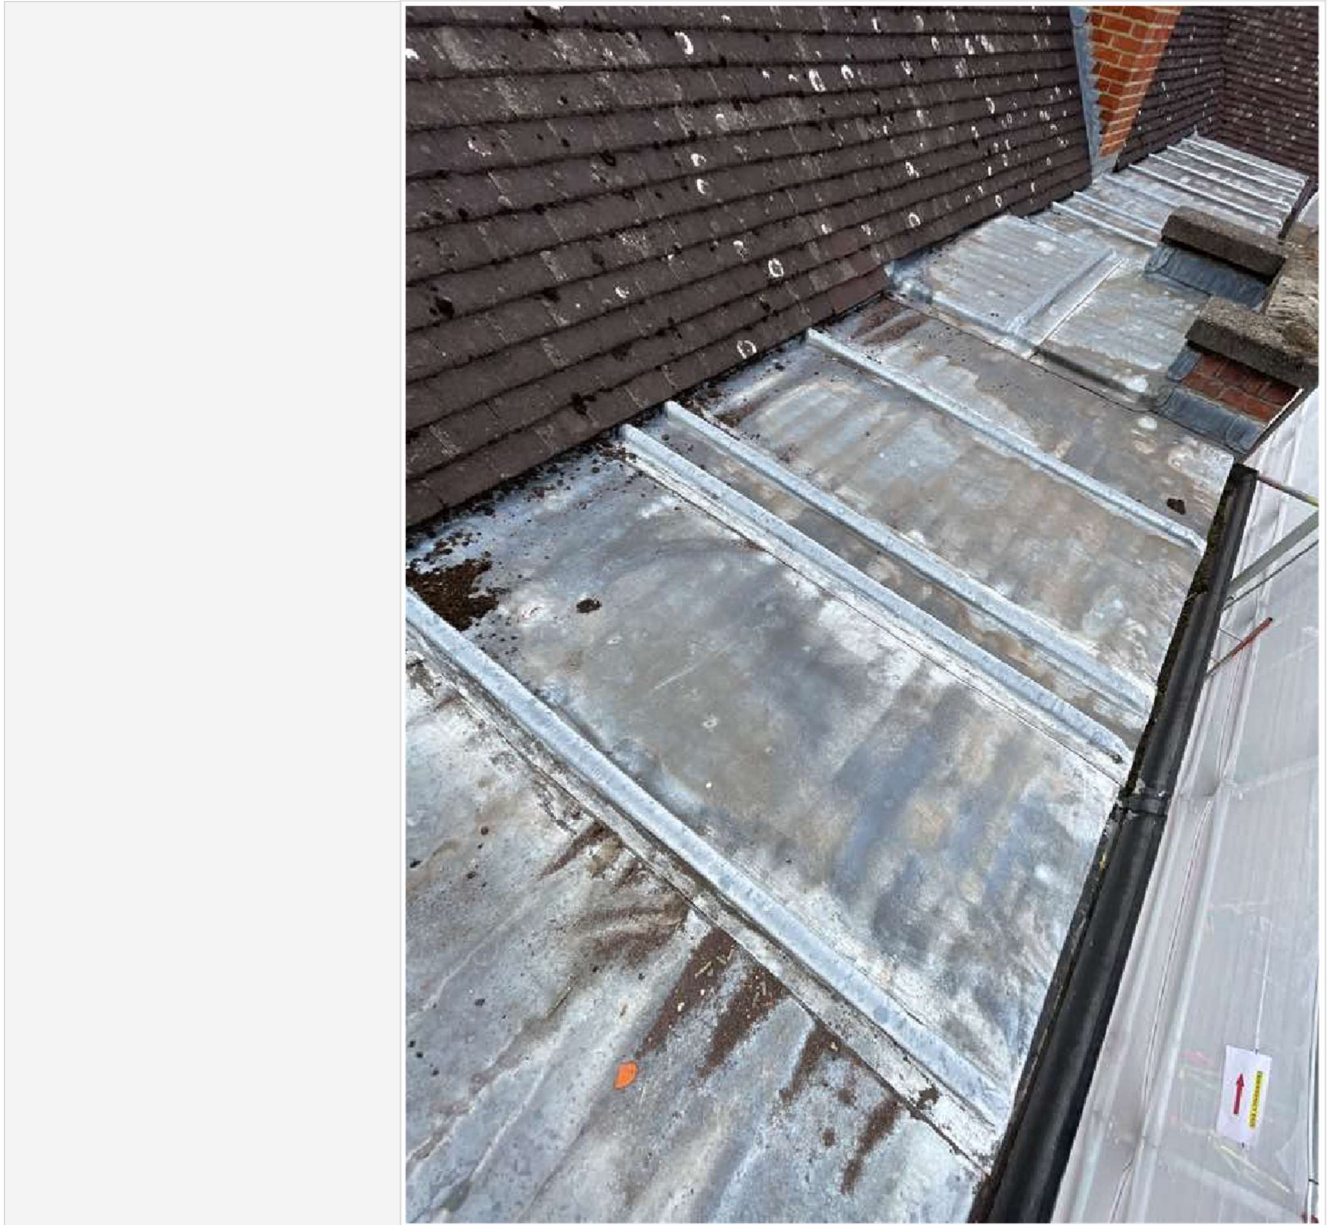
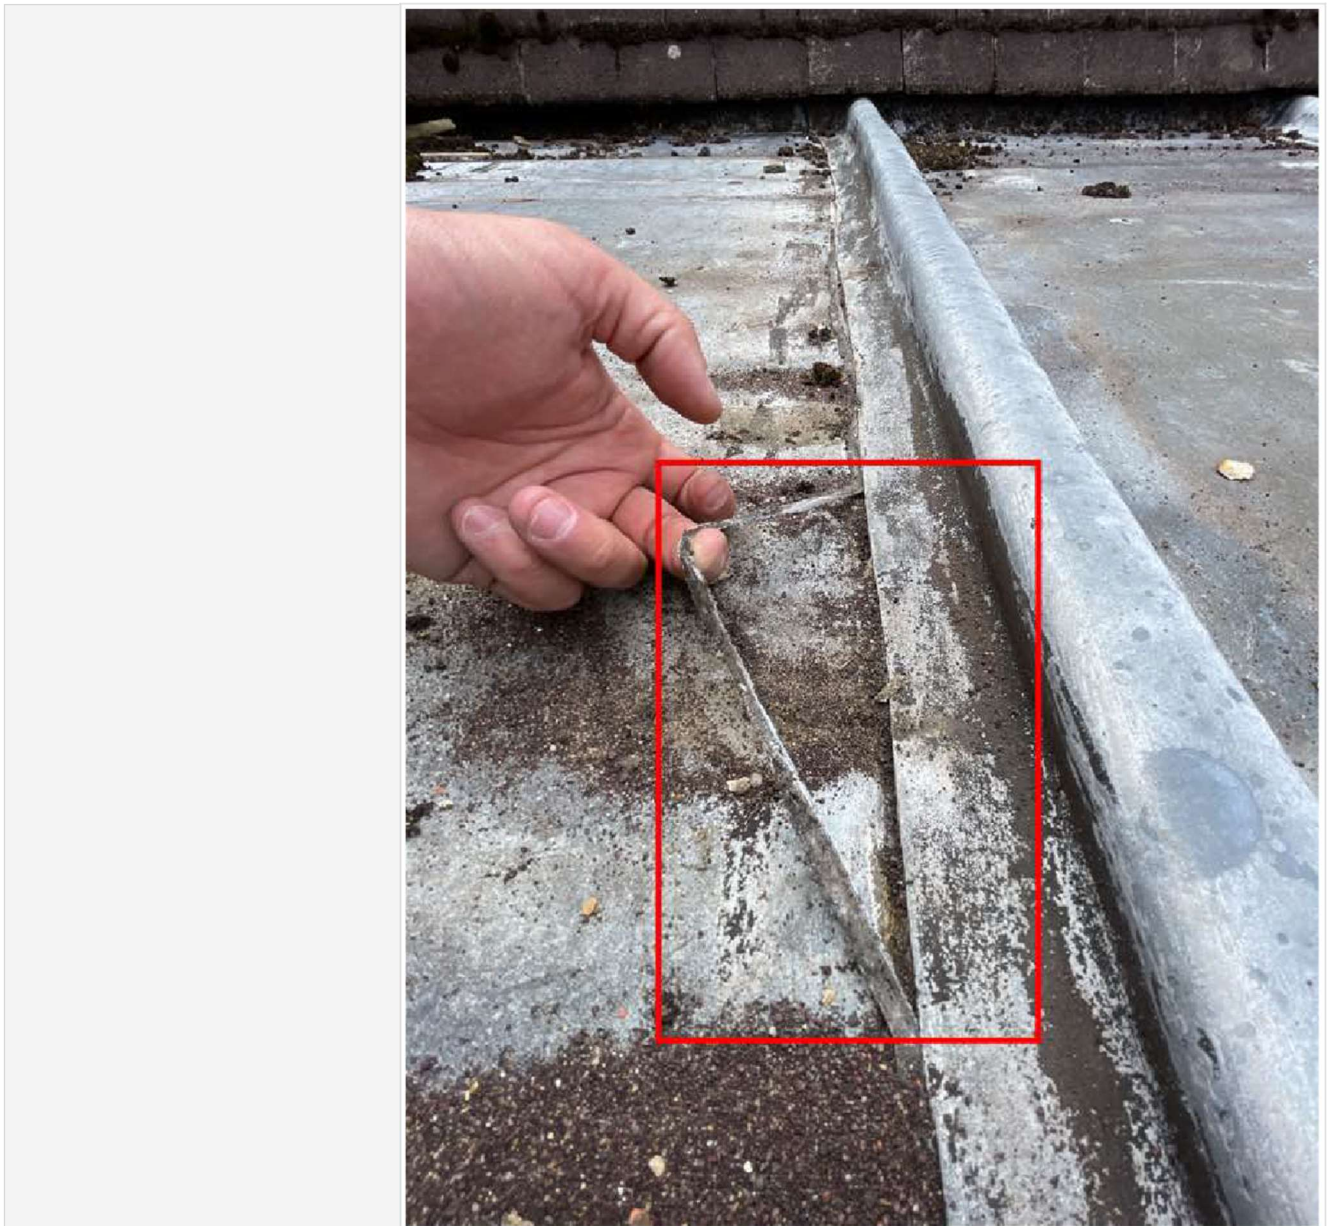
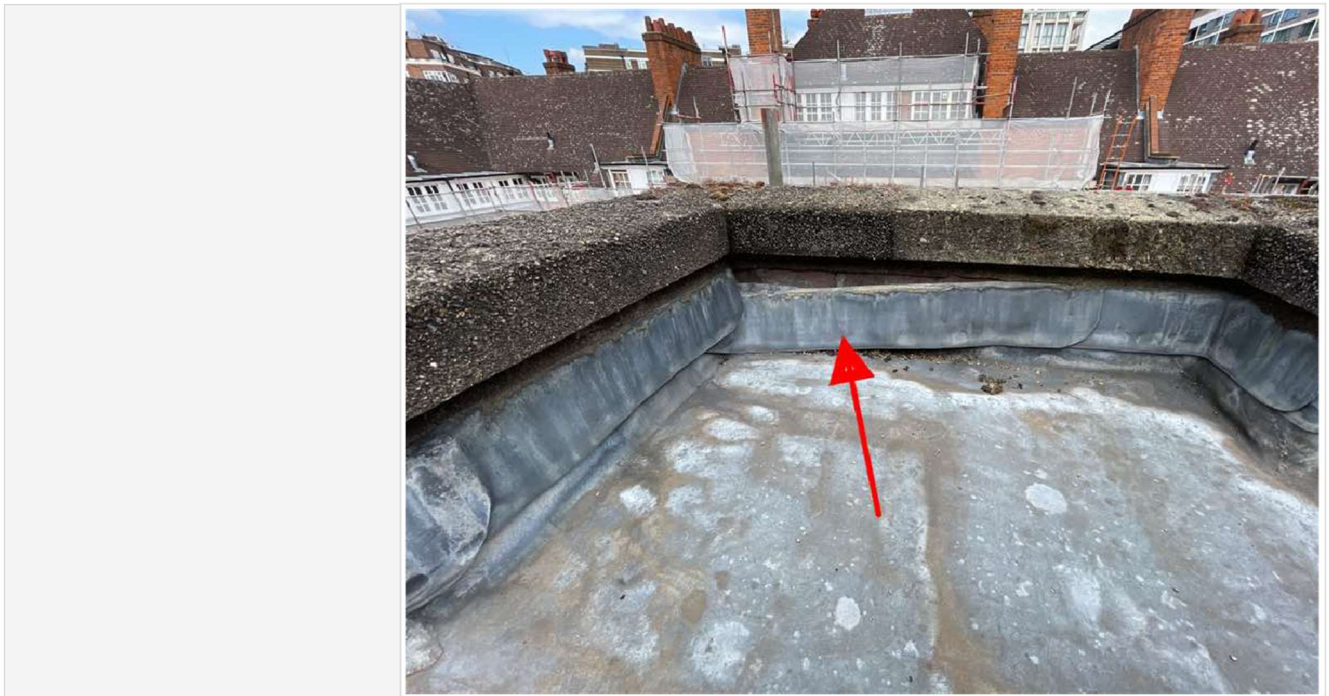
Pre-Work Inspection Checklist (Dormer 6)

Comments	The existing Lead roof has been repaired in multiple locations, mastic repairs where present in the bays. The lead cheeks are showing signs of recent replacement with a poor level of workmanship The gutters are blocked and showing signs of leakage.
Proposed Works	We would recommend changing the lead on a like for like basis to the areas identified within the pictures. All lead works would be carried out in line with the current LSA guidelines. We would also recommend relining the existing aluminum gutters with a liquid applied waterproofing.
Quantity of Materials	6 no. Lead bays (Code 6 Lead) 3 lm flashing (Code 4 Lead) 6lm Liqui seal

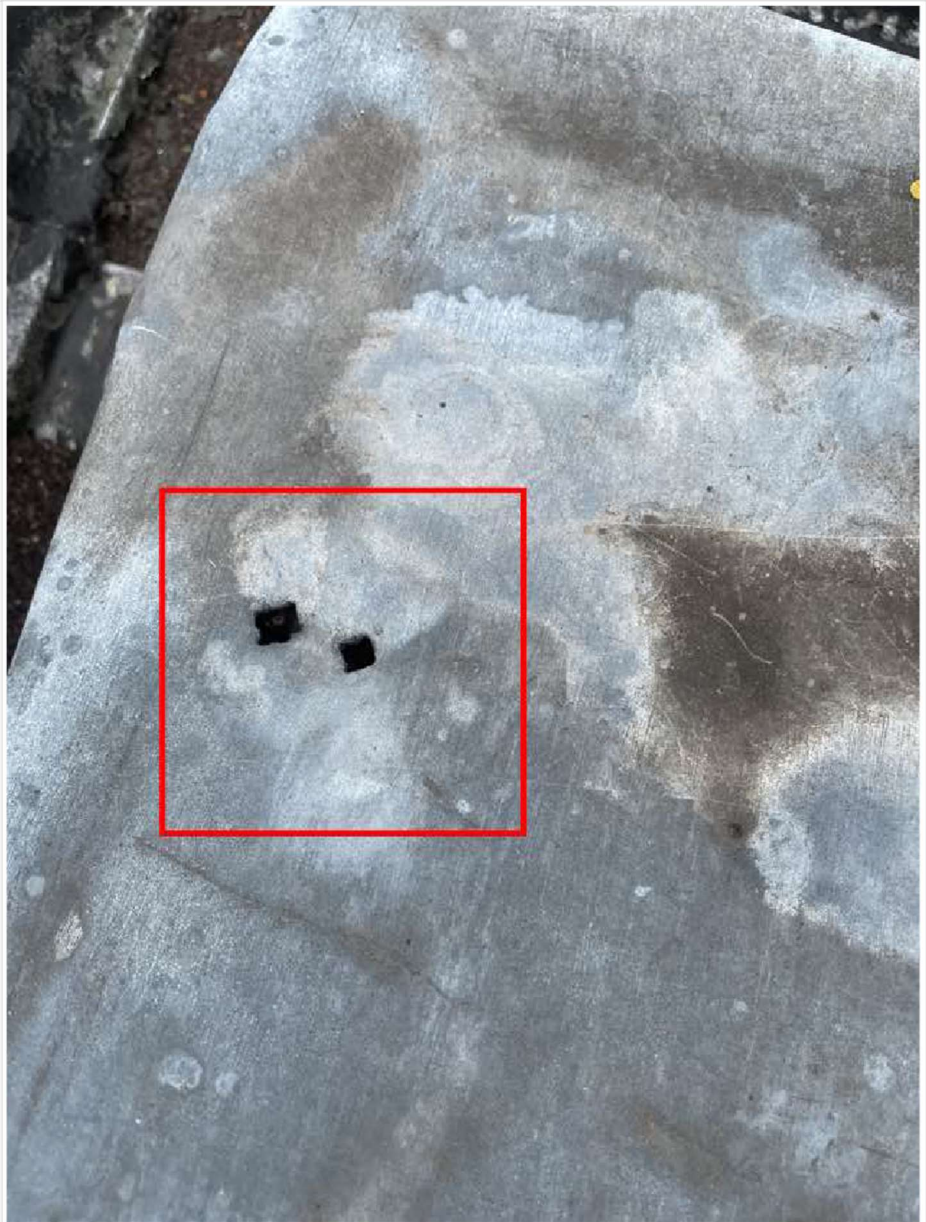
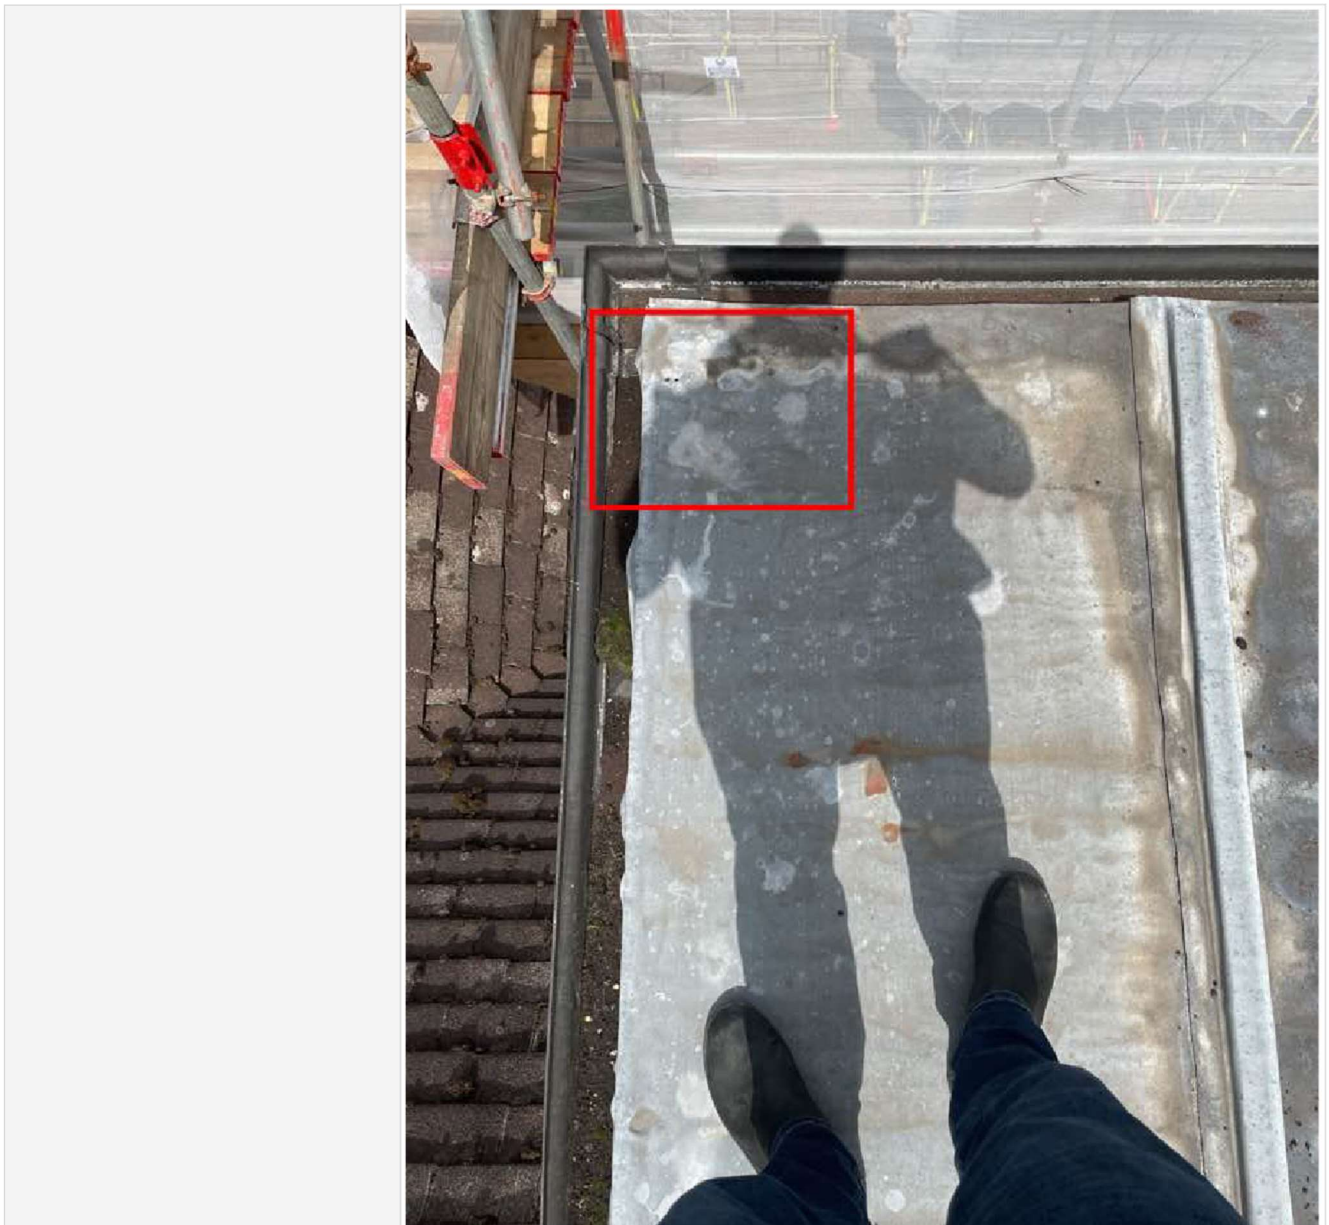
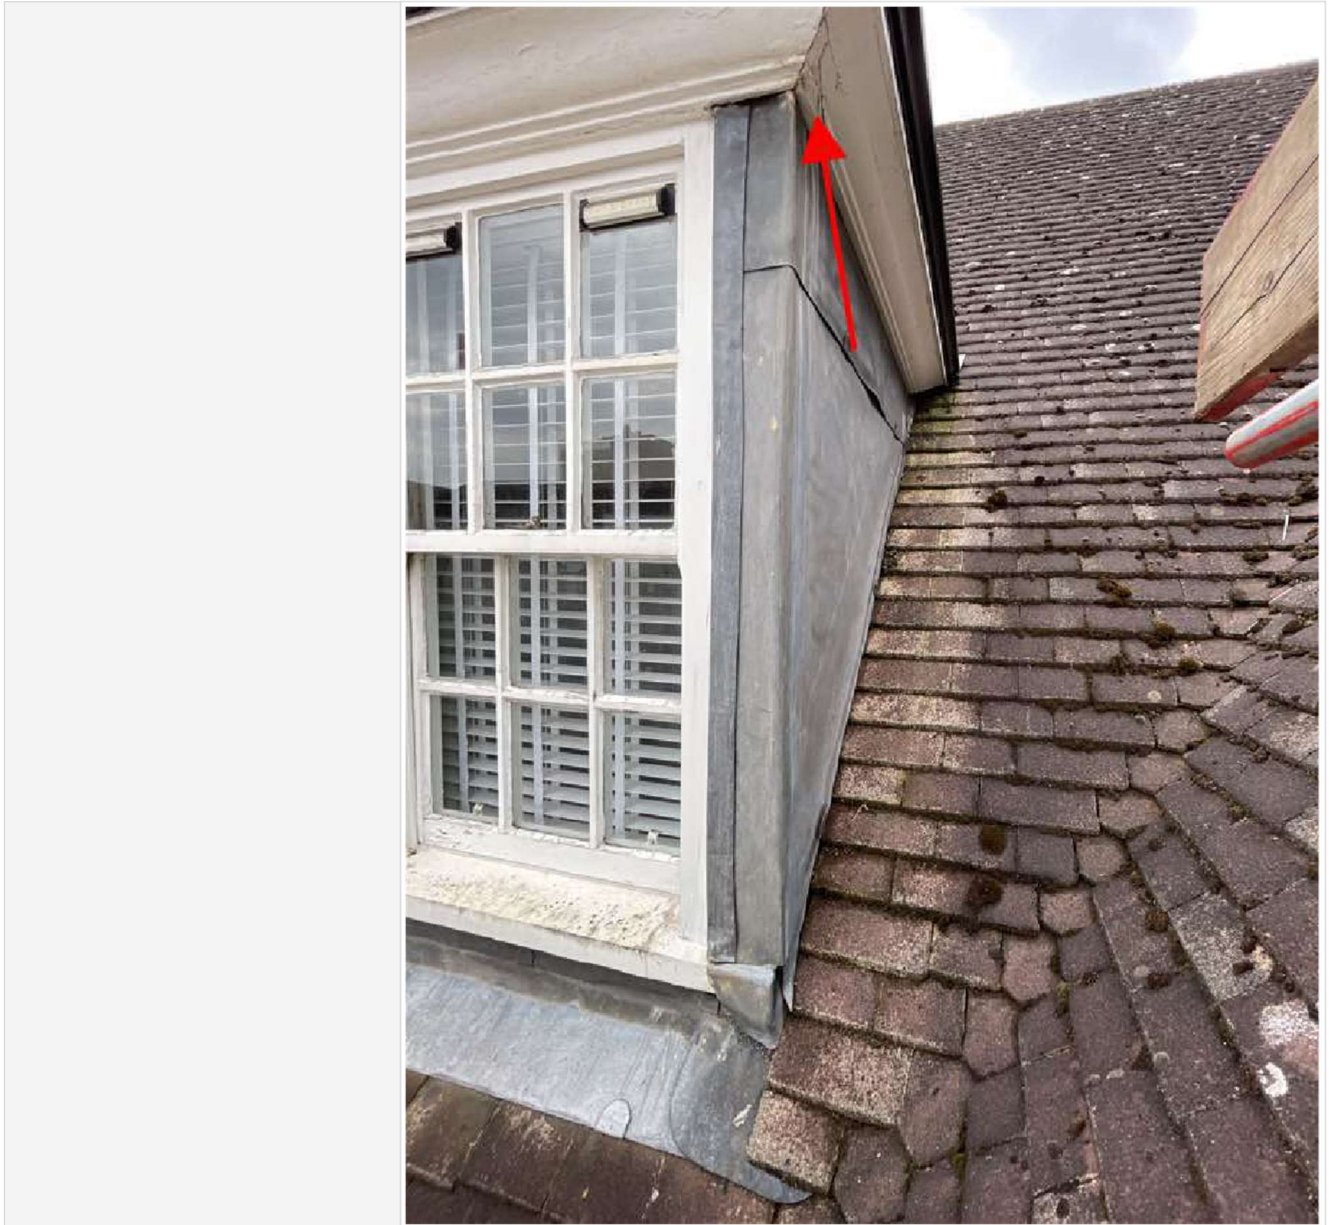
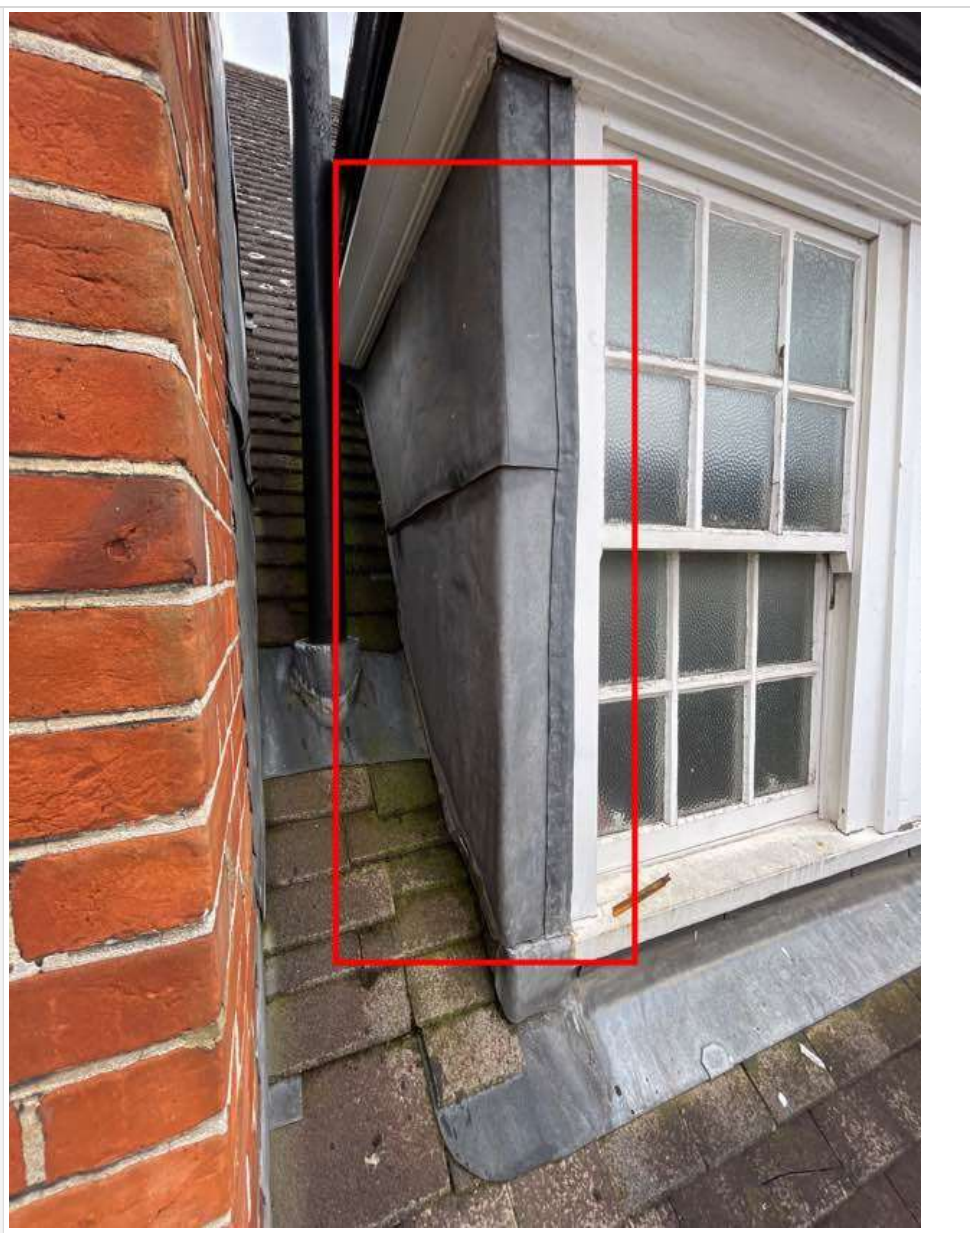
Pre-Work Inspection Checklist (Dormer 7)

Comments	<p>The existing Lead roof has been repaired in multiple locations, mastic repairs were present in the bays. The lead cheeks are showing signs of recent replacement with a poor level of workmanship, holes were also found within the lead sheet and flashing are coming away from the wall. The gutters are blocked and showing signs of leakage.</p>
Proposed Works	<p>We would recommend changing the lead on a like for like basis to the areas identified within the pictures. All lead works would be carried out in line with the current LSA guidelines. We would also recommend relining the existing aluminum gutters with a liquid applied waterproofing.</p>
Quantity of Materials	<p>7 no. Lead bays (Code 6 Lead) 3 lm flashing (Code 4 Lead) 6lm Liquid seal</p>
