Photographic Report

Client Name	United Living
Name of Surveyor	Richard Keeley
Project Name	Mulready House
Address	Mulready House, Marsham St, London SW1P 4JL
Phone Number	079-401-2929
Email Address	Richard@opuswaterproofing.co.uk
Weather Conditions	Overcast

Pre-Work Inspection Checklist (Dormer 1)

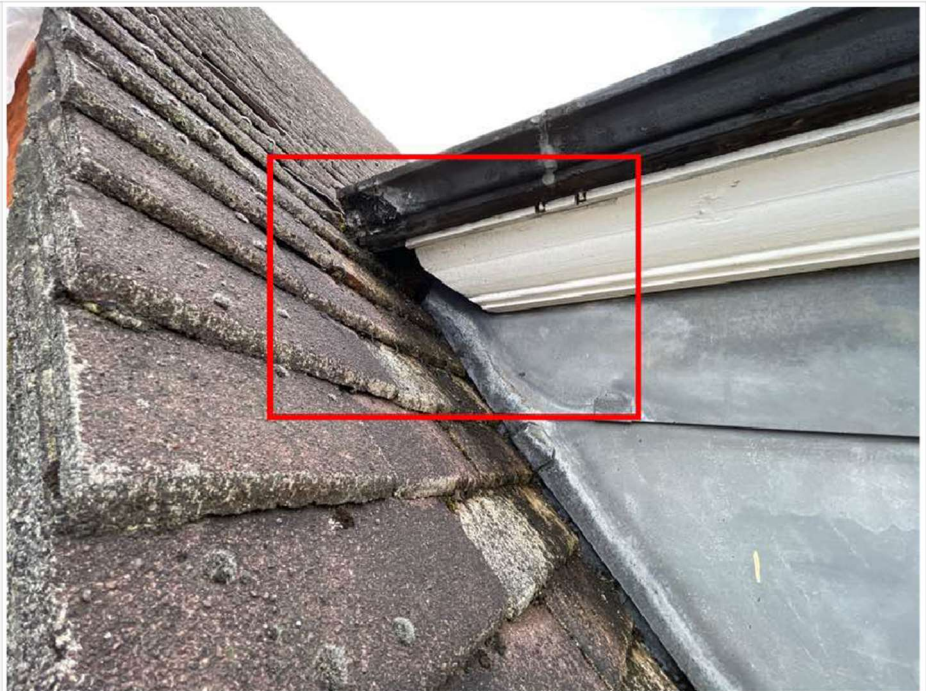
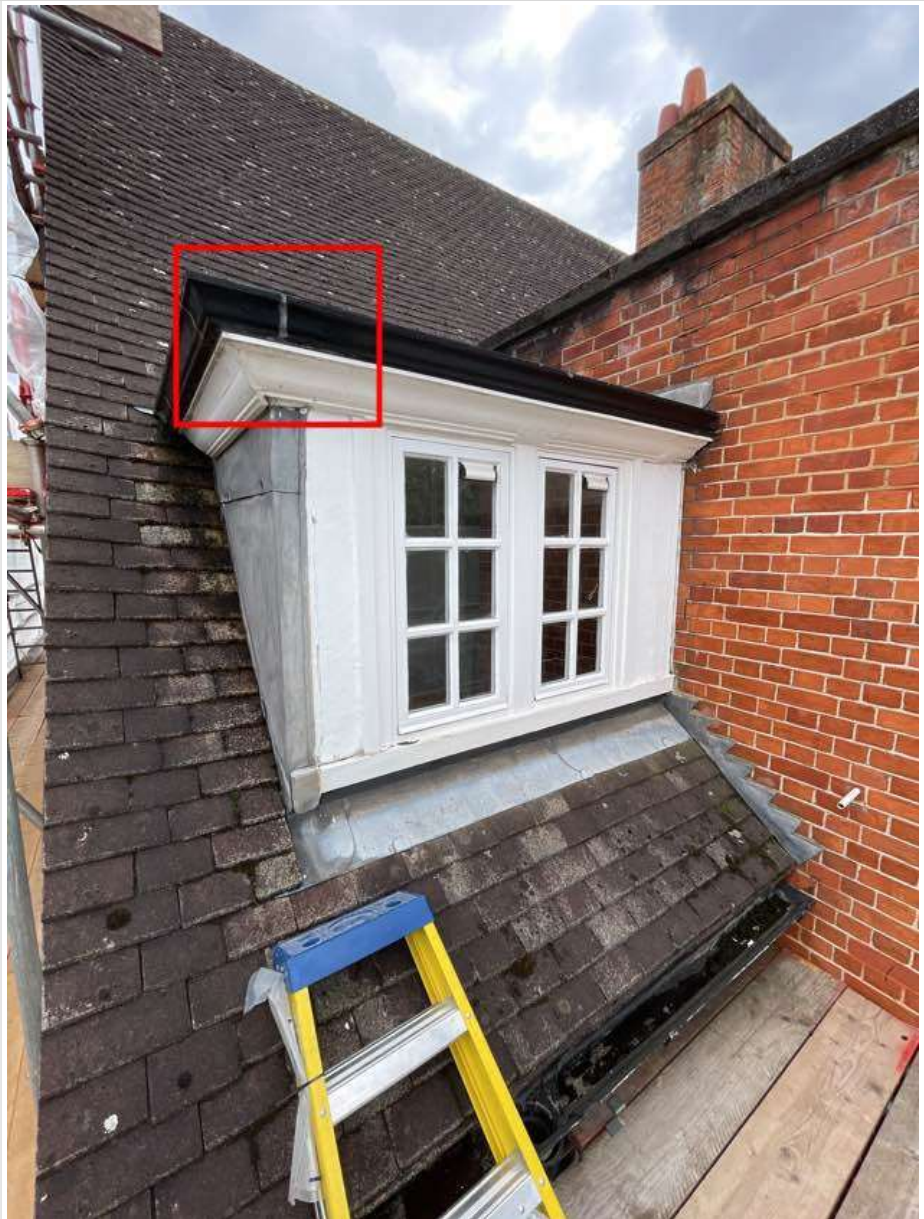
Pre-Work Inspection Checklist (Dormer 8)

Comments	The decorative soffits were showing sign of rot mainly due to the existing gutters leaking. Also, it was noted there has been previous repairs to the timber work installed to a poor standard.
Proposed Works	We would recommend relining the gutter with a Liqui Seal Coating and the timber works being replaced by a skilled carpenter.
Quantity of Materials	4 lm liquid seal

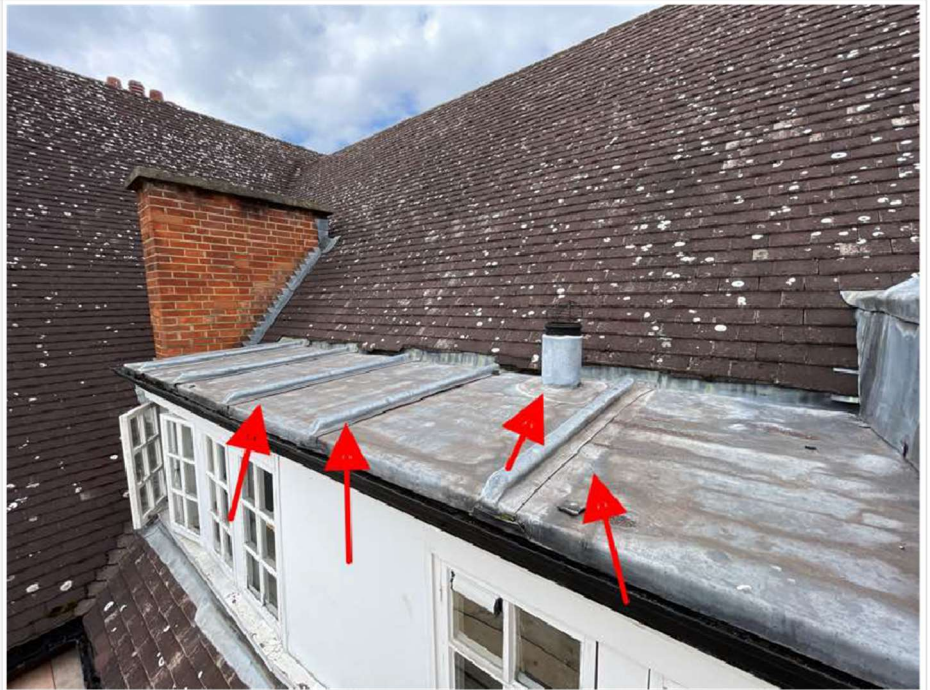
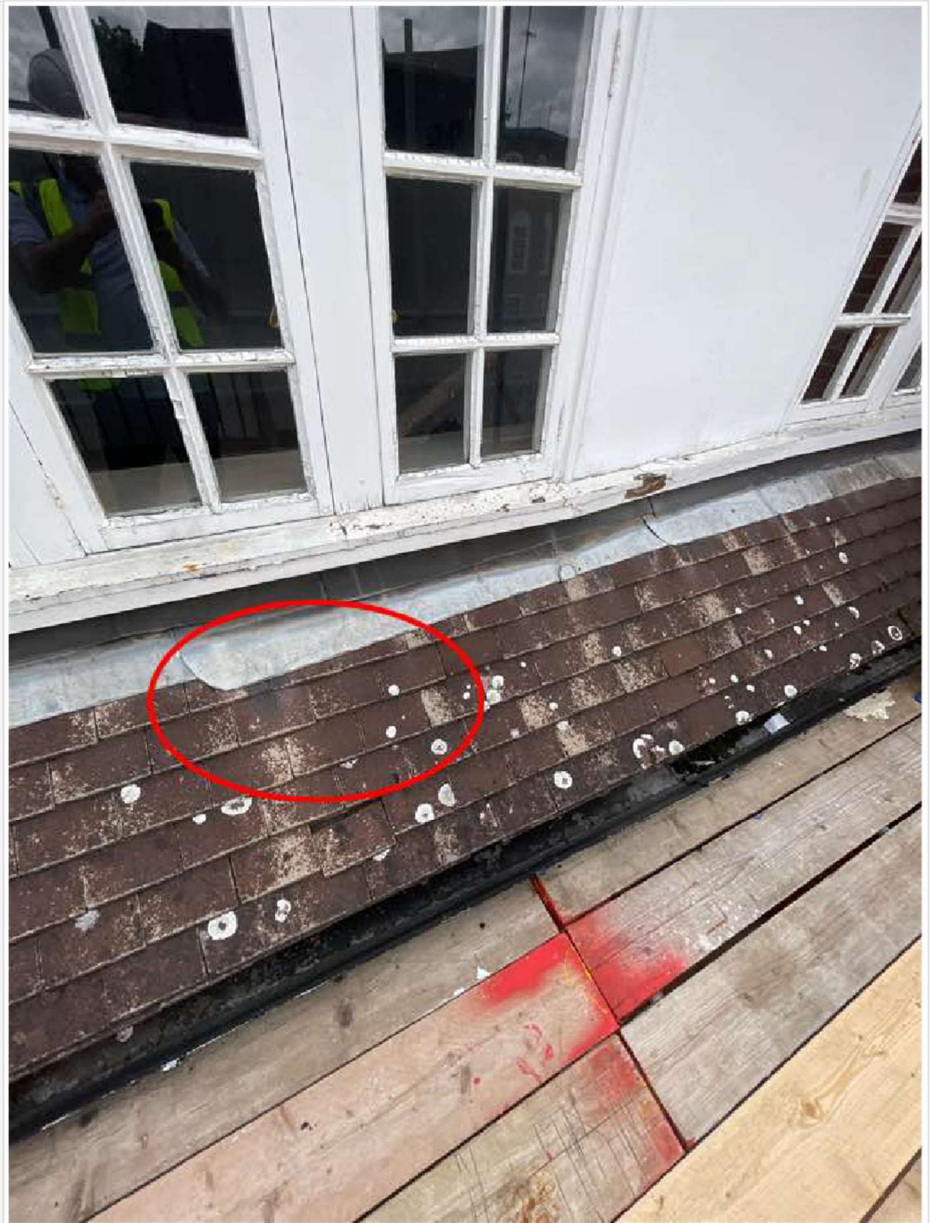
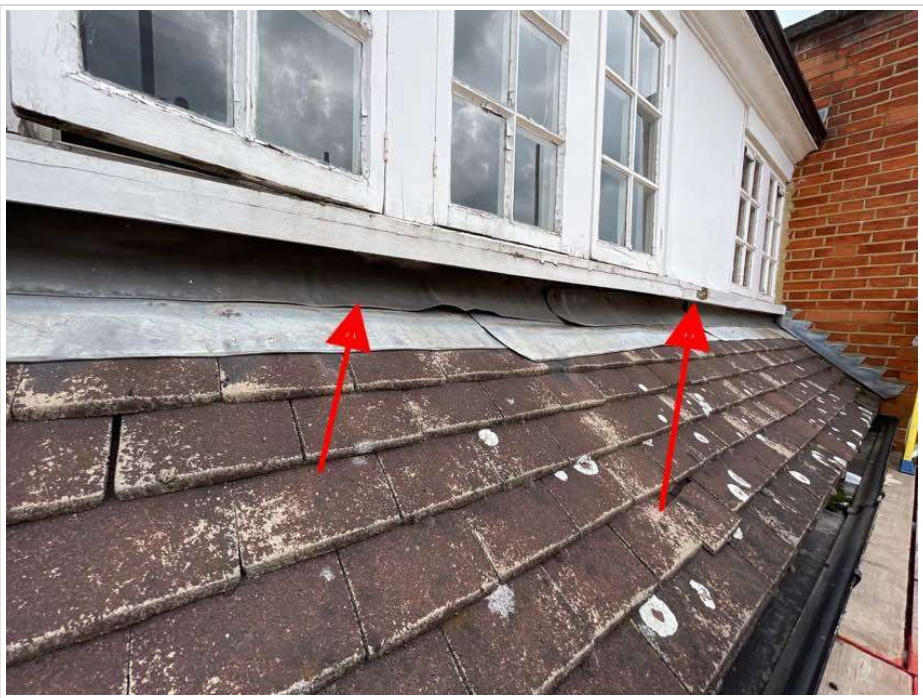
Pre-Work Inspection Checklist (Dormer 10)

Comments	The existing Lead has been repaired in multiple locations which would suggests there has been historic water ingress. The was also evidence of mastic repairs to the gussets and flashings.
Proposed Works	If water is found to be penetrating the building. We would recommend changing the lead on a like for like basis to the areas identified within the pictures. All lead works would be carried out in line with the current LSA guidelines. We would also recommend lining the existing aluminum gutters with a liquid applied waterproofing.
Quantity of Materials	6 roof bays 1200mm x 2000mm (code 6 lead sheet) - 4lm 100mm flashing (code 5 lead) - liquid seal 9lm

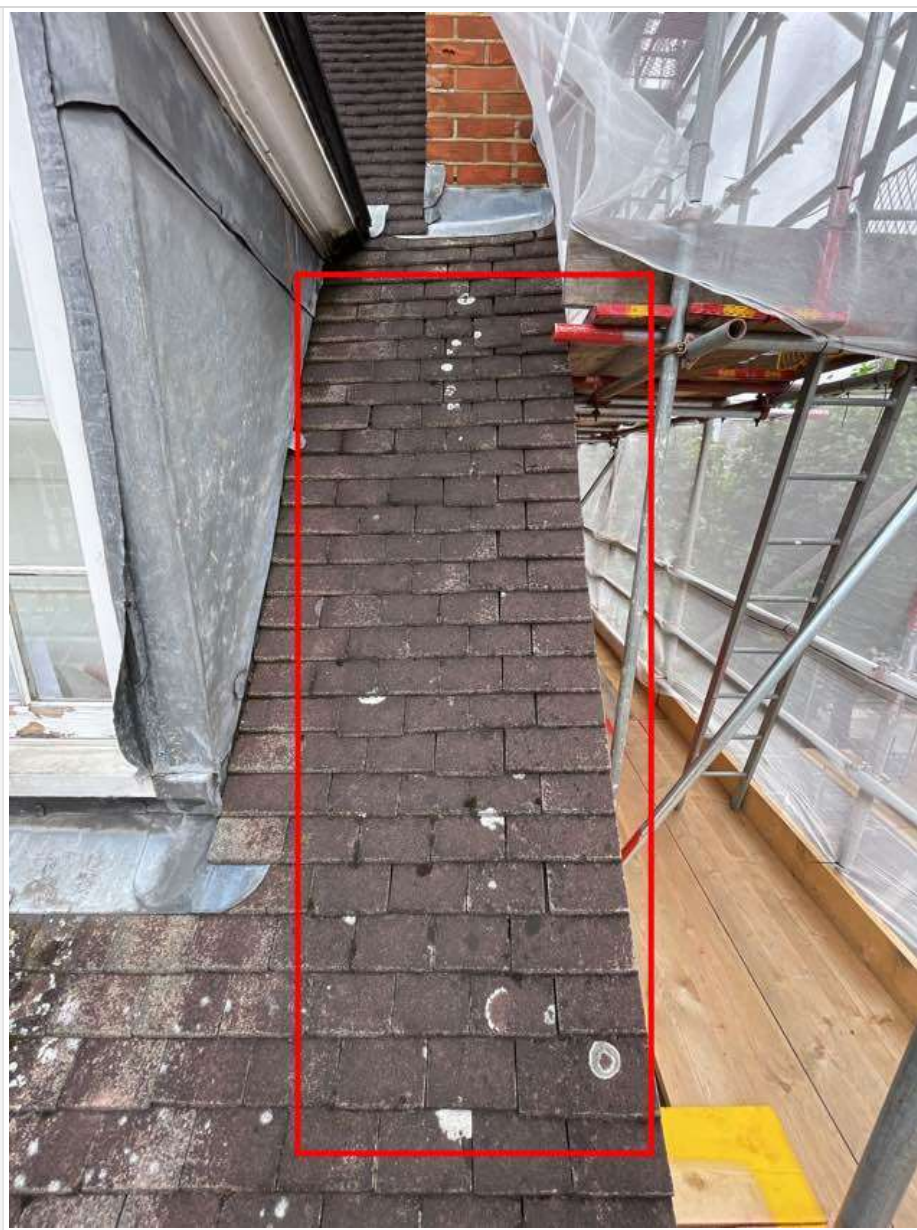
Pre-Work Inspection Checklist (Area 4)

<p>Comments</p>	<p>This image shows Verge movement and enlarge bonds between the tiles.</p>
<p>Proposed Works</p>	<p>The tiles would require relining the ensure the bonds are equal without removing the cemented verge.</p>
<p>Quantity of Materials</p>

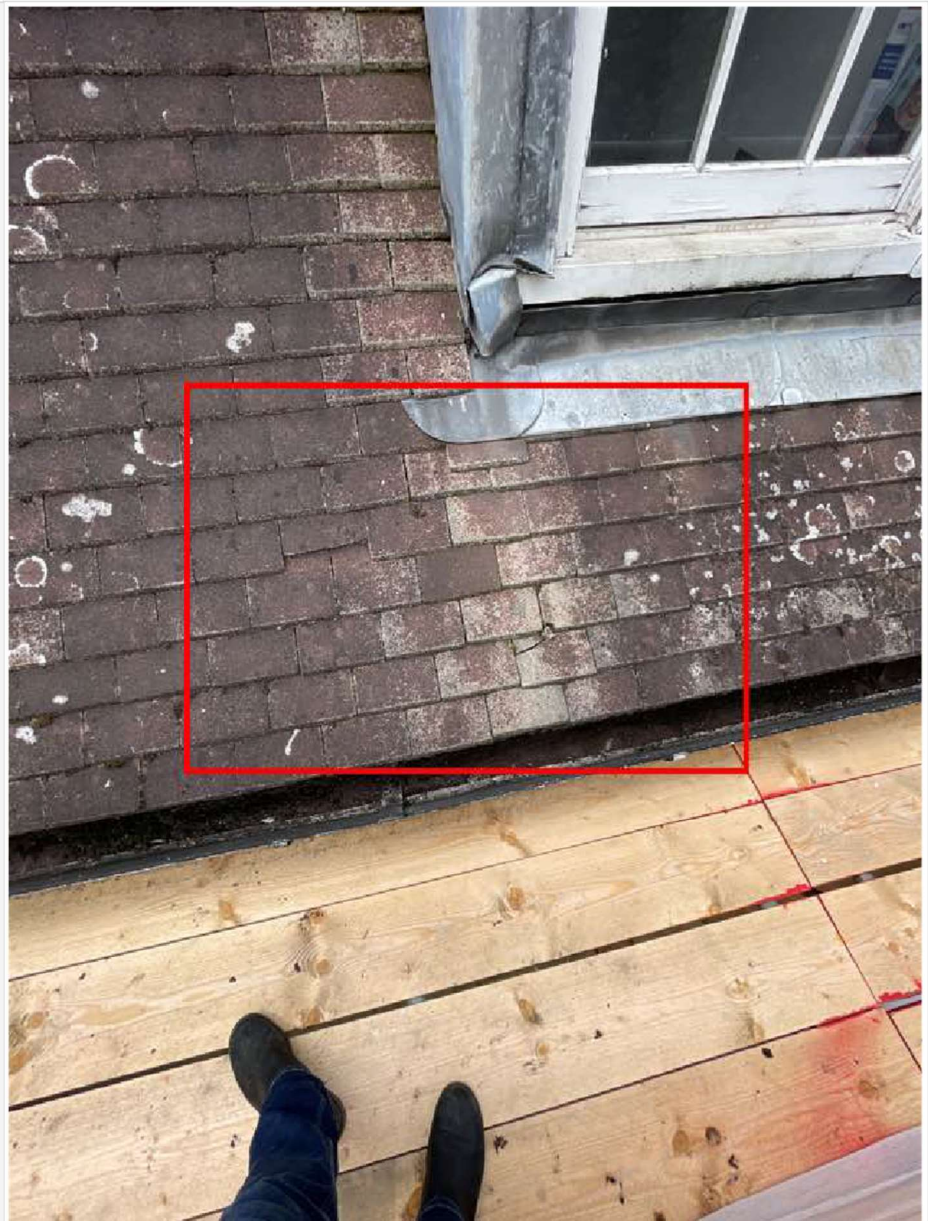
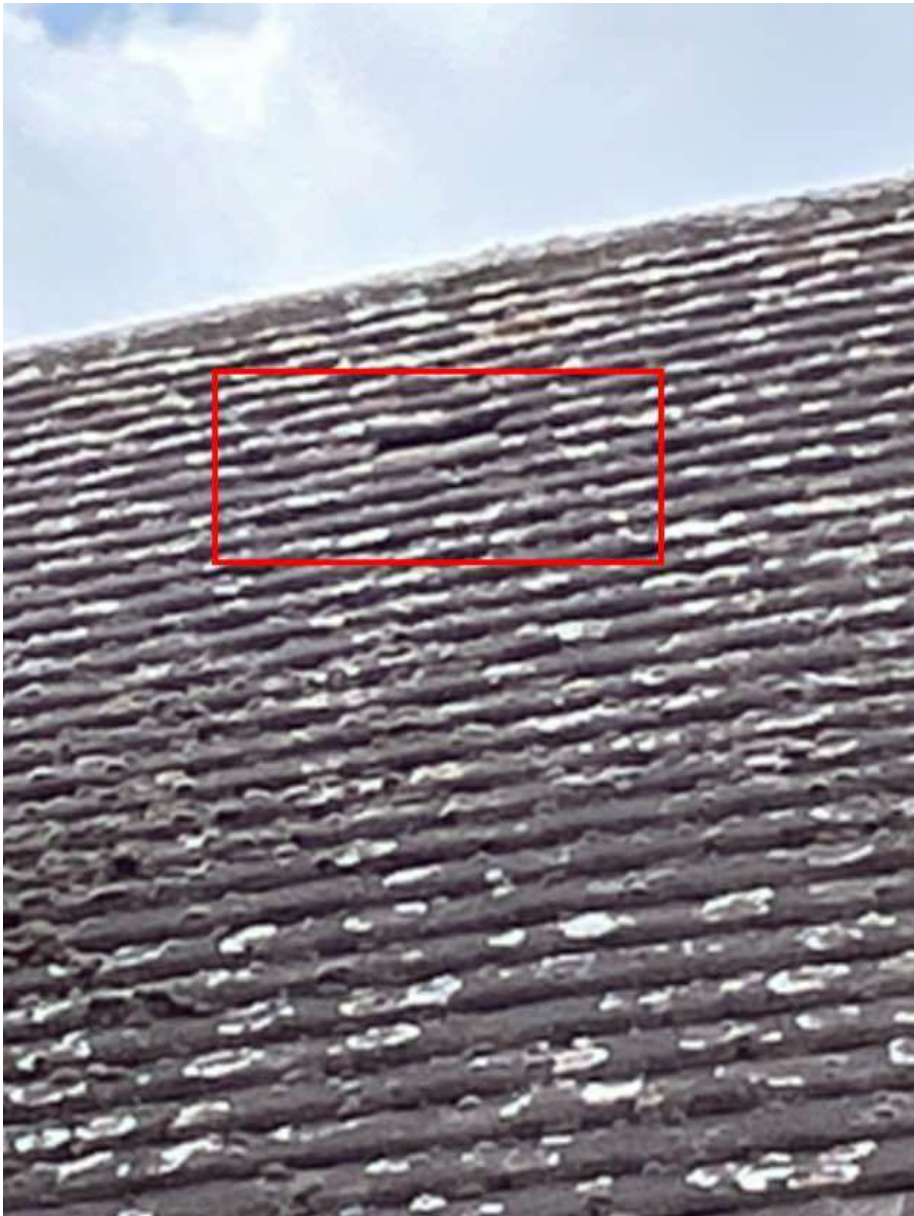
Pre-Work Inspection Checklist (Area 8 & 9)

Comments	Images show broken and slipped tiles
Proposed Works	We would recommend changing the tiles where necessary on a like for like basis.
Quantity of Materials

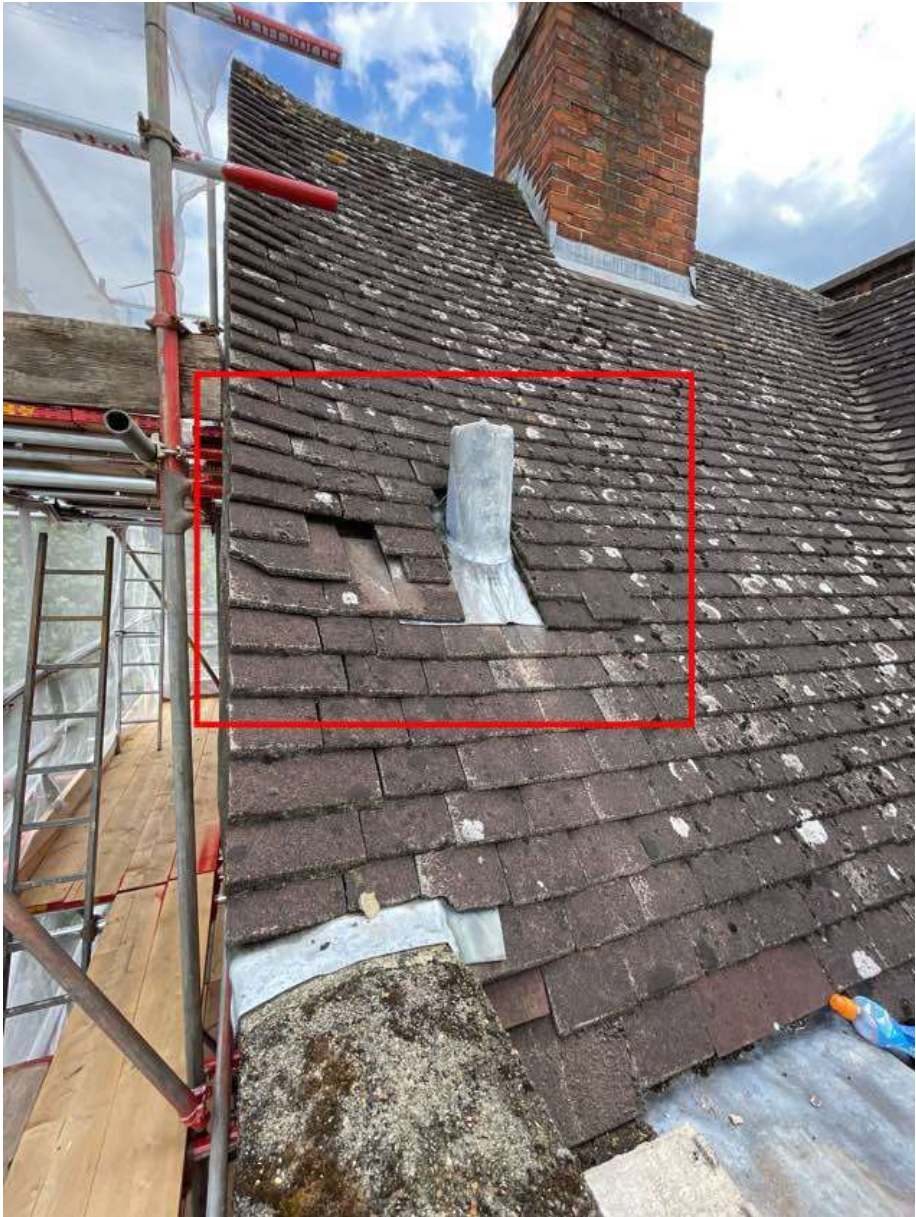
Pre-Work Inspection Checklist (Area 11)

<p>Comments</p>	<p>Images shows missing tiles around Soil Stack.</p>
<p>Proposed Works</p>	<p>New tiles are required on a like for like basis.</p>
<p>Quantity of Materials</p>	<p>10no. tiles</p>

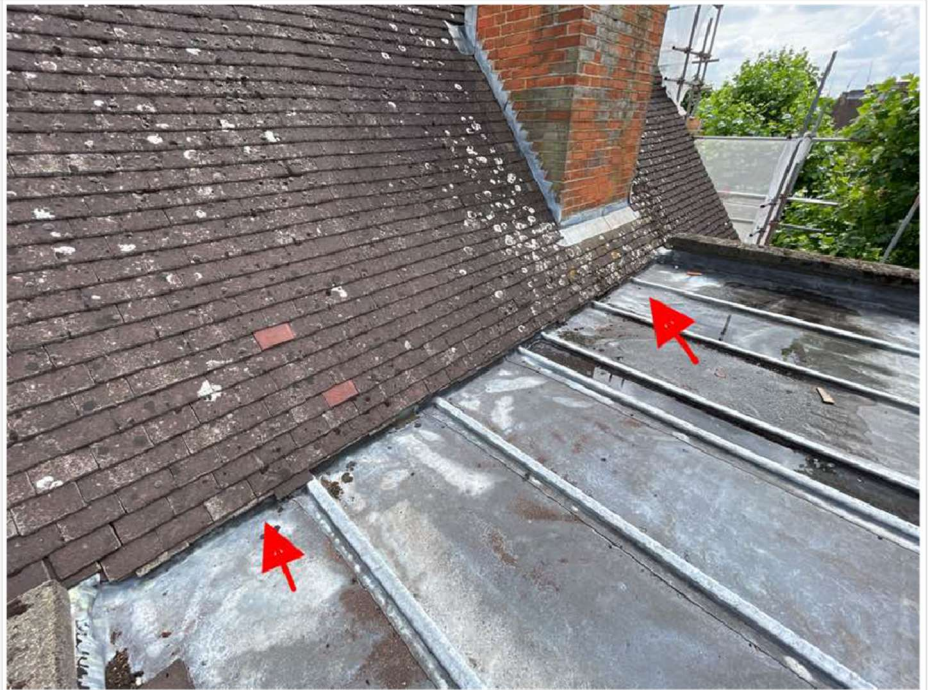
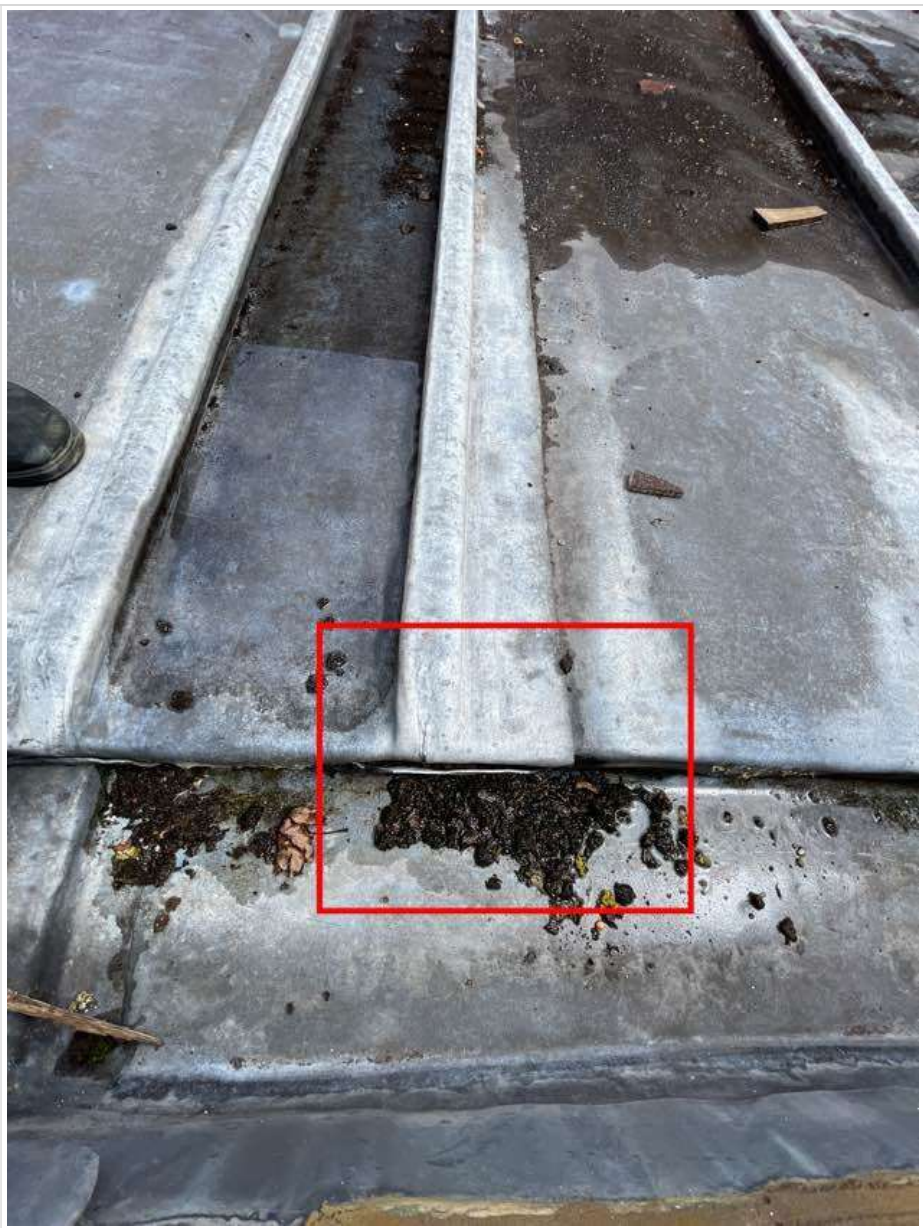
Pre-Work Inspection Checklist (Ref LFR)

Comments	<p>The existing Lead has been repaired in multiple locations which would suggest there has been historic water ingress. The eaves course has also dropped in various locations.</p>
Proposed Works	<p>We would recommend changing the lead on a like for like basis to the areas identified within the pictures. All lead works would be carried out in line with the current LSA guidelines. We would also strip back the bottom three course and investigate the reason why the tiles have dropped and repair and replace accordingly.</p>
Quantity of Materials	<p>Lead Bays 14 no. – Lead gutter 71m – Eve's course 71m</p>

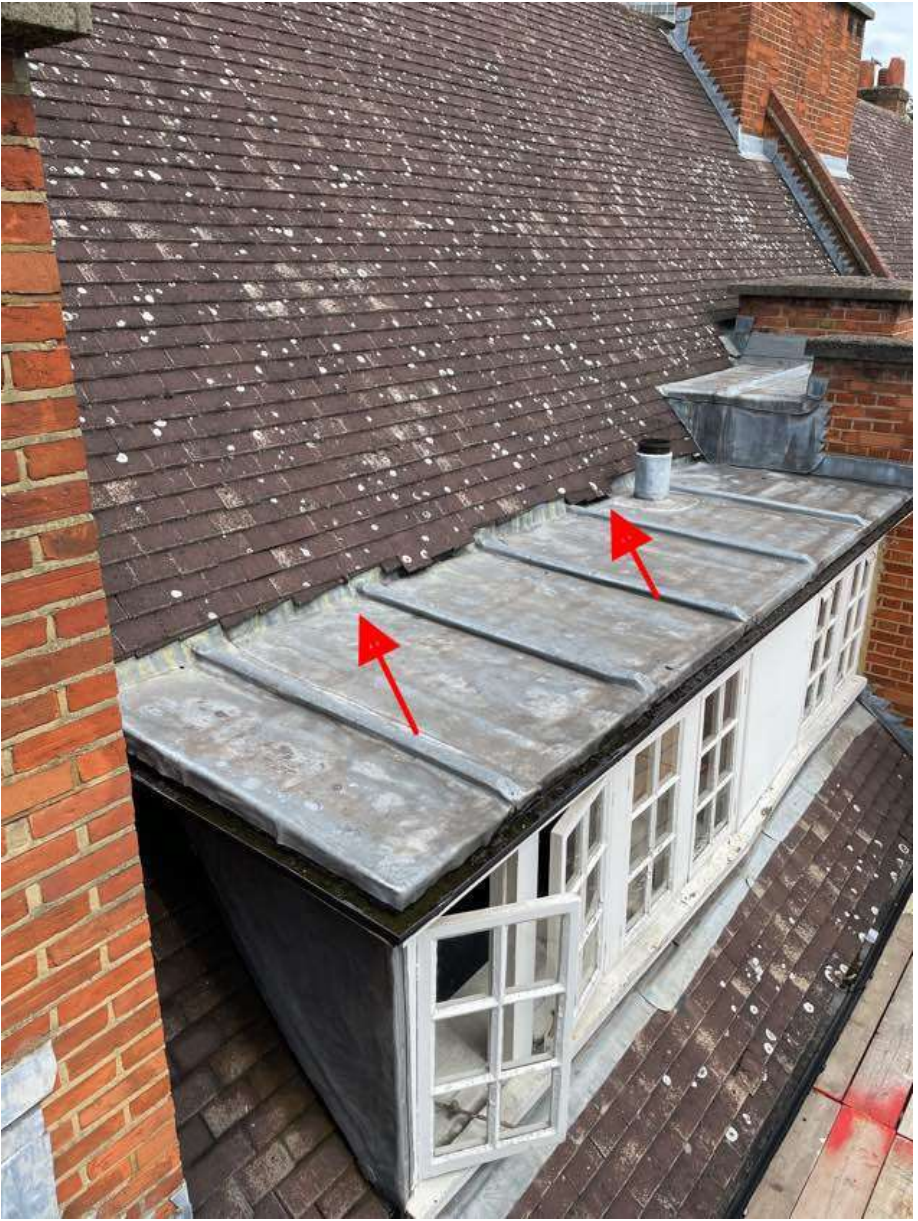
Pre-Work Inspection Checklist (Area 13)

Comments	Images shows the eaves course has also dropped in various locations.
Proposed Works	We would also strip back the bottom three course and investigate the reason why the tiles have dropped and repair and replace accordingly
Quantity of Materials	Eve's course – 5lm

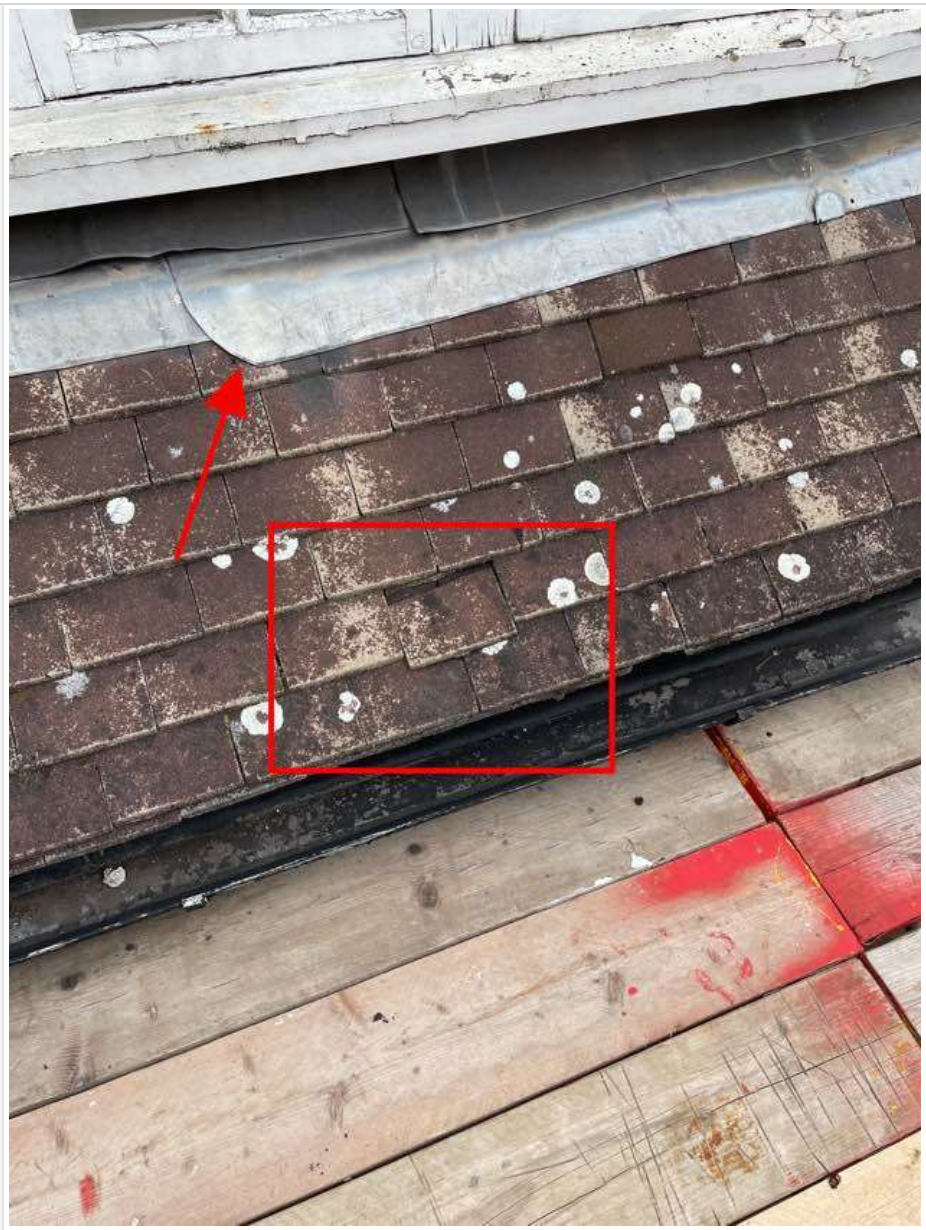
Pre-Work Inspection Checklist (Area 15)

<p>Comments</p>	<p>Images shows a slipped Tiles and slipped Lead flashings</p>
<p>Proposed Works</p>	<p>The existing Lead flashing would need to be rescued in line with the current LSA Guidelines and the tiles replaced on a like for like basis.</p>
<p>Quantity of Materials</p>	<p>4lm Lead Flashing – 10no. Tiles</p>
