13th October 2021

Our ref: JW/B091/1021

Re: Dolton C of E School EX19 8QF

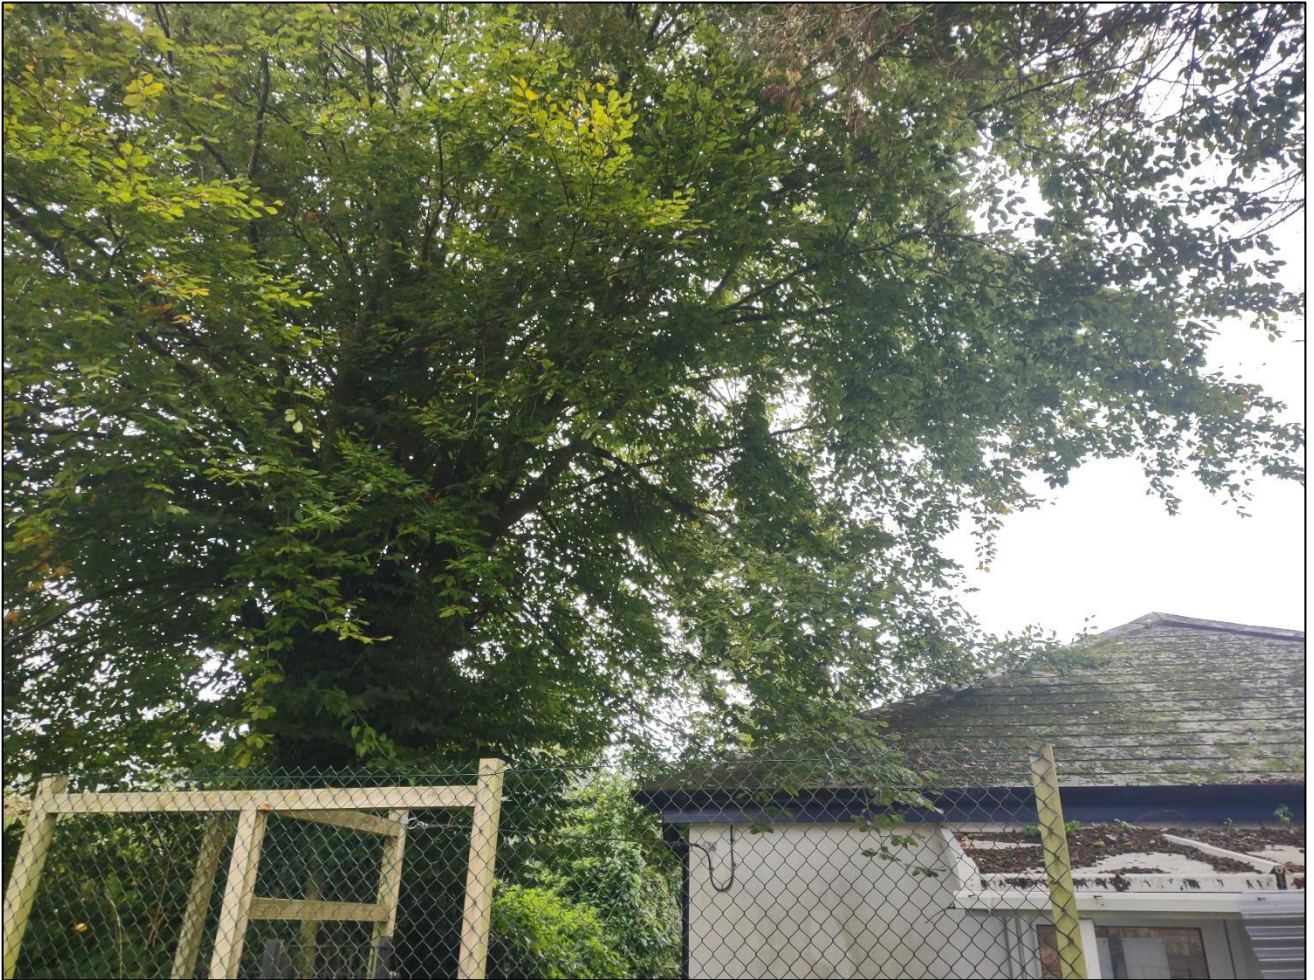
I note that branches from the Beech tree (T555) within the immediate grounds of the school are rubbing on the school building roof. Should this be allowed to continue there is a risk they will cause damage to the roof.

Photograph 1 – Beech T555 rubbing on roof

When time and finances permit, I recommend crown raising the north-eastern aspect to achieve a clearance of 1.5m over the roof. This can be achieved through the removal of four branches no greater than 50mm in diameter.

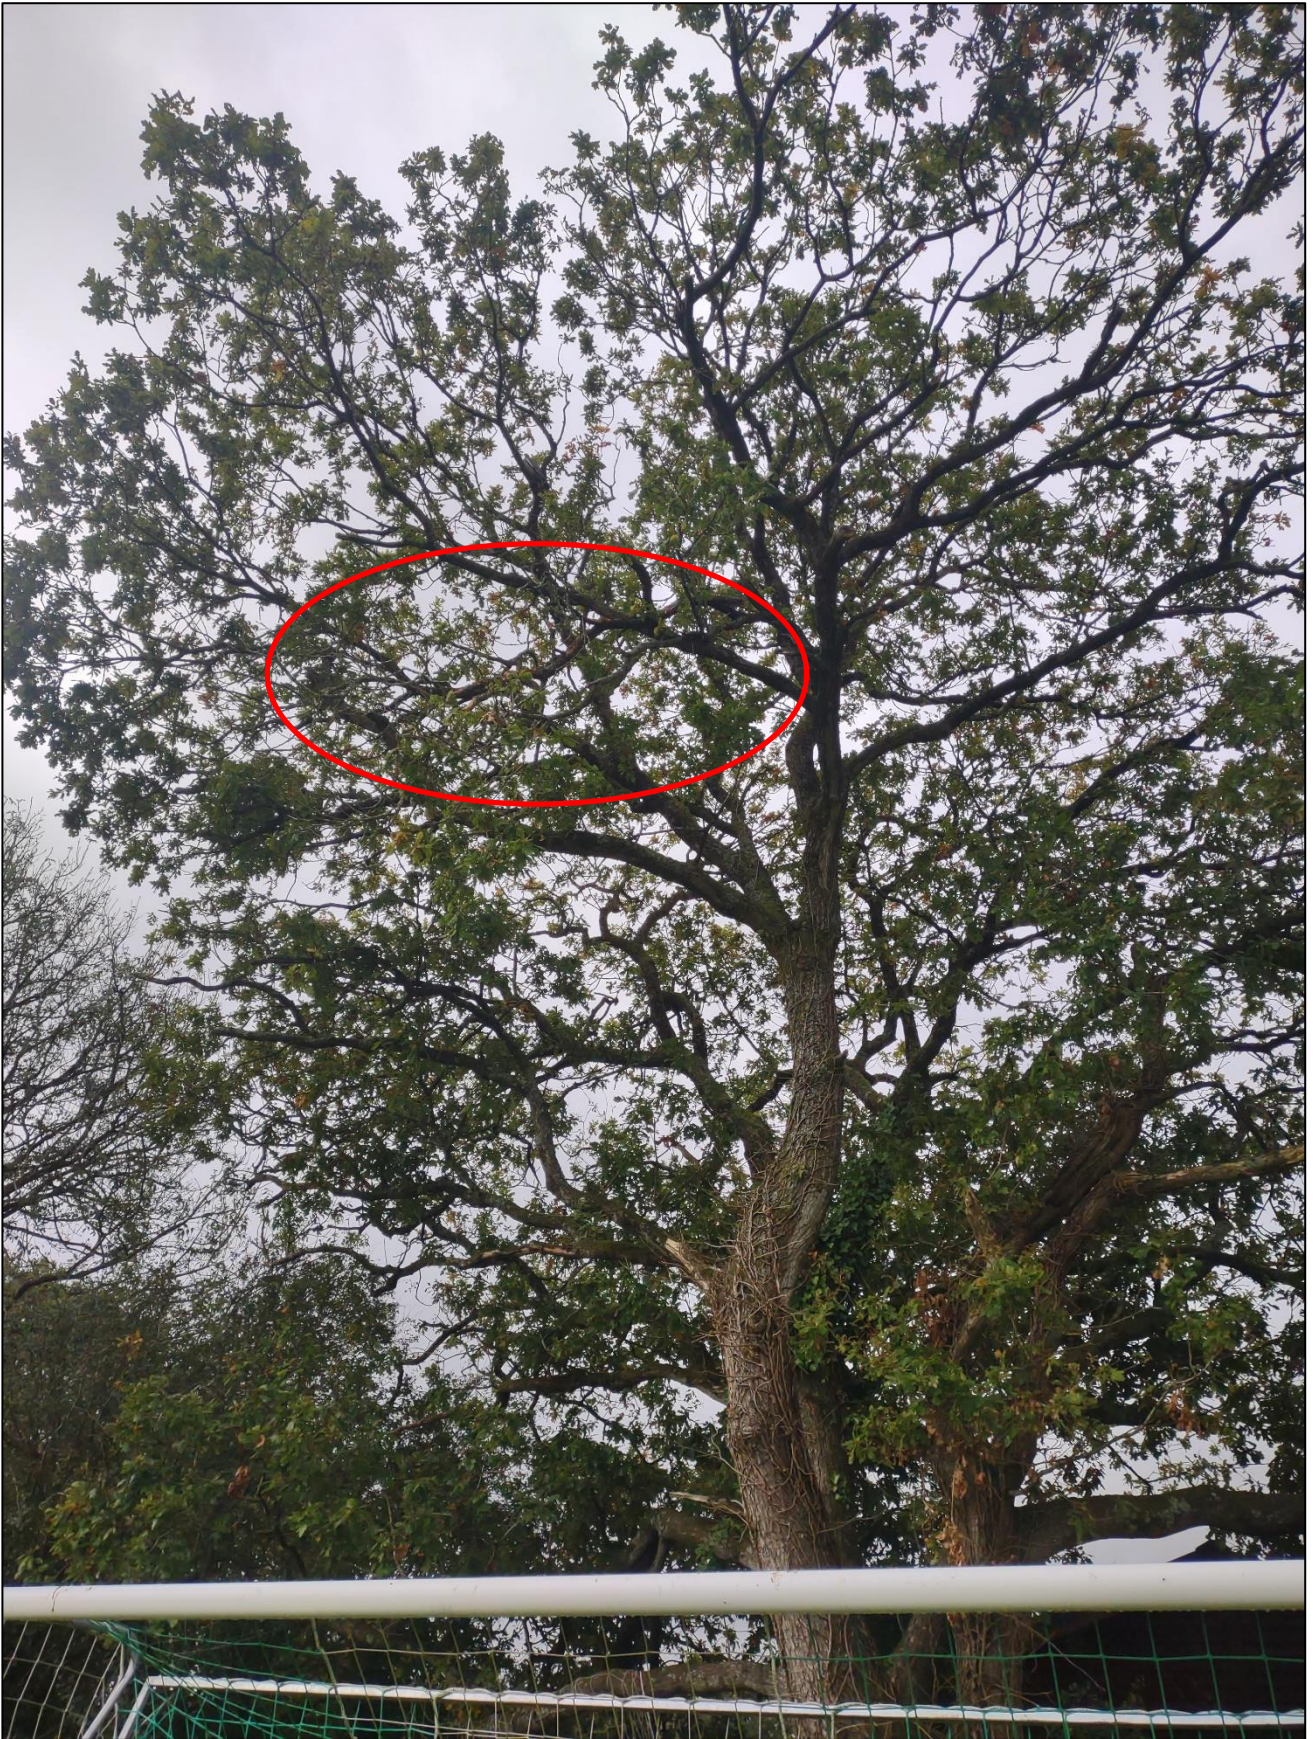
I note the presence of a hanging branch within T554, an Oak on the western boundary of the playing fields. The medium size lateral branch is partially attached and is suspended over the goalkeepers area on the football field. Although risk of harm from the branch falling is low I suggest removing this branch at the same time as Ash G556 are dealt with.

Photograph 2 – Hanging branch in Oak T554 highlighted

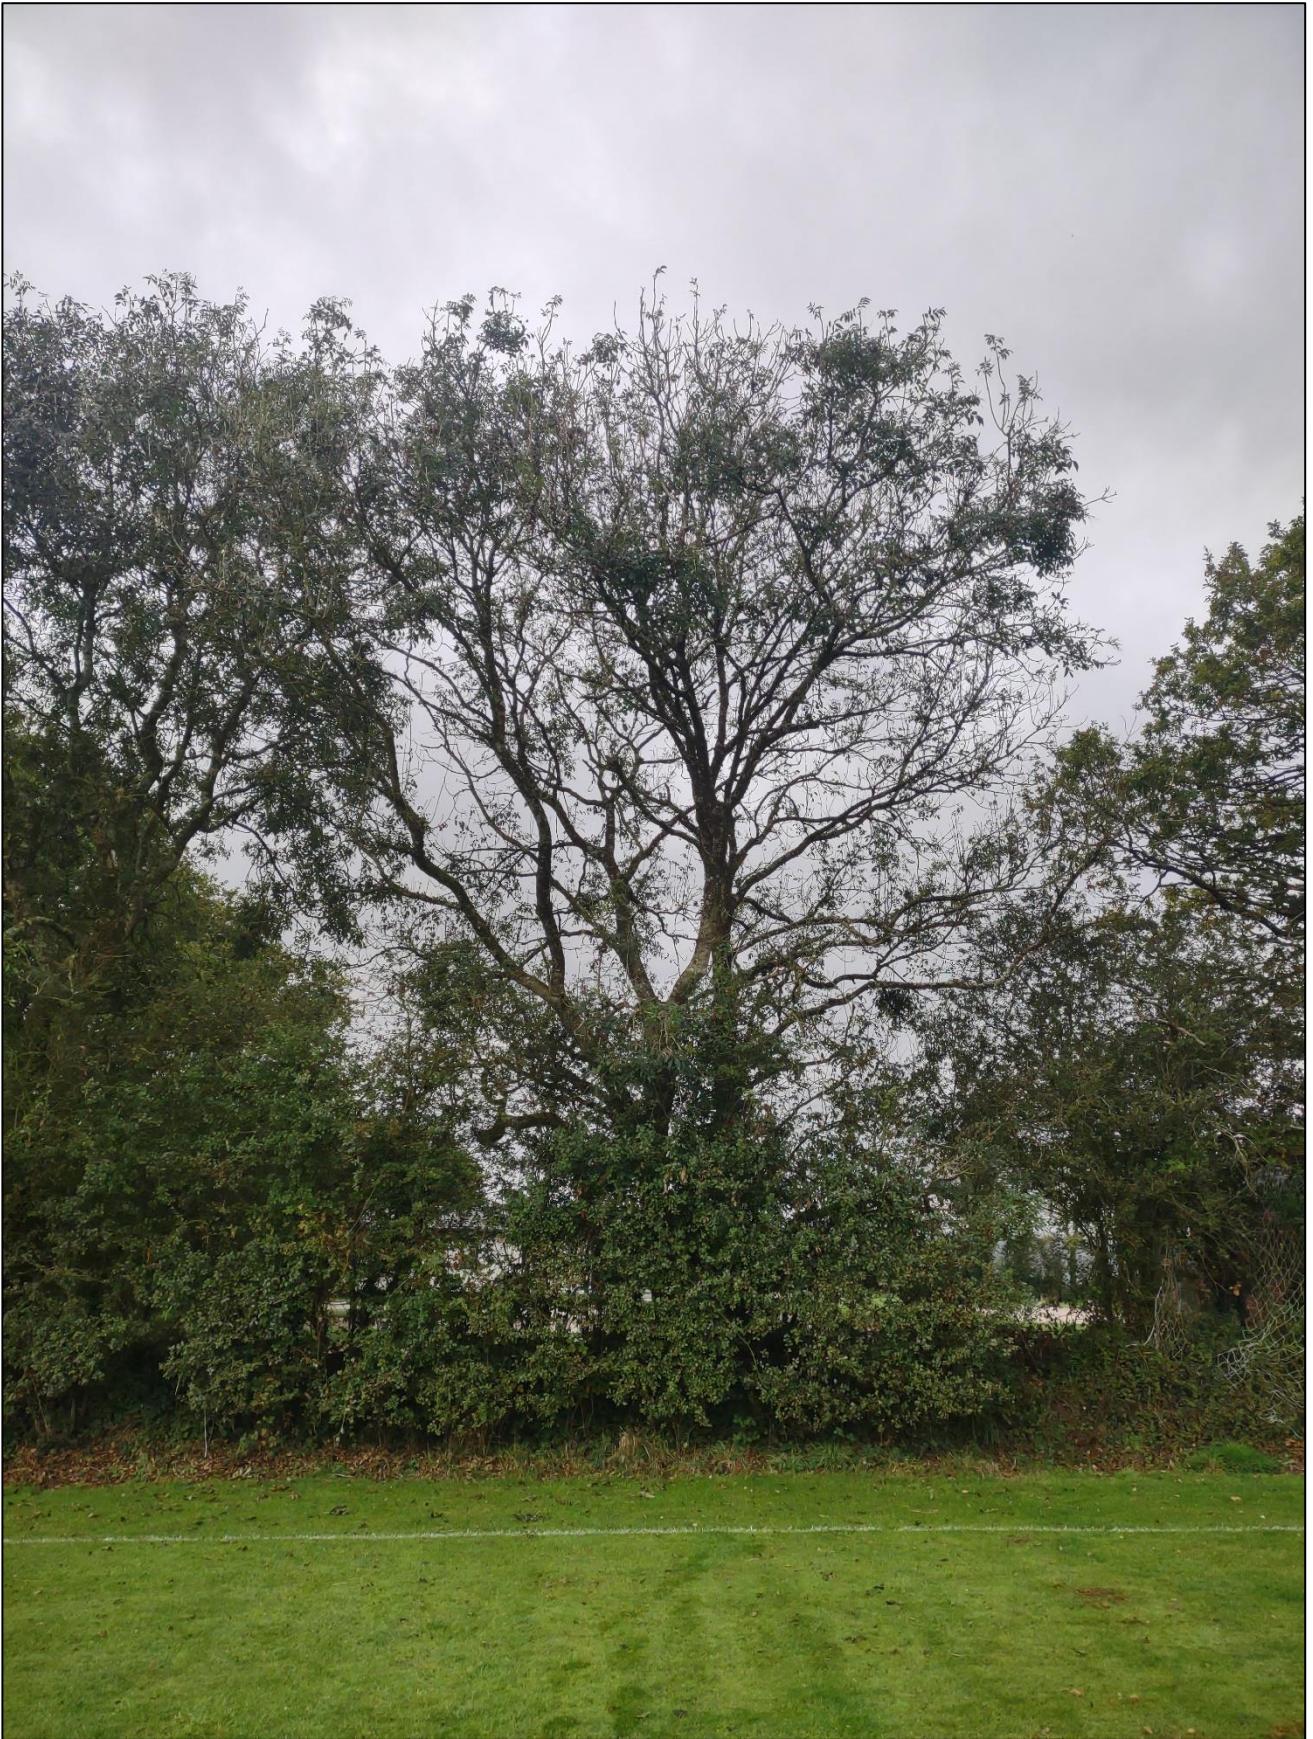
I note that on the western boundary of the playing fields is a group of Ash (G556). I did not note the presence of any other Ash on site. This group includes two large multi-stem trees, both exhibiting signs of Ash Dieback Disease. The loss in foliar density is estimated to be approximately 30%. The group stands within falling distance to the football field and a caravan plot, in the neighbouring property. The amenity value of the group is low. The risk of harm from the group is low, however I recommend felling the group within the next 6 months while it is still possible to deal with them safely using conventional techniques. The removal of G556 at an advanced state of decline from ADD, is likely to be far more technically challenging, and hence more expensive, than its removal at an early stage of decline.

Photograph 3 – Northern member of G556 exhibiting ash dieback disease centre, companion tree to left
