221058.100

STRUCTURAL FEASIBILITY REPORT

EXISTING BARN

NORTH RYE HOUSE, BROADWELL

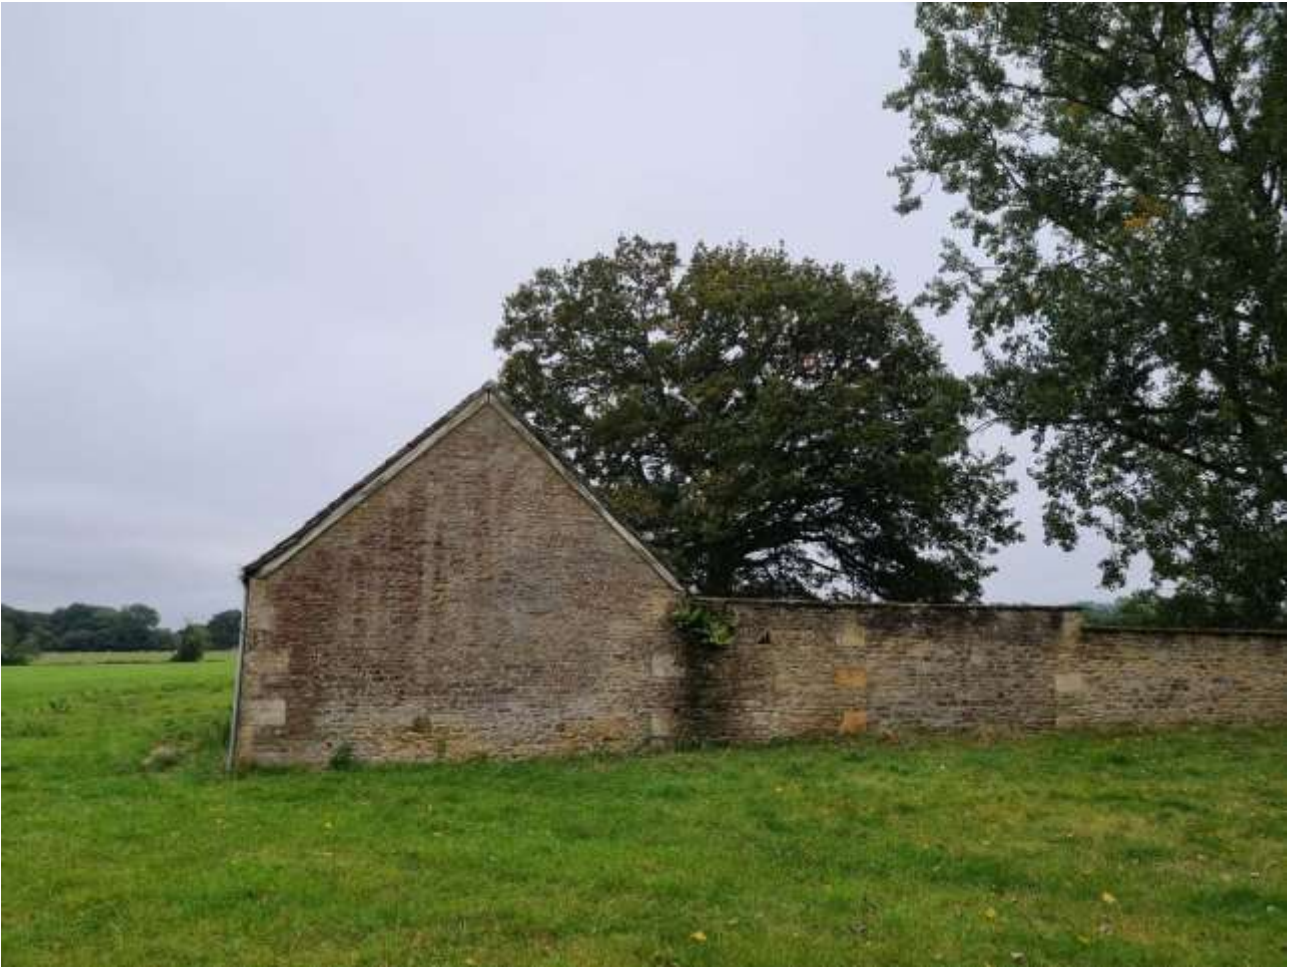
Photograph 1: Showing Northern Elevation

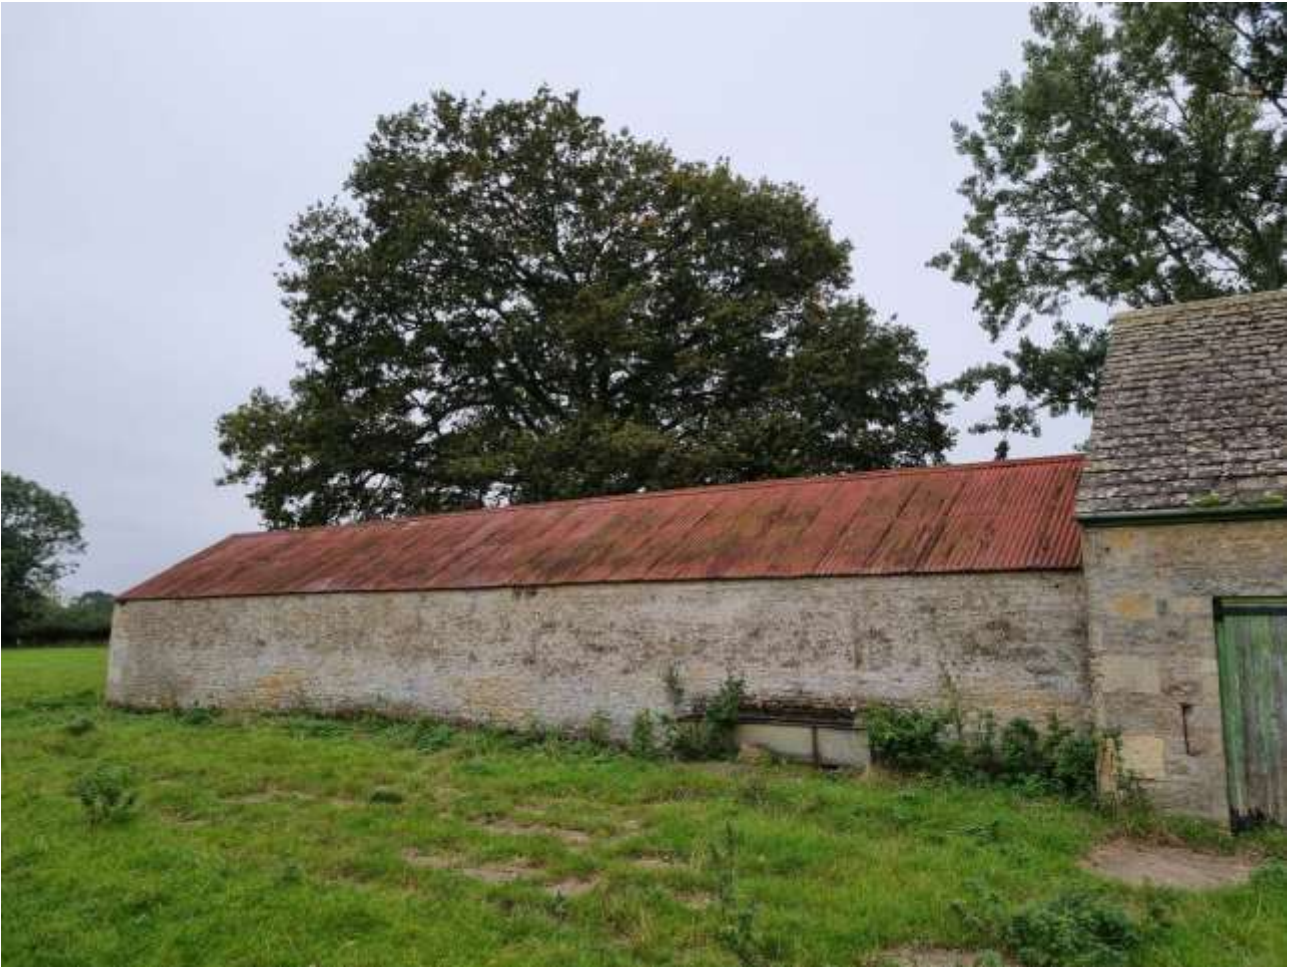
Photograph 2: Showing Eastern Elevation

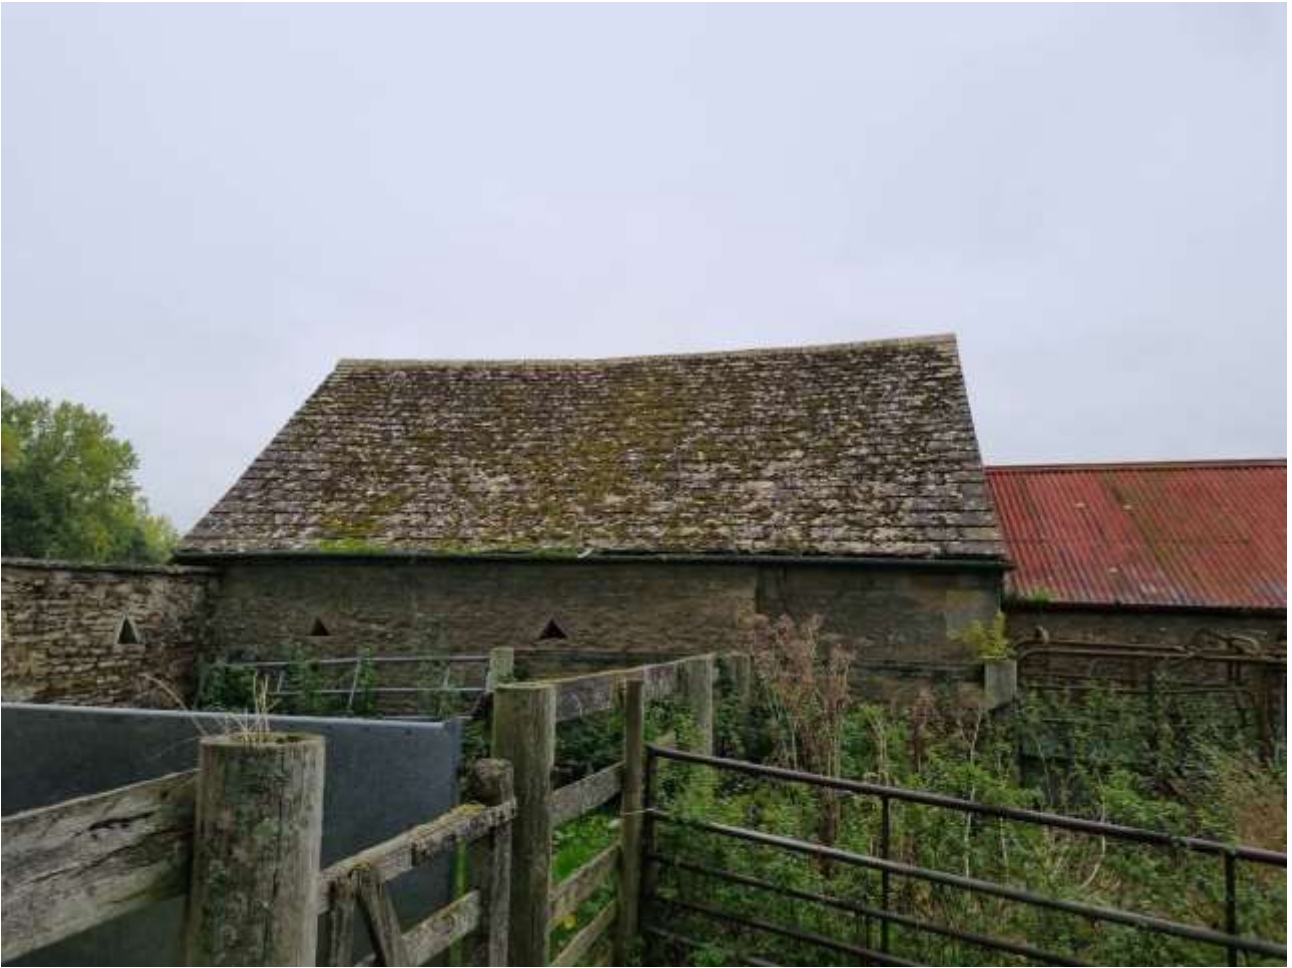
Photograph 3: Showing Western Elevation

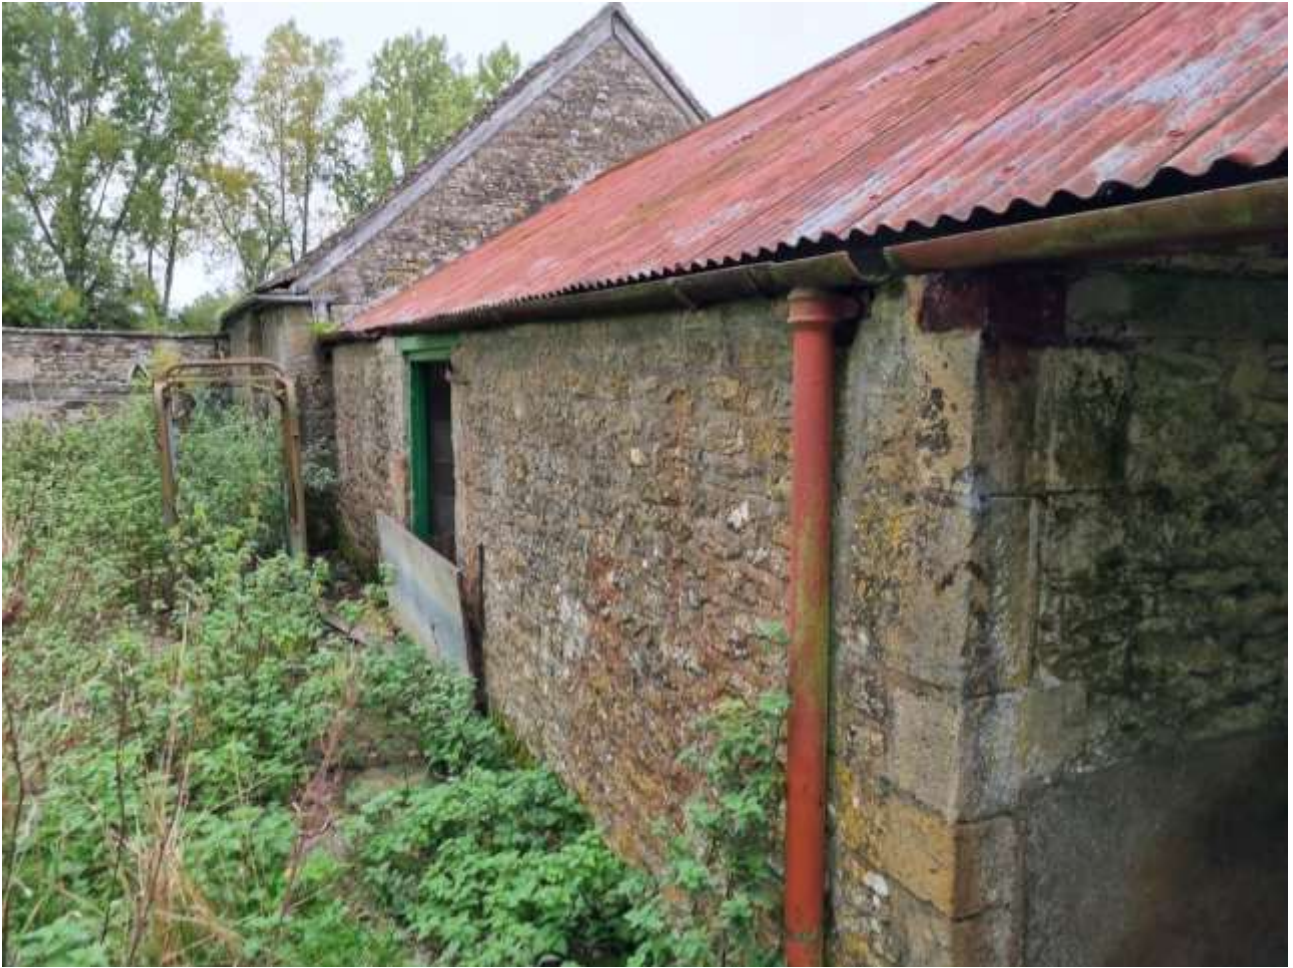
Photograph 4: Showing Western Elevation

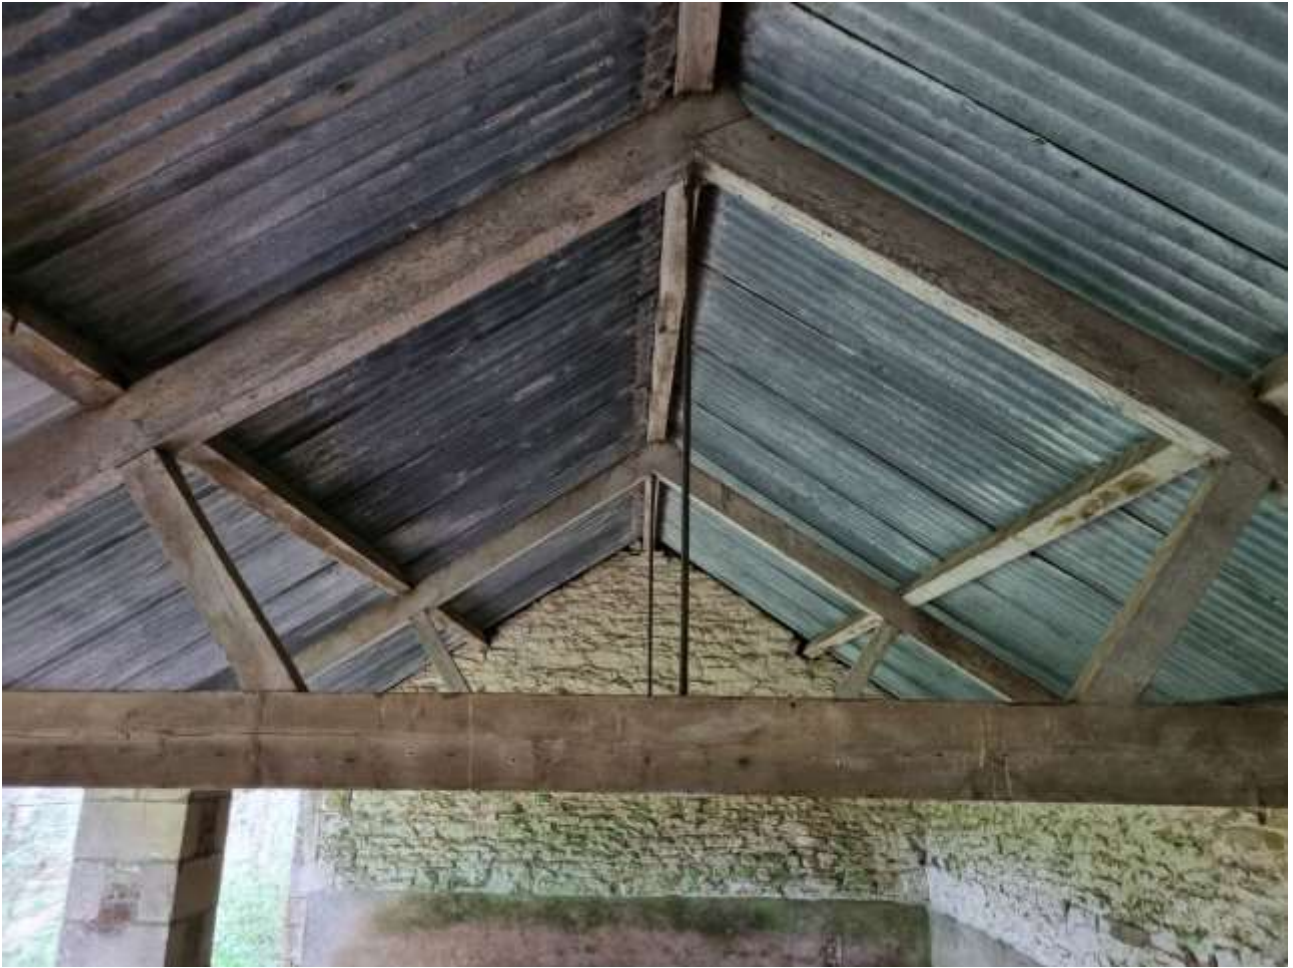
Photograph 5: Showing roof structure to Southern Part of Barn

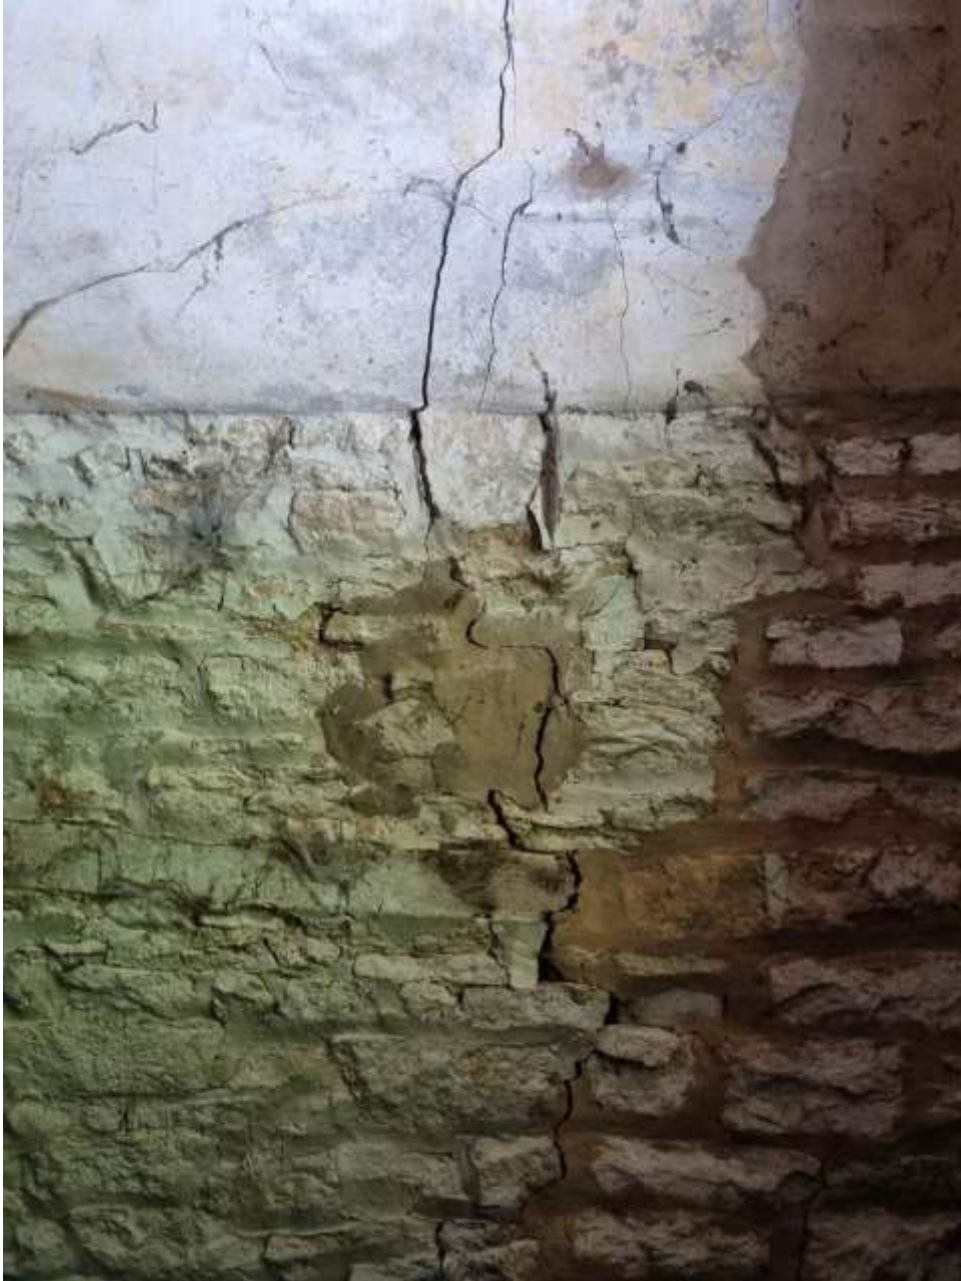
- 4.2.1 The walls are constructed in stone. There are two large openings to the eastern elevation. To the eastern elevation there are two small openings present as well as three larger openings which are framed out by stone piers.
- 4.2.2 The walls appear to be level and in good condition, save for some minor areas of localised cracking/damage.
- 4.2.3 The roof trusses to the northern side of the barn are supported on brickwork piers inboard of the main external walls. To the western side, the pier has come away from the adjacent wall.
- 4.2.4 Some areas of the existing walls appear to have been re-pointed internally.
- 4.2.5 There is cracking present to an internal half height dividing wall to the northern end of the barn.

Photograph 6: Showing internal cracking to walls

- 5.2 Localised crack repairs could be carried out to any affected areas using traditional heli-bar remedial techniques.
- 5.3 The brickwork pier that has come away from the adjacent wall could be locally re-built with adequate wall ties installed.

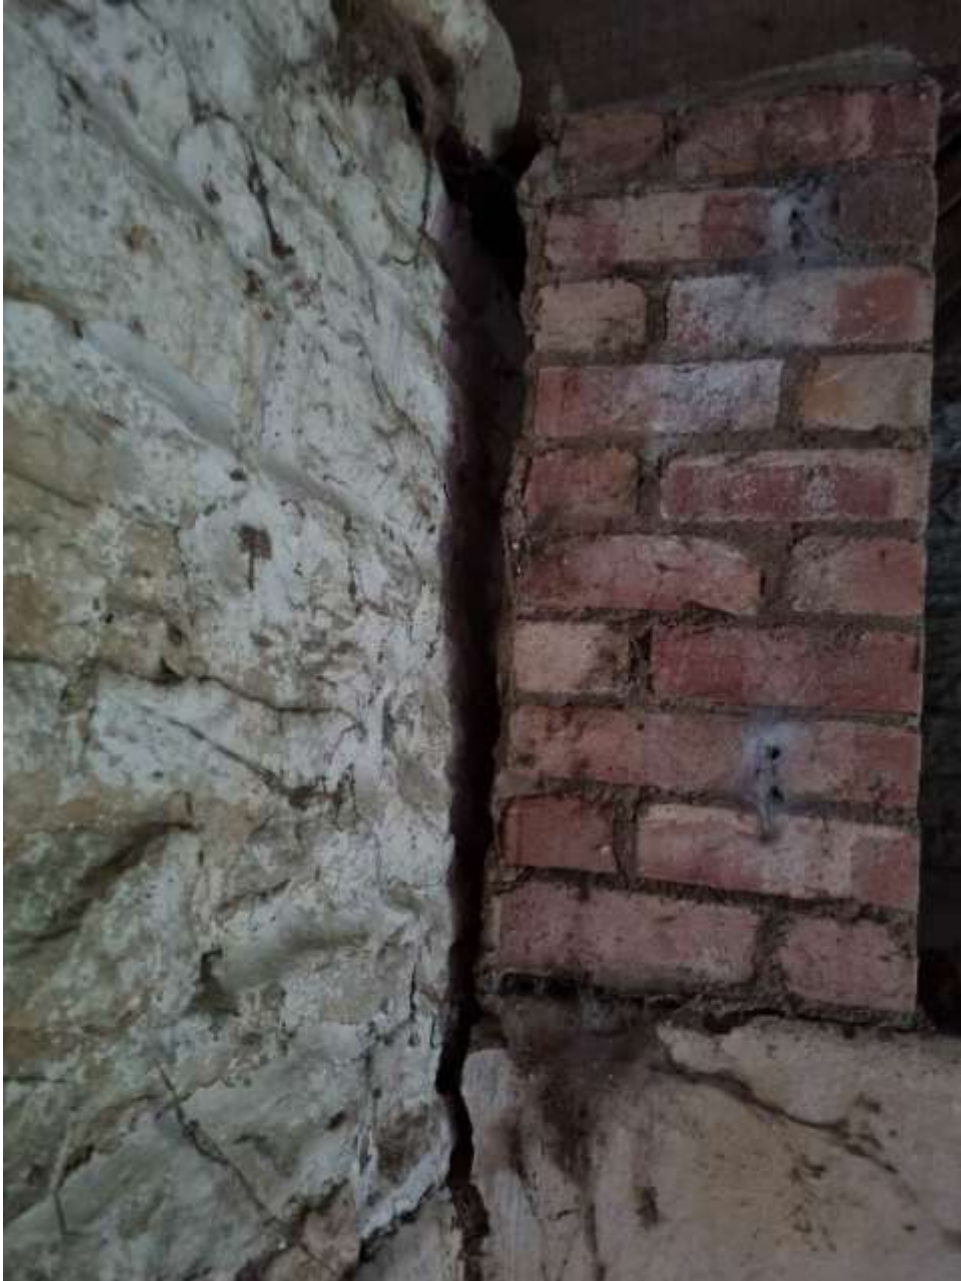
Photograph 7: Showing brickwork pier

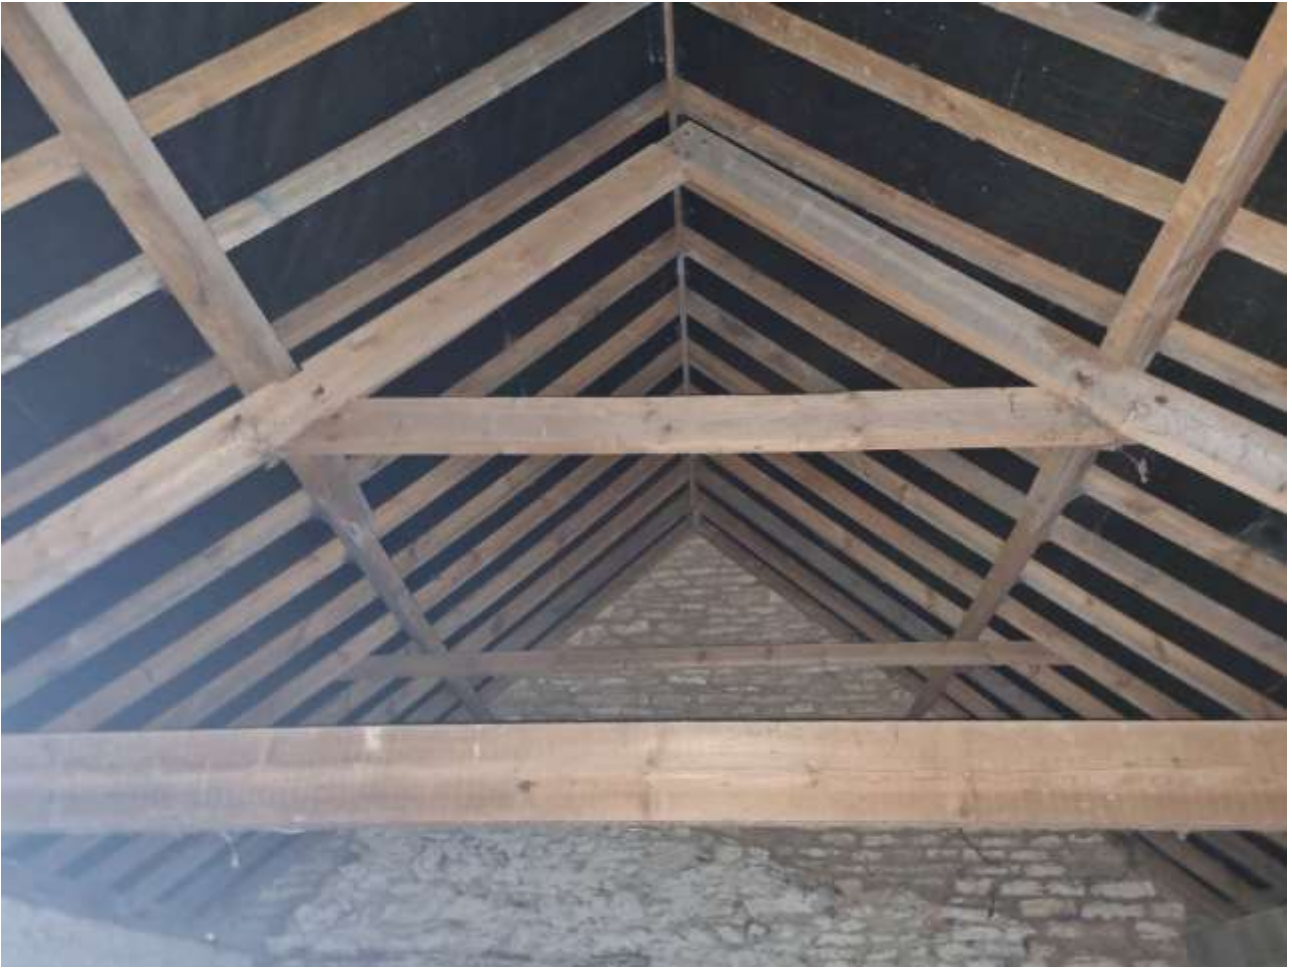
- 4.1.1 The higher portion of roof to the northern side of the barn consists of a Cotswold stone roof covering. This is supported on timber rafters (at approximately 400mm centres) and timber purlins (one either side of the ridge line). These purlins bear onto the gable walls with a timber truss at their midspan.
- 4.1.2 Some additional cross timber members are present at a high level.
- 4.1.3 The low portion of roof to the southern side of the barn consists of a corrugated metal roof sheeting which is supported on timber purlins. The purlins bear onto the gable walls and three intermediate trusses at approximately 3m centres. The trusses are timber but have a vertical steel tension member.
- 4.1.4 The timbers appear to be in good condition to the entire roof. The ridge line appears relatively level and there are no signs of excess deflection.

Photograph 8: Showing roof structure to Northern Part of Barn
