ANTHONY-JOHNSON

Consulting Engineer Ltd

Mintlyn farm,
Queen Elizabeth Way,
Bawsey,
King's Lynn

It is proposed that an existing barn be converted into a residential unit and the purpose of the survey is to review structural elements so as to discern whether the existing structure is suitable for such a purpose.

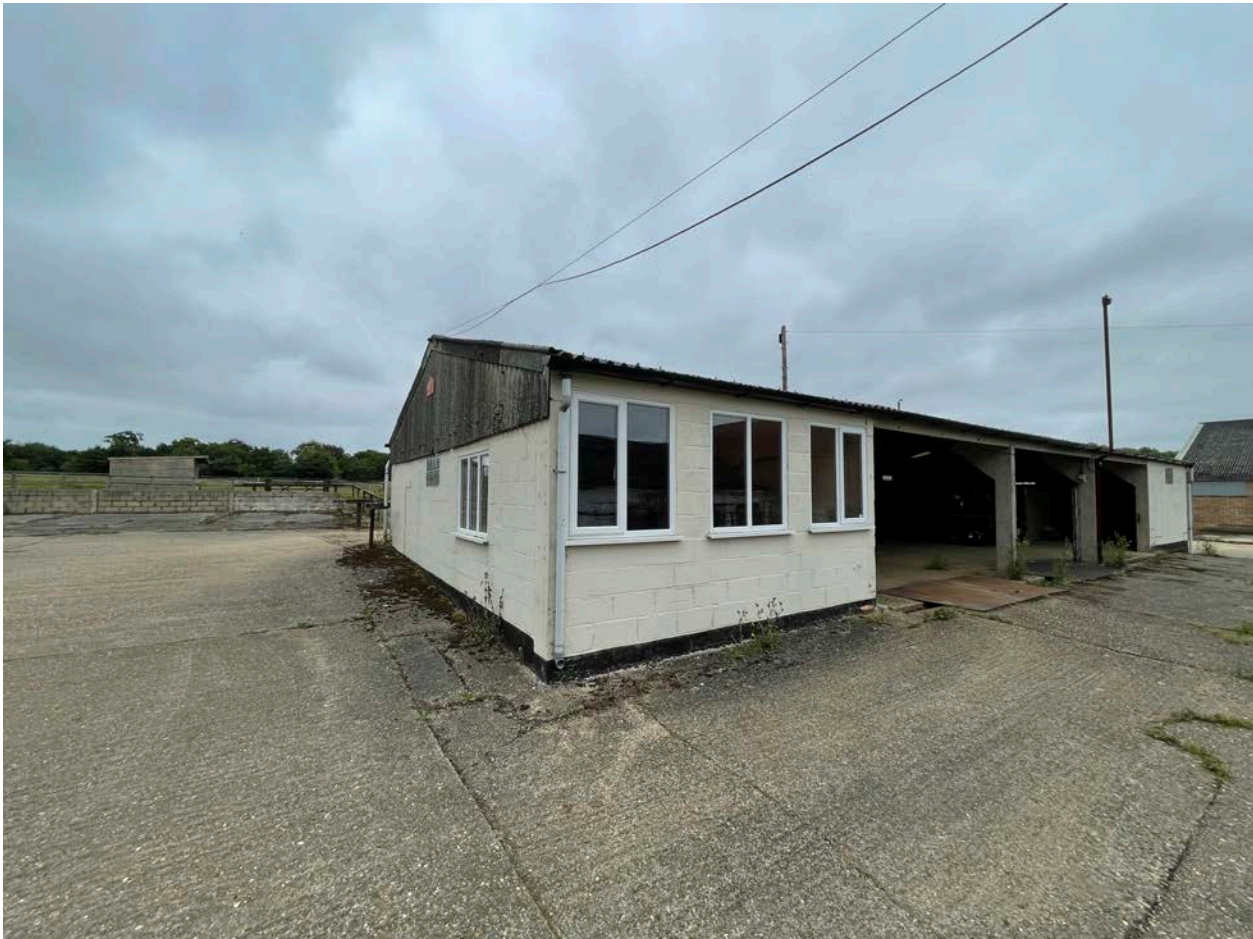
Image 1.0: View of Barn structure

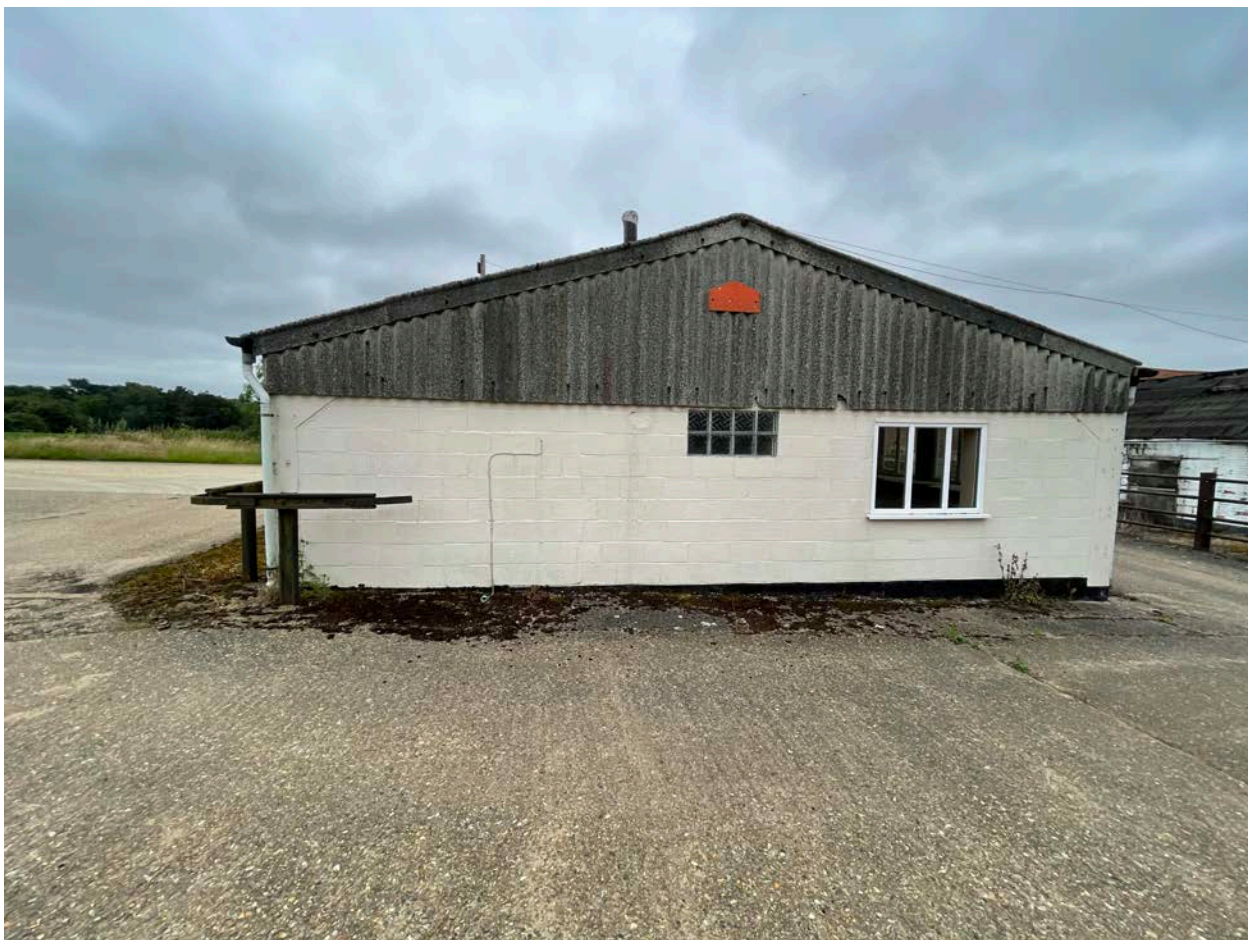
In reviewing the side gable end, facing the existing farmhouse, it is noted that the block infill panel spans between adjacent columns on the portal frame. Block work is cut so as to rise with the concrete haunch at either end. The block work panel stops at lintel height with a steel member running horizontal to the head of the block work, allowing for fixing back of a corrugated cement sheet.

Image 2.0: Gable end to structure.

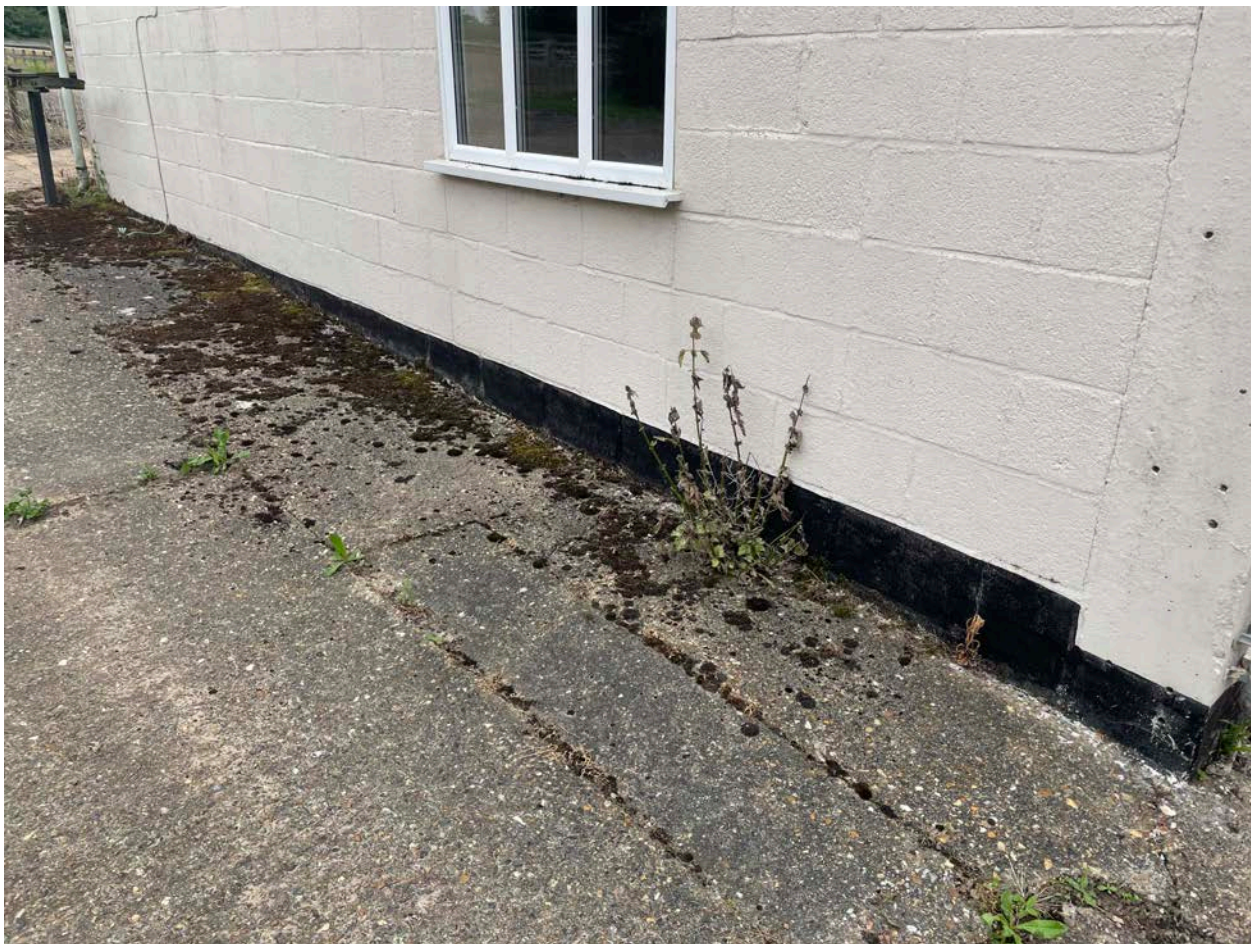
The Base of the block work wall is set abutting an external concrete slab, allowing for vehicle access and ground level is noted as a sloping with a pitch of 200 mm front to back, indicating that block work extends down below ground level.

Image 3.0: Blockwork with concrete laid to falls to gable

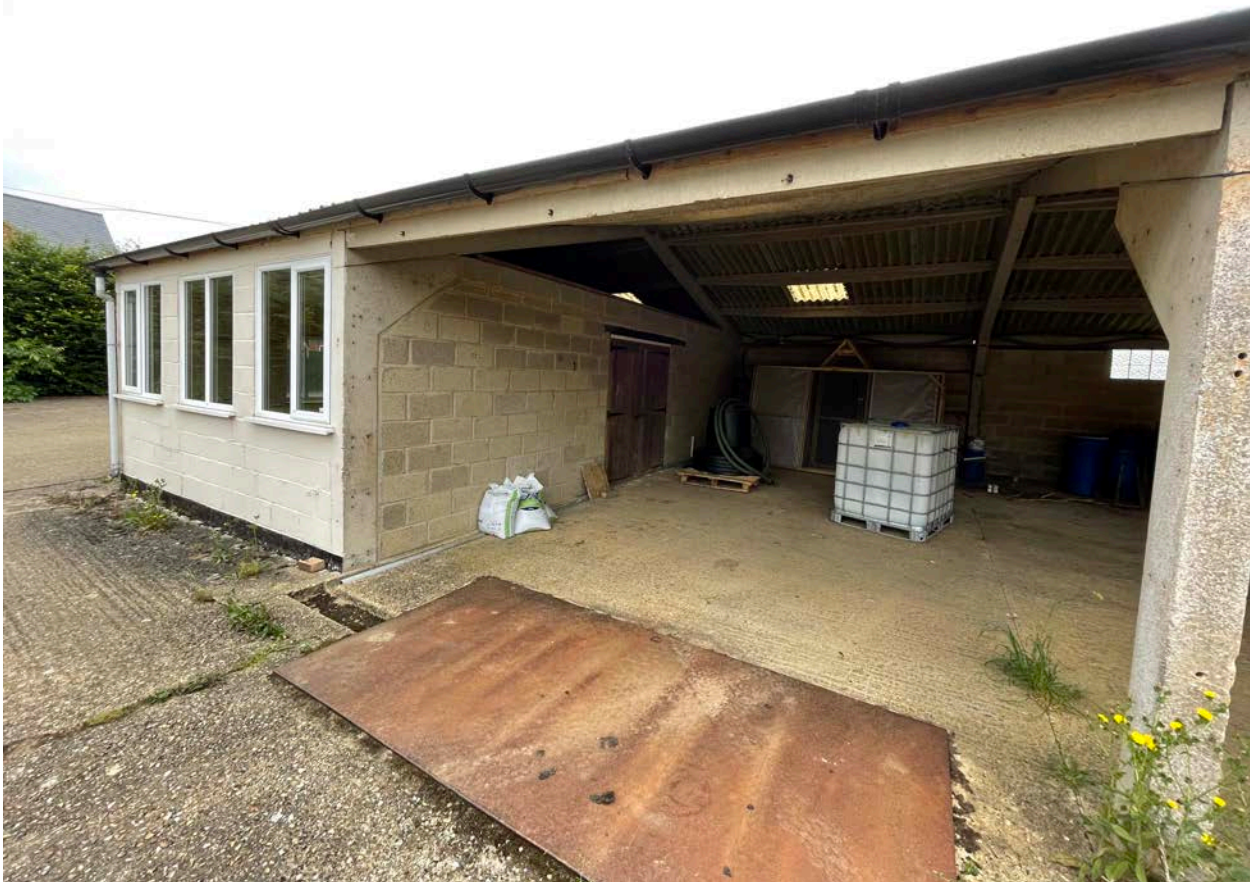
The enclosed office or workshop space is noted as being formed with three additional UPVC windows all set in a block work skin forms from 100 mm wide blocks.

Image 4.0: Office/ workshop block, formed to one end of the Atcost barn

Block work is noted as being in good condition with limited deterioration to bed joints and perpend.

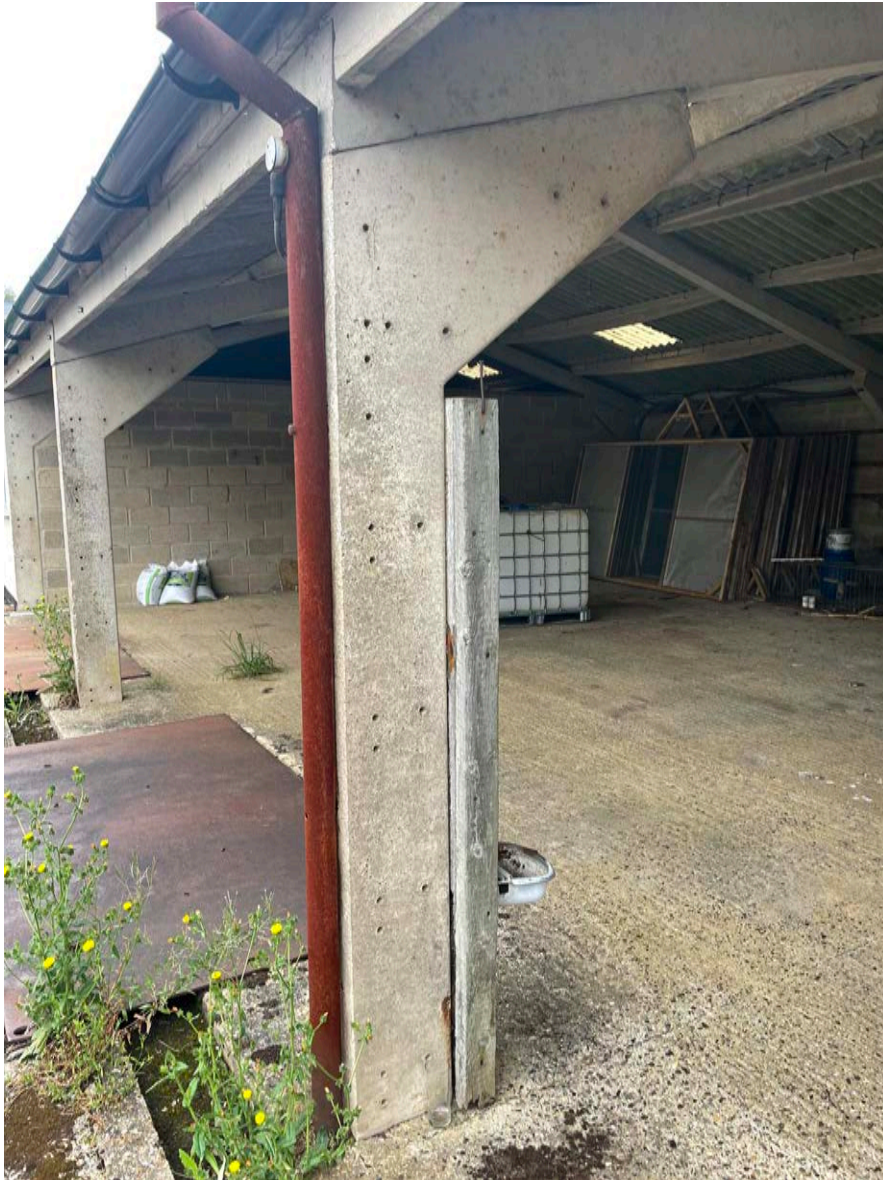
Concrete beams run along eaves level between adjacent portals and beams were noted as being in good condition with no visible damage or surface defects to the concrete.

Concrete columns to the portal frames are noted as lacking any significant staining to the surface indicating that reinforcement remains suitably covered with limited risk of corrosion. Spalling and cracking to the concrete was similarly not noted and to this end it is considered that the stanchions continue to function as intended.

Lichen, identified through grey discolouration of the concrete, is reflective of a long standing structure, with long term exposure to a humid environment. This should be considered as a reflection of the robust design employed in the formation of the concrete elements.

Image 5.0; View of concrete columns/ stanchions with haunches.

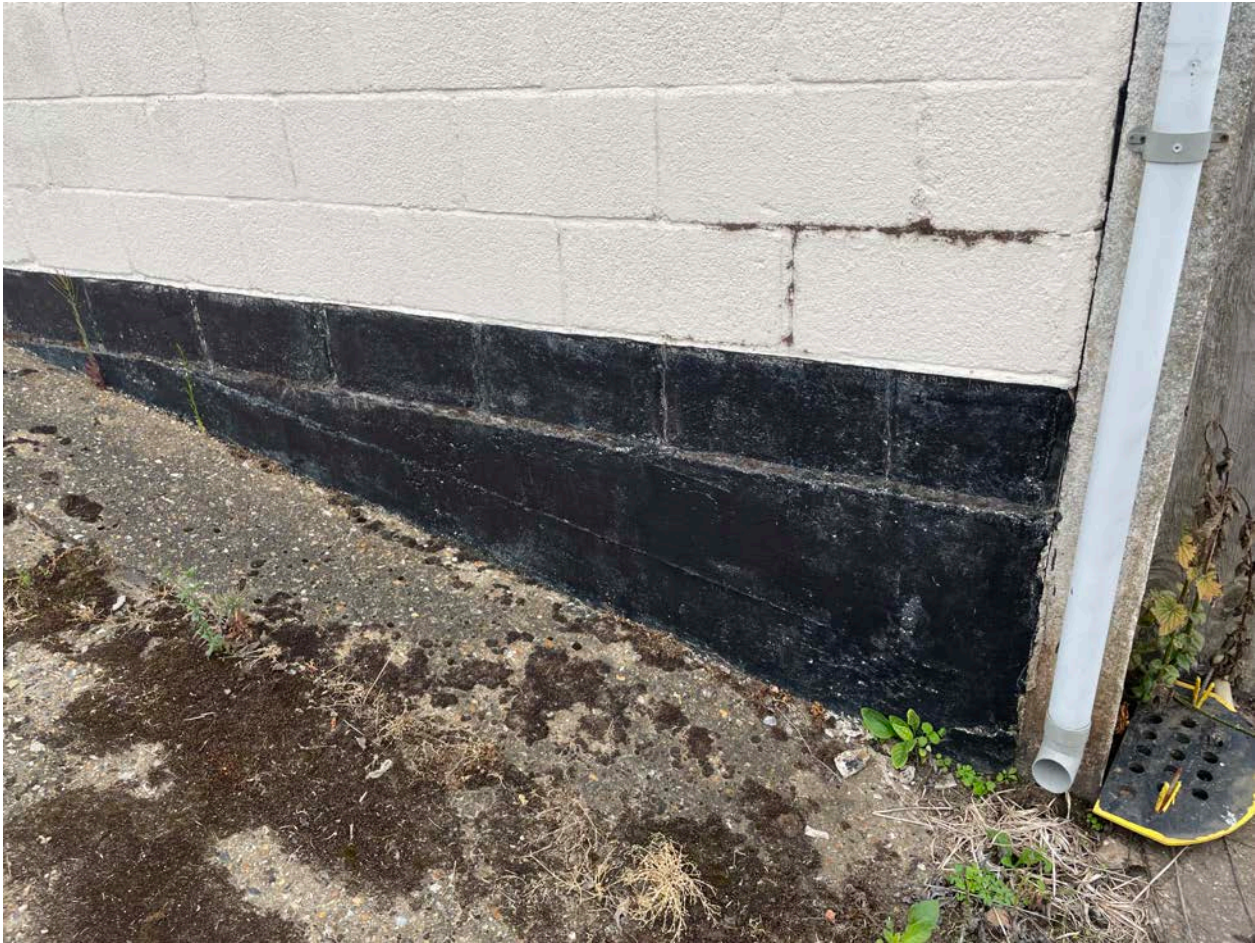
The external ground level falls away sharply at one end of the building, with access ramp dropping down to a lower level serving adjacent barns. This exposes the base of the block work wall, which is noted as being formed to the head of a mass concrete pour with surface marks indicative of shuttering.

Image 6.0: Access ramp, local to opposite gable end with lower mass concrete set to underside of blockwork.

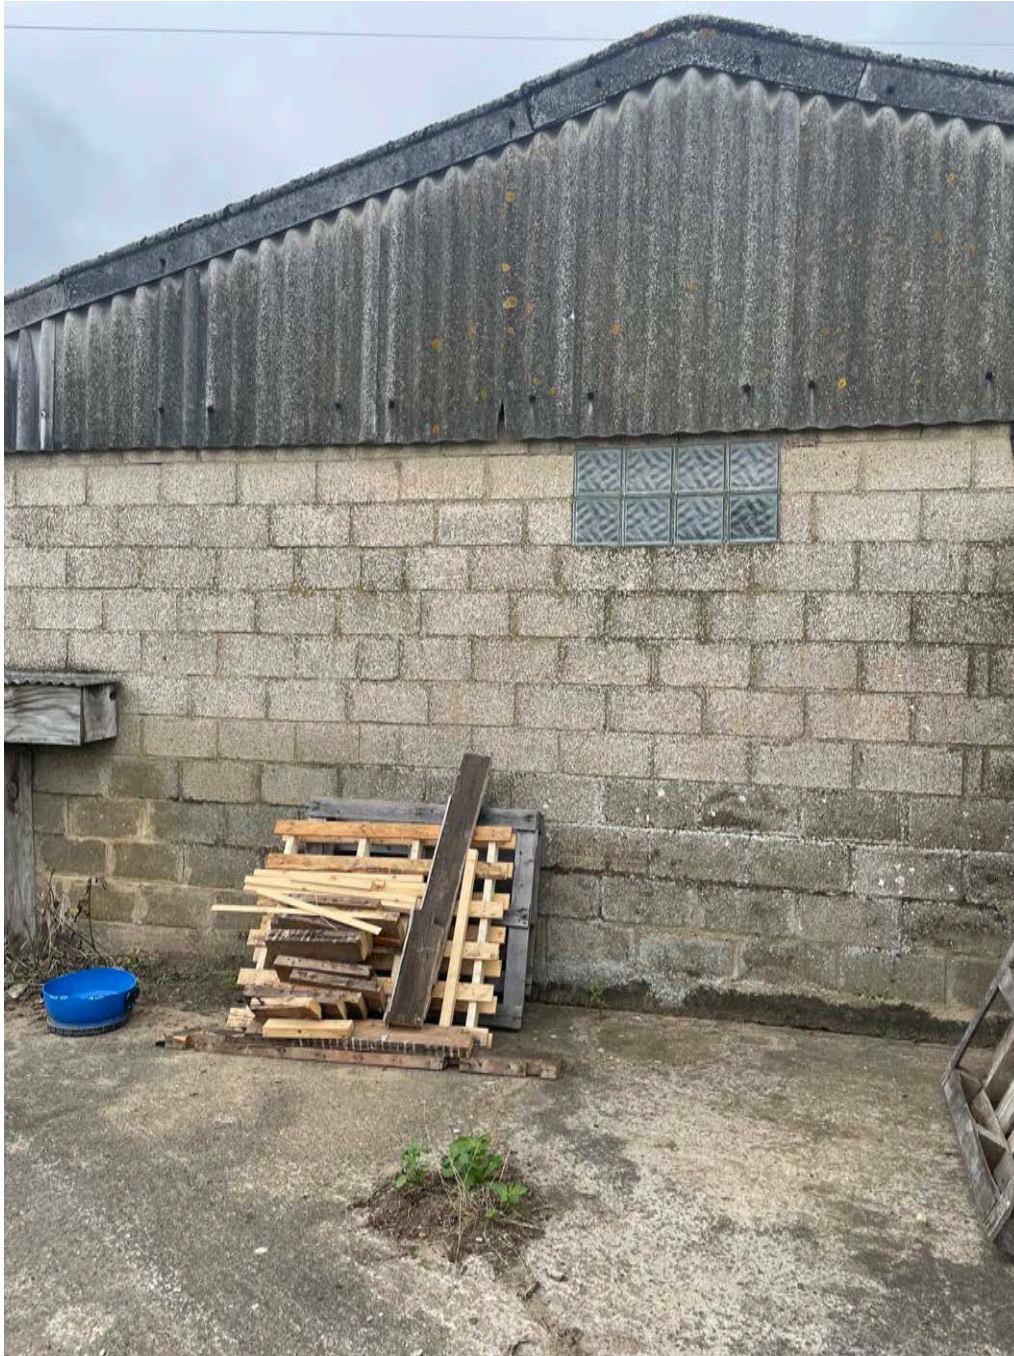
The gable end facing towards the barn complex is noted as being formed again from a concrete block infill panel, set between adjacent columns to the portal frame. Unlike the opposite end of the structure, the block wall to this end rises from the base of a concrete slab which has likely been cast in-situ and given markings to the side elevation, laid to falls.

Formed from dense concrete blocks, the gable elevation rises to haunch level before giving way to vertically hung corrugated cement sheeting. Sheeting is dressed to the eaves line with lap over cement sheeting, running to the head of the gable up to apex.

Image 7.0: Opposite gable end to structure.

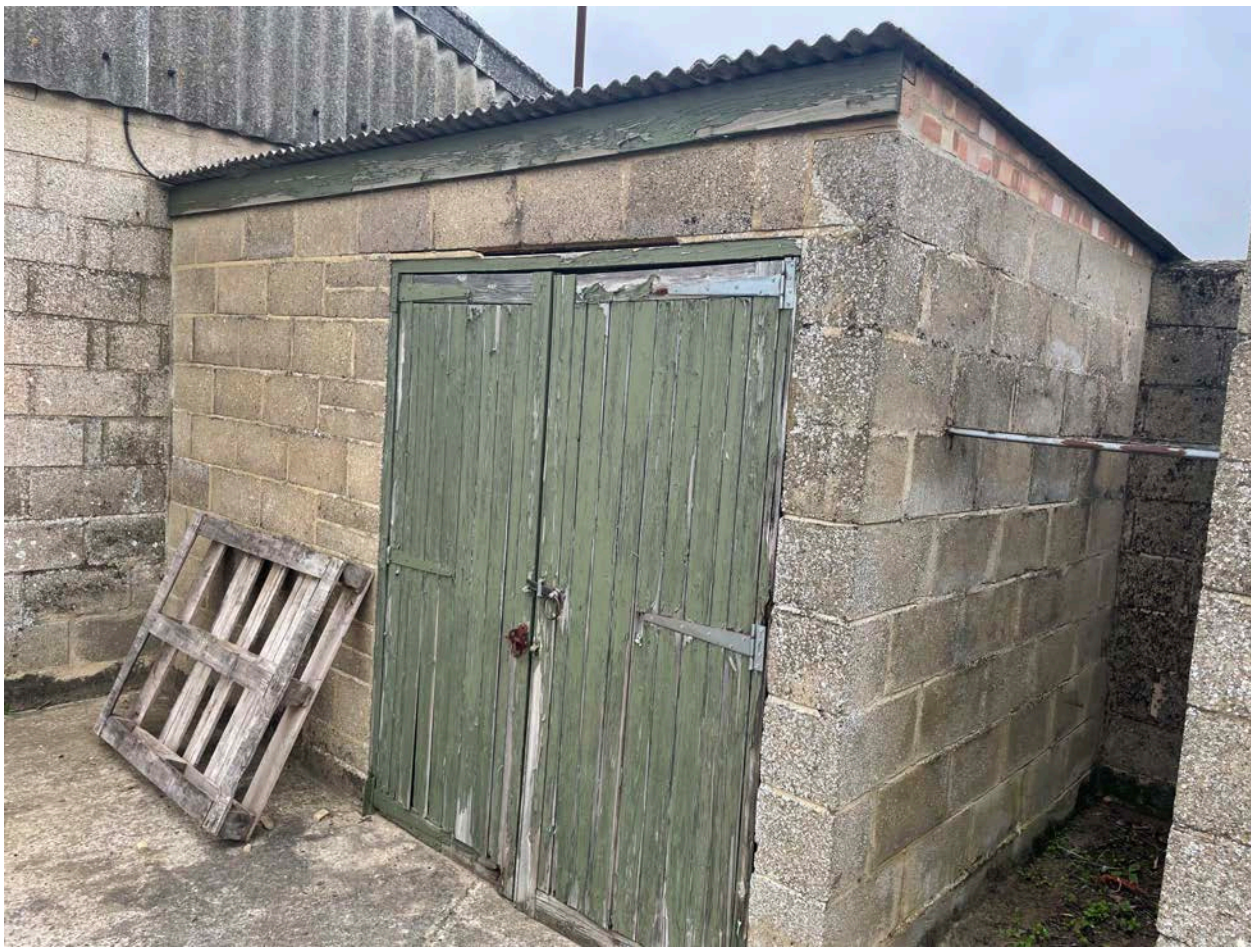
A series of storage bays have been formed to the side of the structure, abutting the gable end and these have again been constructed from solid concrete blocks. The width of blocks is noted as being 200 mm to these bins. The mono pitch structure set between gable to the barn and storage bays is however noted as being formed from 100 mm wide blocks.

Image 8.0: Monopitch storage shed and storage bays, set to gable end of barn.

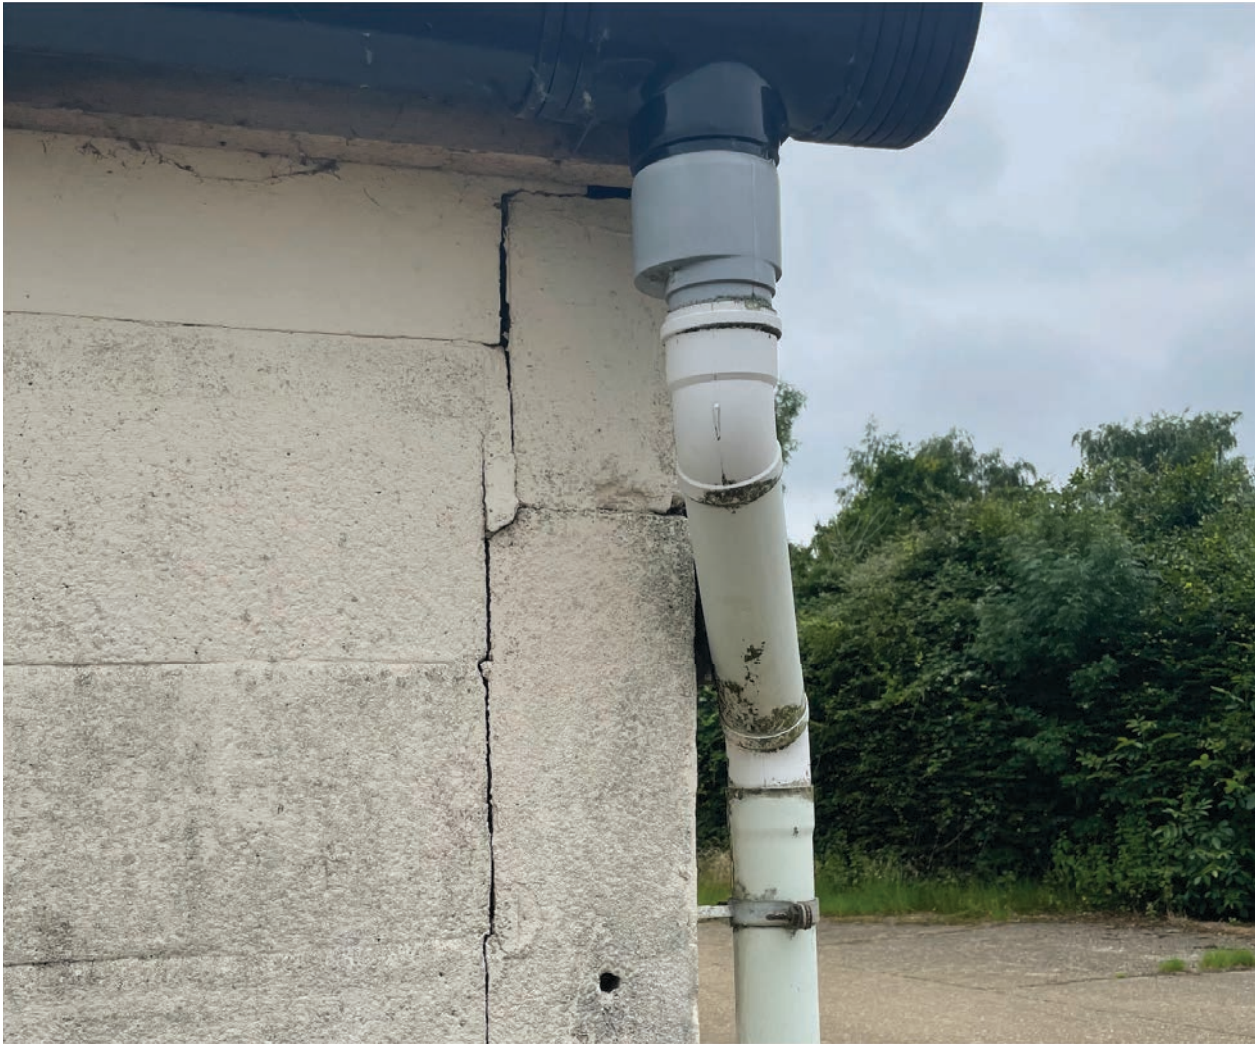
The elevation facing the access track is similarly in very good condition, with limited movement evident where block infill panels abut the existing portal frame stanchions. This is likely the result of sway in the concrete portals and thermal movement within the concrete block infill panels. Movement between both elements is however very limited, at less than 3mm and is not commensurate with any form of structural deterioration. It may be ascribed to there being a lack of physical connectivity between both structural elements, with both being suitably free to move relative to each other.

Image 9.0: Vertical cracks at juncture of wall panel abutting end portal frame.

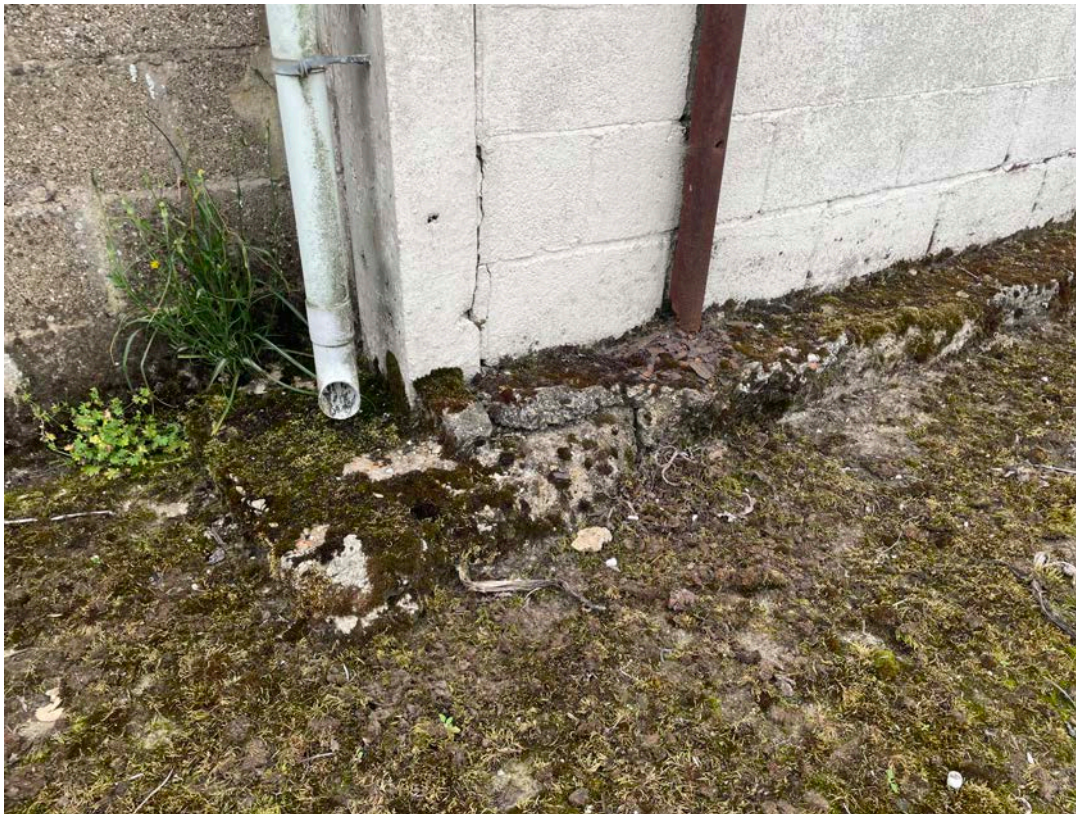
The base along this elevation is noted as having an excessive amount of moss, indicative of a high moisture content within the slab, likely as a result of silt building up on the head of the concrete slab local to this building elevation.

Image 10.0: Excessive SILT to head of concrete slab and moss growing in this medium.

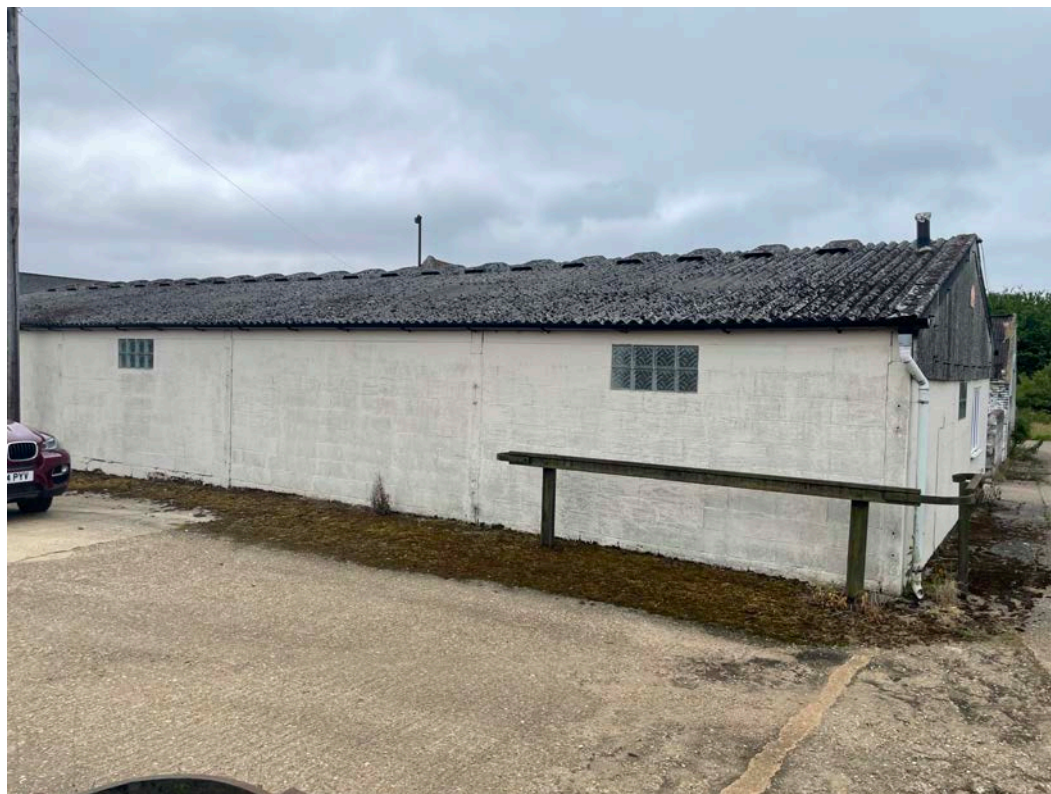
The base of the elevation follows a variable ground level with the wall panels stepping as each bay with a continual change in external ground level

Image 11.0: Side elevation of barn facing access track.

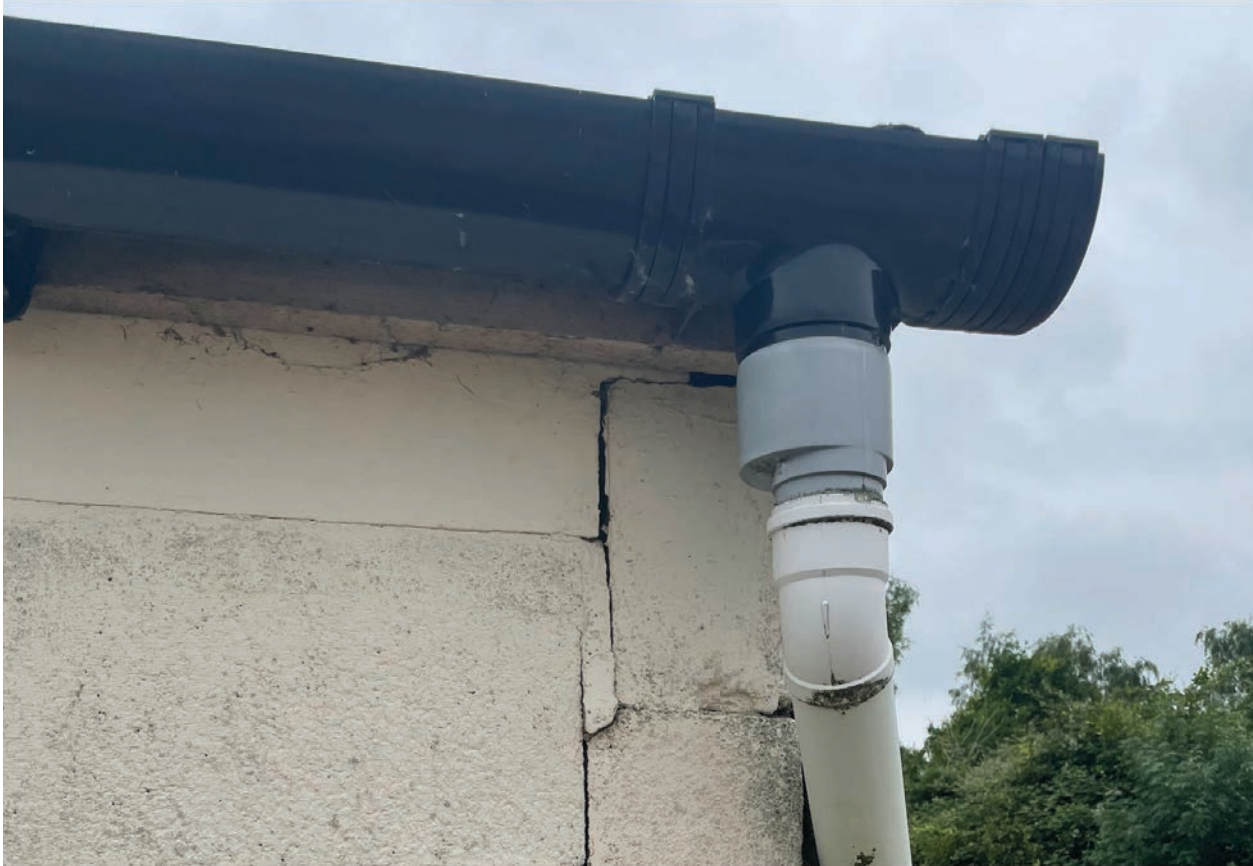
It is noted to the new UPVC gutter with downpipe and fascia board have been fitted along the entire elevation. The gutter is formed of a deep gully, 150 mm in width, suitable for significant rain water run-off. Downpipes set either end of the structure allow for capture and discharge of the rainwater to ground only.

Image 12.0: Deep gutter, discharging into 75mm diameter downpipe

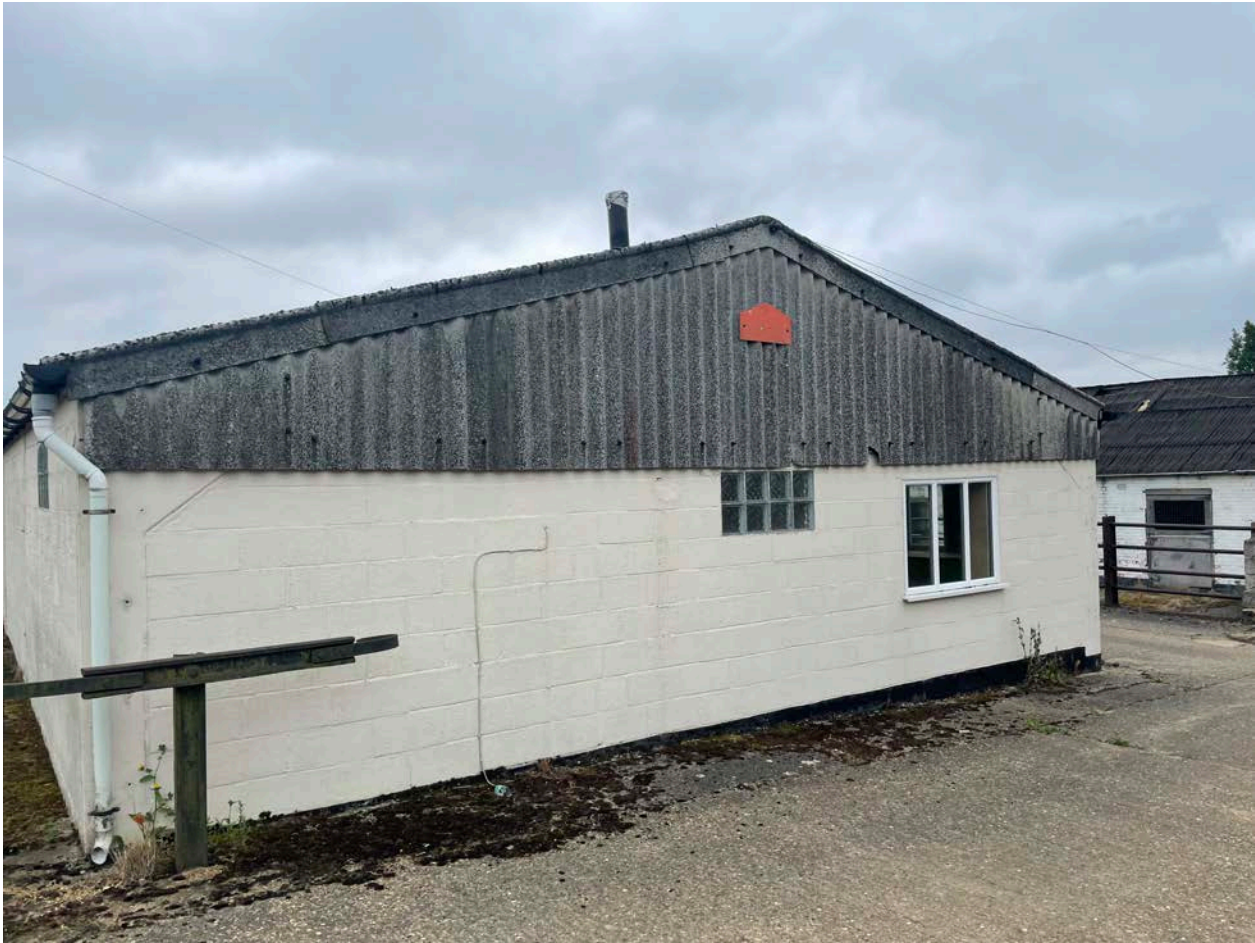
The roof to the structure is noted as being finished in a corrugated cement sheeting with ventilation set to ridge line and a stack/ vent pipe clearly installed at one end rising up through the roof and terminating short.

Image 13.0: Stack/ Flue rising through head of roof structure. Note gradual 200mm fall, side to side of the structure.

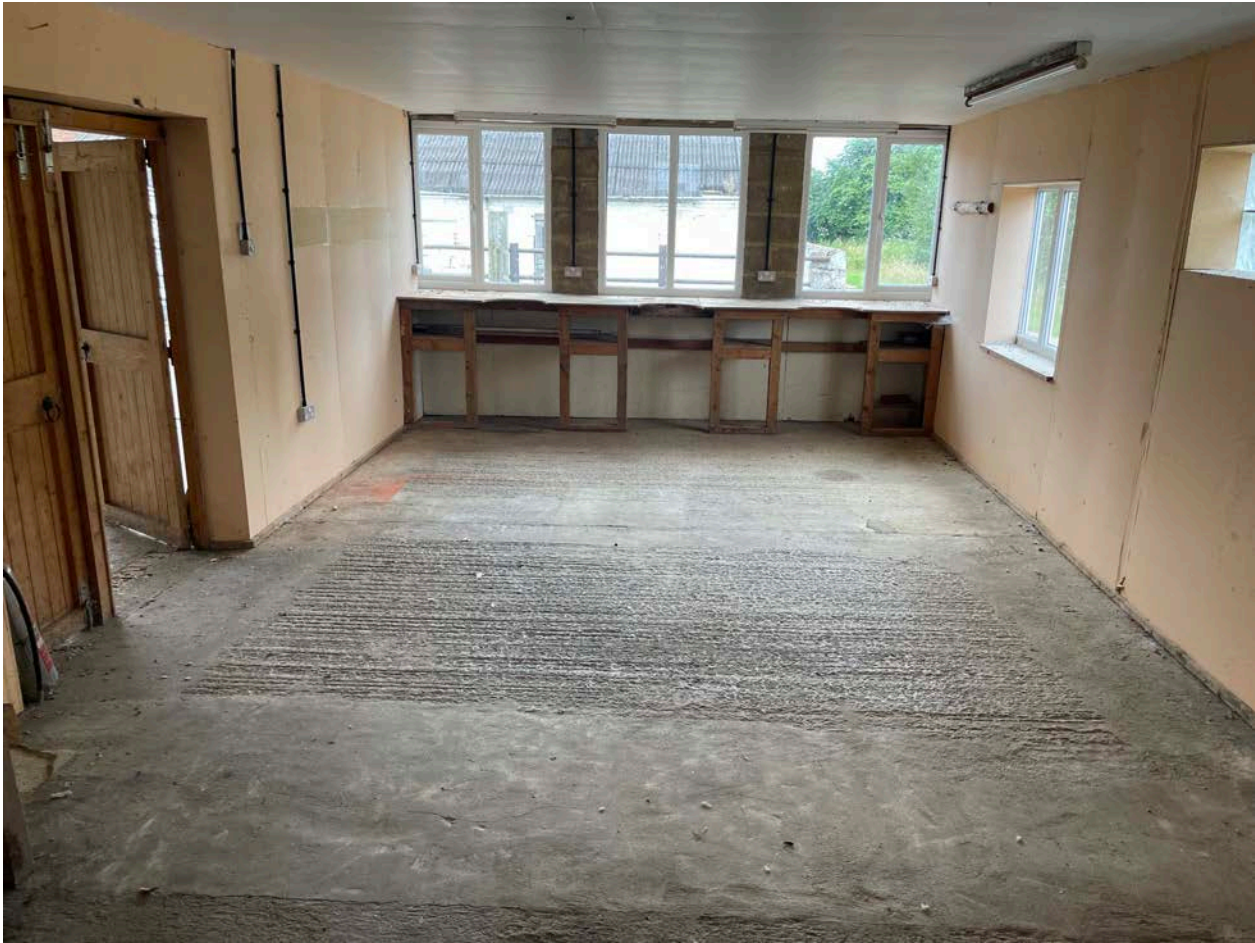
The work space comprises a concrete floor and partitions clad in plasterboard, rising floor to ceiling with further plasterboard sheeting set to the ceiling line. Nail lines are indicative of timber elements spanning side to side between adjacent walls allowing for the suspension of the ceiling.

Image 14.0: Internal view of workshop/ office area.

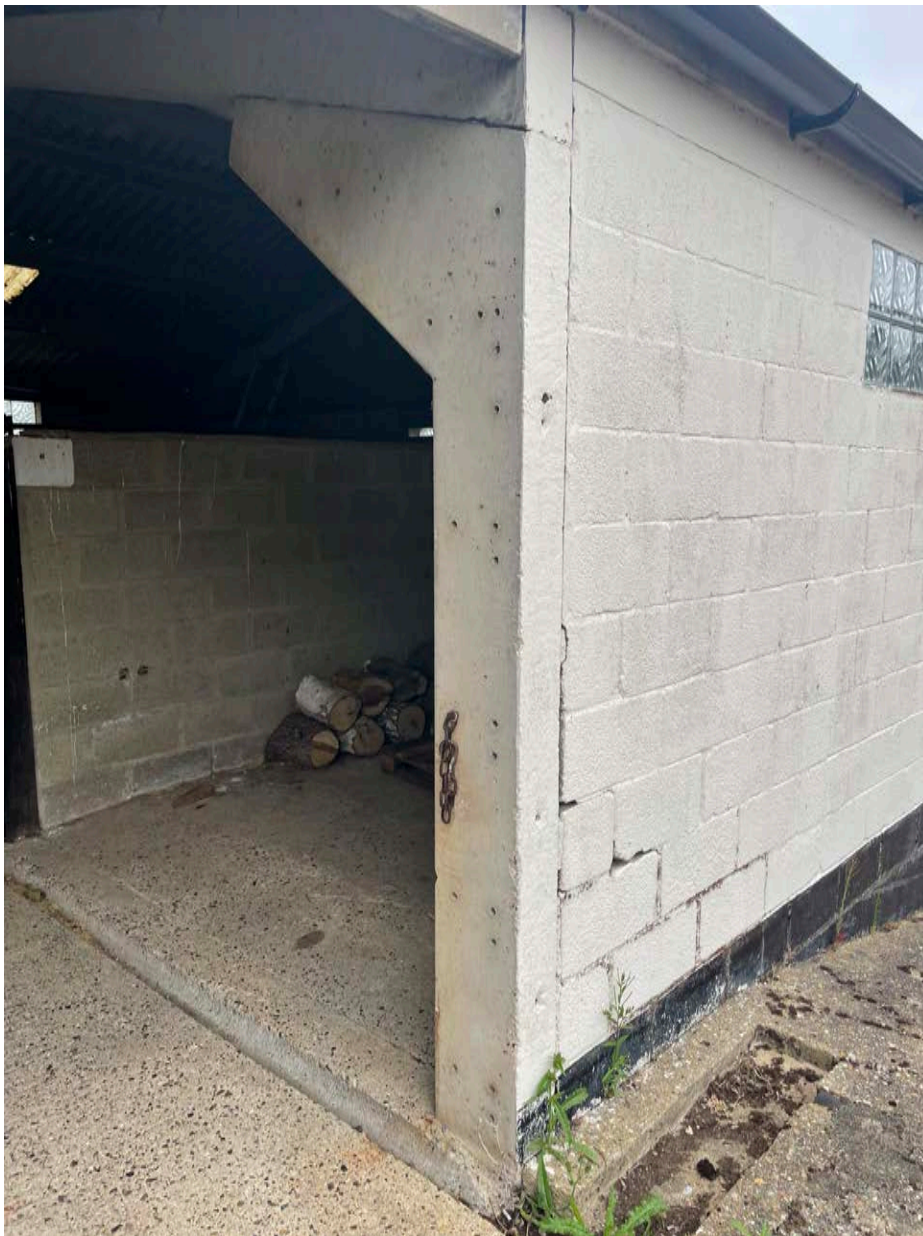
Livestock bays are noted as being formed to the opposite gable end of the structure, set to the head of the concrete slab, with block infill panels dividing the depth of the structure into three individual bays.

Image 15.0: First of three livestock bays, with sub-dividing wall evident

Block work is noted as rising 7 1/2 courses above finished floor level, providing some limited buttressing to the gable end.

Limited stepped cracking is noted as having arisen in the block work to the gable end. Inspection of the blockwork panel to this elevation and to the gable elevation abutting the livestock pens indicates some limited stepped cracking, arising as a result of thermal movement. Inspection of blockwork local to external ground level failed to reveal further cracking or movement, indicating a lack of movement within the underlying foundation.
