The property was inspected on 1 October 2021.

IRJ/AH/P1446/SR

- 2.1. The property is a detached former joiner's shop built in the second half of the 19<sup>th</sup> Century.
- 2.2. There were previously two buildings, one of which has become derelict and has been removed.
- 2.3. The building is of traditional construction comprising load bearing stone masonry walls supporting a timber framed pitched roof.

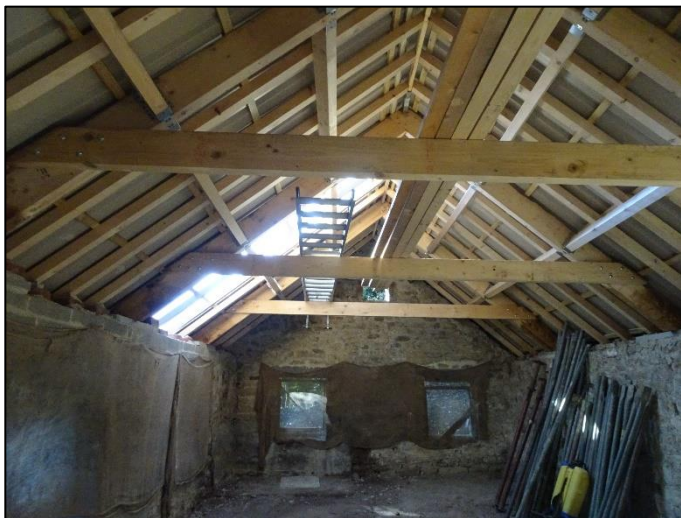
**Photograph 1**

- 3.1. The roof structure has been replaced as part of recent repairs following partial re-building of the front elevation.
- 3.2. The original roof structure comprised principal trusses and purlins supporting a profiled sheet roof, the latter replacing a former slate or tiled covering.
- 3.3. The new roof structure is traditional comprising principal trusses supporting two rows of purlins to each roof slope with a new profiled metal sheet covering.

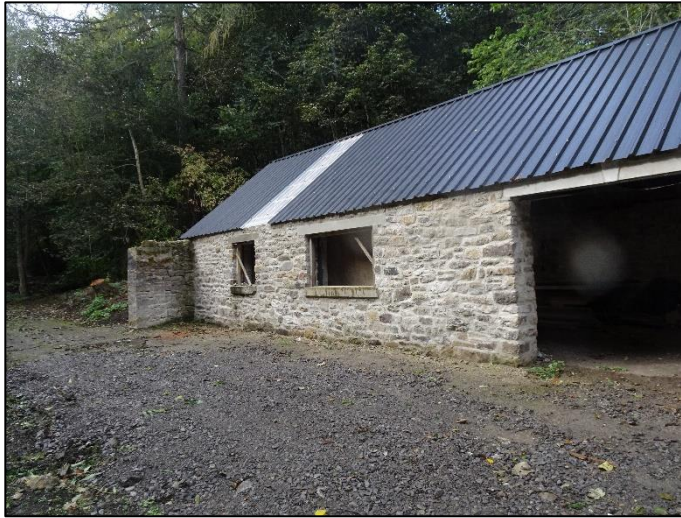
**Photograph 2**

- 3.4. An area of re-building has been undertaken to the front elevation to the left side of the vehicular entrance door.
- 3.5. All other elevations are original and in sound condition.
- 3.6. A former door opening has been built into the front corner of the right-side elevation.

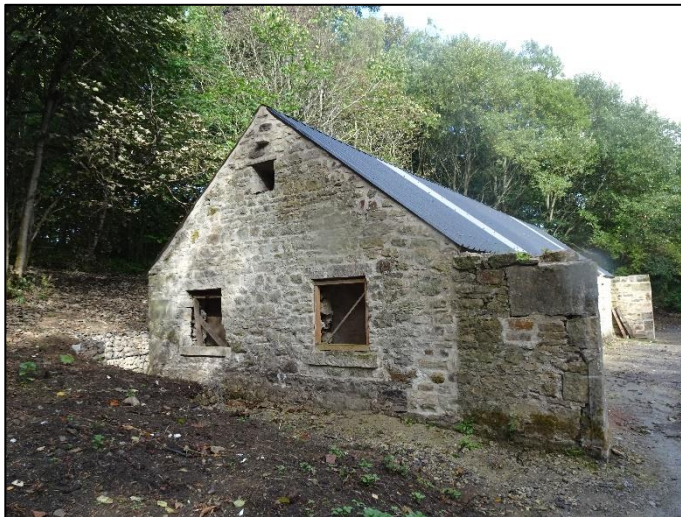
**Photograph 3**

- 3.7. Two window openings have been created to each of the gable walls as part of recent repairs.
