**STRUCTURAL  
ASSESSMENT**

**General Farm Store  
Building  
Tranwell Airfield  
Morpeth  
Northumberland**

**November 2021**

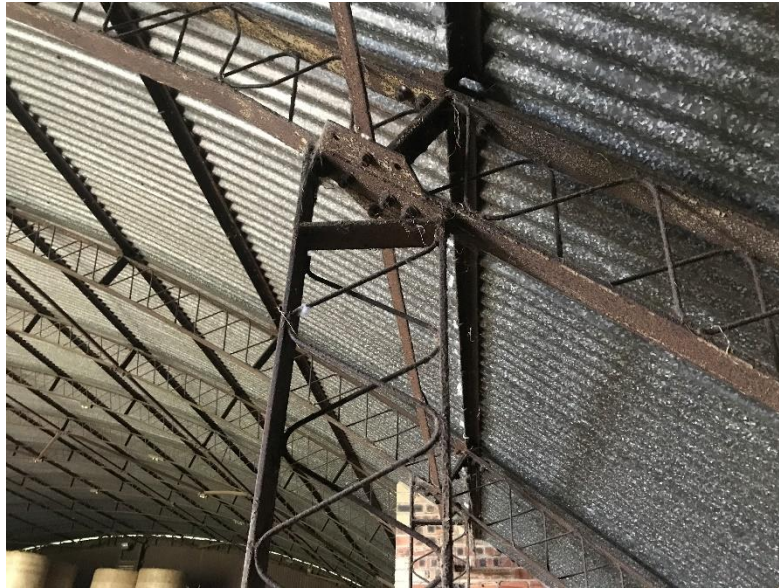
The principal trusses are arranged to form 11 equal bays of approximately 2.2m centres to provide an overall external building length of approximately 25.35m and width of 28.85m. Each of the trusses is formed by painted steel outer bands of approximately 80mm width separated to a depth of around 280 mm by a series of 200 mm steel bars triangulating at alternate centres across the span.

Each truss has a vertical support of similar steel lattice, at around 2.5m from the dwarf walls, to provide additional stability.

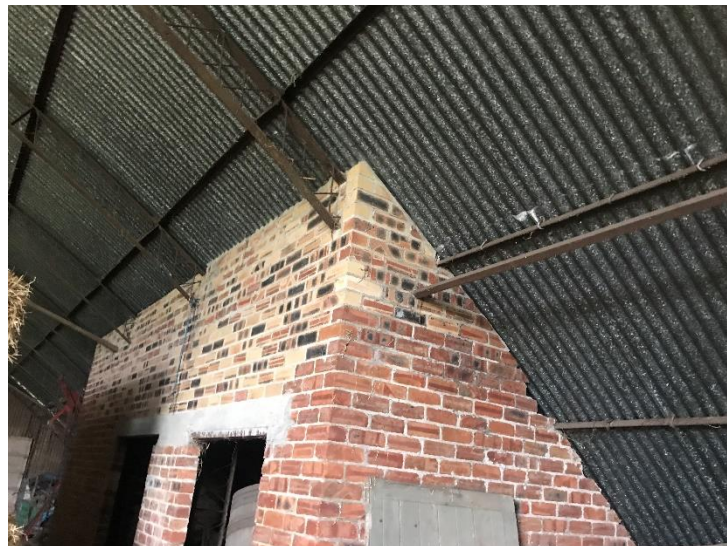
A small room has been partitioned from the eastern side of the building by way of single leaf brickwork around the steelwork.
