**Tree Survey, Arboricultural Impact Assessment
Preliminary Arboricultural Method Statement & Tree Protection Plan
In Accordance with BS 5837:2012**

Proj. No 8989	Monks Hall Treehouse, Syleham Road, Eye, Suffolk, IP21 4LN		
Client:		Blue Forest	
Date of Report:	01/09/2021	Revision:	Original

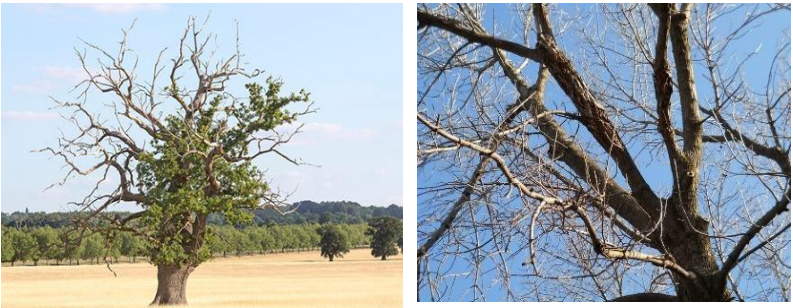
Name: Deadwood	
Symptoms/damage type and cause:	This relates to dead branches in the crown of the tree. In the majority of cases, this is caused by the natural ageing process of the tree or shading due to its close proximity to neighbouring trees. However, in some situations, it may be related to fungal, bacterial or viral infection.
Consequence:	Depending upon the location and mass of dead wood removal of the affected tissue may be necessary to prevent harm to persons or property as the wood will become unstable as it decays and in some circumstances is likely to fall from the tree with little or no warning.
Control:	Detailed monitoring should be undertaken on those trees showing signs of excessive deadwood production to identify the underlying cause.
Species affected:	Most tree species.
Images:

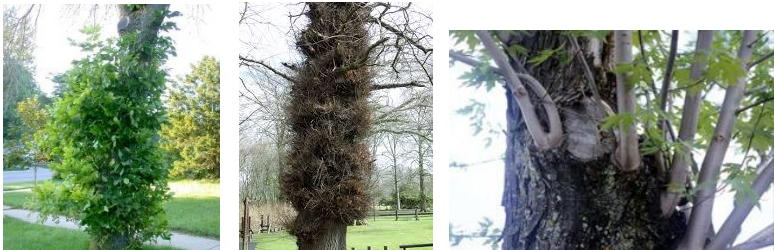
Name: Epicormic growth	
Symptoms/damage type and cause:	This is the production of numerous shoots on the main stem and branches of the tree. They are produced by the bursting into life of otherwise dormant buds. It is commonly associated with elevated levels of stress on the tree.
Consequence:	Whilst epicormic growth is usually symptomatic of an issue elsewhere within the tree, heavy proliferation can cause the trees resources to become depleted or may mask significant structural weaknesses within the framework of the tree.
Control:	Pruning off epicormic growth may be necessary to improve the visual amenity of the tree or prevent the development of a hazard or obstruction. No direct means of prevention are available other than therapeutic measures to alleviate stresses on the tree.
Species affected:	Most tree species, including European Lime, Willow species, Sweet Chestnut, and Silver Maple.
Images:
