Derek LOFTY & Associates

Project: Pitchers Barn Conversion

Report on the Existing Barn Structure

Pitchers Barn, Denham Farm, Bullocks Farm
lane, Wheeler End, HP14 3NQ

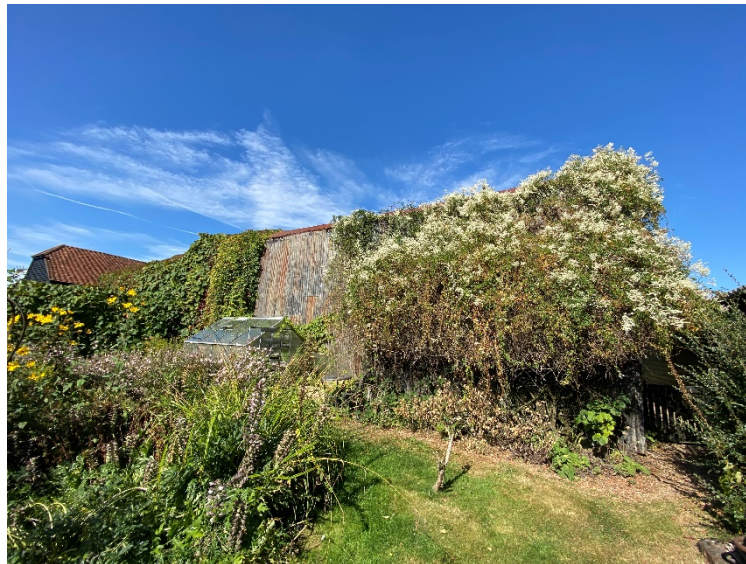
Figure 3 - Rear (South) Elevation

3.13. The concrete floor slab, although substantial, slopes gently by approximately 30mm toward the rear elevation. The slab otherwise is considered to be in sound structural condition.

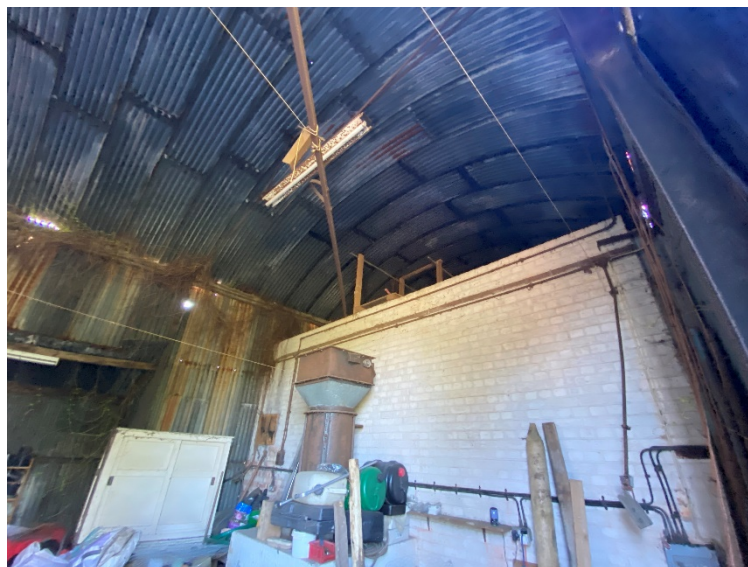
Figure 4- Internal left-hand Side

- 3.3. The steel framed element to the left-hand side is a regular arrangement of steel columns and lattice trusses. The trusses span perpendicular to the long side of the barn building. A series of steel angle section cladding rails and purlins support the external cladding.

3.11. The steel-clad external walls are slightly out of vertical alignment and are not particularly true to line. However, the structural integrity remains unaffected.

- 6.3. It is therefore considered that the existing external masonry walls could be retained, upgraded to meet modern thermal requirements. The cladding will need to be replaced with a thermally efficient, lightweight stud partitioning, to keep the loadings commensurate with the existing structure. The external finishes should be lightweight, as prescribed by the architect.

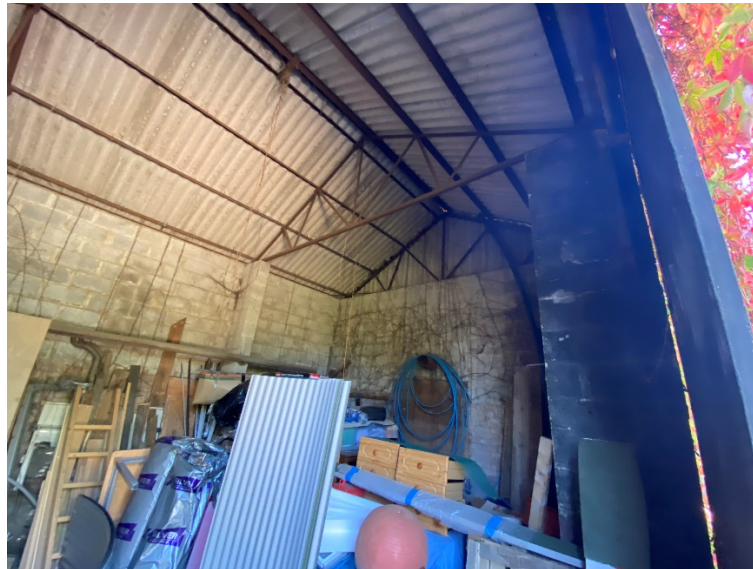
Figure 5 - Internal right-hand side elevation

- 3.4. The masonry structure to the right-hand side is a regular arrangement of facing brickwork that supports a regular arrangement of steel lattice trusses. The trusses span perpendicular to the long side of the barn building. A series of equal angle steel sections form the purlins that support the corrugated steel roofing sheets.

3.12. The masonry construction external walls remain reasonably vertical and true to line.
