## **TREE CONDITION SURVEY & REPORT**

**HOSPITAL OF ST JOHN & ST ELIZABETH,  
60 GROVE END ROAD, LONDON**

**20.10.21 EAS-018**

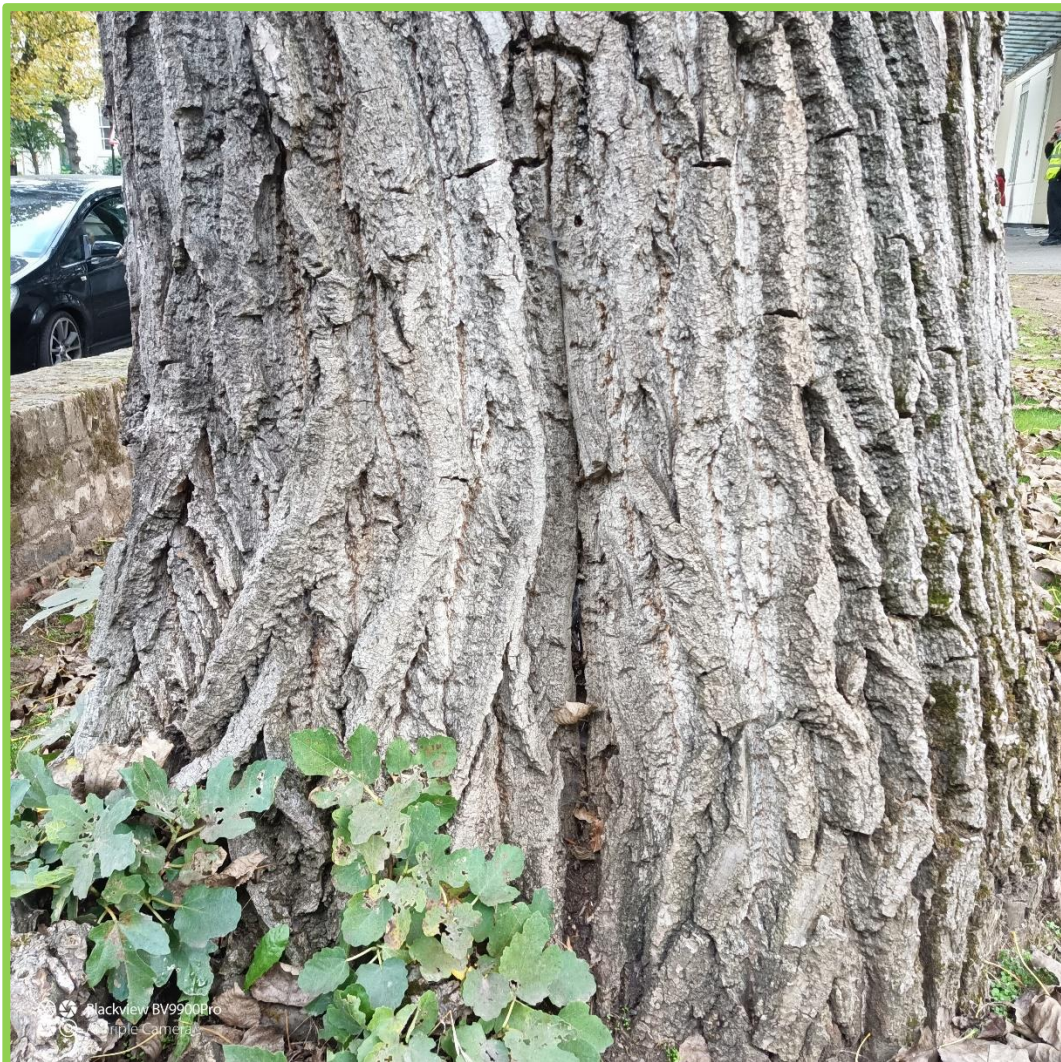
One tree, T19 – Hybrid Poplar, was identified as requiring a PICUS decay detection detailed inspection due to a basal root cavity observed with brown exudate. This will determine the extent of any internal decay. The tree is recommended to be re-pollarded to previous pollard crown points, in the interim period, to reduce 'crown sail'.

**Cavity split on the root crown of T19 – Hybrid Poplar, advised to undertake a PICUS decay detection inspection**

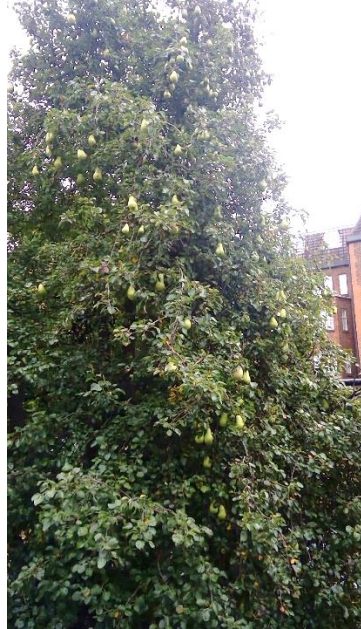
31 trees were categorised as requiring works to be undertaken within 3 months, See details at Appendix 4. These include to remove the large Pear fruits from T1, as required each year to eliminate identified H&S hazards from falling fruit.

**T1 – Pear – Heavily Fruiting Hazard**

Tree No	Species	Ht (m)	DBH (mm)	Age Class	Observation	Recommendations	Priority Works	Plans
T1	Pear	14.4	690	Mature	Historically trimmed and pruned. Epicormic growth at root crown, trunk and branches. Bark wound on main stem. Branches overhang and rub building, lean-to and paths. Heavy and large fruiting hazard.	Remove All fruits. Remove epicormic growth to a height of 3m. Cut back from buildings and lean to canopy to give 2m clearance. Crown reduce and reshape by 2-3m.	2 - Within 3 Months	1, 2
T2	Tree of Heaven	24	760	Mature	Previously crown reduced and lifted - dense, vigorous re-growth. Epicormic growth at root crown. Branches overhanging and rubbing buildings. Partially Occluded trunk wounds. Light materials stored on root crown hardscape.	Remove epicormic growth to a height of 3m. Remove stored materials at root crown. Crown reduce by 2-3m to previous reduction points.	2 - Within 3 Months	1, 2

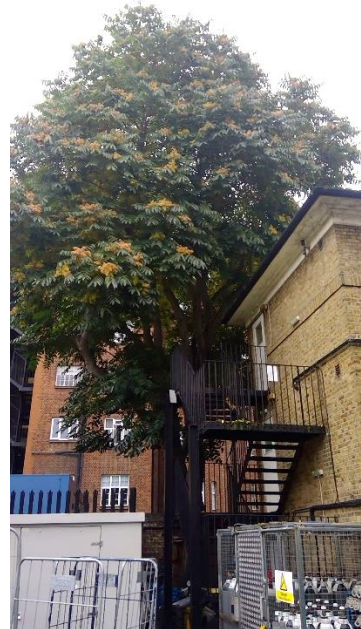
**T2 – Tree of Heaven**

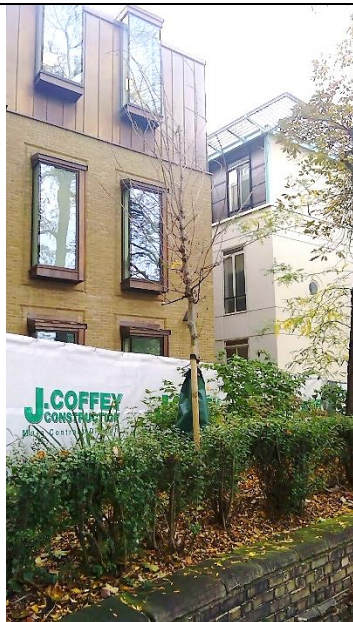
**T11 – dead SM London Plane to be replaced**

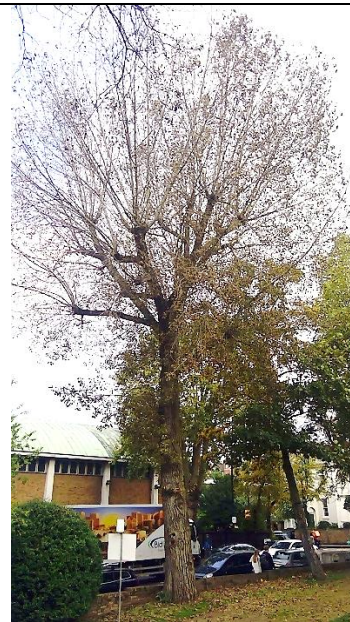
**T19 – Hybrid Poplar to be re-pollarded**

Tree No	Species	Ht (m)	CS N	CS E	CS S	CS W	DBH (mm)	Cond	Age Class	Re-inspect	Observation	Recommendations	Priority Works	Plans
T19	Poplar (Hybrid Black)	26.7	8	8	8	8	930	Fair	Mature	Year 1	Previously crown lifted and reduced / pollarded at 15m. Vigourous re-growth. Partially occluded trunk wounds. Minor dead wood in upper crown. Trunk epicormic growth. Basal root crown wood, brown exudate and occluded cavity.	Crown reduce by 8-10m to previous pollard reduction points. Remove epicormic growth to a height of 8m to crown break. PICUS root crown to decay test trunk.	2 - Within 3 months.	1, 4, 5, 6
T20	Privet	3	2	2	2	2	200	Fair	Mature	Year 1	Trimmed/Pruned regularly. Domed form large shrub.	Annual trimming maintenance.	3 - Within 12 Months	1, 4, 5, 6
T21	Pissard Plum	9	5	5	3	3	580	Fair	Mature	Year 1	No significant past tree works. Co-dominant stem with included union (with natural crown bracing). Asymmetric low crown over highway. Previously reduced, vigourous regrowth.	Crown lift to 4m.	2 - Within 3 months.	1, 4, 5, 6

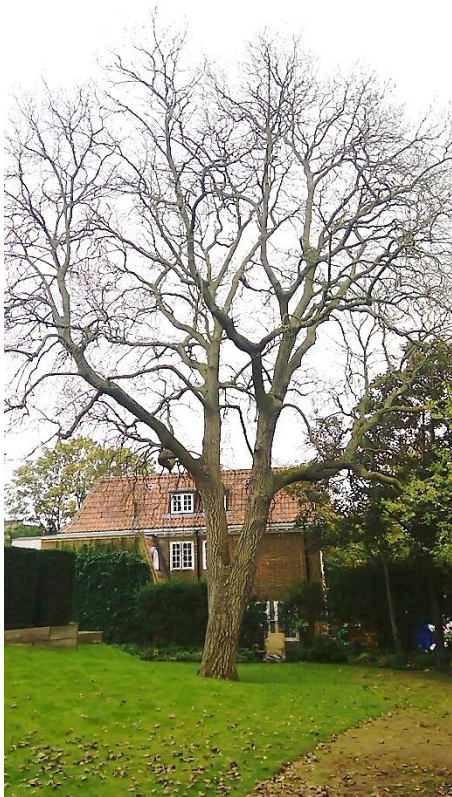
T26	Luccombe Oak	22	10	10	10	10	980	DDDD	Mature	3mth	Previously Crown lifted and braced. Dead Tree in decline. Foliage brown and thin. TPO tree. Approved to be felled and replaced.	Fell close to ground level. Remove stump completely by grinding. Replace with large SM standard tree.	2 - Within 3 Months.	1, 4, 5, 6
T27	Horse Chestnut	23	8	8	8	8	810	Fair	Mature	Year 1	Previously pruned. Epicormic growth on trunk / branches. Previous pruning wounds partially occluded. Low branches rubbing roof of building.	Remove epicormic growth to a height of 6m. Remove dead wood. Crown lift low branches rubbing building by 2m.	2 - Within 3 months.	1, 4, 5

**T26 – Luccombe Oak to be felled and replaced**

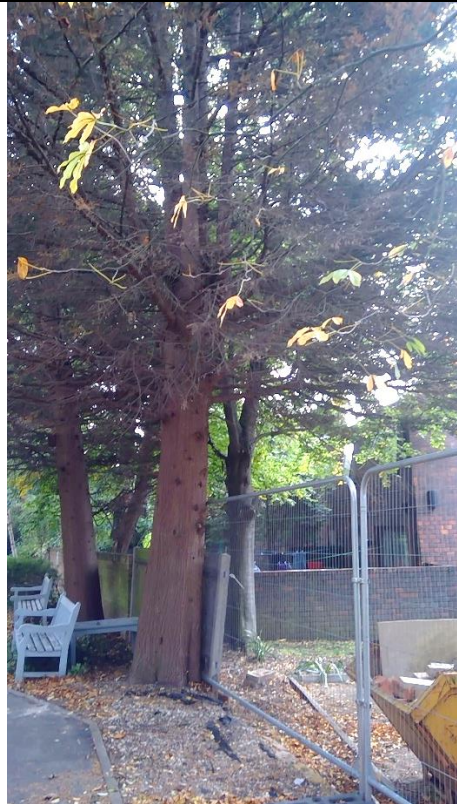
T38	Cypress (Monterey)	16	6	6	6	6	500	Poor	Mature	Year 1	Branches lifted over footpath. Moderate crown deadwood. Recent Lower crown necrosis likely from direct damage to root crown by car accident to adjacent boundary wall.	Crown lift to 4m over footpath. Remove dead wood. Cut back by 4m over site.	2 - Within 3 months.	1, 8, 9

**T38 – Monterrey Cypress – Foliar necrosis**

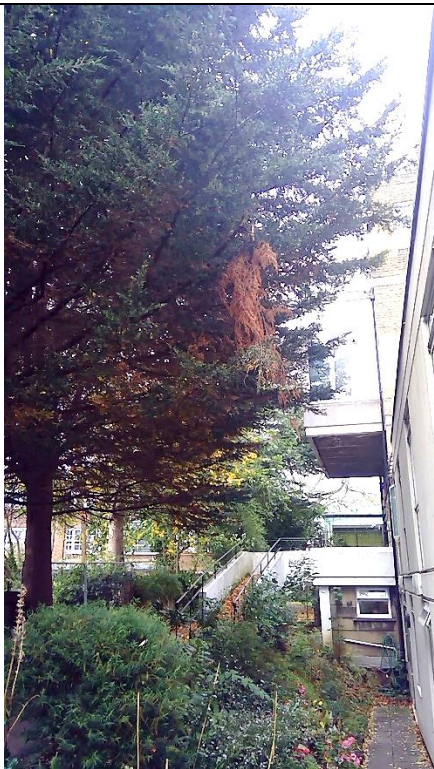
**T39 – Monterrey Cypress overhanging building and with broken hanging branch**

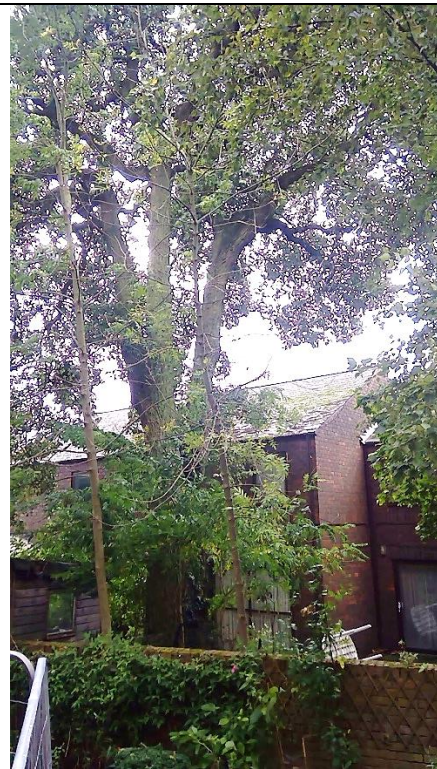
**T43 – Common Ash SM tree in decline from Ash Die-back**
