Forester and Arborist Services Ltd

Inspection of trees on Benefice Land

Record of Remedial Work Proposed and Completed

The Vicarage Tong Shropshire TF11 8PW

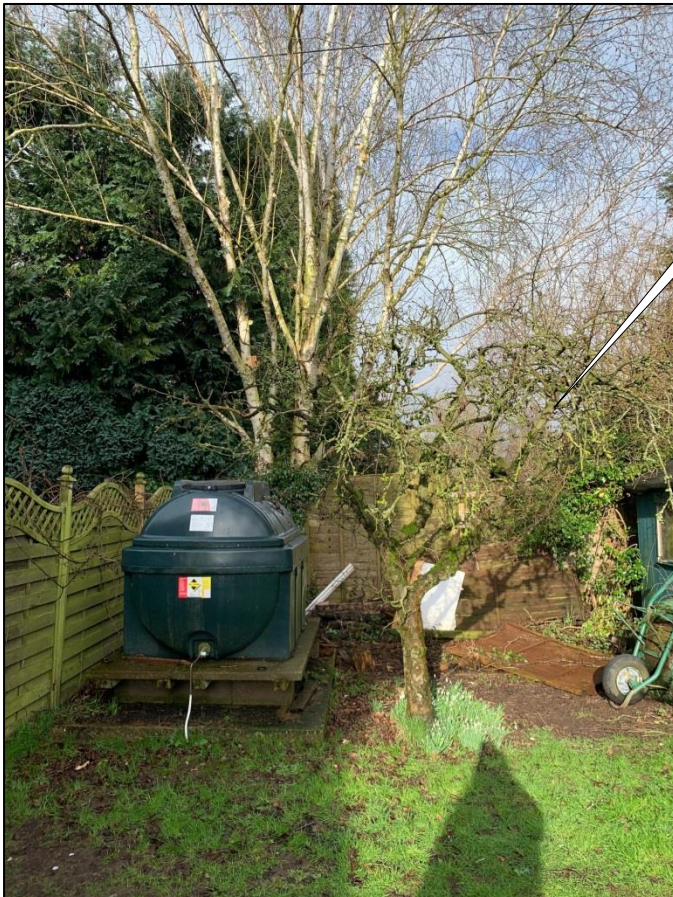
Tree No.	Species	Growth stage	Condition	Date inspected	Action required	Priority level	Date completed
T4	Holly	Mature	Root: No evidence of soil movement. Stem: Multiple stems; foliage to ground level. Crown: No recent breakouts or dieback. BT cable in contact with upper crown. Risk Assessment: No significant defects visible from ground level	TFM 23.7.12	Inspect in 5years or following storms Refer to photo detail.	4	
			Root: No evidence of soil movement. Stem: Multiple stems; foliage to ground level. Crown: No recent breakouts or dieback. BT cable in contact with upper crown. Crown is deflecting the telephone cable. Risk Assessment: the telephone cable is being deflected by the crown of T4.	ZA 12.02.2020	Reduce the height of the holly by 2m to give clearance to overhead telephone cables. Seek permission from neighbours to reduce the height of the neighbouring western red cedar at the same time. Inspect within 5 years or following storms. Refer to photo detail.	3

T4-indicative pruning position.

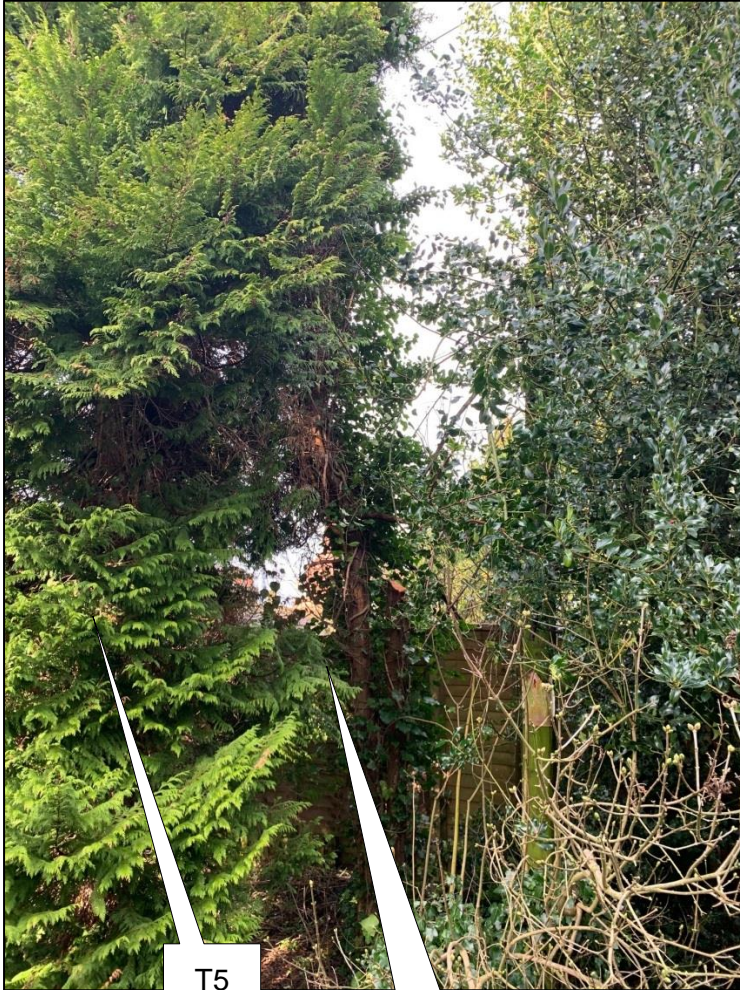
T5a- fell

T5	Lawson cypress Gold cv	Mature	Root: No evidence of soil movement. Stem: foliage to ground level Crown: No recent breakouts or dieback. BT cable in contact with upper crown. Risk Assessment: No significant defects visible from ground level.	TFM 23.7.12	Inspect in 5years or following storms Refer to photo detail.	4	
			Root: No evidence of soil movement. Stem: foliage to ground level. Crown: No recent breakouts or dieback. BT cable in contact with upper crown and is deflecting the line. Risk Assessment: the crown is deflecting the telephone line and could cause damage to the line in times of high wind.	ZA 12.02.2020	Reduce the height of the Lawson's cypress by 2m to give clearance to overhead telephone cables. Inspect within 5 years or following storms. Refer to photo detail.	3	
T5a	Dead stem	Dead	Stem is dead and completely obscured by dense ivy.	ZA 12.02.2020	Fell stem to ground level.	3

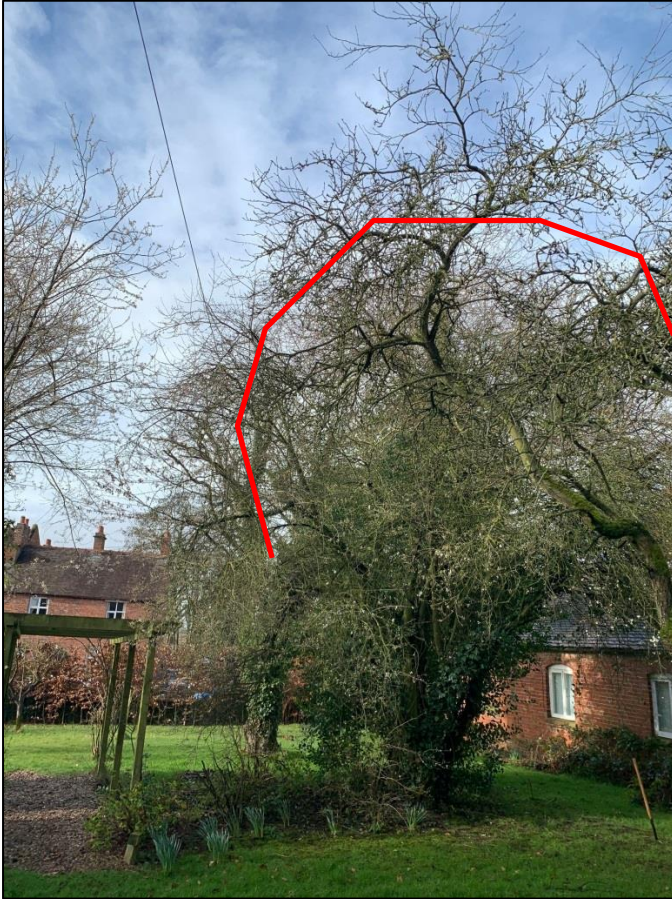
Root: No evidence of soil movement. Stem: partially obscured by ivy. Crown: telephone cable in contact with overhead telephone cable. Clearance from neighbouring property is adequate. No recent breakouts or dieback. Risk Assessment: thorough visual inspection of the stem could not be made due to the presence of ivy.	ZA 12.02.2020	End reduction of 20% (1.5m) to give clearance to telephone cable. Avoid creating wounds greater than 75mm diameter. Pruning to BS3998 (2010). Inspect in 5 years or following storms. Refer to photo detail.	3

T10- indicative pruning position

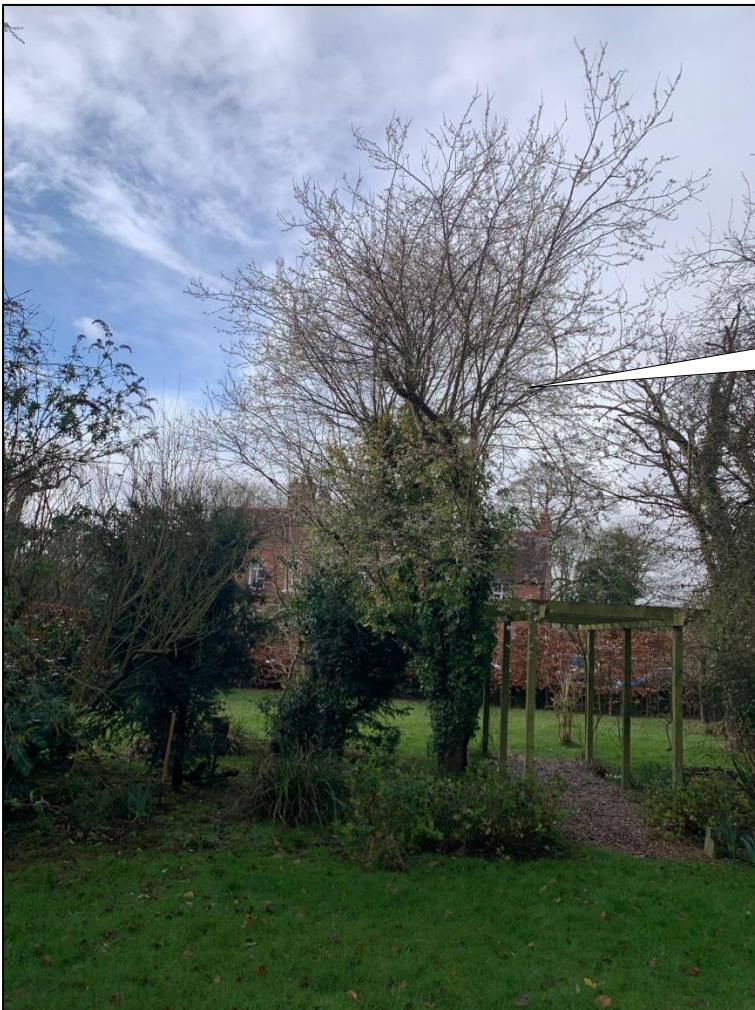
Tree No.	Species	Growth stage	Condition	Date inspected	Action required	Priority level	Date completed
T11	Bird cherry	Mature	Root: No evidence of soil movement. Stem: multiple stems Crown: No recent breakouts or dieback. Risk Assessment: No significant defects visible from ground level.	TFM 23.7.12	Inspect in 5years or following storms Refer to photo detail.	4	
			Root: No evidence of soil movement. Stem: obscured by ivy. Crown: No recent breakouts or dieback. Crown has been reduced to poor pruning positions. Wounds unable to occlude. Risk Assessment: thorough visual inspection of the stems could not be made due to the presence of ivy.	ZA 12.02.2020	Sever ivy. Inspect within 5 years or following storms. Refer to photo detail.	3	
T12	Lilac	Mature	Root: No evidence of soil movement. Stem: multiple prostrate stems Crown: No recent breakouts or dieback. Risk Assessment: No significant defects visible from ground level.	TFM 23.7.12	Inspect in 5years or following storms Refer to photo detail.	4

T11- sever ivy

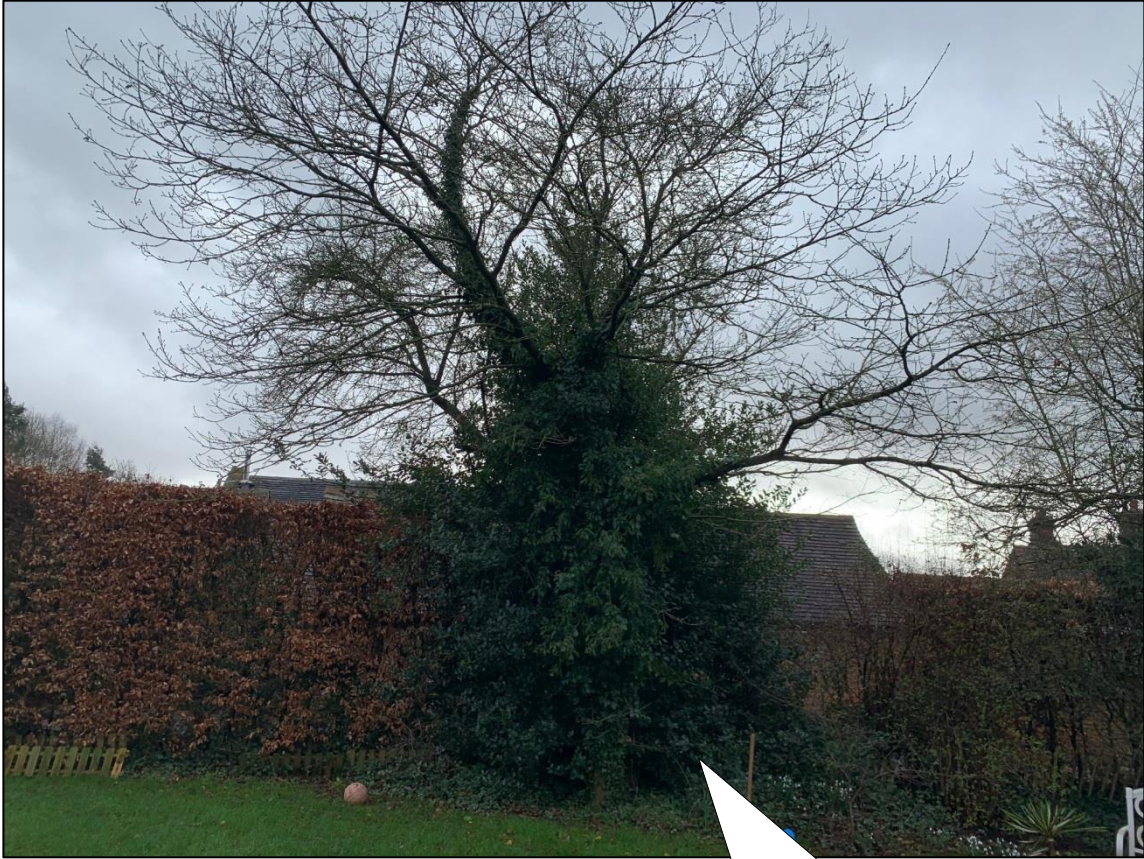
Tree has been removed.	ZA 12.02.2020			
T15	Oak + small damson	Young	Root: No evidence of soil movement. Stem: small wounds occluded Crown: Asymmetric development over lawn. No recent breakouts or dieback. Risk Assessment: No significant defects visible from ground level	TFM 23.7.12	Inspect in 5 years or following storms Refer to photo detail.	4	
			Root: No evidence of soil movement. Stem: obscured by dense holly growth. Crown: Asymmetric development over lawn. No recent breakouts or dieback. Risk Assessment: thorough visual inspection of the stems and around base of stems could not be made due to the dense holly regeneration.	ZA 12.02.2020	Cut back holly to ground level and sever ivy. Inspect within 5 years or following storms. Refer to photo detail.	3

T15- cut back holly and sever ivy to allow for inspection of stems.

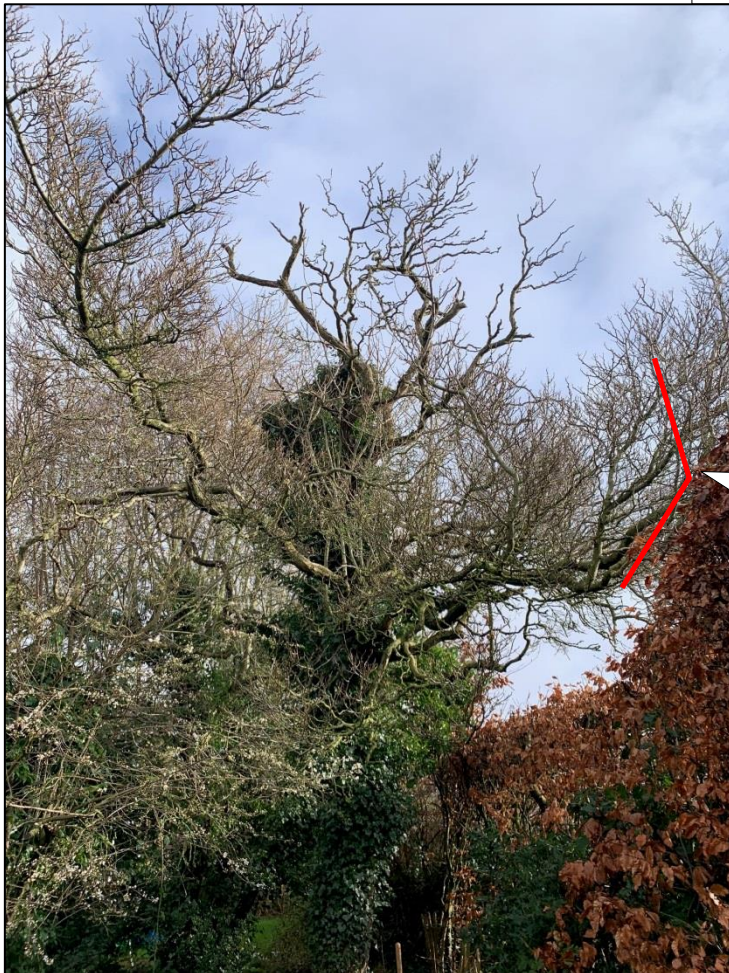
Tree No.	Species	Growth stage	Condition	Date inspected	Action required	Priority level	Date completed
T16	Crataegus cv	Mature small	Root: No evidence of soil movement. Stem: wounds occluded Crown: No recent breakouts. Localised dieback in reduced limbs overhanging the access drive. Risk Assessment: No significant defects visible from ground level	TFM 23.7.12	Inspect in 5 years or following storms Refer to photo detail.	4	
			Root: No evidence of soil movement. Stem: ganoderma fruiting body at base of stem. Ivy obscuring the stem and inner crown. Crown: the top of the crown has completely died back- around 40% crown dieback. Major deadwood. Lower crown is overhanging the boundary wall adjacent to the driveway. No recent breakouts. Risk Assessment: significant dieback in the top of crown which could indicate loss of connectivity between root and shoot. Crown could fail into the driveway.	ZA 12.02.2020	Remove major deadwood and reduce lower limbs by 15% (1m). Give clearance over the driveway. Inspect within 5 years or following storms. Refer to photo detail.	3

T16- remove major deadwood from the top of crown. Reduce lateral branches by 1.5m.

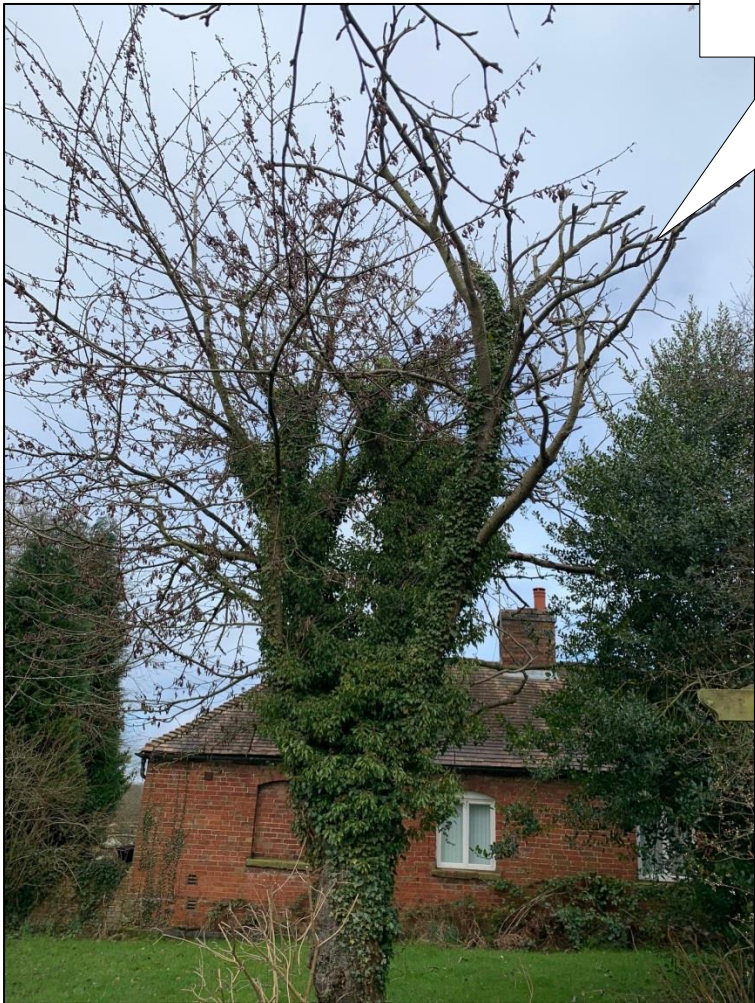
T17	Cherry cv	Late Mature Large	Root: No evidence of soil movement. Stem: multiple large pruning wounds Crown: localised crown dieback on east side associated with large wound sites Risk Assessment: weak wound wood response to largest wound at spring of crown.	TFM 23.7.12	Inspect in 5 years or following storms Refer to photo detail.	4	
			Root: No evidence of soil movement. Stem: multiple large pruning wounds. Stem partially obscured by ivy. Crown: significant dieback on the north and east side affecting 25% of the crown. Major deadwood. Level of dieback appears to have got significantly worse since inspection 2012. Risk Assessment: major deadwood is at risk of failure over the garden. It has already begun to collapse.	ZA 12.02.2020	Fell tree to ground level. Refer to photo detail.	3

T17- fell tree to ground level.
