Structural Report

Ash Farm
Morse Lane
Drybrook
Glos

20093

Anne Sullivan and Hazel Bullock

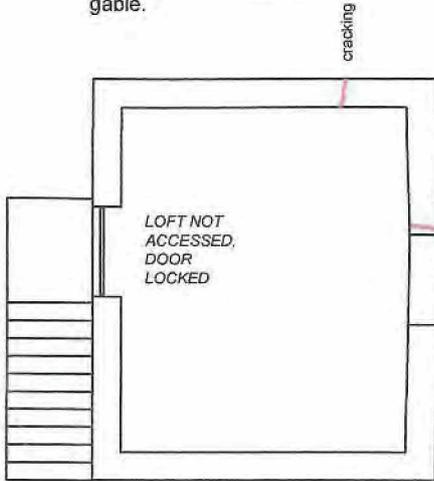
LOFT

Significant movement and cracking in stonework on gable.

Ridge sagging and wall plate bulging above external loft access

Diagonal cracking below access to loft

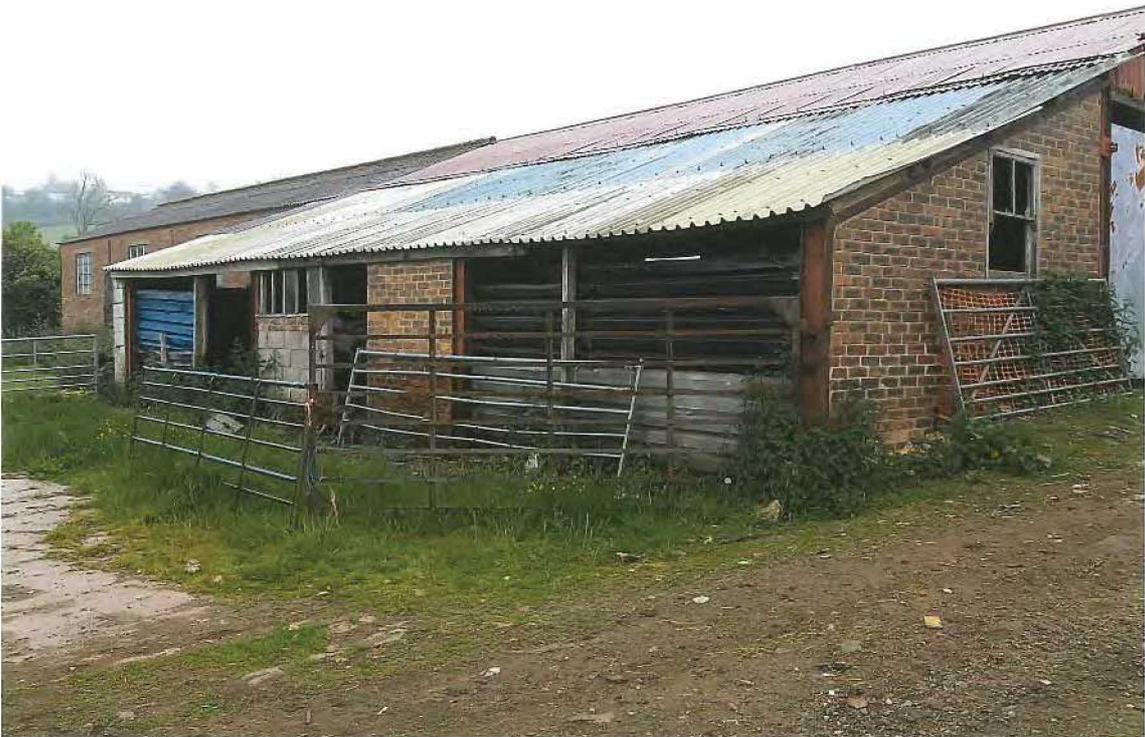
BARN 1 Lower Section

Bays 5- 7 include a lower section which is presumed to have been added to provide additional livestock space. In the lower section the roof has been 'propped' as the timber purlins are in very poor condition.

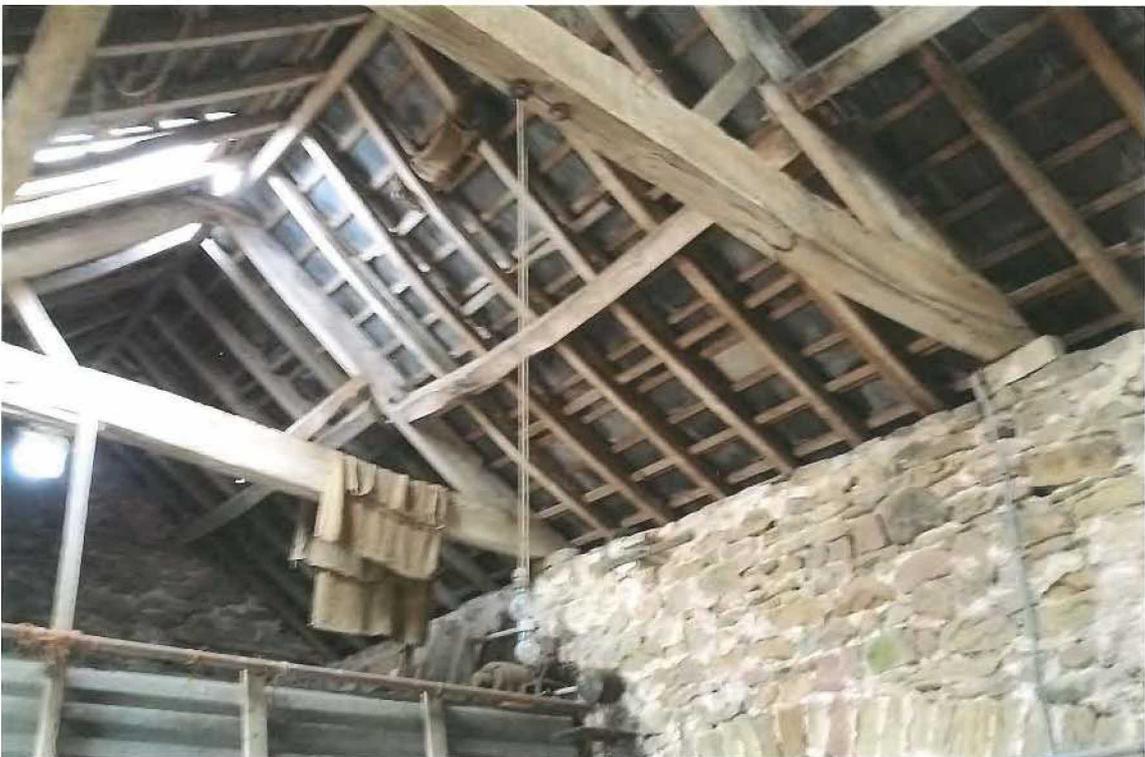
The roof is slate and the batten has been 'packed' off the 'wonky' rafters to achieve an even profile. The mid-span purlins are nominally 150 x 150 hardwood and have a significant sag. It was not established whether the movement is ongoing but it is very probable that strengthening – plating of the purlins - will be required, or that they will have to be replaced.

BARN 2 Sagging Roof structure
